6.0 Grand Junction, Colorado, Disposal Site

6.1 Compliance Summary

The site, 18 miles southeast of Grand Junction, Colorado, was inspected on December 19, 2022. The inspection was conducted by J. Lobato, P. Wetherstein, H. Petrie, R. Mumby, and J. Warkentin of the Legacy Management Support contractor. S. Woods (LM) and M. Cosby (Colorado Department of Public Health and Environment) also attended the inspection. The purposes of the inspection were to confirm the integrity of visible features at the site, identify changes in conditions that might affect conformance with the Interim LTSP, and evaluate whether maintenance or follow-up inspection and monitoring are needed.

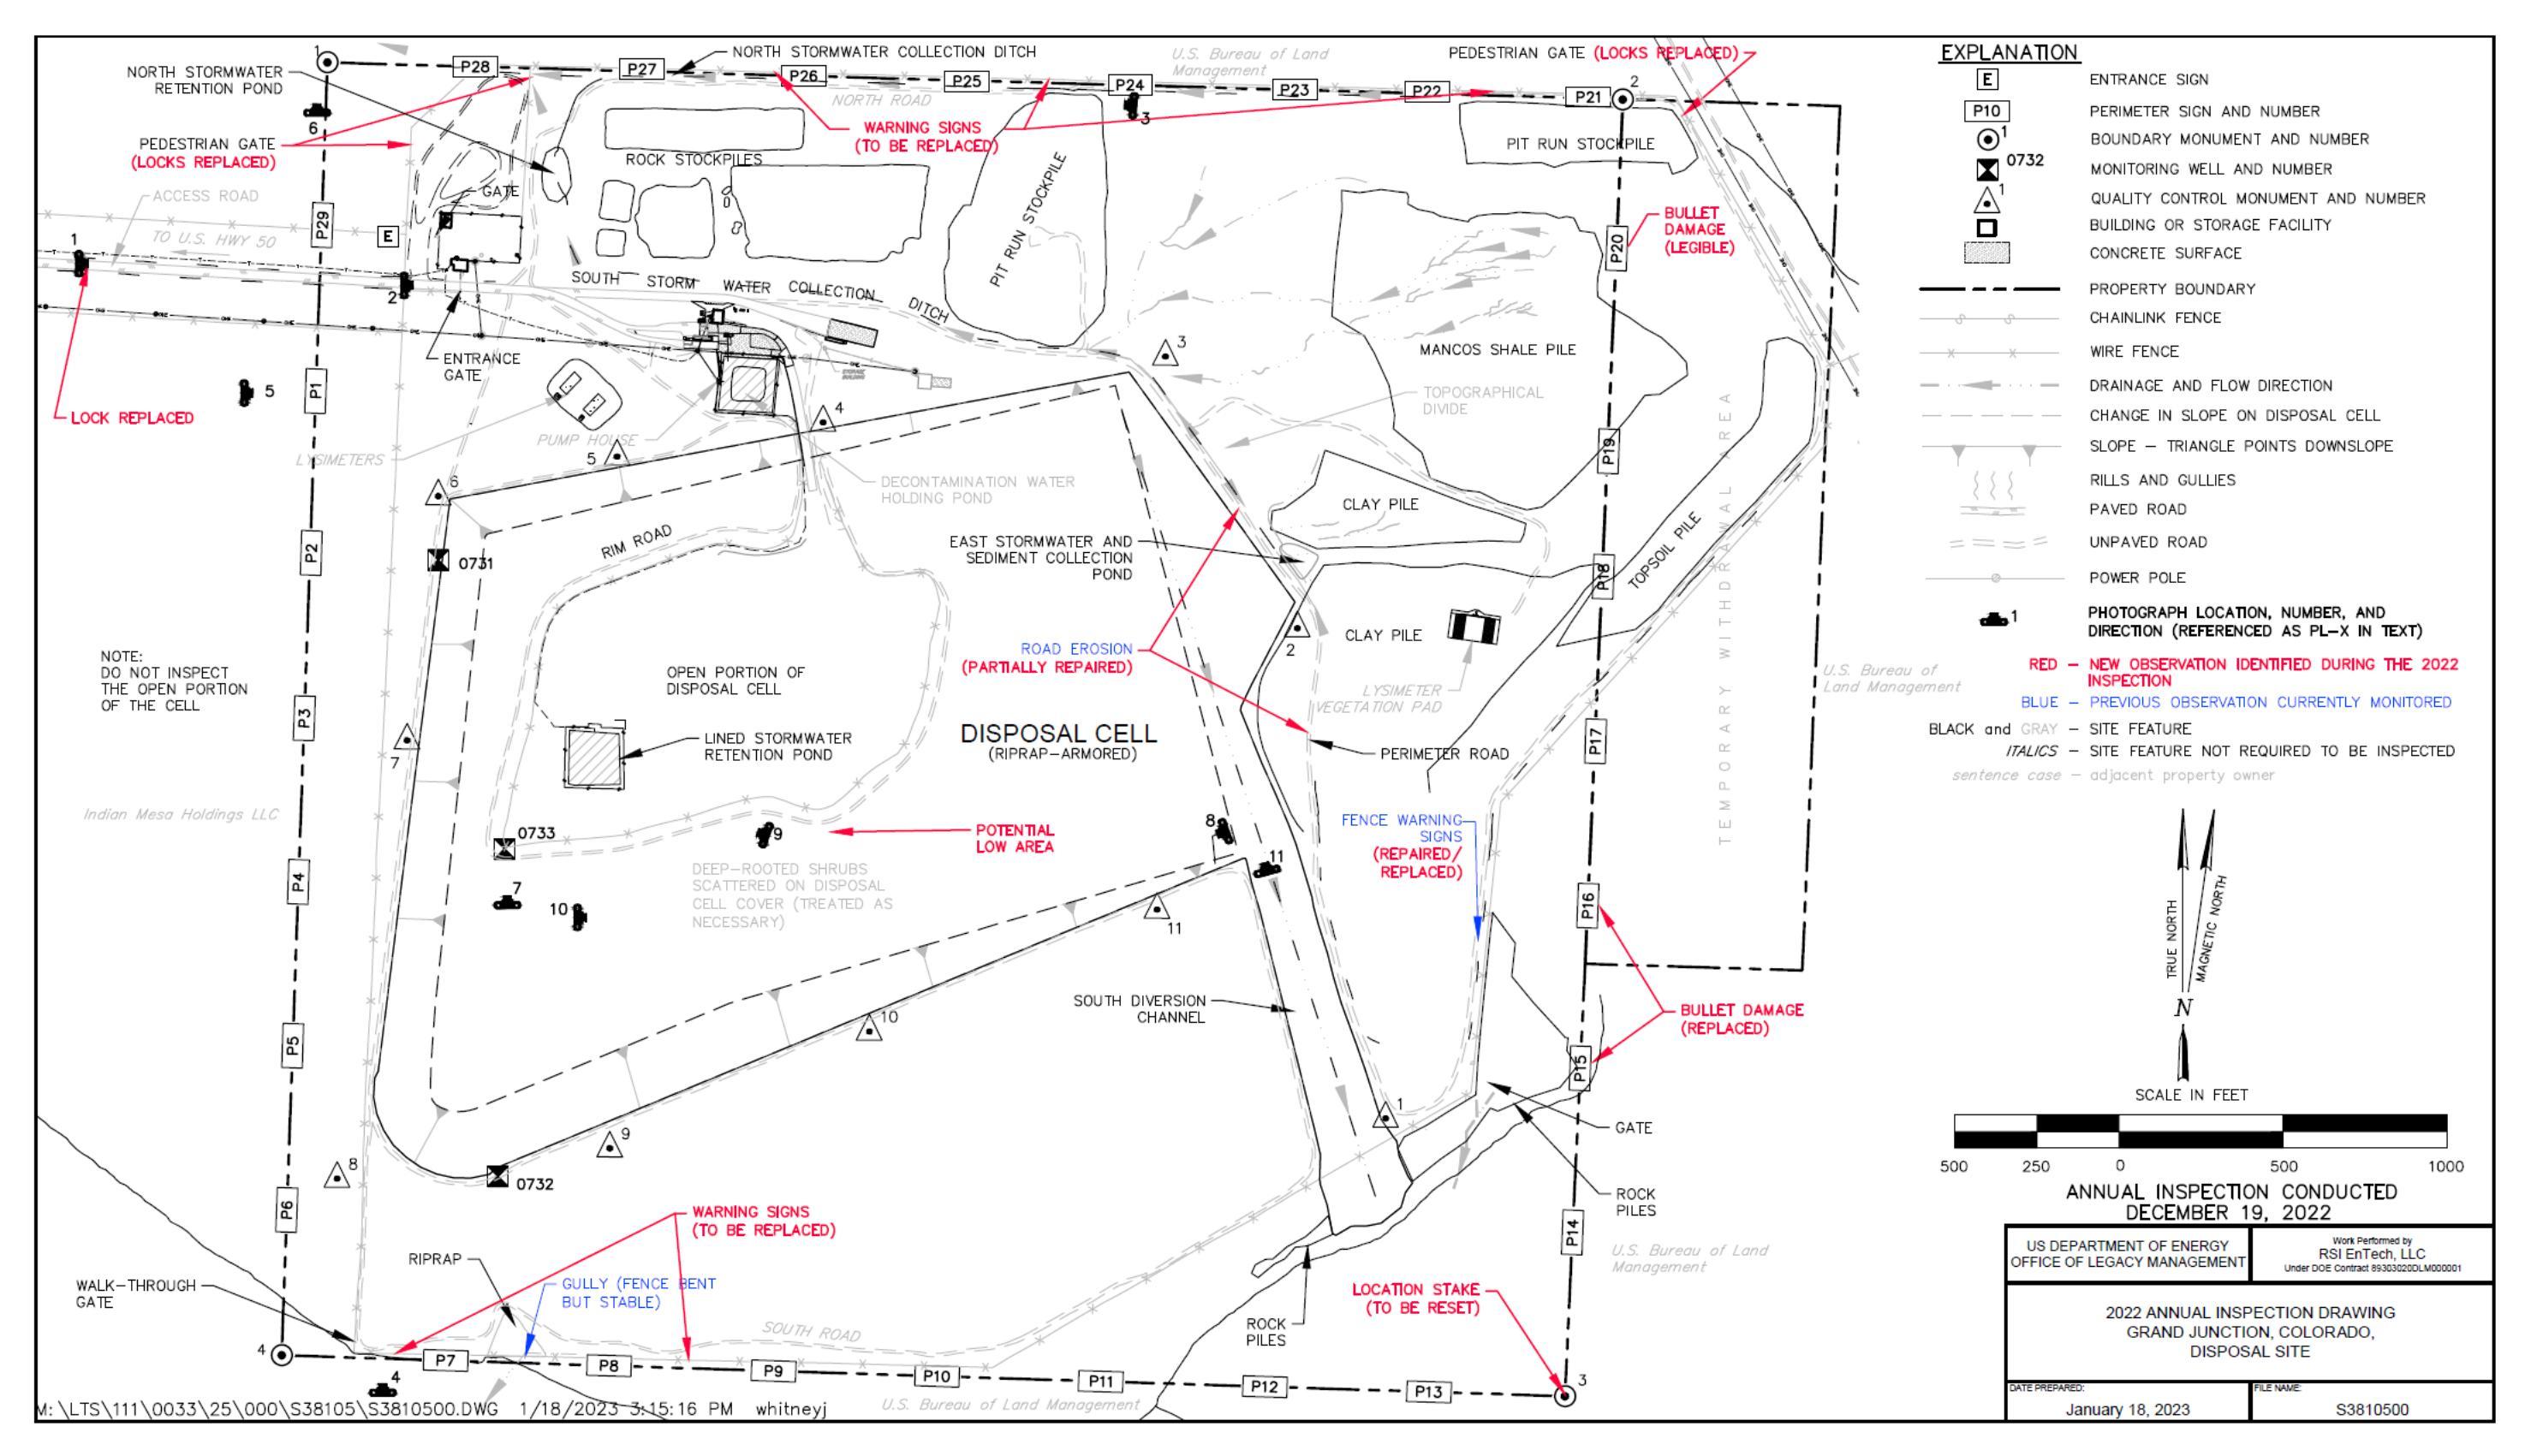
Figure 6-1. 2022 Annual Inspection Drawing for the Grand Junction, Colorado, Disposal Site

Figure 6-1 shows the locations of site features, including site surveillance features and inspection areas, in black and gray font. Some site features that are present but not required to be inspected are shown in italic font. Observations from previous inspections that are currently monitored are shown in blue, and new observations identified during the 2022 annual inspection are shown in red. Inspection results and recommended maintenance activities associated with site surveillance features are described in the following subsections. Photographs to support specific observations are noted in the text and in Figure 6-1 by photograph location (PL) numbers. The photographs and photograph log are presented in Section 6.10.

Most of the flat areas between the disposal cell and the property boundary are vegetated with native shrubs, scant perennial grasses, and annual weeds. This area includes roads adjacent to the inside of the site perimeter fence, the disposal cell, the south diversion channel, the site stormwater collection ditches, and a few other locations. Localized erosion was reported in 2021 at two locations on the perimeter road adjacent to the east side of the south diversion channel (Figure 6-1). Those erosion areas were partially repaired in 2022, and repairs will continue with

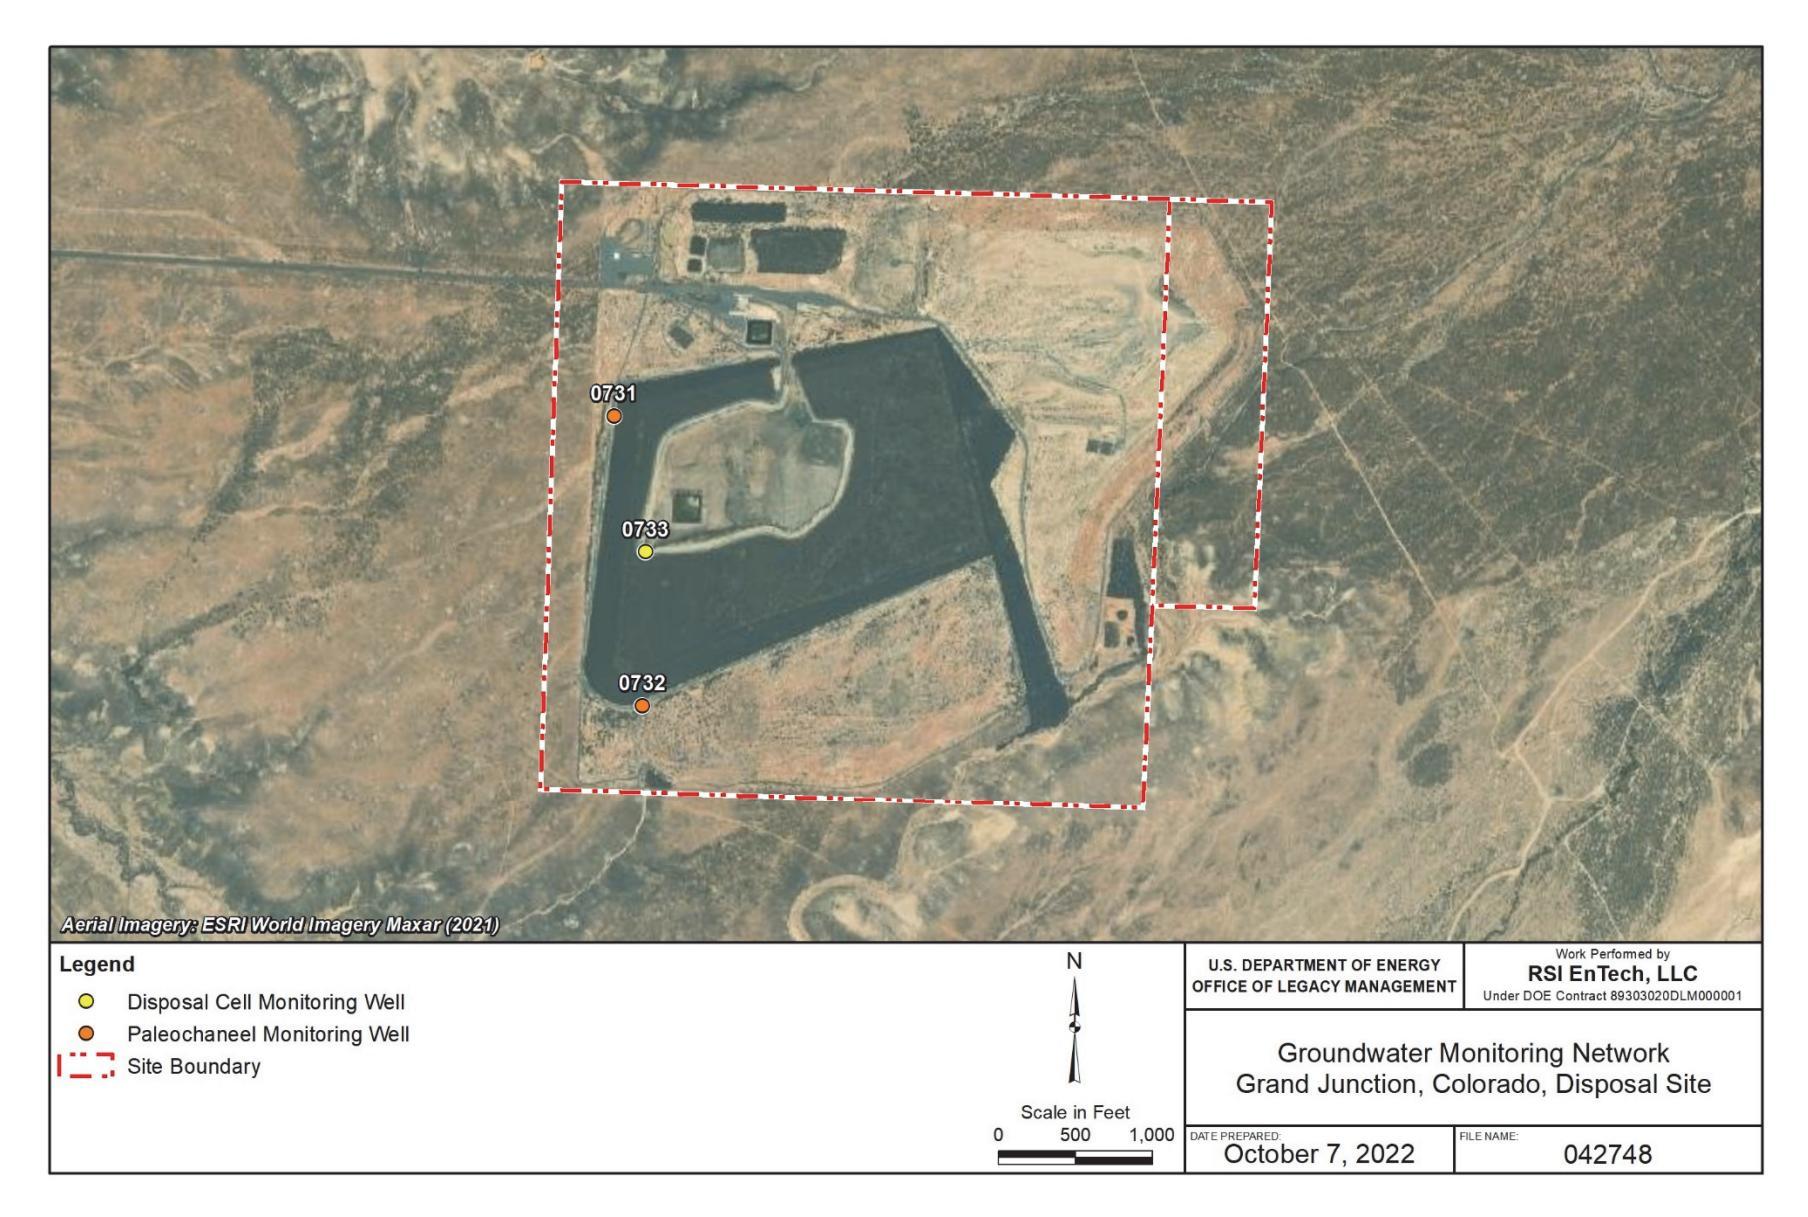
Figure 6-2. Groundwater Monitoring Network for the Grand Junction, Colorado, Disposal Site

Monitoring wells 0731 and 0732 are screened within the alluvial paleochannels adjacent to the disposal cell and extend 5 to 7.5 ft into weathered Mancos Shale. These wells are in two separate paleochannel systems downgradient from the disposal cell (DOE 1998). Monitoring well 0733 is screened below the paleochannel monitoring wells in the lower tailings in the disposal cell (Table 6-2 and Figure 6-2). Disposal cell construction was initiated by excavating Mancos Shale, which resulted in the base of the disposal cell being below the weathered Mancos Shale horizon. Monitoring well 0733 is primarily used to measure water levels within the disposal cell. All groundwater monitoring results for the site are reported and published on the LM Geospatial Environmental Mapping System (GEMS) website (https://gems.lm.doe.gov/#site=GRJ).

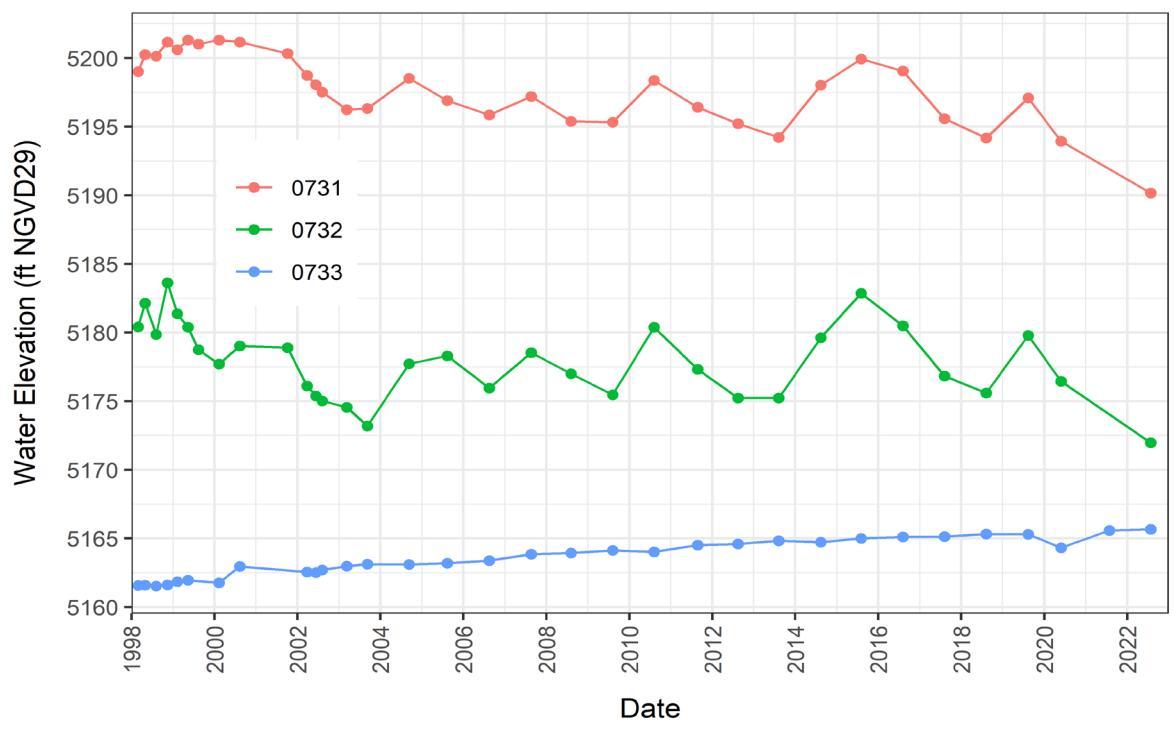
Figure 6-3. Water Level Measurements at the Grand Junction, Colorado, Disposal Site

Static water level measurements are obtained from each monitoring well before water quality samples are collected. Water levels in disposal cell monitoring well 0733 increased approximately 4 ft since 1998 and remain lower than water levels in the two paleochannel monitoring wells (Figure 6-3).

Groundwater levels in wells 0731 and 0732 vary periodically and (for the period from 1998 to 2022) have a slight decreasing trend. The timing of groundwater elevation fluctuations is similar in these two wells (Figure 6-3), suggesting that the two paleochannel systems are influenced by the same upgradient recharge mechanisms. Because the scale in Figure 6-3 spans approximately 40 ft, to provide greater resolution, Figure 6-4 plots the same data using unique scales to better show the magnitude of groundwater elevation fluctuations in each individual well. This figure also includes corresponding continuous water level measurements obtained from pressure transducers installed in each of the wells in accordance with the LTSP (DOE 1998). Higher frequency water level measurements from the pressure transducers enable better understanding of sources of recharge to the paleochannel systems and fluctuations in analyte concentrations.
