ORNL/TM-2000/305

Results of the Indoor Radiological Survey of the Iowa Army Ammunition Plant, Middletown, Iowa

Draft Issued - November 2000

Prepared by the OAK RIDGE NATIONAL LABORATORY Oak Ridge, Tennessee 37831-6285 managed by UT-BATTELLE, LLC, for the U. S. DEPARTMENT OF ENERGY under contract DE-AC05-00OR22725

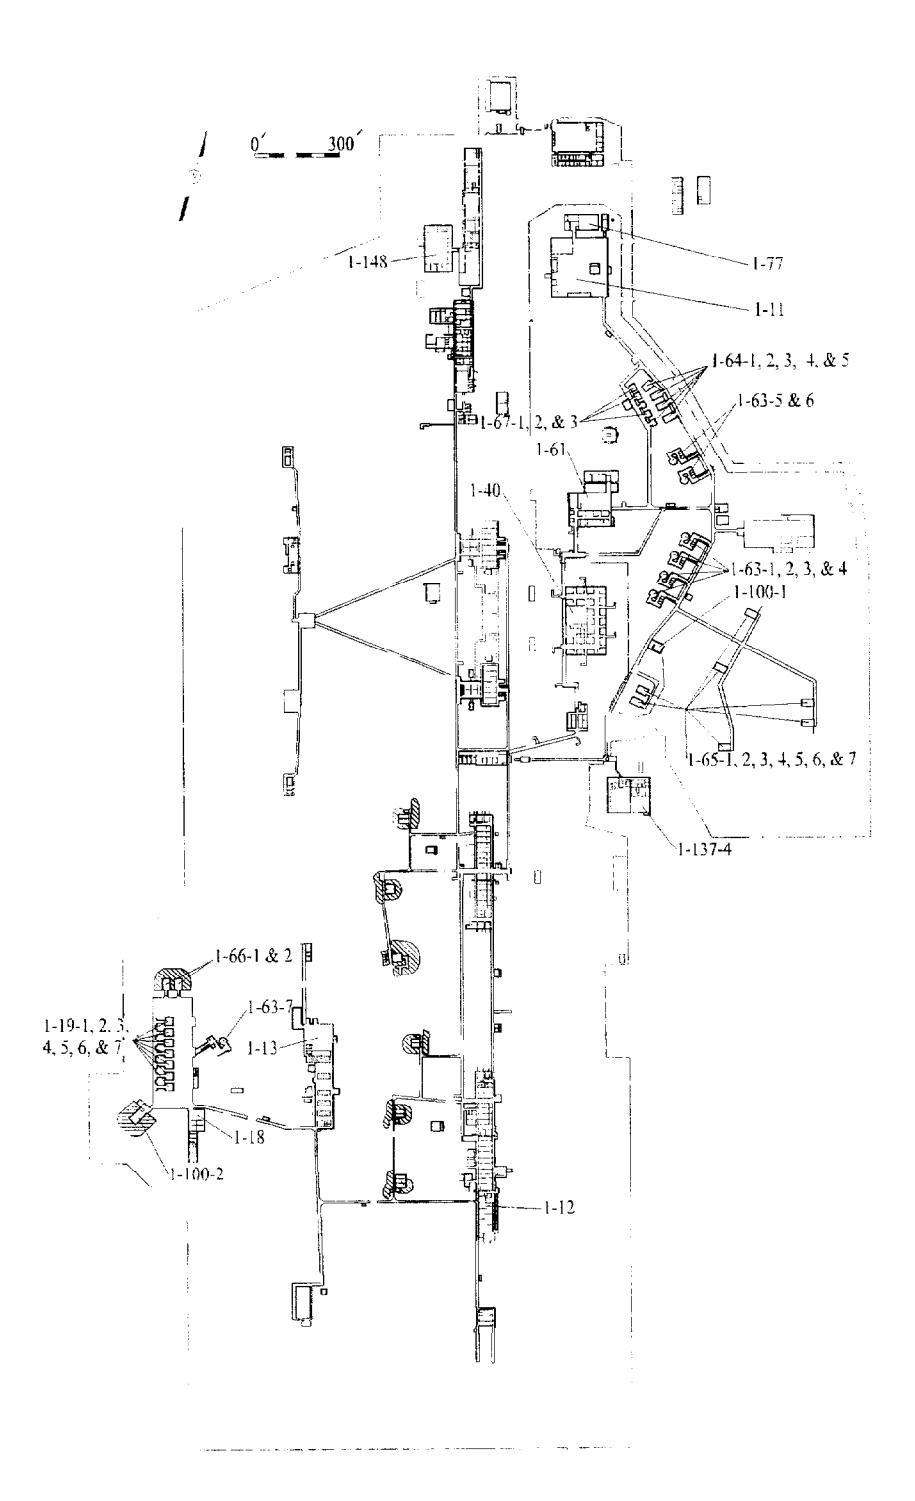
Fig. 3. Diagram showing surveyed buildings at Line 1, IAAAP.

were scanned for both alpha and beta-gamma radiation using portable instrumentation where areas of floor contamination were found. A small percentage of the overhead structures was also surveyed for both alpha and beta-gamma radiation, depending upon how much contamination was detected in floor areas. Measurements were also made on miscellaneous structures, including air ventilation systems, floor drains, equipment and window sills. Special attention was given to areas where contamination typically collects; i.e., cracks, joints, and corners. Surveyed buildings are listed in Table 1 and shown on Fig. 3.
