## 7.0 Green River, Utah, Disposal Site

### 7.1 Compliance Summary

The Green River, Utah, Uranium Mill Tailings Radiation Control Act (UMTRCA) Title I Disposal Site was inspected on April 30, 2024. No changes were observed on the disposal cell or in the associated drainage features. Inspectors identified several minor maintenance issues at the site but did not identify concerns that required a follow-up or contingency inspection.

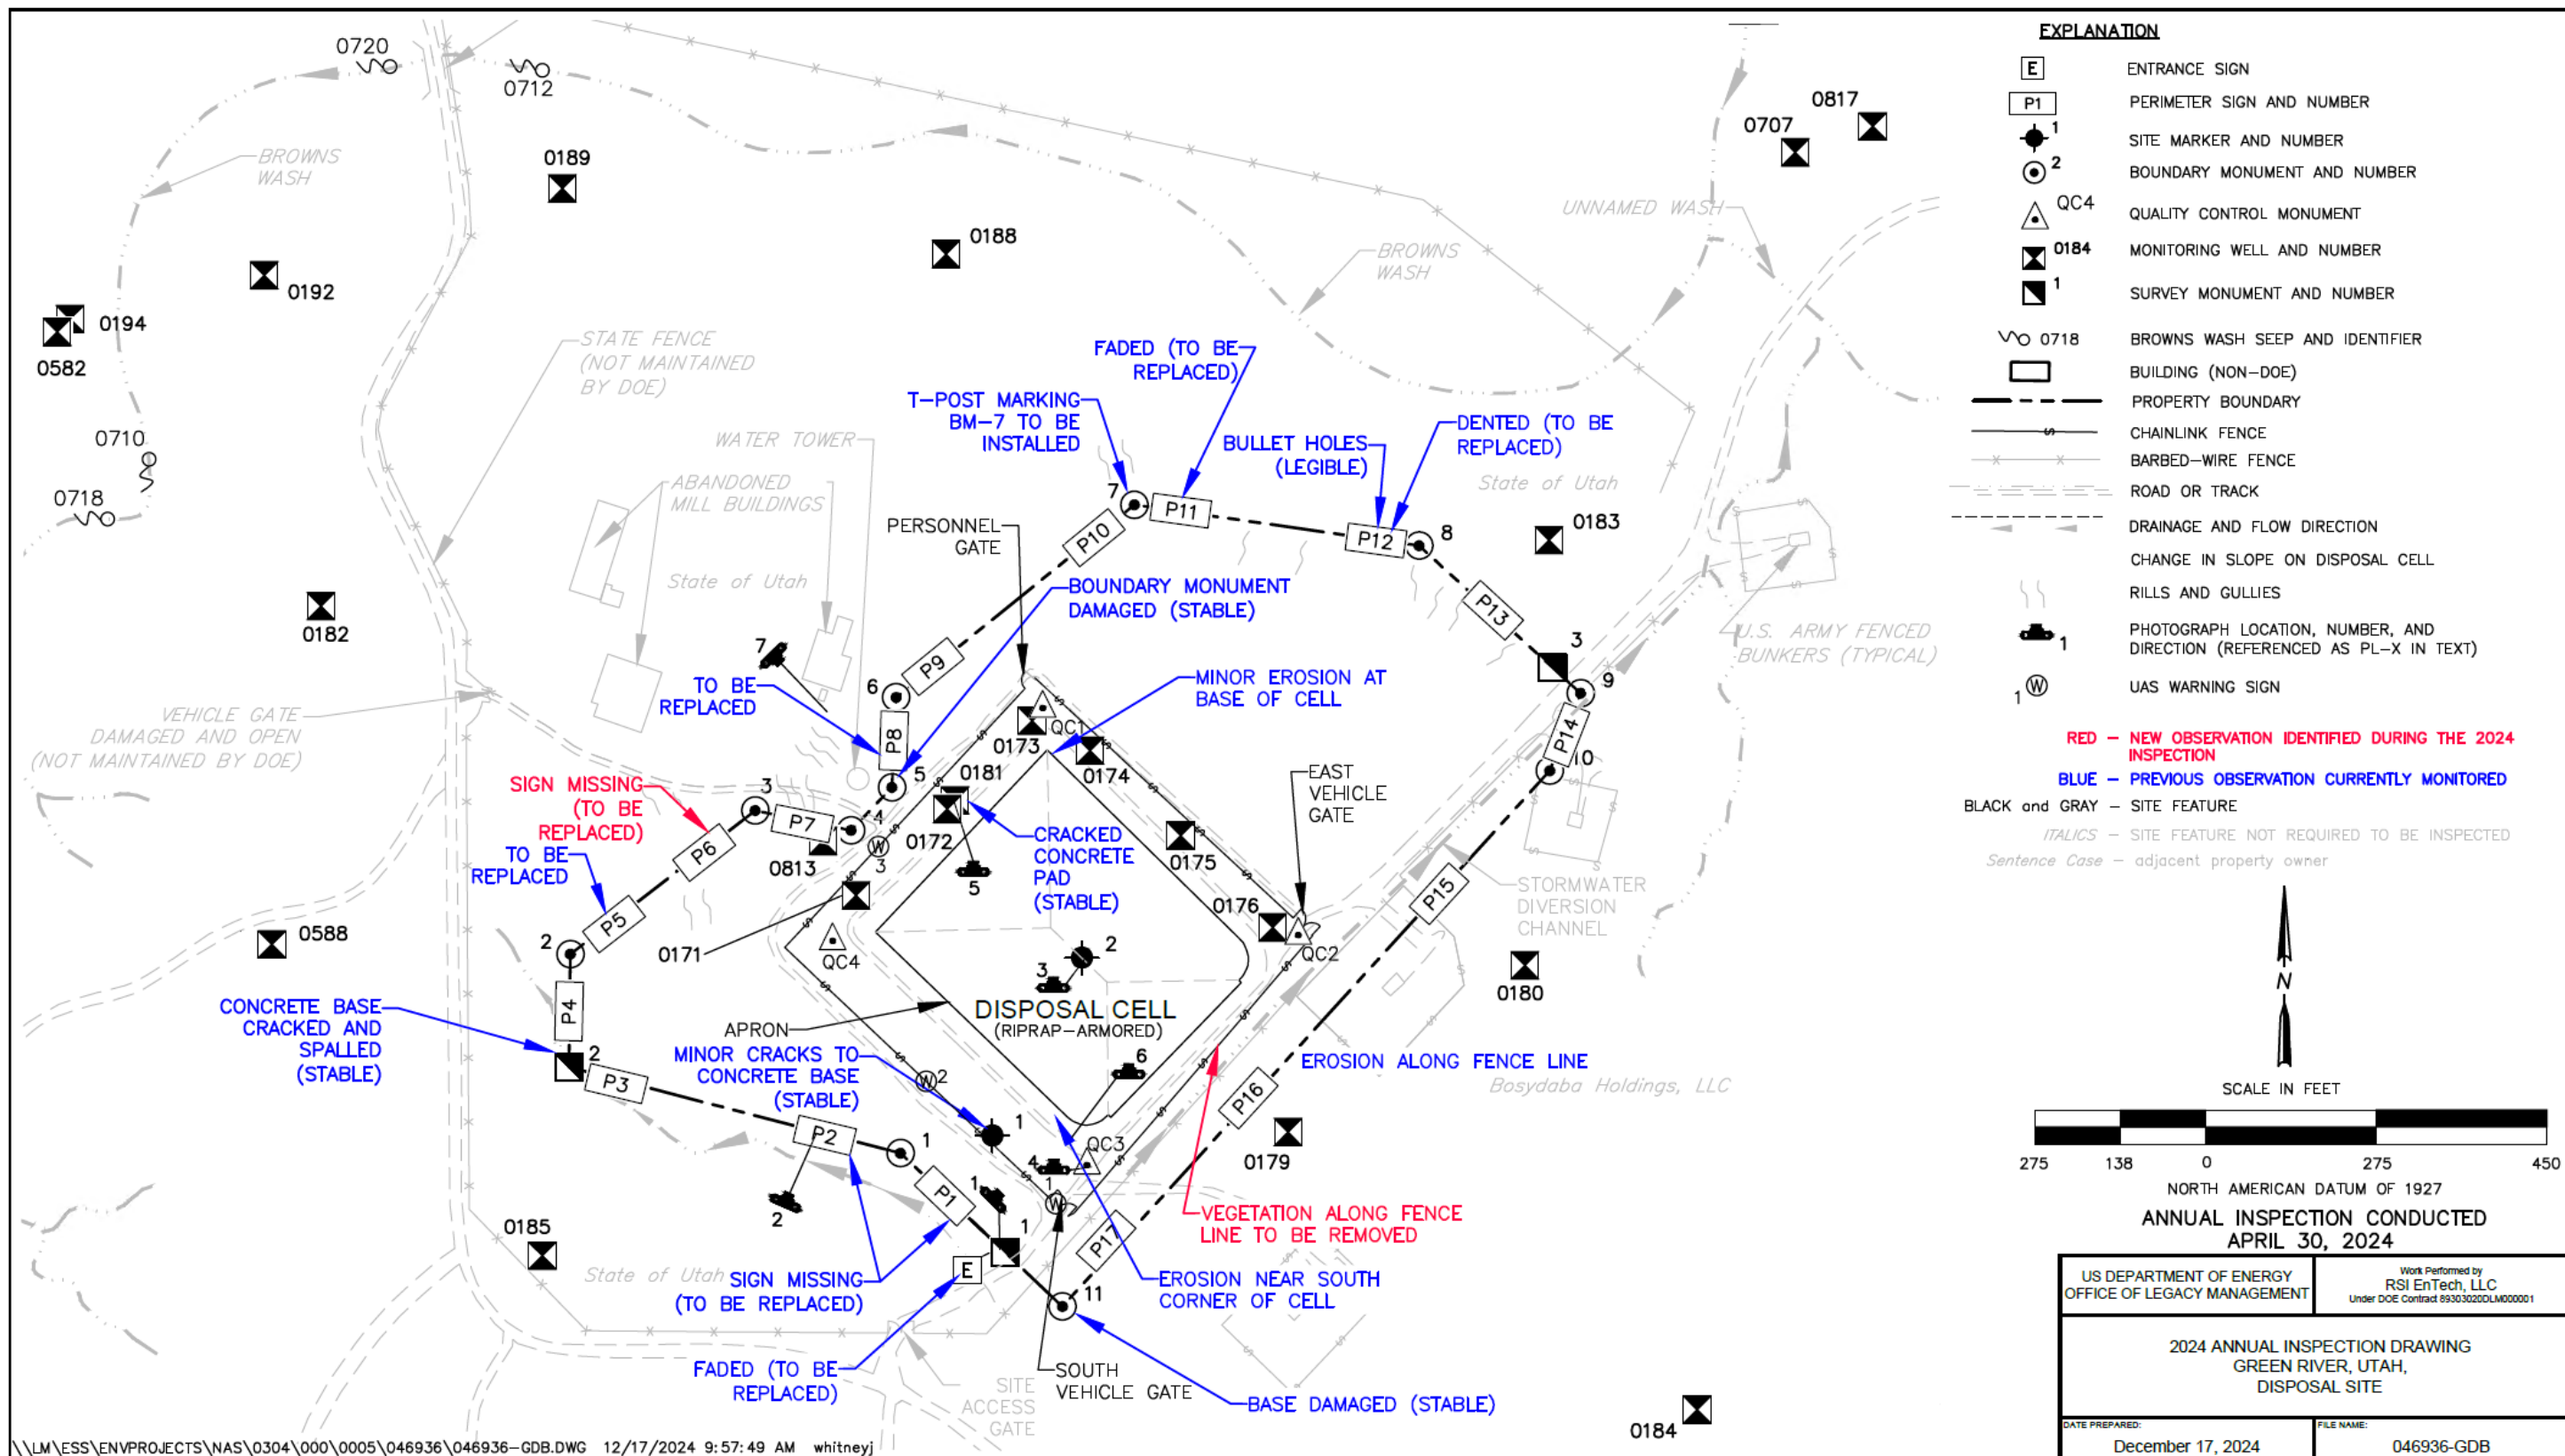
Figure 7-1. 2024 Annual Inspection Drawing for the Green River, Utah, Disposal Site

Figure 7-1 shows the locations of site features, including site surveillance features and inspection areas, in black and gray font. Some site features that are present but not required to be inspected are shown in italic font. Observations from previous inspections that are currently monitored are shown in blue, and new observations identified during the 2024 annual inspection are shown in red. Inspection results and recommended maintenance activities associated with site surveillance features are described in the following subsections. Photographs to support specific observations are noted in the text and in Figure 7-1 by photograph location (PL) numbers. The photographs and photograph log are presented in Section 7.10.

A chainlink security fence encloses the portion of the site that contains the disposal cell. Vehicle gates are at the south and east corners of the security fence, and a personnel gate is at the north corner of the security fence. The security fence was intact, but inspectors observed vegetation growth along the fence line and a buildup of tumbleweeds that will need to be removed. The vegetation will be treated, and the tumbleweeds will be removed before the next annual inspection to ensure that no damage to the fence occurs. A minor erosional rill that was observed under the fence near perimeter sign P16 during the previous inspection seems to be stable. This rill poses little risk at this time because it remains small and is not adjacent to a fence post. Inspectors will continue to monitor this area. The gates were operable and locked at the time of the inspection.

Seventeen perimeter signs, attached to steel posts set in concrete, are positioned along the unfenced property boundary. Perimeter signs P1, P2 (PL-2), P5, and P6 were missing and will be replaced before the next annual inspection. Perimeter signs P8 and P11 were faded and will be replaced before the next annual inspection. Perimeter sign P12 was dented and will be replaced before the next annual inspection. All other perimeter signs were present with several that were dented, had bullet holes, or sun damage (faded or illegible). Perimeter signs P1, P2, P5, P6, P8, P11, and P12 will be replaced before the next annual inspection along with any other perimeter signs exhibiting damage. Two new signs for prohibited activities and emergency instructions were installed along the security fence at the entrance gate during the 2024 inspection. No other maintenance needs were identified.

The site has two granite markers. Site marker SMK-1 is inside the security fence near the southwest corner of the site, and site marker SMK-2 (PL-3) is on the top of the disposal cell. The concrete base of site marker SMK-1 has several minor cracks, but they do not compromise the integrity of the base, and repairs are not necessary at this time. No maintenance needs were identified.

Eleven boundary monuments and three survey monuments delineate the property boundary. As reported in 2021, boundary monument BM-5 is bent from being hit by a vehicle, and the concrete base around survey monument SM-2 is cracked and spalled. Both boundary monument BM-5 and survey monument SM-2 are fully functional, and repairs of these monuments are not needed at this time but will be continually monitored. The base of boundary monument BM-11 is damaged but stable, and no repairs are needed at this time. Boundary monument BM-7 is difficult to find and will be marked with a T-post before the next annual inspection.

Twenty-two monitoring wells are on or near the site. The LTSP establishes four POC wells at the site for postclosure groundwater monitoring. All wellhead protectors observed during the inspection were undamaged. Monitoring well 0181 has a cracked concrete pad (PL-5). Some of the concrete monitoring well pads were cracked, but the wellhead protectors at those wells are stable, and repairs are not necessary at this time. No other maintenance needs were identified.

A boulder-filled trench, known as an apron, surrounds the disposal cell. The apron was intact and stable. Inspectors noted small (less than 8 square feet) instances of erosion and possible soil piping features along the base of the side slopes that have been observed during previous inspections. The rills and piping features are formed from stormwater runoff along the perimeter road draining into the disposal cell apron. This occurrence is not a concern because the erosion is minor and the sediment has not filled the apron or become visible in the apron, indicating that the apron's performance is not adversely affected. Inspectors will continue to monitor these features. Possible erosion or an animal burrow was found on the south corner of the drainage channel (PL-6). Inspectors will continue to monitor the area in the future. No additional maintenance is needed.

Signs of erosion noted during previous inspections appear in multiple areas in the site perimeter. Erosional rills are present on the west side of the site near perimeter sign P7 and the water tower (PL-7) but are currently not affecting site surveillance features. Rills and gullies are also present along the escarpment northeast of the disposal cell between boundary monument BM-7 and survey monument SM-3 (approximately 400 feet [ft] from the base of the disposal cell). The maximum gully depth in this area is approximately 3 ft, but the erosion appears to be stabilizing as larger rocks drop to the bottom of the gullies and provide armoring. A portion of the

stormwater diversion channel along the southeast side of the site continues to erode slowly. These erosional features could eventually damage site surveillance features (i.e., perimeter signs, boundary monuments, and the security fence). The closest erosional features are approximately 300 ft from the disposal cell and do not pose a risk to its integrity at this time. Inspectors will continue to monitor these features. No immediate maintenance needs were identified.

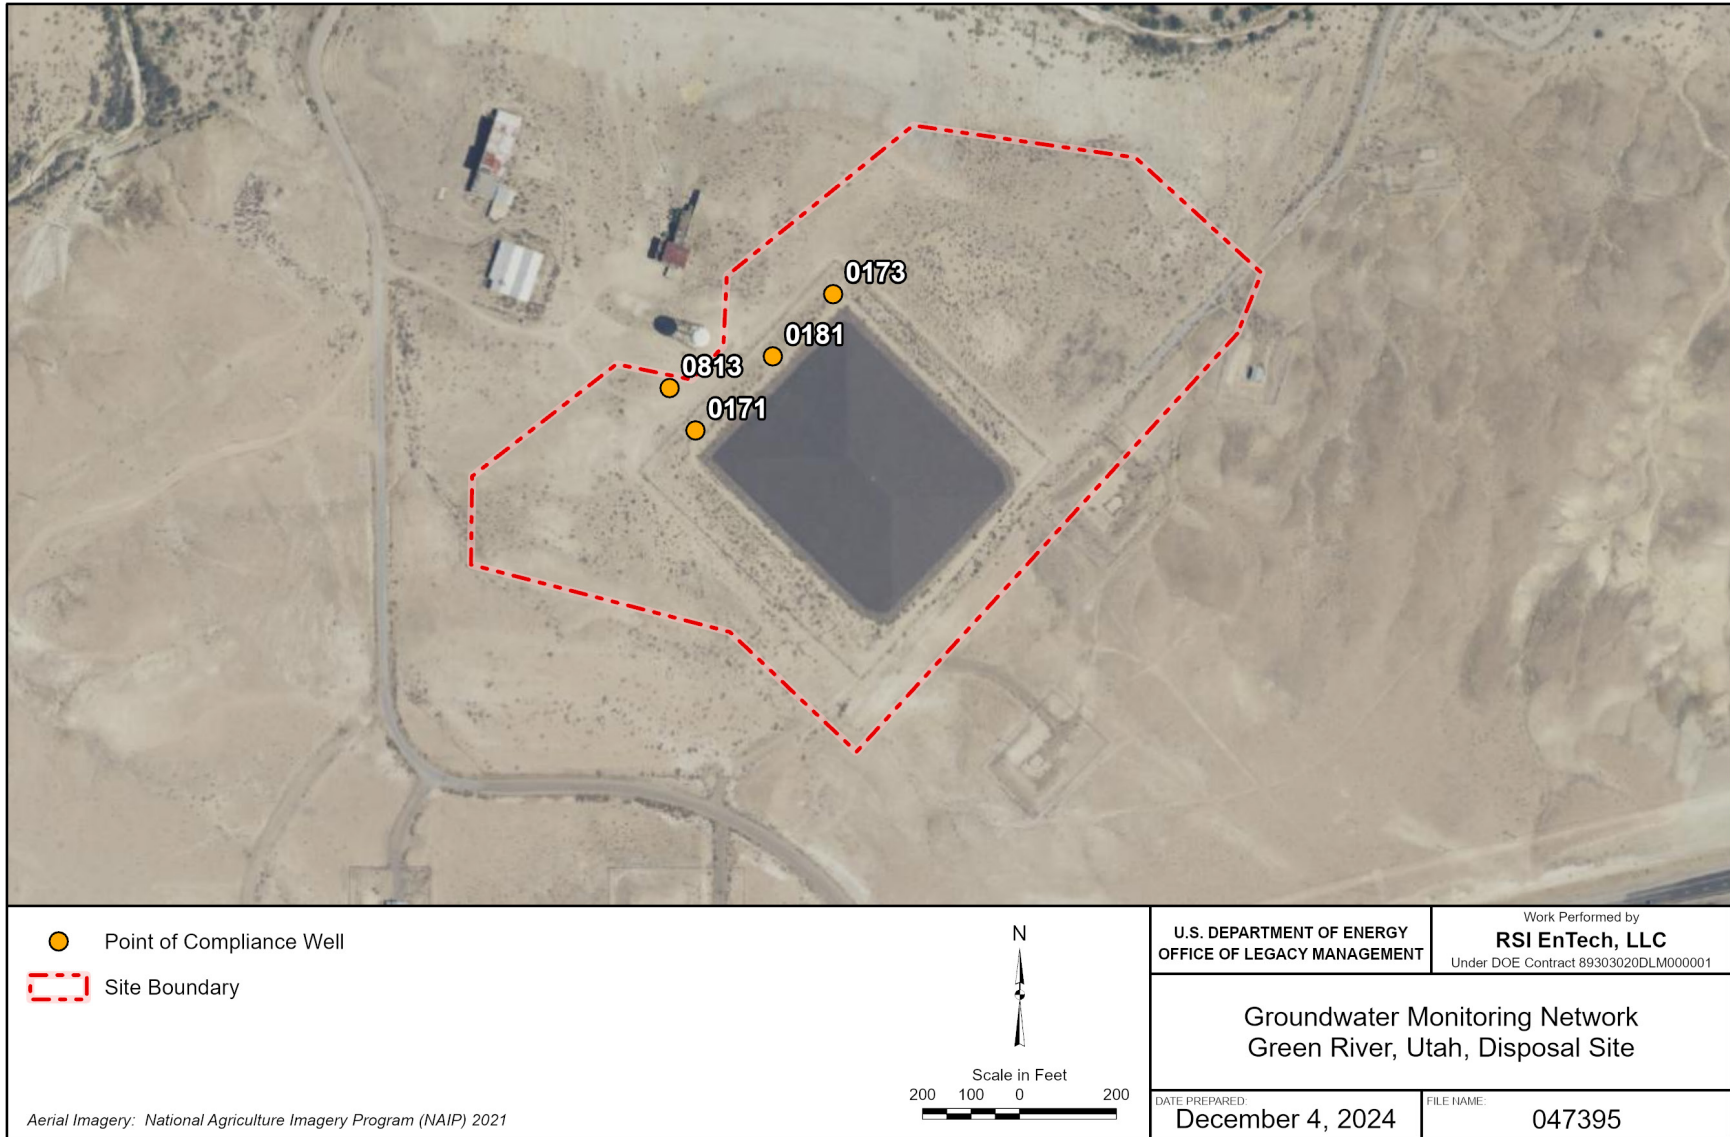
*Figure 7-2. POC Groundwater Monitoring Network at the Green River, Utah, Disposal Site*

In accordance with the LTSP, annual groundwater monitoring is conducted at four POC wells to evaluate the performance of the disposal cell (DOE 1998). The most recent sampling event occurred on June 10, 2024. The locations of the four POC wells are shown in Figure 7-2. Table 7-2 lists the wells included in the current site groundwater monitoring network.

**Note:** Well 0181 was installed in June 2002 to replace former POC well 0172 (refer to discussion in text).
