8.0 Gunnison, Colorado, Disposal Site

8.1 Compliance Summary

The U.S. Department of Energy (DOE) Office of Legacy Management (LM) conducted the Gunnison, Colorado, Uranium Mill Tailings Radiation Control Act (UMTRCA) Title I Disposal Site inspection on September 7, 2021. No cause for a follow-up inspection was identified.

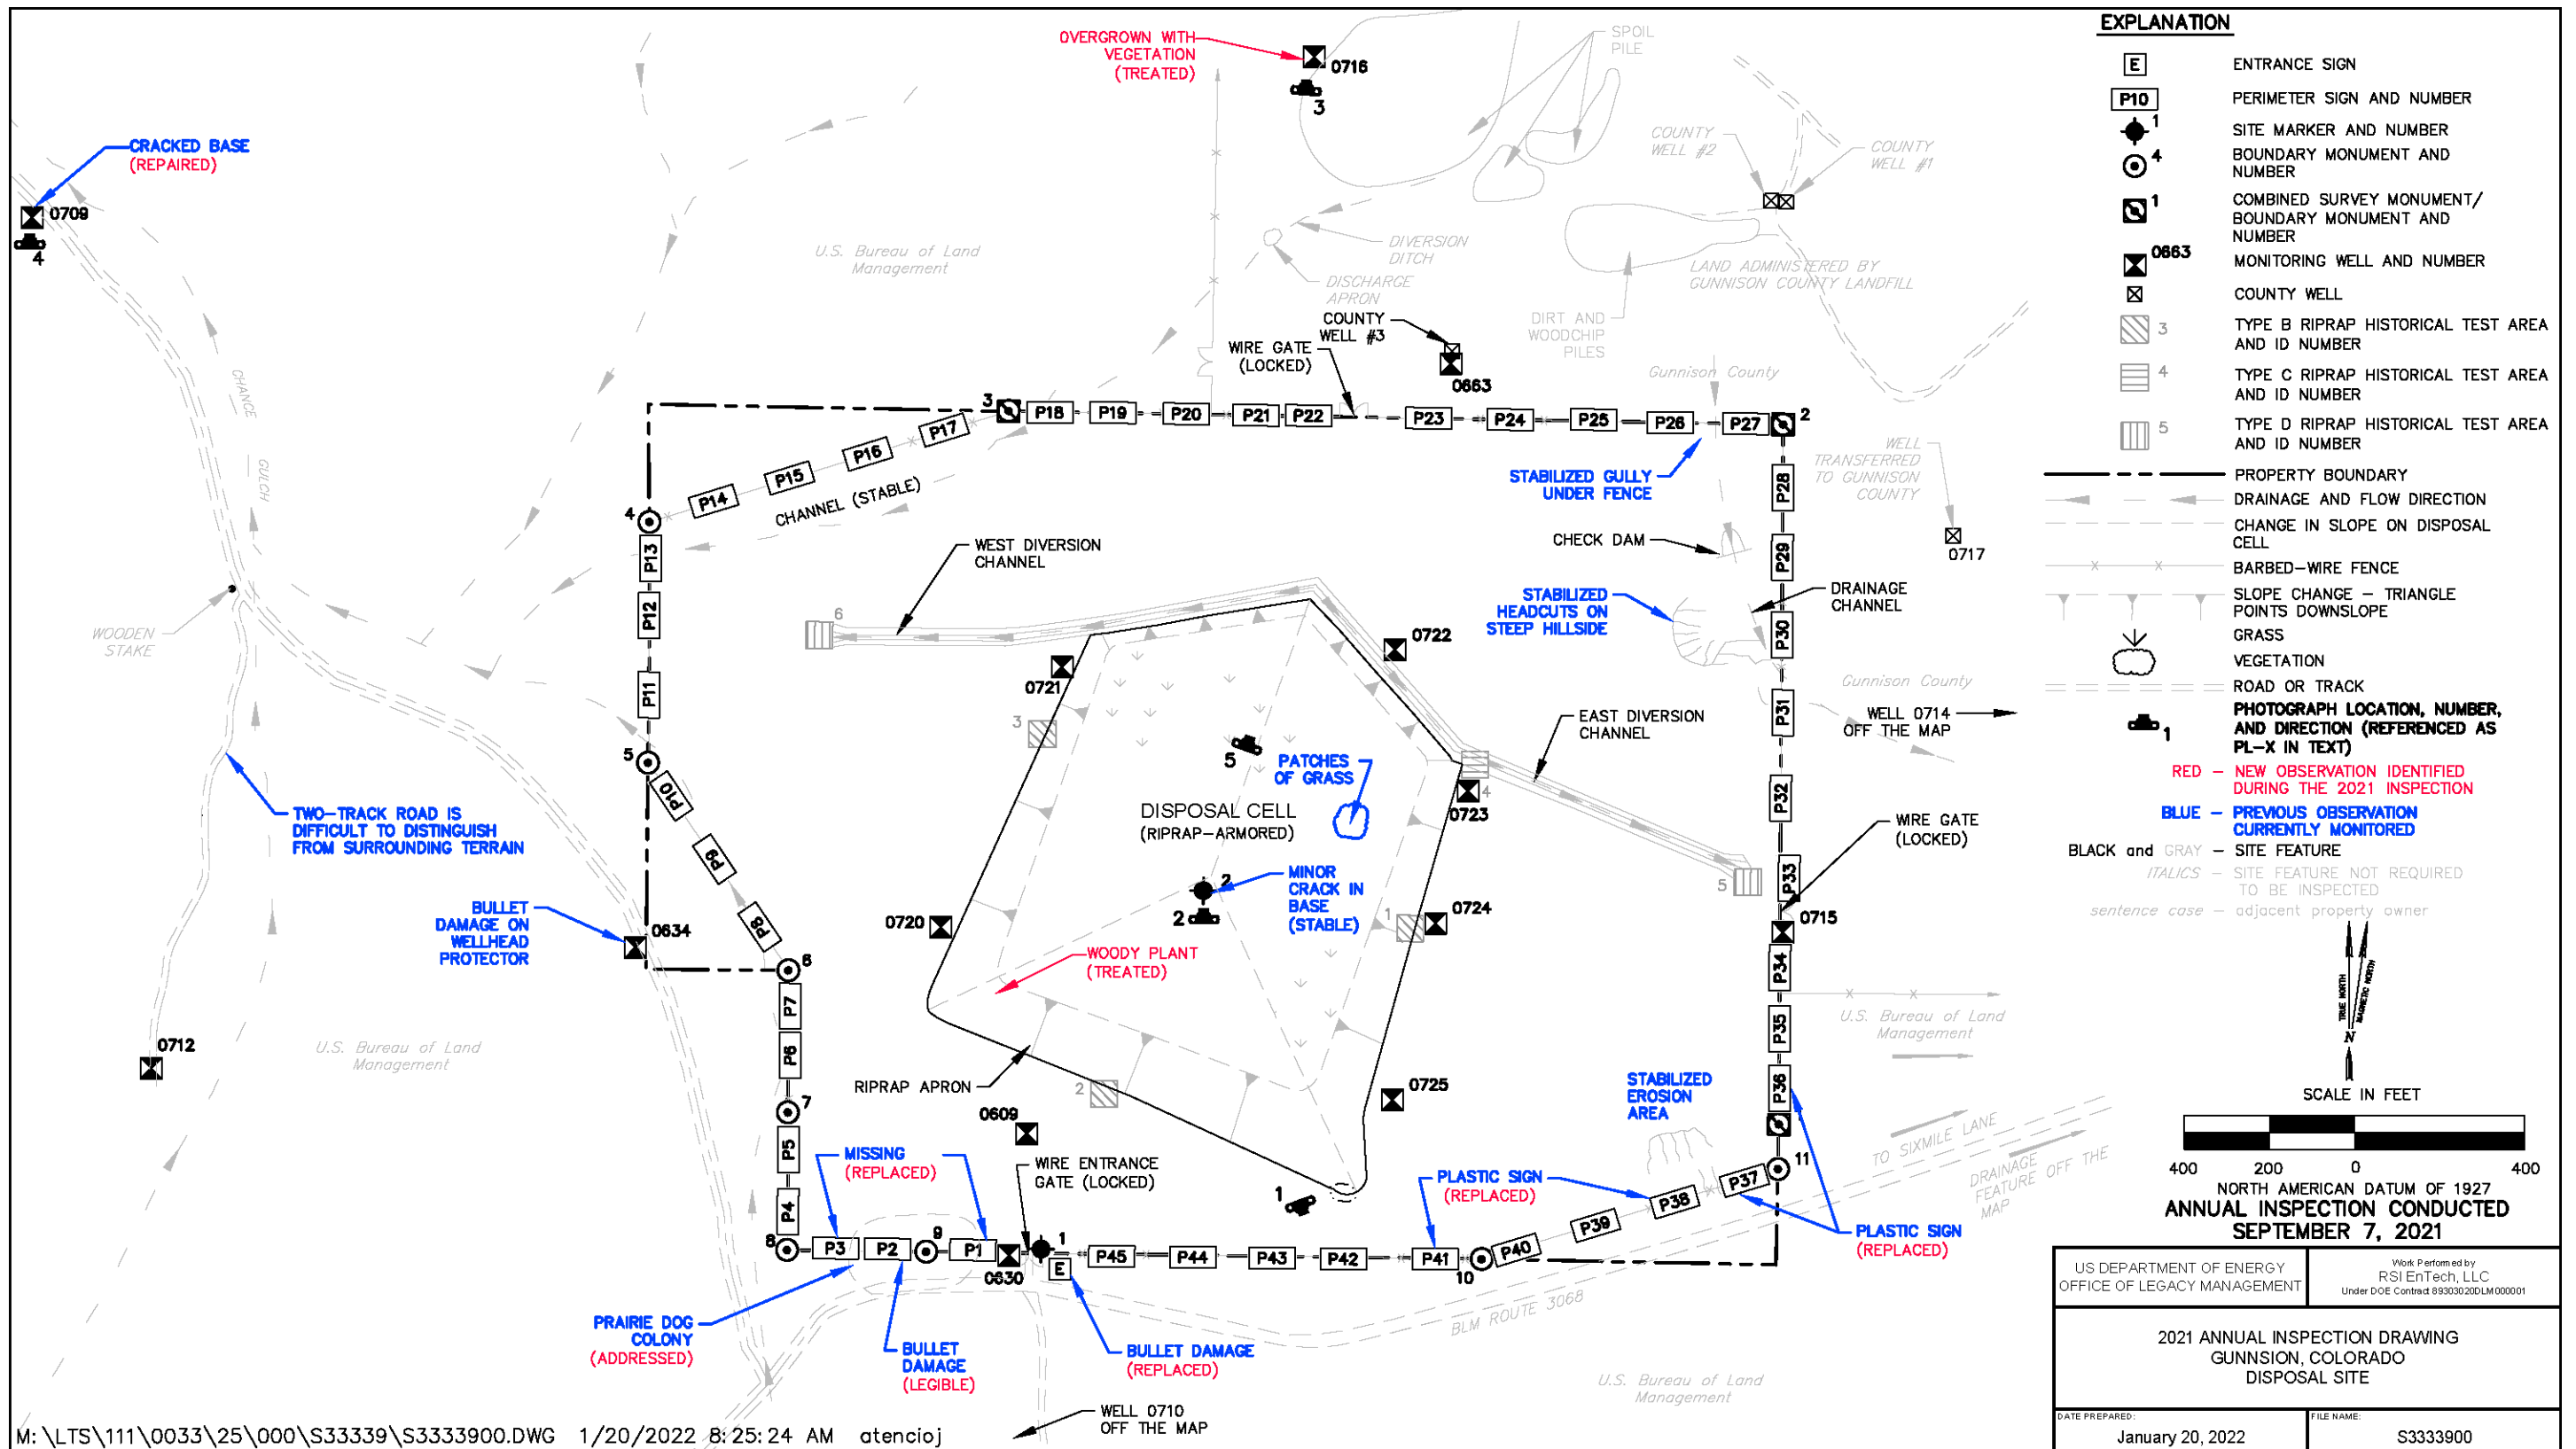
Figure 8-1. 2021 Annual Inspection Drawing for the Gunnison, Colorado, Disposal Site

Figure 8-1 shows the locations of site features, including site surveillance features and inspection areas, in black and gray font. Site features that are present but not required to be inspected are shown in italic font. Observations from previous inspections that are currently monitored are shown in blue text, and new observations identified during the 2021 annual inspection are shown in red. Inspection results and recommended maintenance activities associated with site surveillance features are included in the following subsections. Photographs to support specific observations are identified in the text and in Figure 8-1 by photograph location (PL) numbers. The photographs and photograph log are presented in Section 8.10.

There are 45 perimeter signs bolted to the perimeter fence posts. Several perimeter signs have bullet damage but remain legible. Perimeter sign P3 was missing, and other perimeter signs constructed of plastic were faded and curling and were replaced following the inspection. Bullet damage to perimeter sign P1, identified in 2019, was replaced after the 2021 inspection. No other maintenance needs were identified.

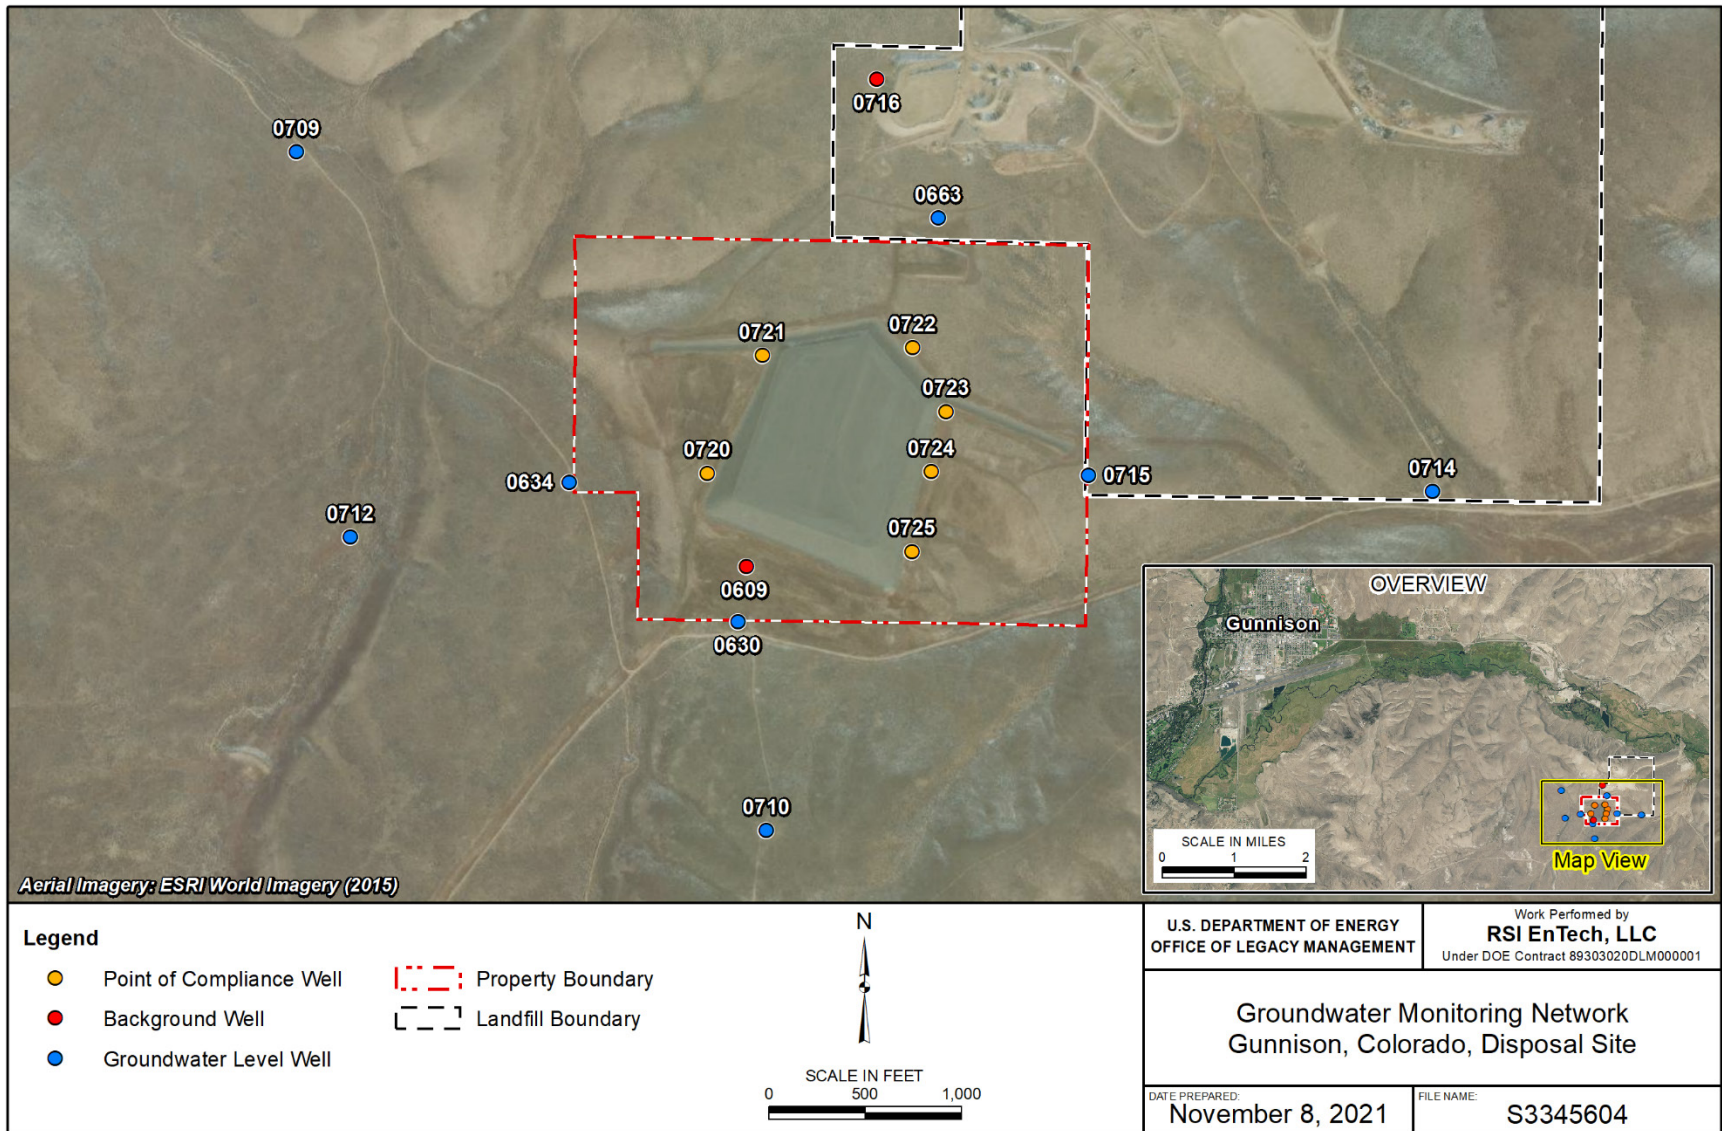
Figure 8-2. Groundwater Monitoring Network at the Gunnison, Colorado, Disposal Site

The groundwater monitoring network consists of 16 monitoring wells. That total includes six POC wells, two monitoring wells to monitor background groundwater quality, and eight wells to monitor groundwater levels (Table 8-2 and Figure 8-2). The indicator analyte for disposal cell performance is uranium, which was selected because of its presence in tailings pore fluid, relatively high mobility in groundwater, and low concentration in background groundwater samples (DOE 1997) (Figure 2.5). The site-specific screening monitoring action level (action level) concentration for uranium is 0.013 milligram per liter (mg/L). The basis for this action level is the maximum observed concentration of uranium in background samples before long-term surveillance and maintenance activities began. The U.S. Environmental Protection Agency established a maximum concentration limit for uranium of 0.044 mg/L in groundwater (40 CFR 192 Subpart A Table 1). Water levels are measured at each monitoring well during groundwater monitoring events.
