8.0 Gunnison, Colorado, Disposal Site

The U.S. Department of Energy (DOE) Office of Legacy Management (LM) conducted the Gunnison, Colorado, Uranium Mill Tailings Radiation Control Act (UMTRCA) Title I Disposal Site inspection on September 7, 2022. No cause for a follow-up inspection was identified.

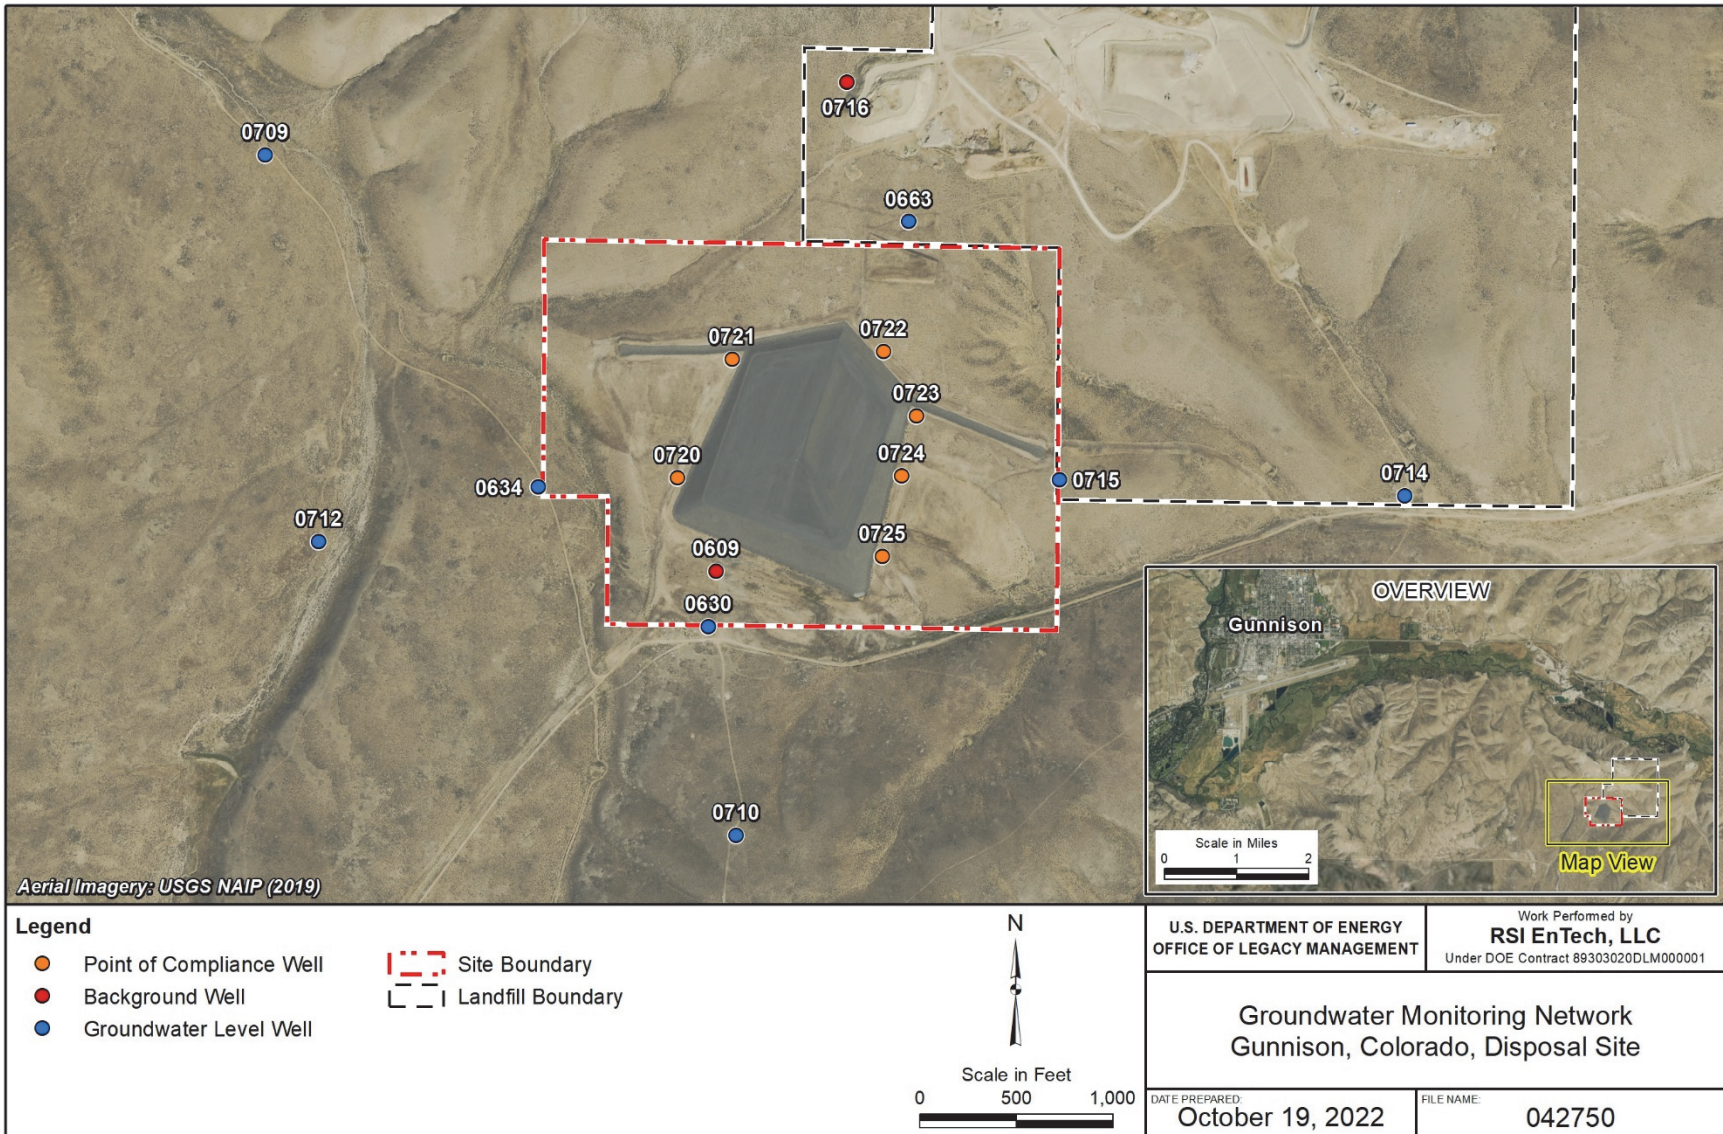
Figure 8-2. Groundwater Monitoring Network at the Gunnison, Colorado, Disposal Site

Table 8-2 lists the site's groundwater monitoring network, and Figure 8-2 presents the locations of the groundwater monitoring network.
