## 8.0 Gunnison, Colorado, Disposal Site

The U.S. Department of Energy (DOE) Office of Legacy Management (LM) conducted the Gunnison, Colorado, Uranium Mill Tailings Radiation Control Act (UMTRCA) Title I Disposal Site inspection on August 31, 2023. No cause for a follow-up inspection was identified.

The site, 6 miles southeast of Gunnison, Colorado, was inspected on August 31, 2023. The inspection was conducted by J. Lobato and M. Guziak of the Legacy Management Support contractor. M. Hurt (LM site manager), M. Cosby (Colorado Department of Public Health and Environment), and M. Schmidt and S. Casebolt (Gunnison County Public Works) also attended the inspection. The purposes of the inspection were to confirm the integrity of visible features at the site, identify changes in conditions that might affect conformance with the LTSP, and evaluate whether maintenance or follow-up inspection and monitoring are needed.

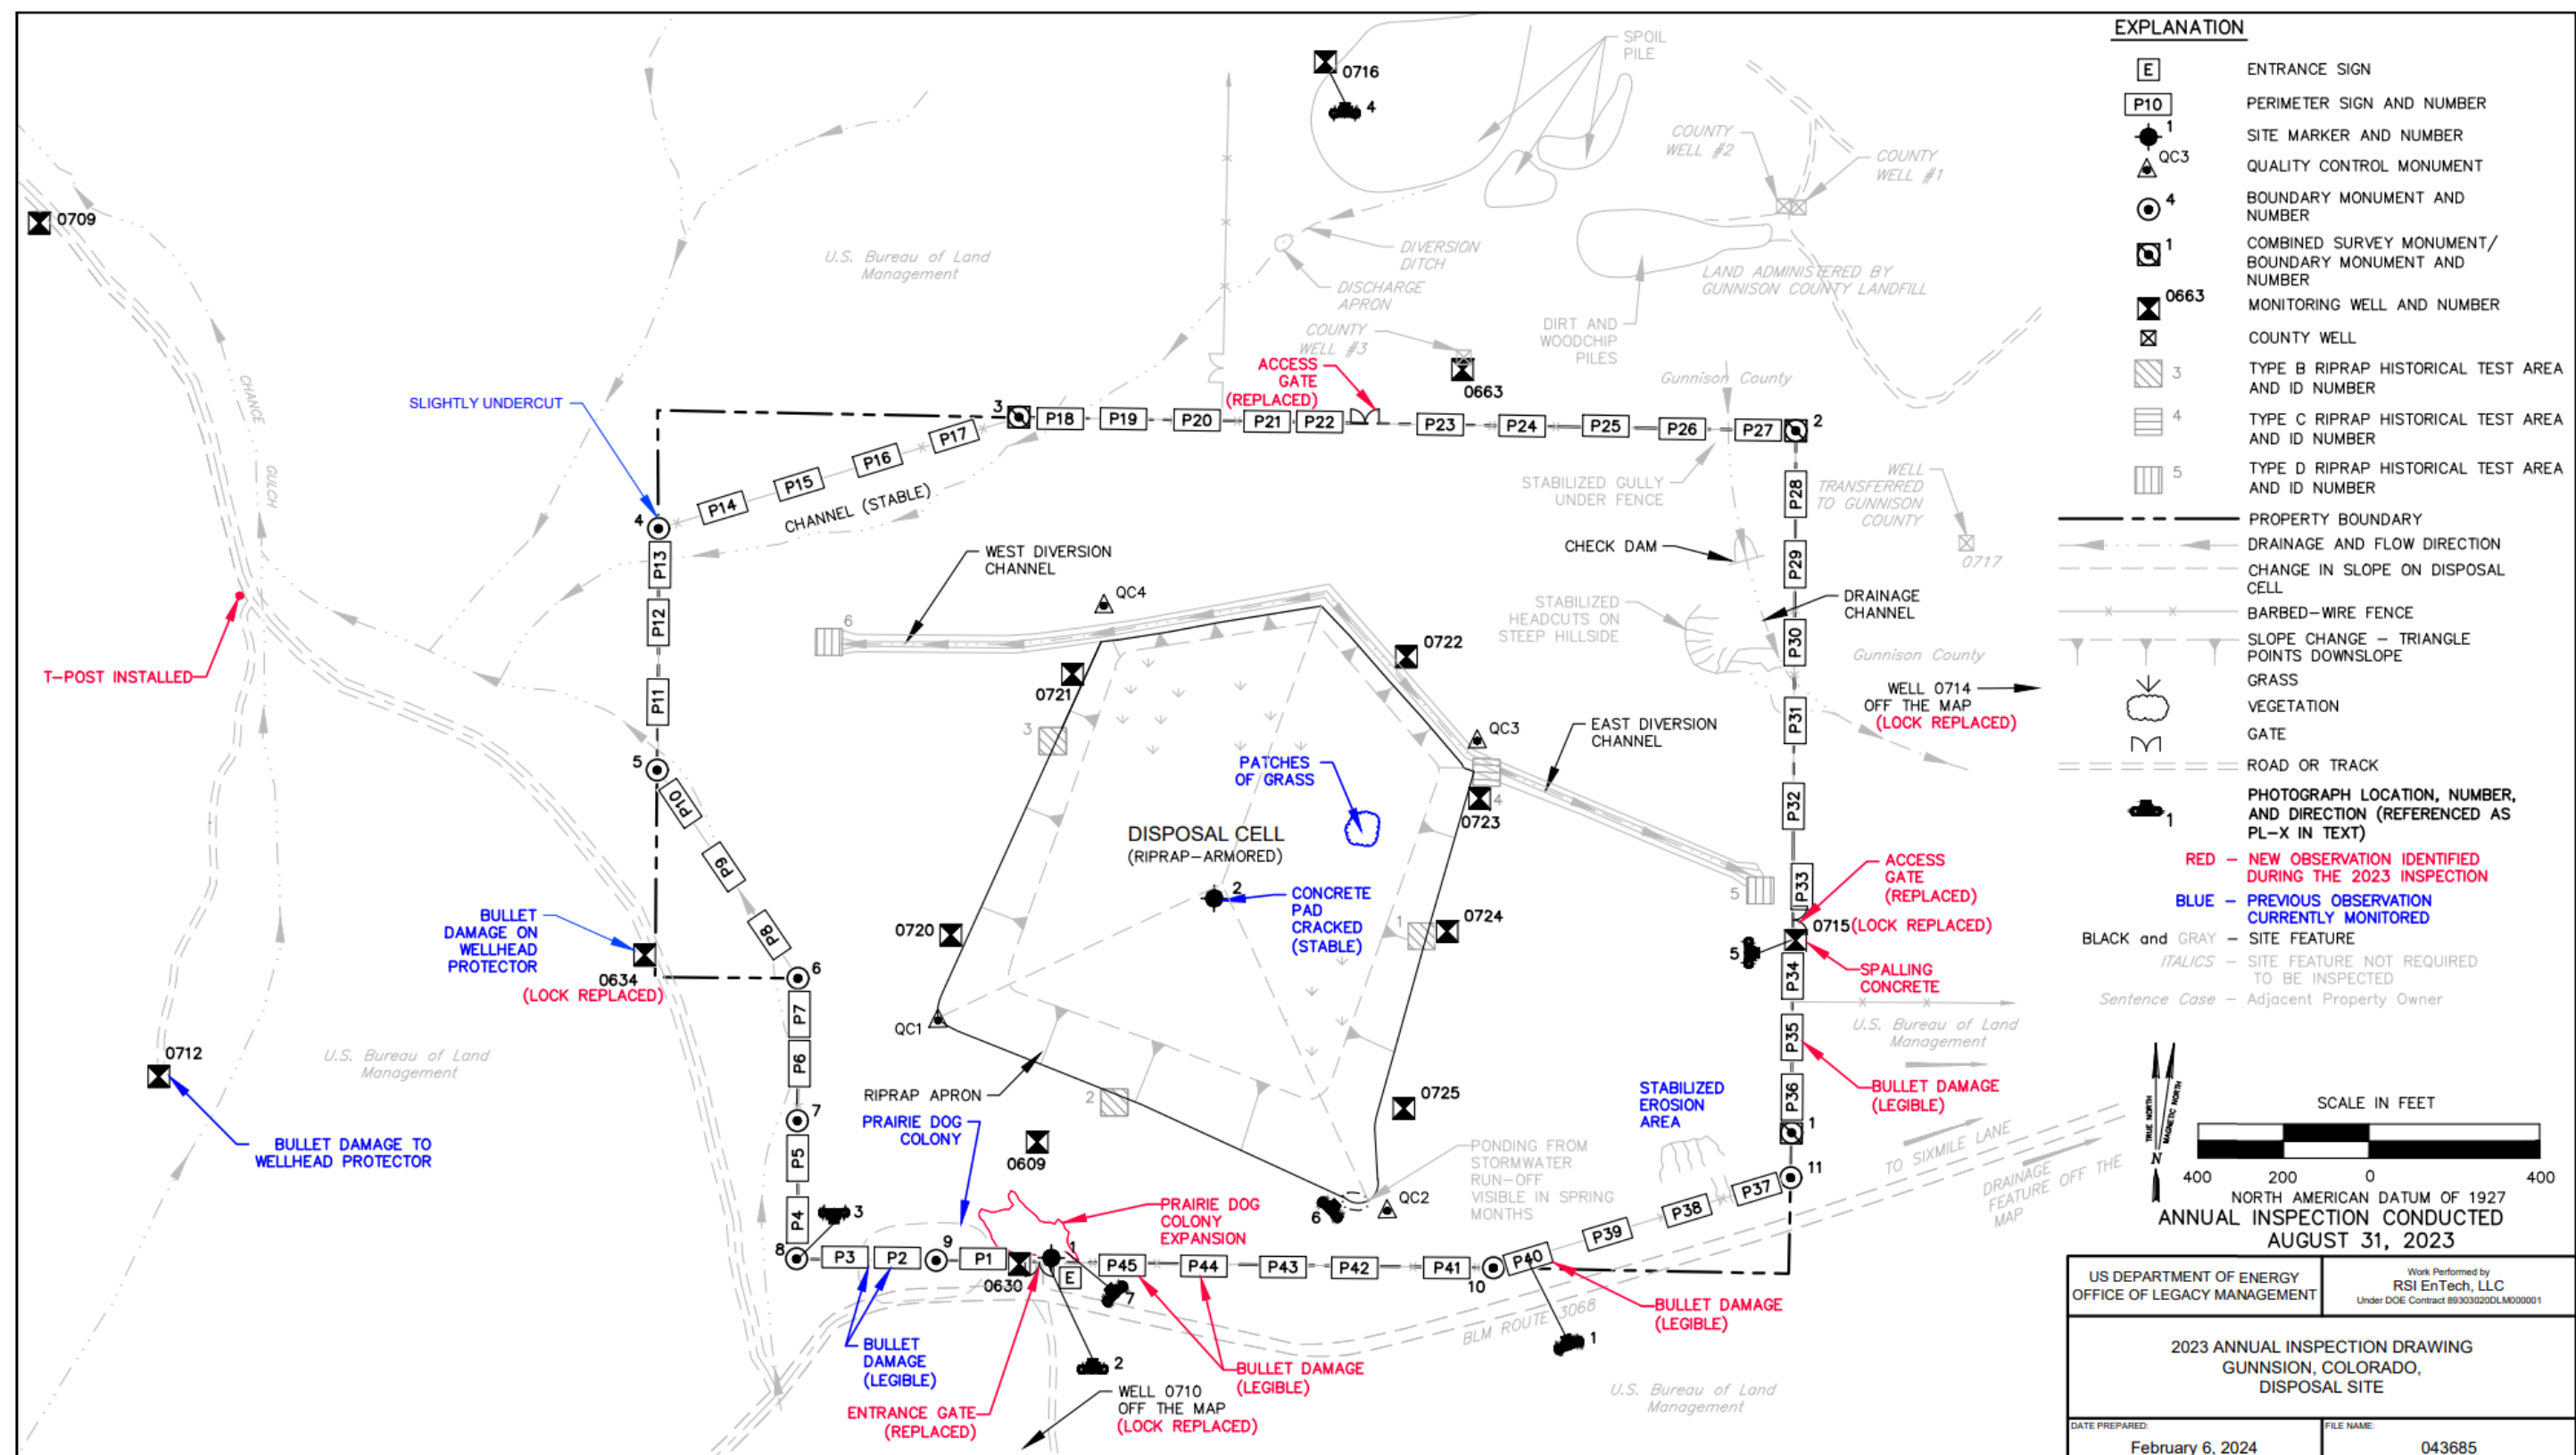
Figure 8-1. 2023 Annual Inspection Drawing for the Gunnison, Colorado, Disposal Site

Figure 8-1 shows the locations of site features, including site surveillance features and inspection areas, in black and gray font. Some site features that are present but not required to be inspected are shown in italic font. Observations from previous inspections that are currently monitored are shown in blue, and new observations identified during the 2023 annual inspection are shown in red. Inspection results and recommended maintenance activities associated with site surveillance features are described in the following subsections. Photographs to support specific observations are noted in the text and in Figure 8-1 by photograph location (PL) numbers. The photographs and photograph log are presented in Section 8.10.

The site has two granite site markers. Site marker SMK-1 (PL-2) is just inside the entrance gate, and site marker SMK-2 is on the top slope of the disposal cell. The concrete base of site marker SMK-2 has cracks lining up with each of the four monument corners but remains stable. No maintenance needs were identified.

Three combined survey and boundary monuments and eight additional boundary monuments delineate the property boundary (PL-3). Inspectors noted that boundary monument BM-4 is slightly undercut but remains stable. No maintenance needs were identified.

In October 2022, four permanent aerial survey quality control monuments were installed at the site for an aerial survey of the disposal cell. The quality control monument locations are shown in Figure 8-1. No maintenance needs were identified.

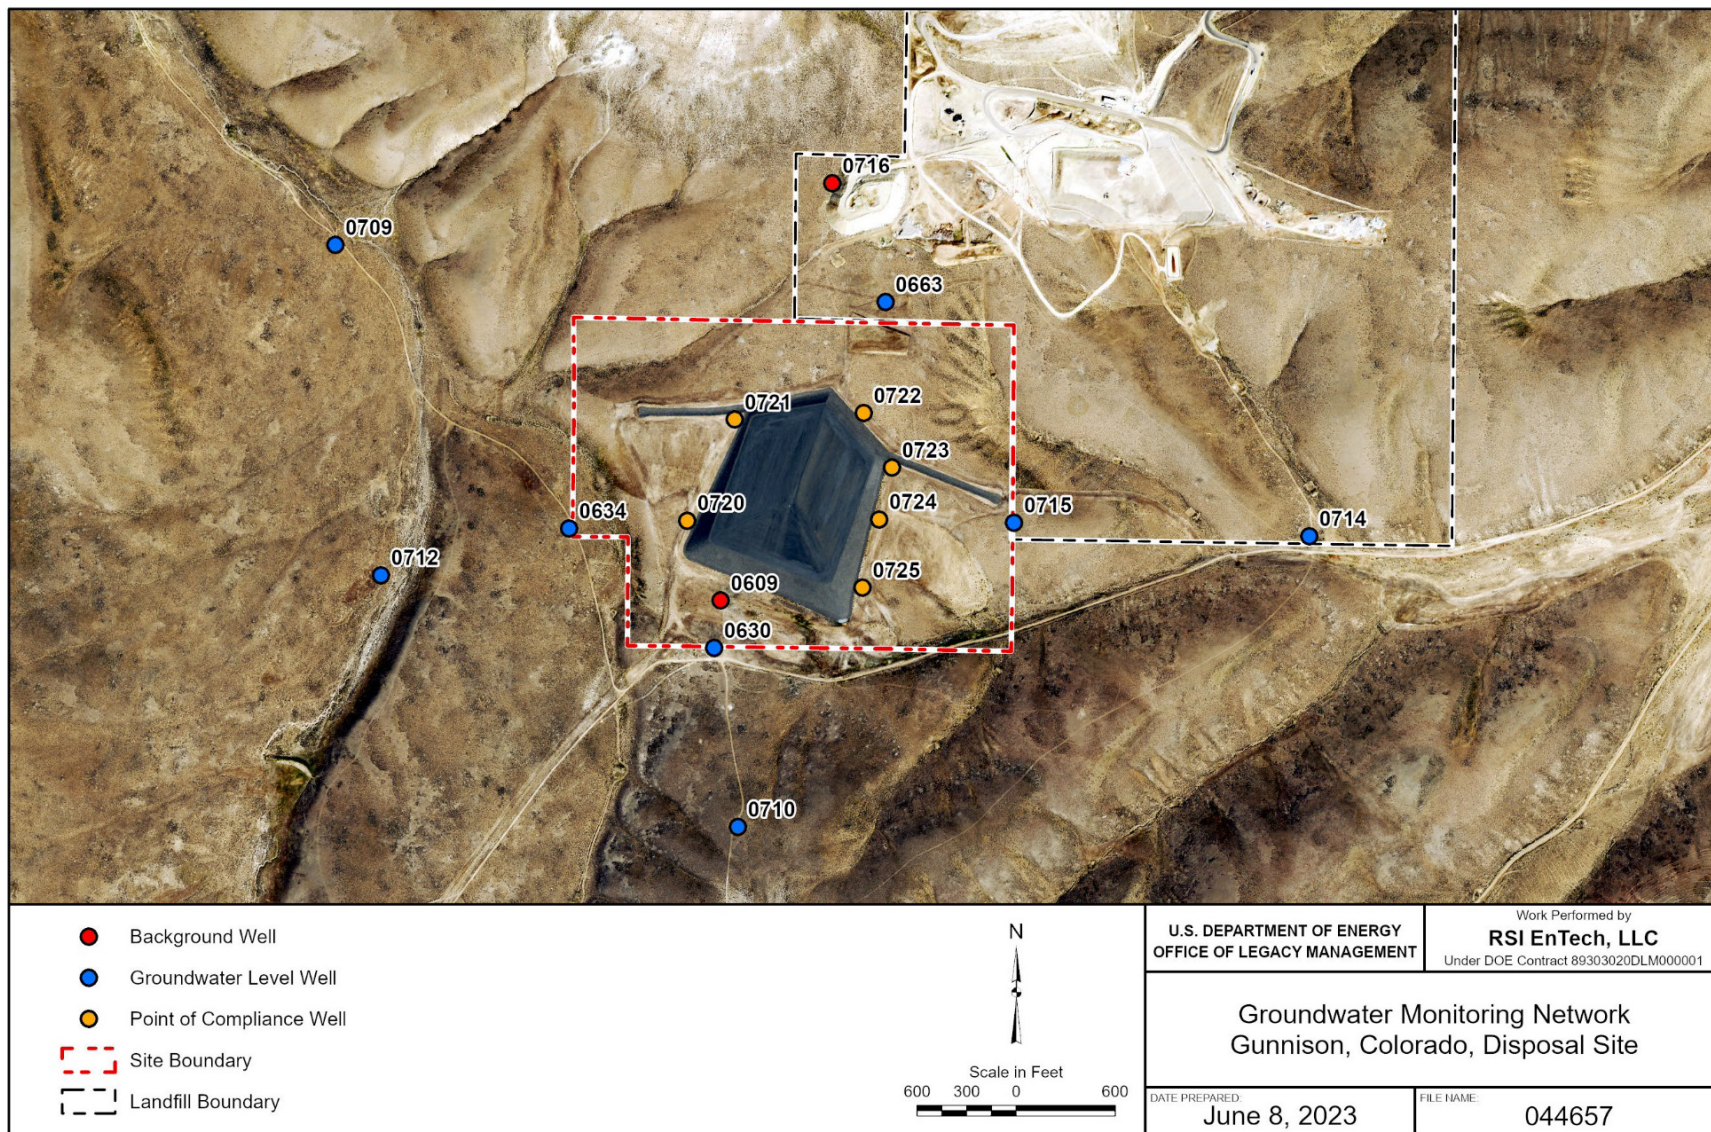
Figure 8-2. Groundwater Monitoring Network at the Gunnison, Colorado, Disposal Site

The concentrations of uranium in samples collected and analyzed from the POC wells in 2021 ranged from 0.001 mg/L to 0.005 mg/L. In 2021, uranium concentrations were consistent with historical results in five of the POC wells; however, they slightly exceeded the historical maximum in POC well 0721. Uranium results from the POC wells in 2021 were below the action level of 0.013 mg/L.

Figure 8-2 presents the locations of the groundwater monitoring network and Table 8-2 lists the site's groundwater monitoring network.
