## 8.0 Gunnison, Colorado, Disposal Site

The U.S. Department of Energy (DOE) Office of Legacy Management (LM) conducted the Gunnison, Colorado, Uranium Mill Tailings Radiation Control Act (UMTRCA) Title I Disposal Site inspection on September 10, 2024. No cause for a follow-up inspection was identified.

The site, 6 miles southeast of Gunnison, Colorado, was inspected on September 10, 2024. The inspection was conducted by J. Lobato and D. Atkinson of the Legacy Management Support contractor. A. Farinacci (LM site manager) and M. Cosby and A. Lawrence (Colorado Department of Public Health and Environment) also attended the inspection. The purposes of the inspection were to confirm the integrity of visible features at the site, identify changes in conditions that might affect conformance with the LTSP, and evaluate whether maintenance or follow-up inspection and monitoring are needed.

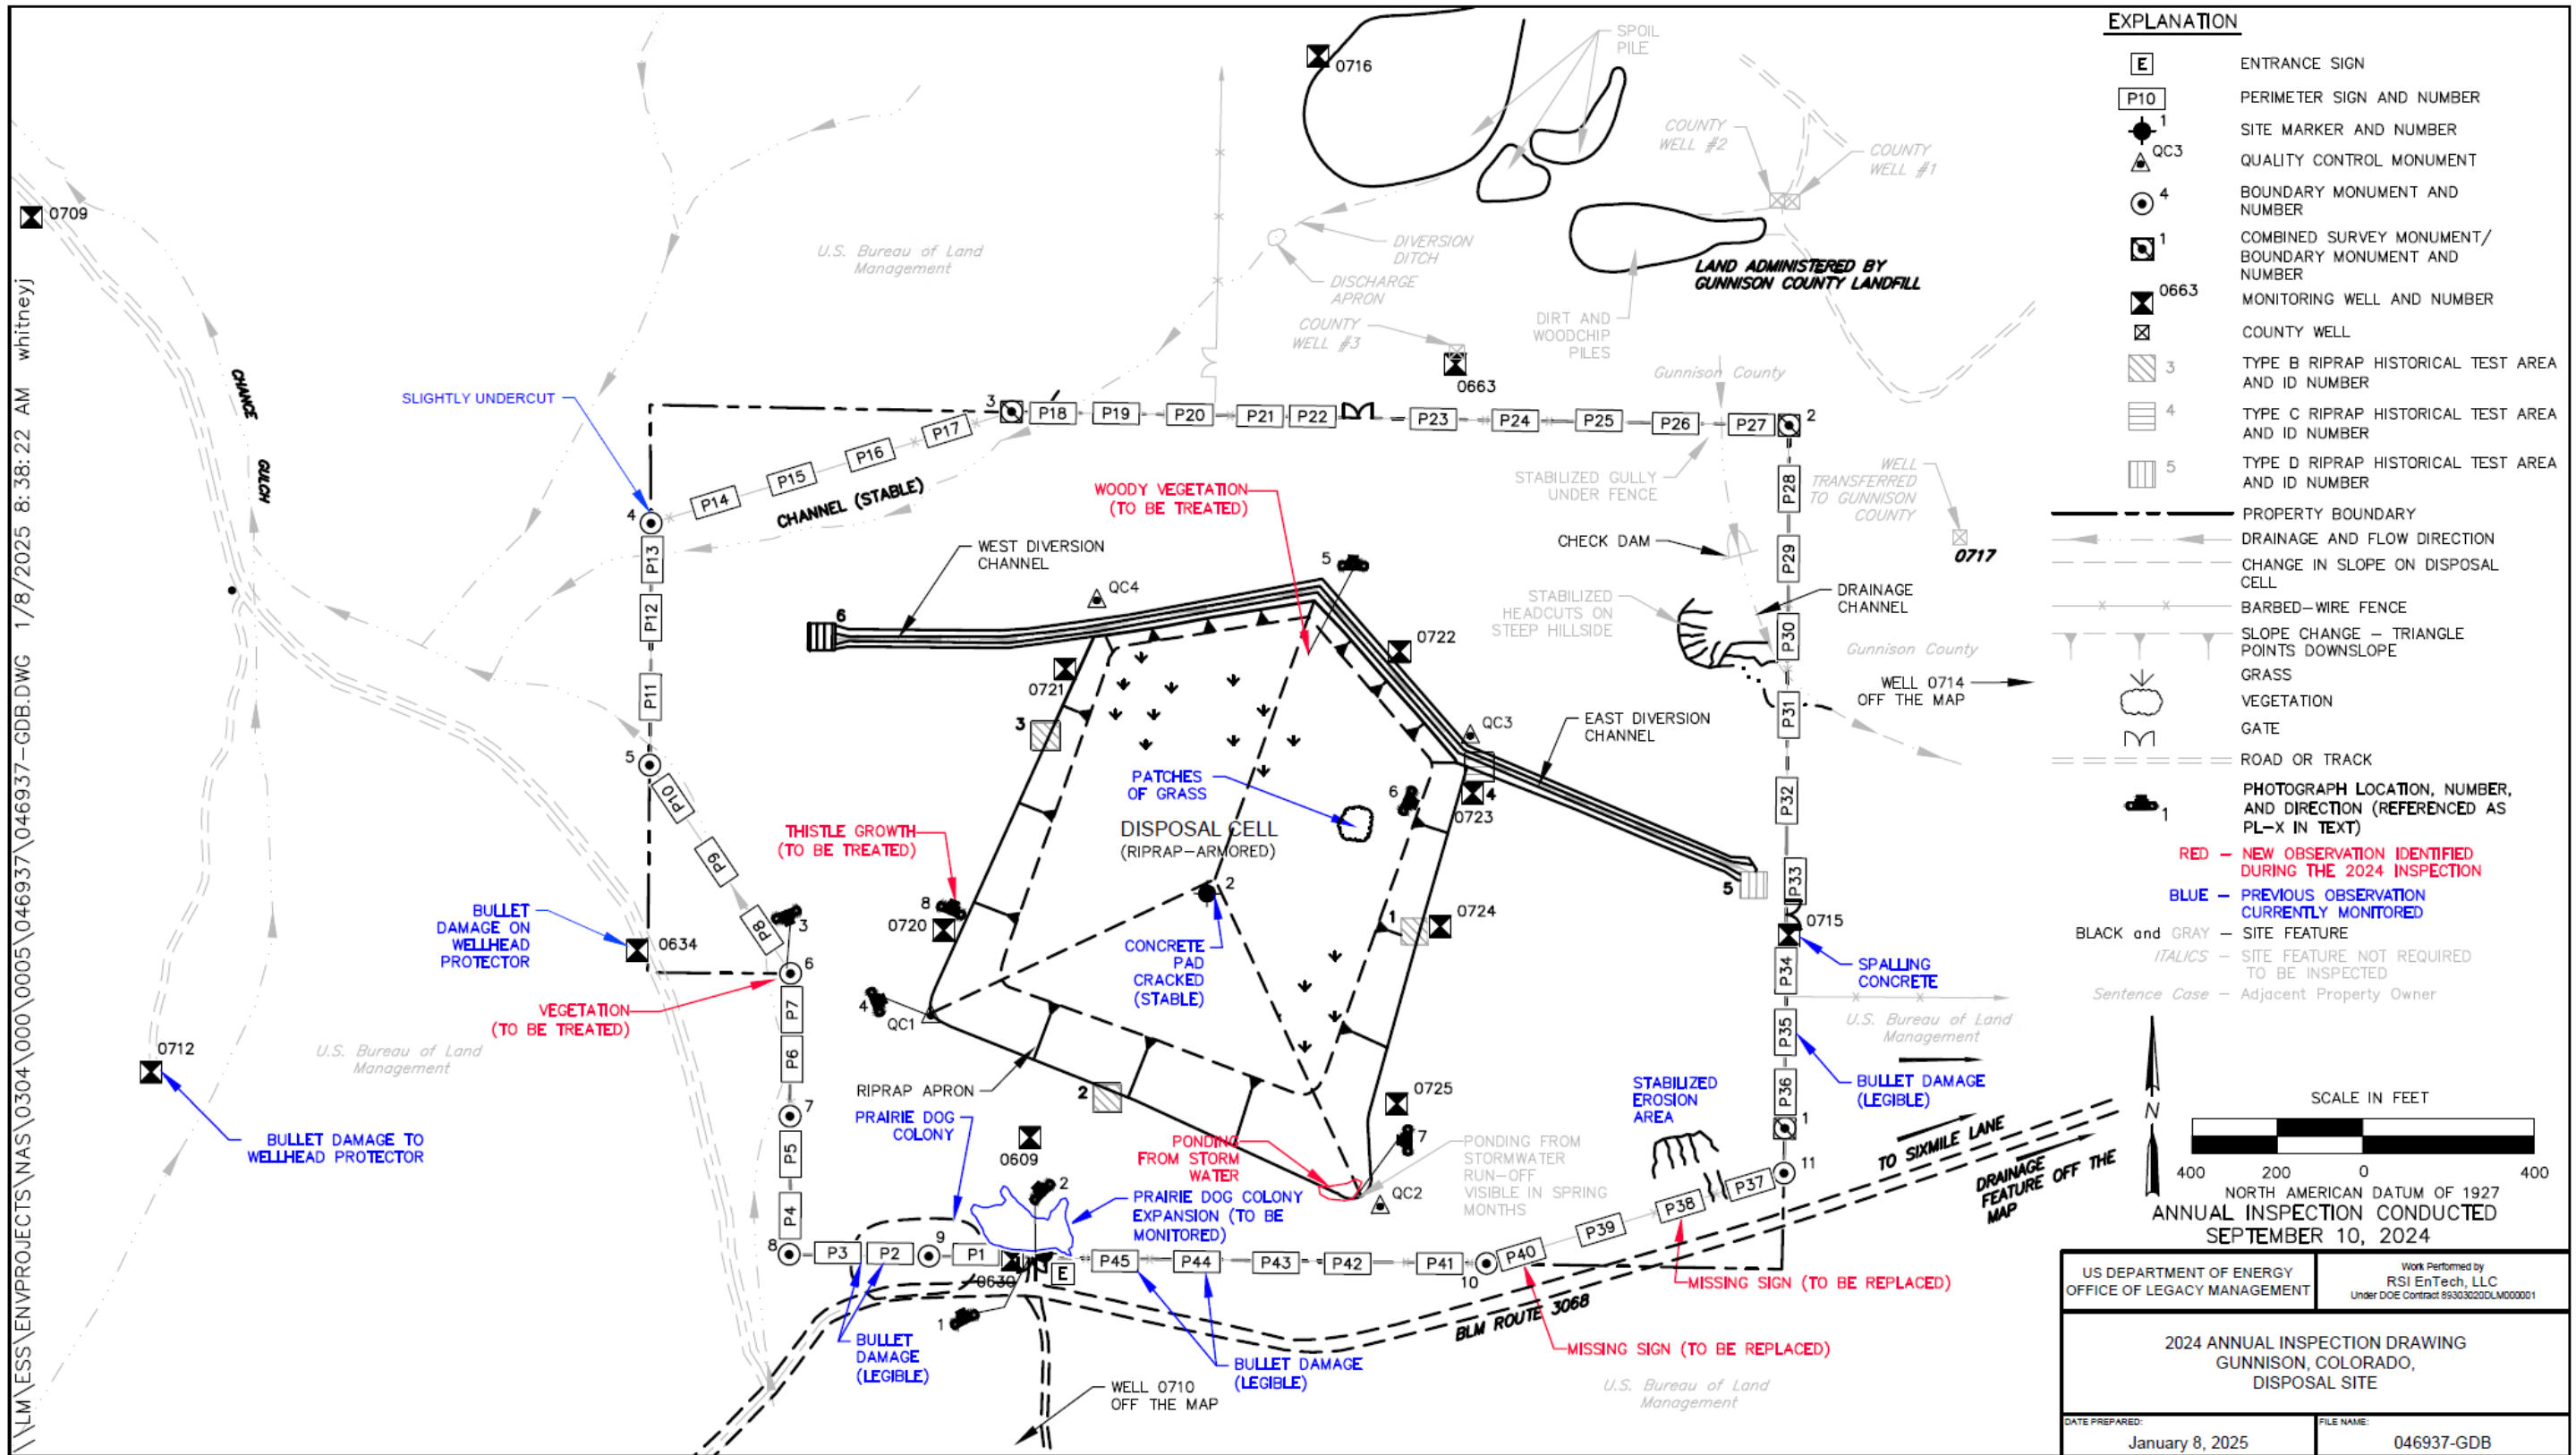
Figure 8-1. 2024 Annual Inspection Drawing for the Gunnison, Colorado, Disposal Site

The site has two granite site markers. Site marker SMK-1 (PL-2) is just inside the entrance gate, and site marker SMK-2 is on the top slope of the disposal cell. The concrete base of site marker SMK-2 has cracks lining up with each of the four monument corners but remains stable. No maintenance needs were identified.

Three combined survey and boundary monuments and eight additional boundary monuments delineate the property boundary. Inspectors noted that boundary monument BM-6 is obscured by vegetation (PL-3), which will be treated. During the 2023 inspection, inspectors noted that boundary monument BM-4 was slightly undercut but remains stable. No other maintenance needs were identified.

The site has 16 groundwater monitoring wells. The wellhead protectors were locked and properly labeled. There is bullet damage on the wellhead protector of monitoring wells 0634 and 0712, but the well casings are not impacted and remain functional. Monitoring well 0716 is on landfill property. Gunnison County landfill operators have placed concrete barriers to protect monitoring well 0716 from landfill activities. The concrete around monitoring well 0715 is beginning to spall. Monitoring well locks have been replaced with new DOE locks as part of a programmatic effort. No maintenance needs were identified.

There was no evidence of settling, slumping, erosion, or any other modifying process that might affect the integrity of the top slope of the disposal cell. Inspectors noted a woody plant growing on the north side of the top of the disposal cell (PL-5), which will be treated. Several isolated patches of grass have established on the top slope; however, these shallow-rooted plants do not degrade the performance of the radon barrier component of the disposal cell's engineered cover. No other maintenance needs were identified.

Gunnison County owns the land adjacent to the site boundary to the north and east and uses the land for a municipal landfill. The nearest landfill operations continue to be approximately 400 feet north of the property boundary. Although landfill activities do not affect the site, inspectors will continue to monitor the level of activity occurring near the site boundary and surveillance features (e.g., fences and monitoring wells). There is a spoil pile near monitoring well 0716 (Figure 8-1) that inspectors will continue to monitor. No maintenance needs were identified.

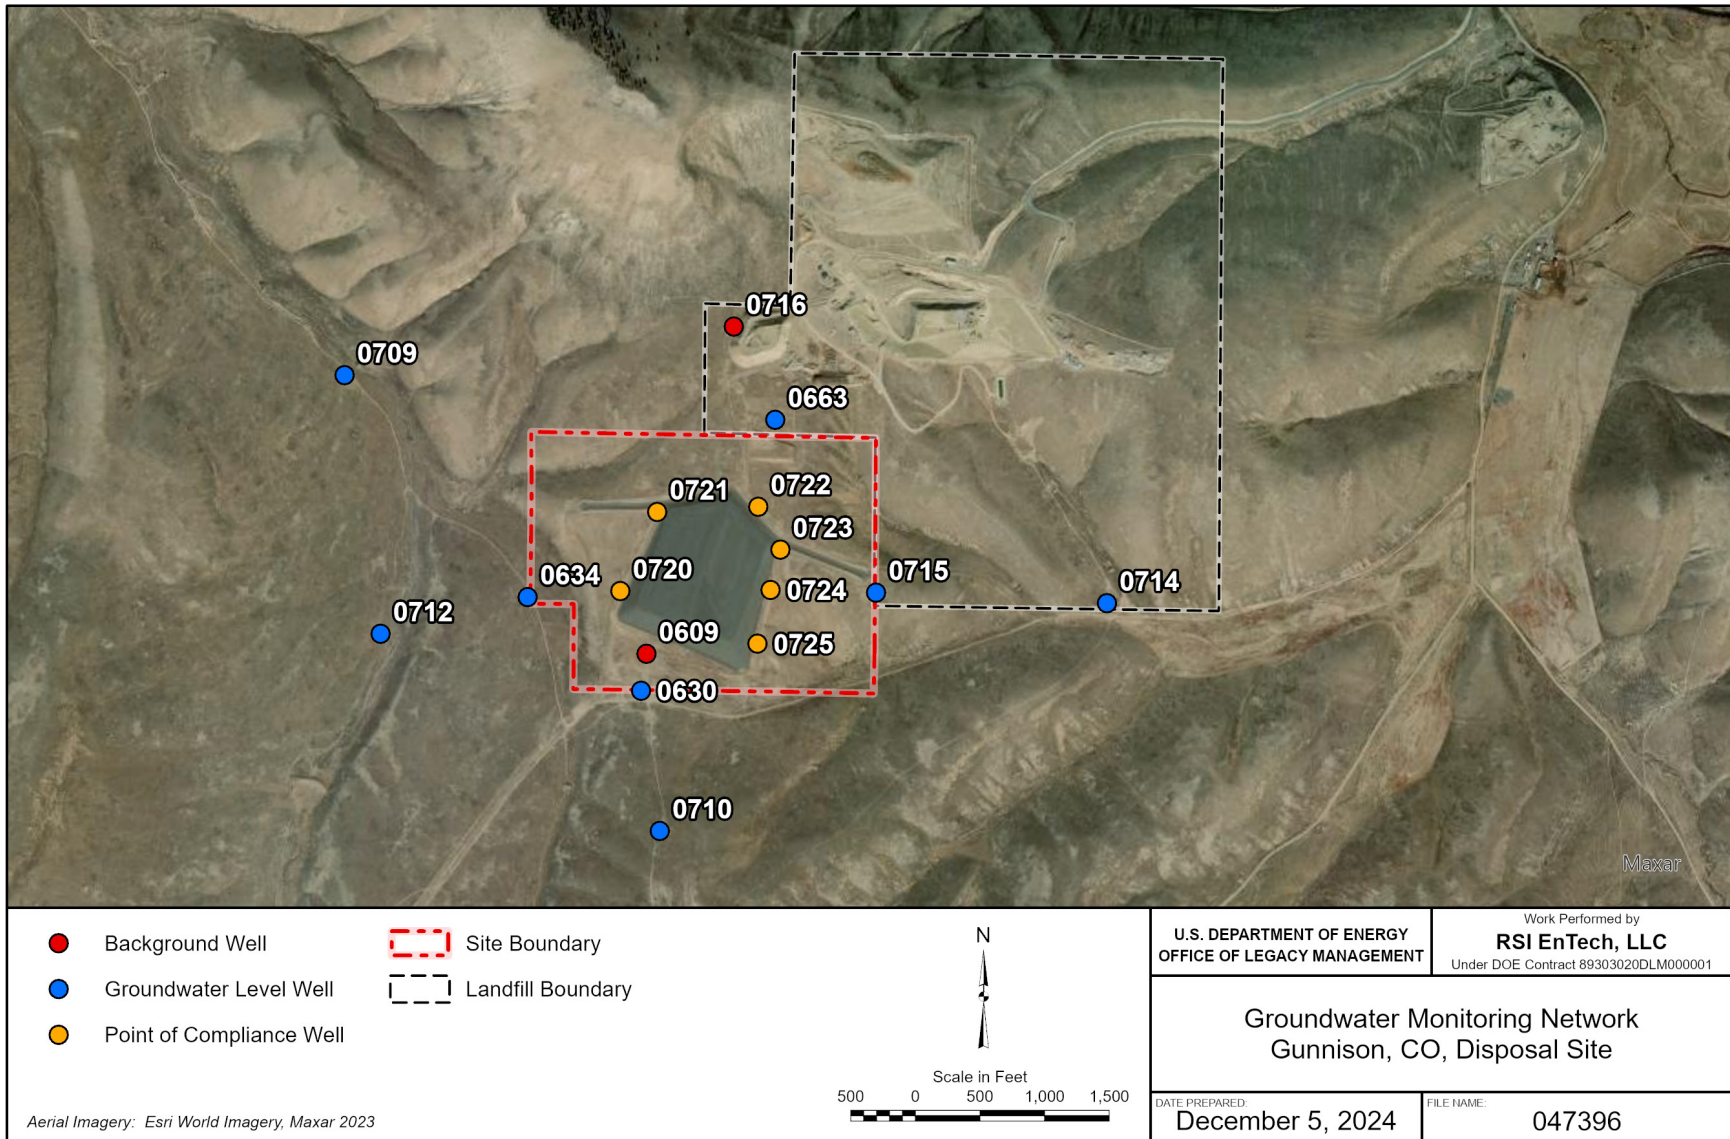
Figure 8-2. Groundwater Monitoring Network at the Gunnison, Colorado, Disposal Site

The most recent groundwater sampling event occurred in July 2021. The next scheduled monitoring event will occur in 2026. Groundwater monitoring results were below the site-specific uranium action level in the six point of compliance (POC) wells.
