ORNL/RASA-94/1

**RESULTS OF THE RADIOLOGICAL
SURVEY
at the former
HERRING-HALL-MARVIN SAFE
COMPANY (3rd Floor)
1550 Grand Boulevard, Hamilton, Ohio
(HO001)**

Date issued —March 1994

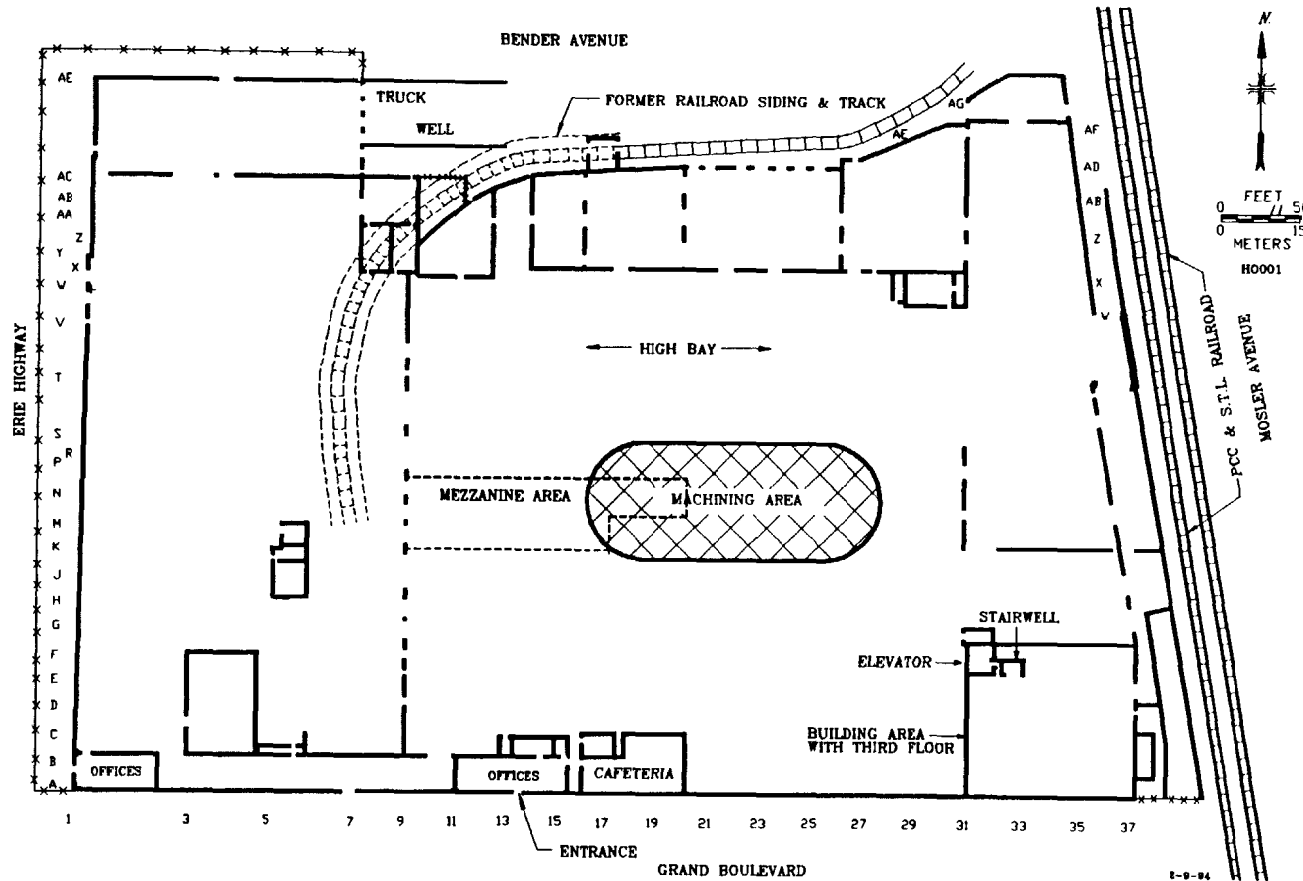
During the spring of 1993, public attention was drawn to this facility by former workers who stated that the earlier radiological surveys did not include that part of the structure which contained the third floor (located in the southeastern corner of the building (Fig. 1) where a portion of the actual machining work was conducted. On August 5 and 6, 1993, the third floor was surveyed by the ORNL group to determine whether fixed surface contamination could be found that might exceed the DOE guidelines. The primary focus of the survey was the third floor, the elevator (including the shaft) and the stairwell leading to the third floor, all of which are in the southeastern corner of the structure. This section of the building is constructed almost entirely of concrete and concrete blocks. The third floor is ~ 9000 ft², including the stairwell, the elevator, and a washroom (out of service). There are currently no operations in the facility and the entire building is devoid of equipment.

Fig. 1. Diagram showing the general facility layout at the former Herring-Hall-Marvin Safe Company, 1550 Grand Boulevard, Hamilton, Ohio. The area in the southeast corner is the part of the facility containing the third floor where the survey was conducted.
