ORNL/RASA-95/14

**Results of the Radiological  
Verification Survey at the Former  
Herring-Hall-Marvin Safe Company,  
1550 Grand Boulevard, Hamilton Ohio  
(HO001V)**

Date issued —November 1995

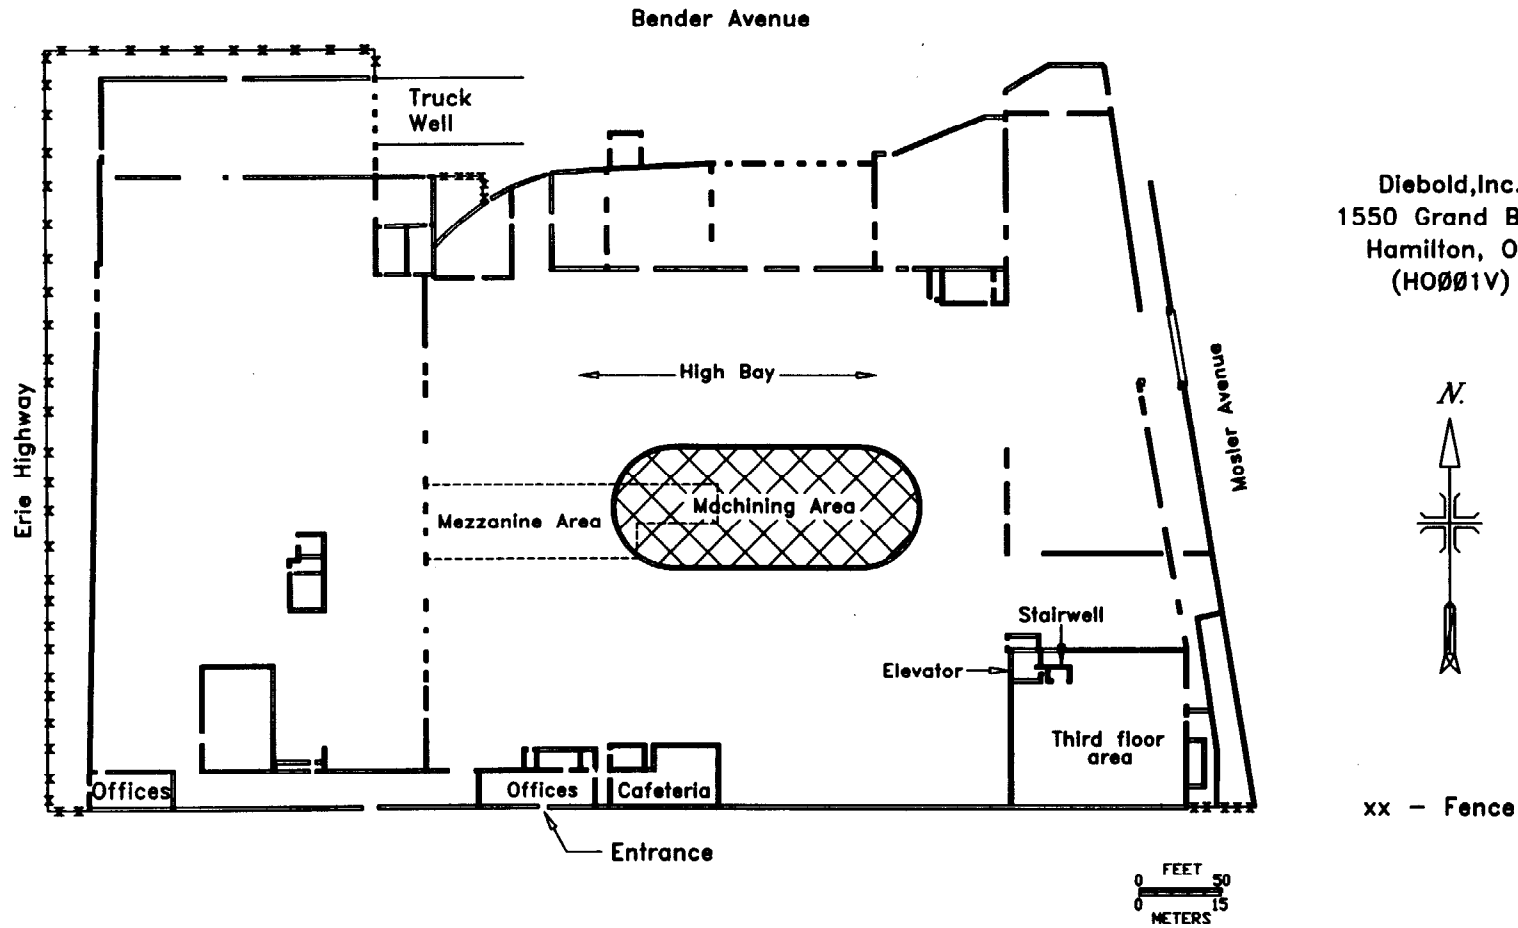
Fig. 1. Diagram showing the general layout at the former Herring-Hall-Marvin Safe Company facility (later Diebold, Inc.). The third floor where remedial action and verification survey were conducted is located in the southeast corner of the building.
