# **2013 Annual Inspection and Radiological Survey Results for the Piqua, Ohio, Decommissioned Reactor Site**

The former Piqua Nuclear Power Facility (PNPF), a decommissioned nuclear power demonstration facility, was inspected on April 18, 2013. The site, located on the east bank of the Great Miami River in Piqua, Ohio, is in good physical condition. There is no requirement for a follow-up inspection.

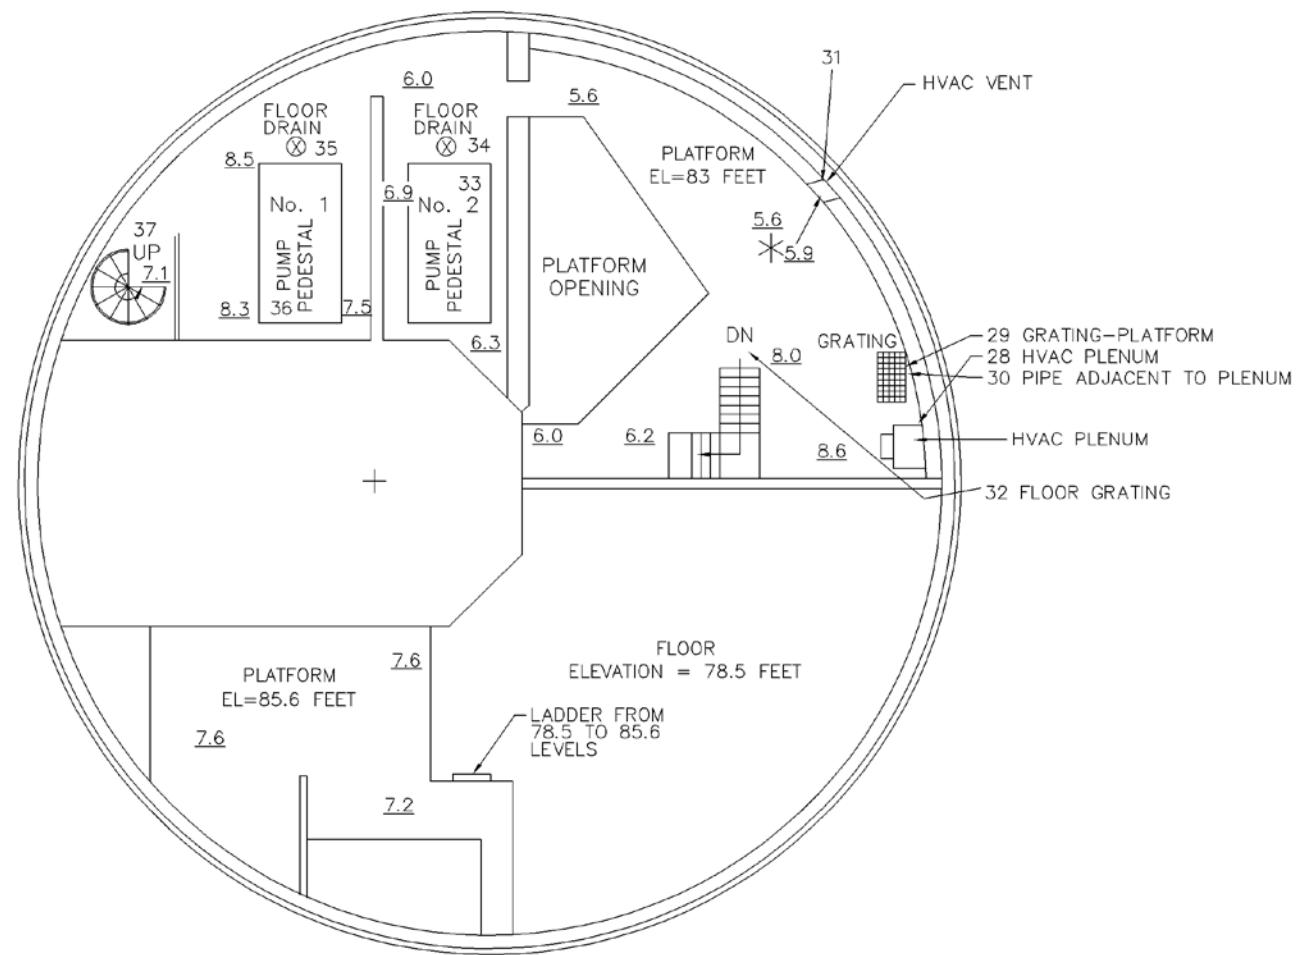
SMEAR/DIRECT LOCATIONS ON THE  
83-FOOT LEVEL

NOTE: ALL 2013 GAMMA READINGS  
WERE < BKGD.

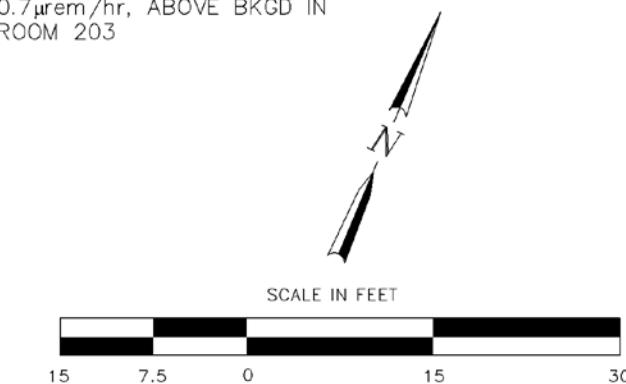
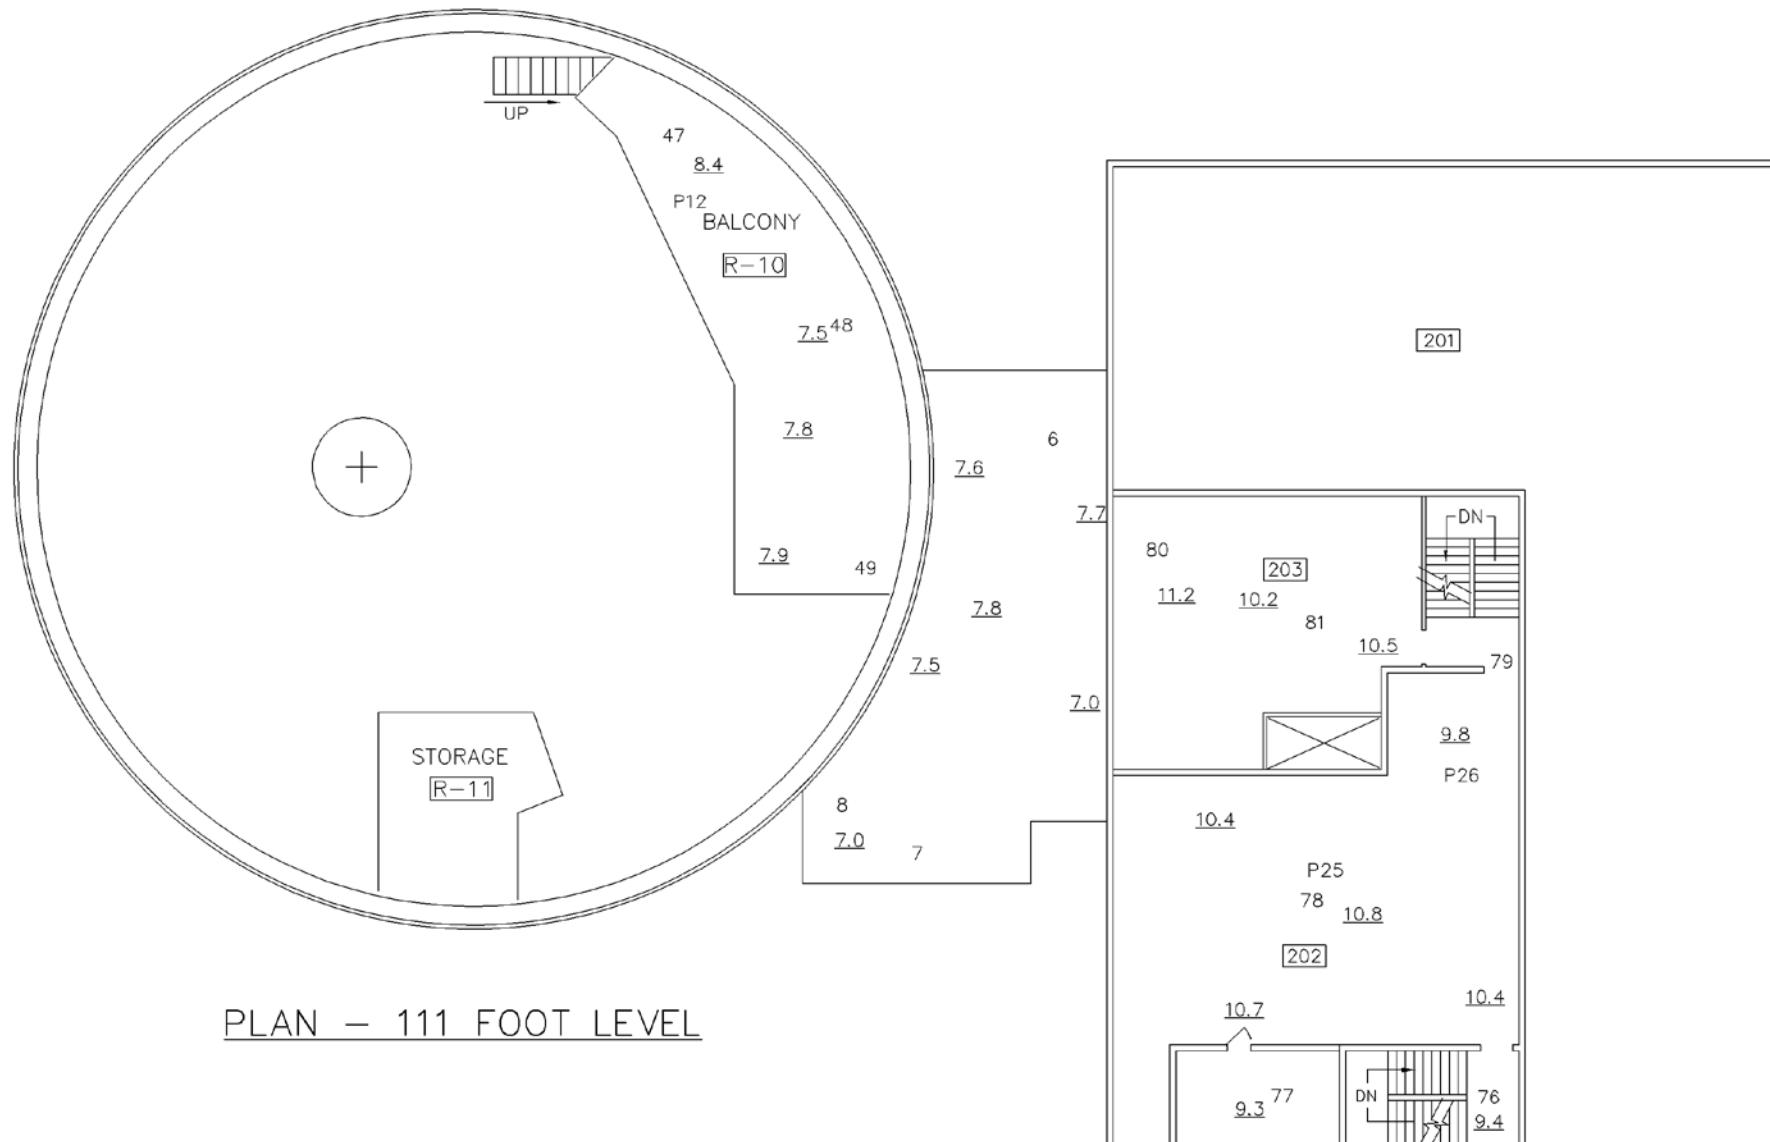
**PLAN - 111 FOOT LEVEL**

NOTE: SAMPLES 1-5 WERE DELETED  
BECAUSE HVAC EQUIPMENT HAS BEEN  
REMOVED FROM THE ROOF.

HIGHEST GAMMA CONTACT  
READING ON THIS LEVEL WAS  
0.7  $\mu$ rem/hr, ABOVE BKGD IN  
ROOM 203

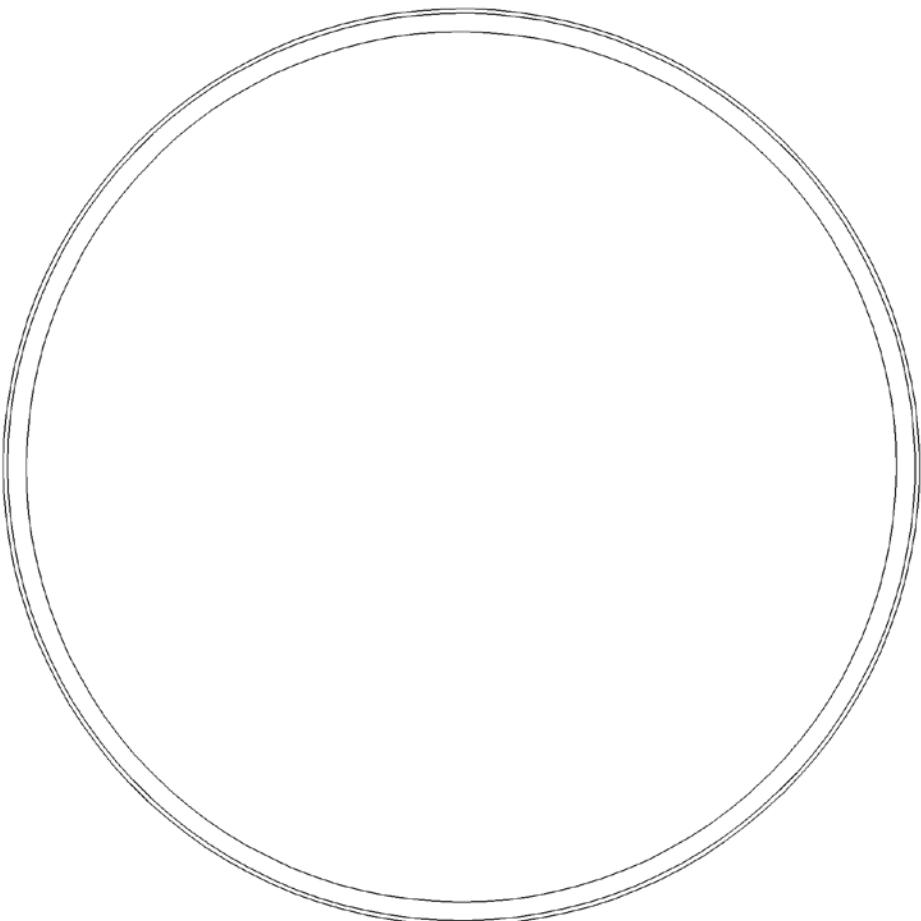
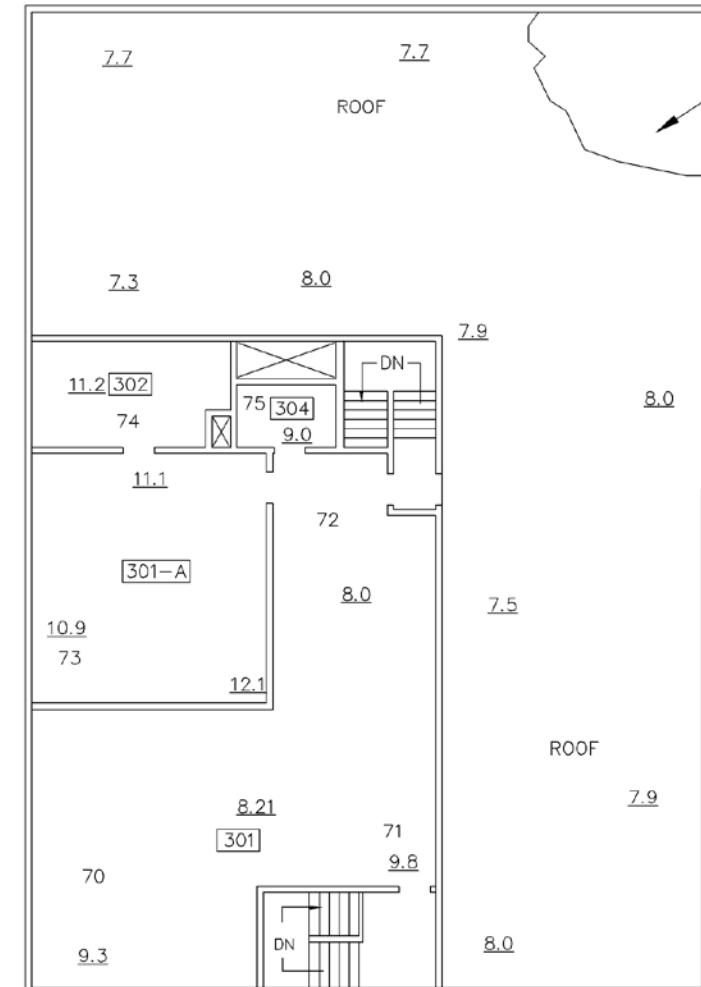
PLAN - 121 FOOT LEVEL

PONDED WATER ON ROOF  
HIGHEST GAMMA CONTACT READING WAS 1.6  $\mu$ rem/hr,  
ABOVE BKGD IN ROOM 301-A
