2015 Annual Inspection and Radiological Survey Results for the Piqua, Ohio, Decommissioned Reactor Site

Summary

The former Piqua Nuclear Power Facility (PNPF), a decommissioned nuclear power demonstration facility, was inspected on April 22, 2015. The site, located on the east bank of the Great Miami River in Piqua, Ohio, was in good physical condition. There is no requirement for a follow-up inspection.

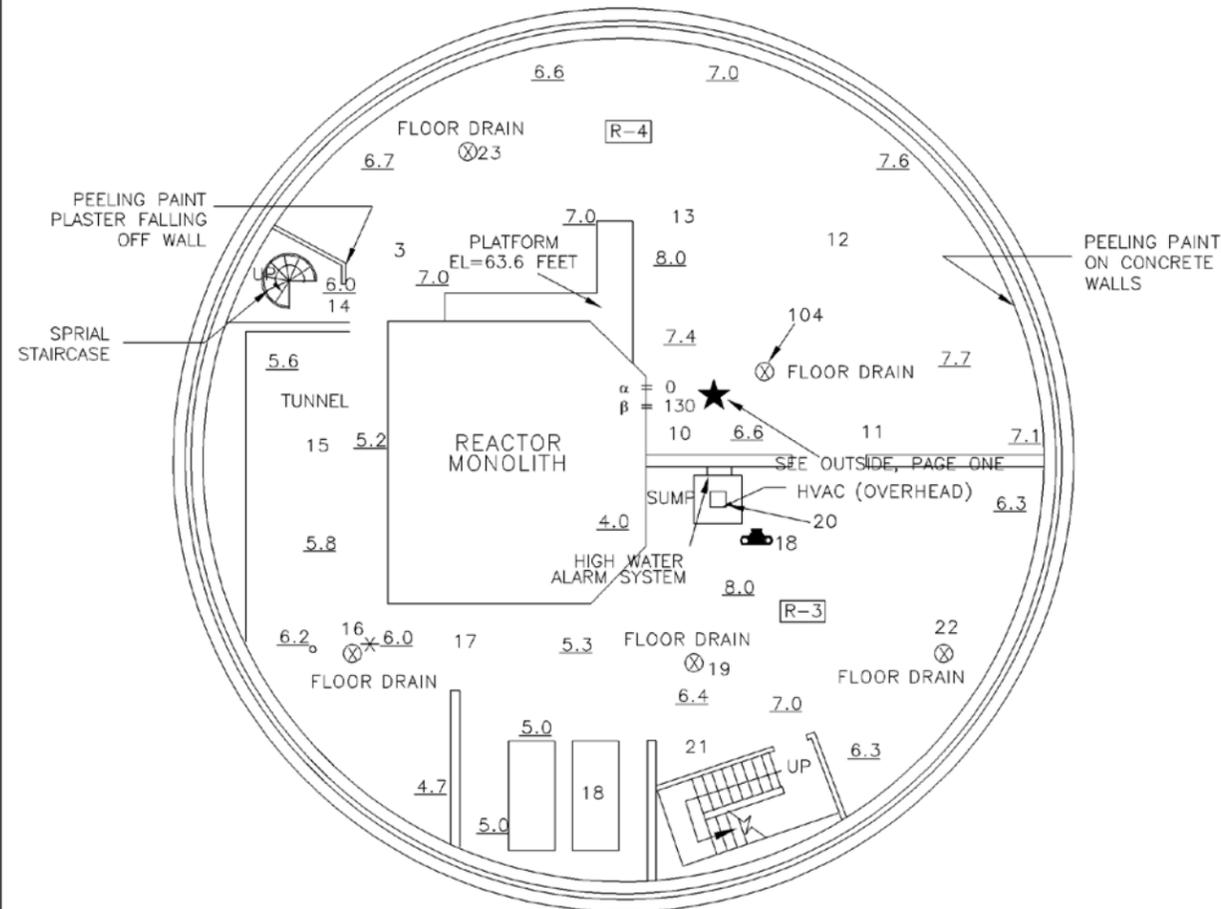
PLAN - 56 FOOT LEVEL

- The floor drain at the 56-foot level (1,140 dpm/100 cm² beta),
- An air duct at the 83-foot level (96 dpm/100cm² alpha), and
- The floor under a flange on the 100-foot level (216 dpm/100 cm² alpha)

NOTE: ALL 2015 GAMMA READINGS WERE < BKGD ON THIS LEVEL.

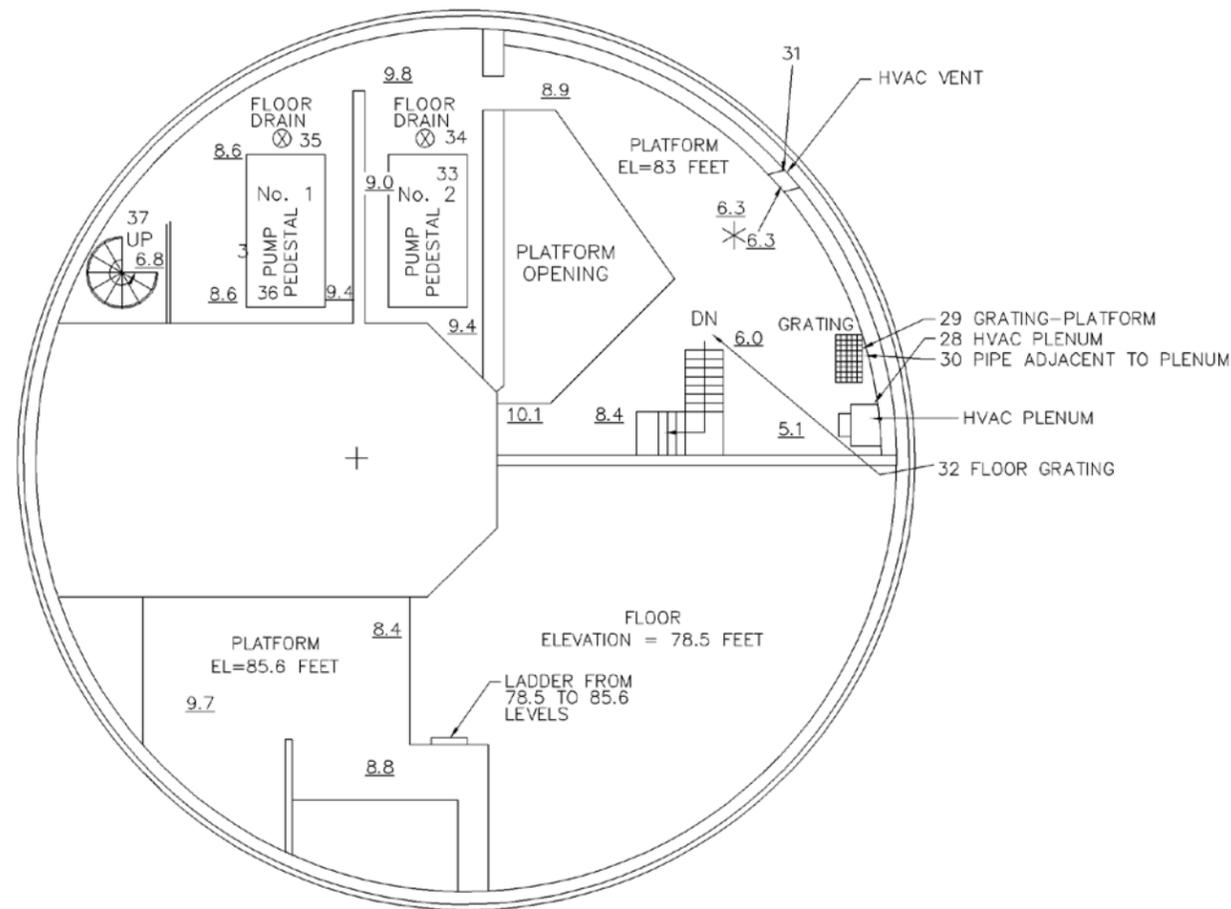
PLAN - 83 FOOT LEVEL

NOTE: ALL 2015 GAMMA READINGS WERE \leq BKGD. ON THIS LEVEL
