*Certification Docket for the  
Remedial Action Performed  
at the Associate Aircraft Site,  
Fairfield, Ohio, 1994-1995*

*Department of Energy  
Former Sites Restoration Division  
Oak Ridge Operations Office*

*October 1996*

**Bechtel National, Inc.**

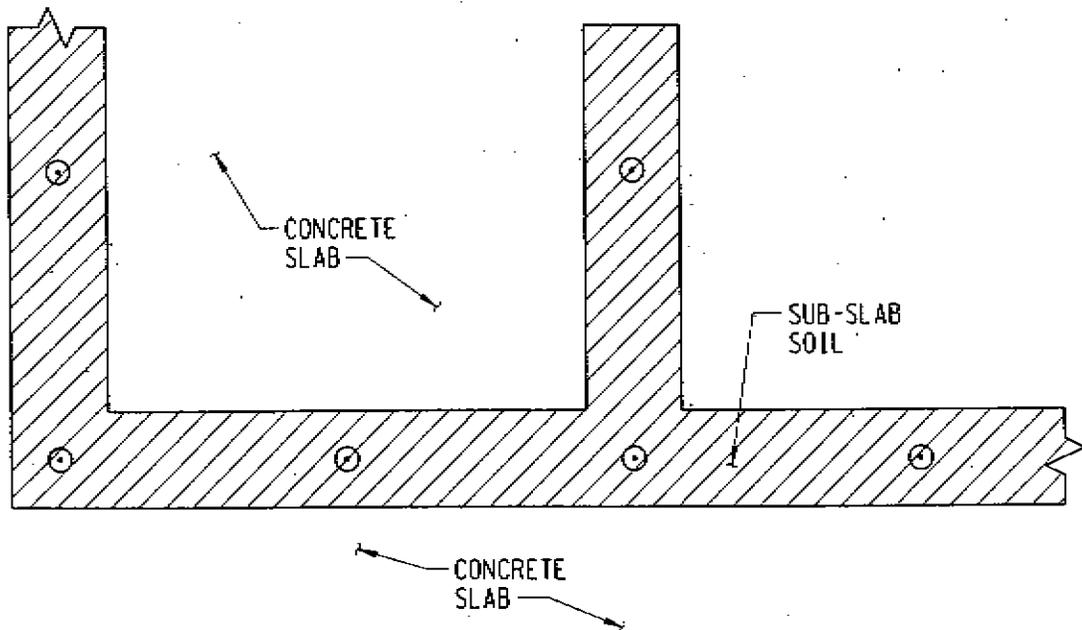
TYPICAL SAMPLING LOCATIONS OF AN EXPANSION JOINT  
(PLAN VIEW)

Interior (sub-slab) soil samples were also collected from each trench created by the removal of contaminated expansion or crack control joints. The method used was similar to that for exterior soil sampling in Zone VII. A 100-m<sup>2</sup> area was determined by considering the 6-in.- (15-cm-) wide trench formed when a contaminated expansion or crack control joint was removed and the total width and length of the trench (Figure I-5). Twenty-five plug soil samples were collected from each 100-m<sup>2</sup> (120-yd<sup>2</sup>) area and composited for gamma spectroscopy analysis to ensure that the average residual uranium contamination was below 35 pCi/g total uranium.

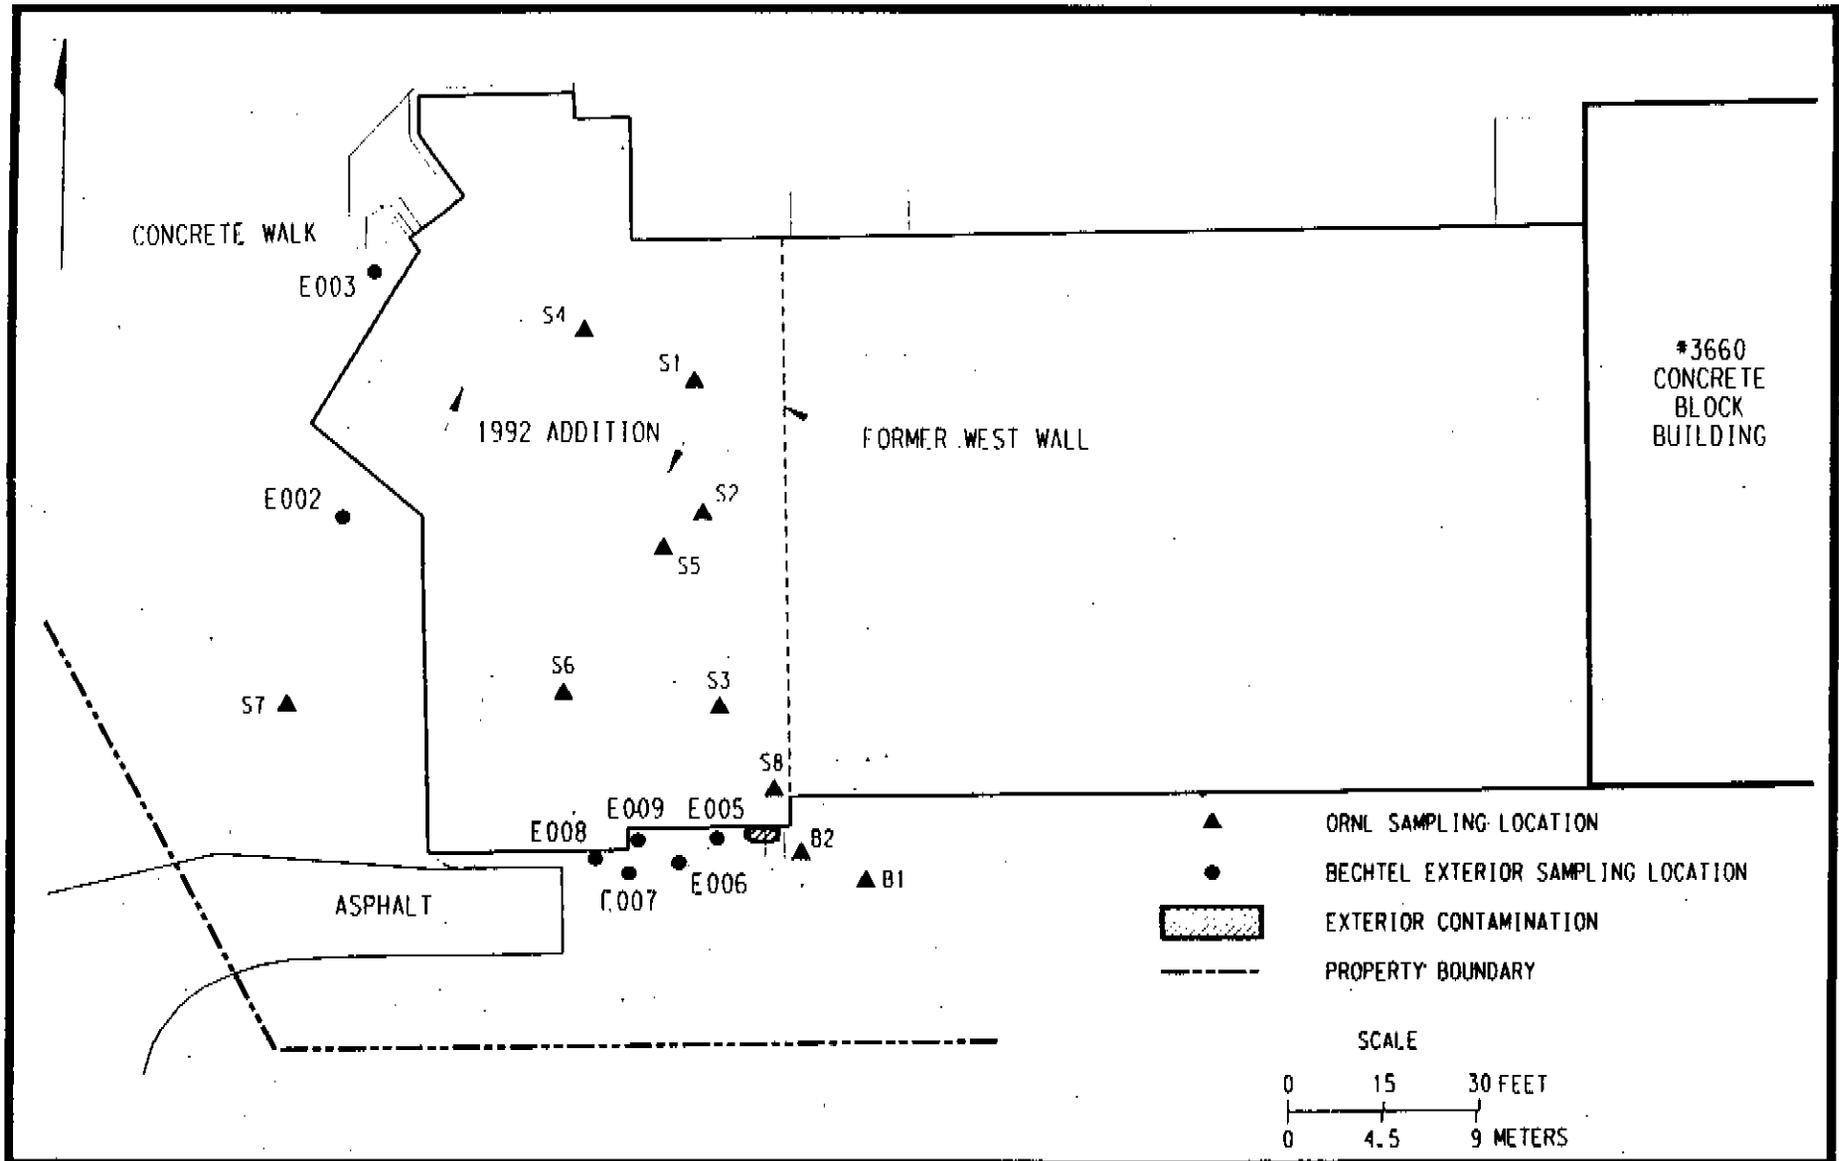
**Figure 1**  
**Characterization Sampling Locations**  
**at the Former Associate Aircraft Site**

Figure 1 shows exterior sampling locations adjacent to the front offices at AAS. Figure 2 shows sampling locations from inside the building as well as sample locations from outside the building near the pipe exit. Uranium-238 concentrations from discrete sampling locations in these areas are presented in Tables 1 and 2 respectively. It should be noted that samples collected during the February 1995 sampling effort have not yet been analyzed. These samples are designated with "TBA". Upon receipt of these sample results from the laboratory, the attached data tables will be completed. Further, final status of the pipe (i.e. where the end is located) has yet to be determined. This determination will dictate if trenching and additional sampling will be required.

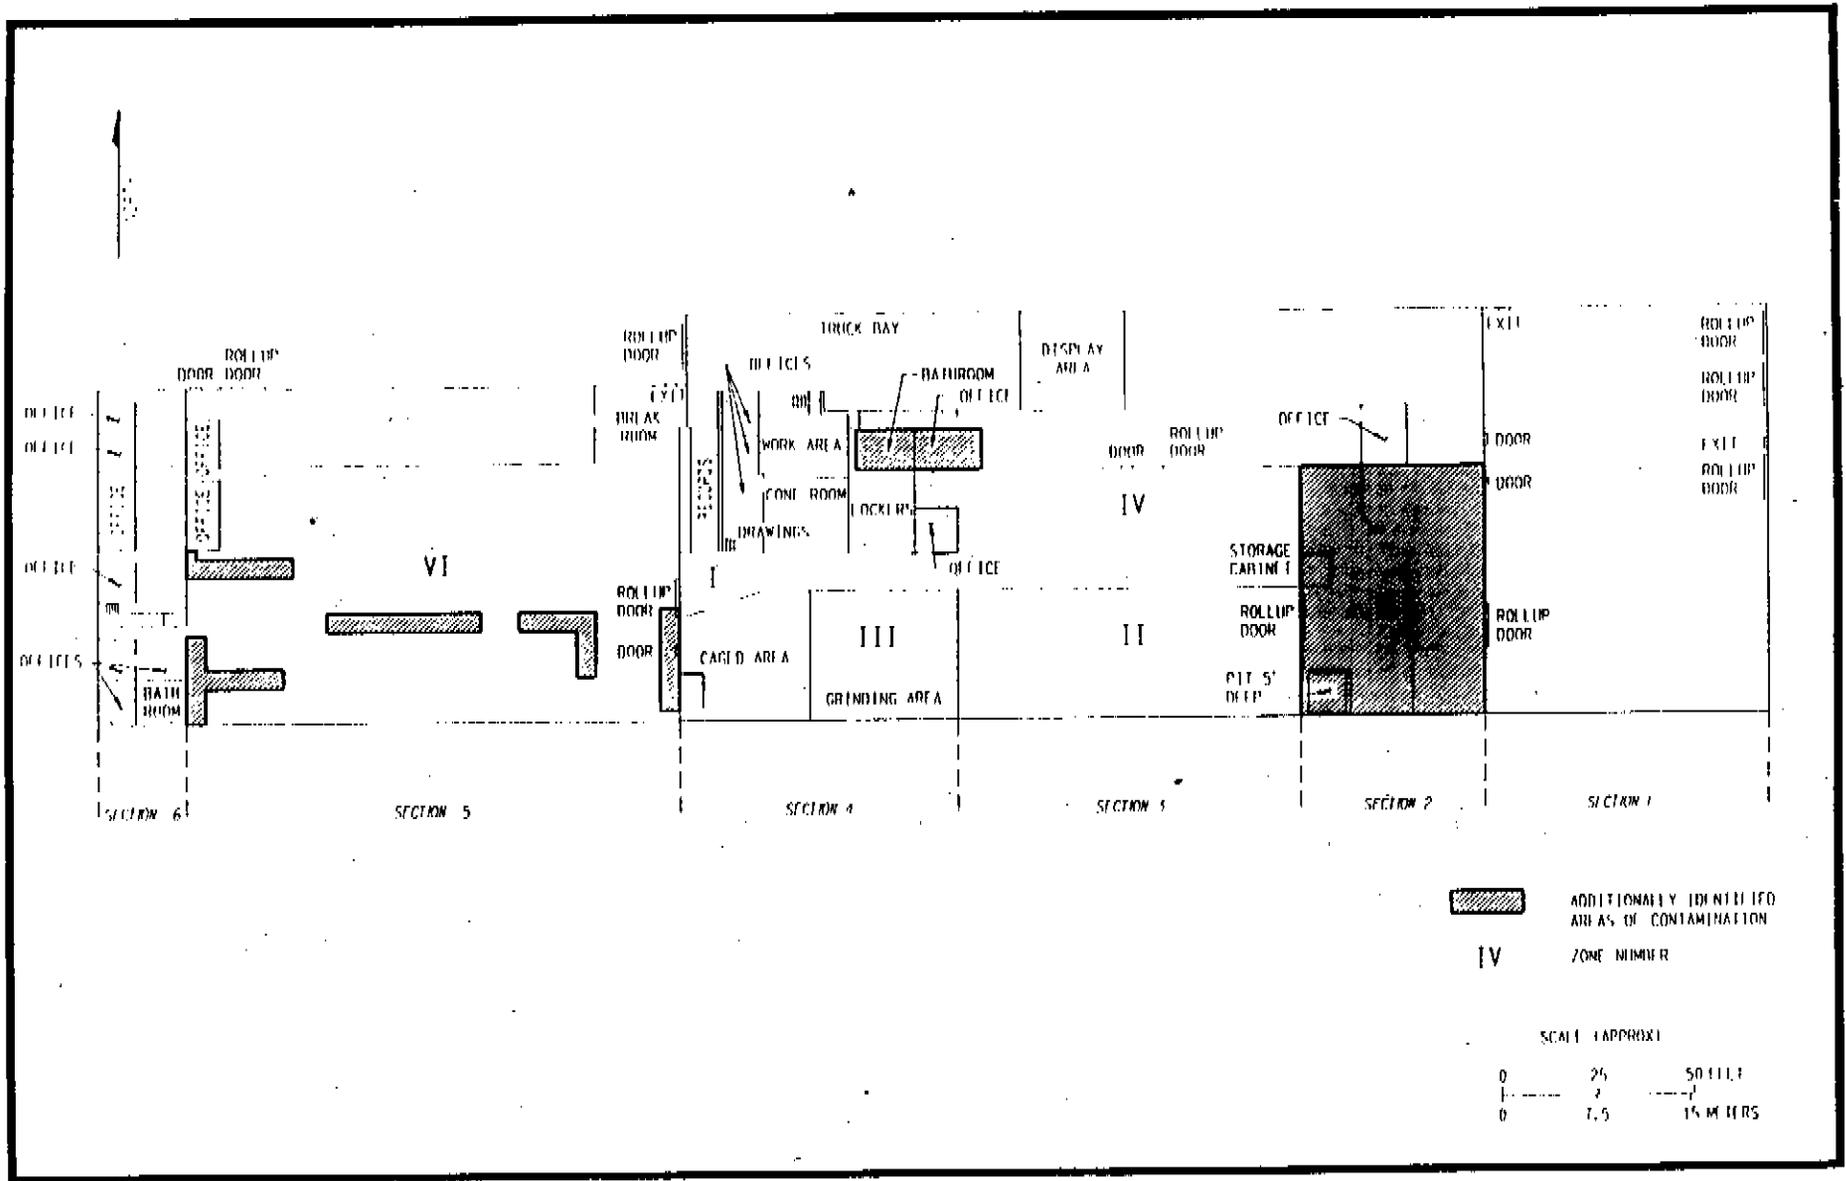
**Figure 3**  
**Additionally Identified Areas of Contamination**  
**at the Former Associated Aircraft Site**

The purpose of this memorandum is to provide results from characterization activities at the Former Associated Aircraft Site (AAS) in Fairfield, Ohio. Additional areas of contamination requiring remediation were identified during these activities. Areas that are currently known to exhibit elevated readings, and were not in the original scope of work are shown in Figure 3. To summarize, the areas added are located in the following areas;

As noted, not all samples collected have been analyzed, and based on the selected incremental delineation approach, further sampling may become necessary. Based on the results currently available, the identified areas, shown in Figure 3, are the only ones known to be additions to the original scope of remedial action activities at AAS. This could also change due to disposition of the pipe status exiting the building in Zone II. At the time this memo was written, it was discovered that the pipe made an unexpected turn before traveling parallel to the building. The total length of the pipe is currently being determined. Upon this determination, trenching and subsequent characterization of the soils along the pipe trench could be required. In regard to the survey data currently available, it is recommended that additional surveys take place in Zone VI, as only 10 % of this Zone was surveyed. This is due to machinery placement currently preventing access to the entire floor. These additional surveys should be performed at the earliest convenient time, and in conjunction with other remedial action tasks where practical.
