*Certification Docket for the Remedial
Action Performed at the
Former Herring-Hall-Marvin Safe
Company Site in Hamilton, Ohio*

*Department of Energy
Former Sites Restoration Division
Oak Ridge Operations Office*

December 1996

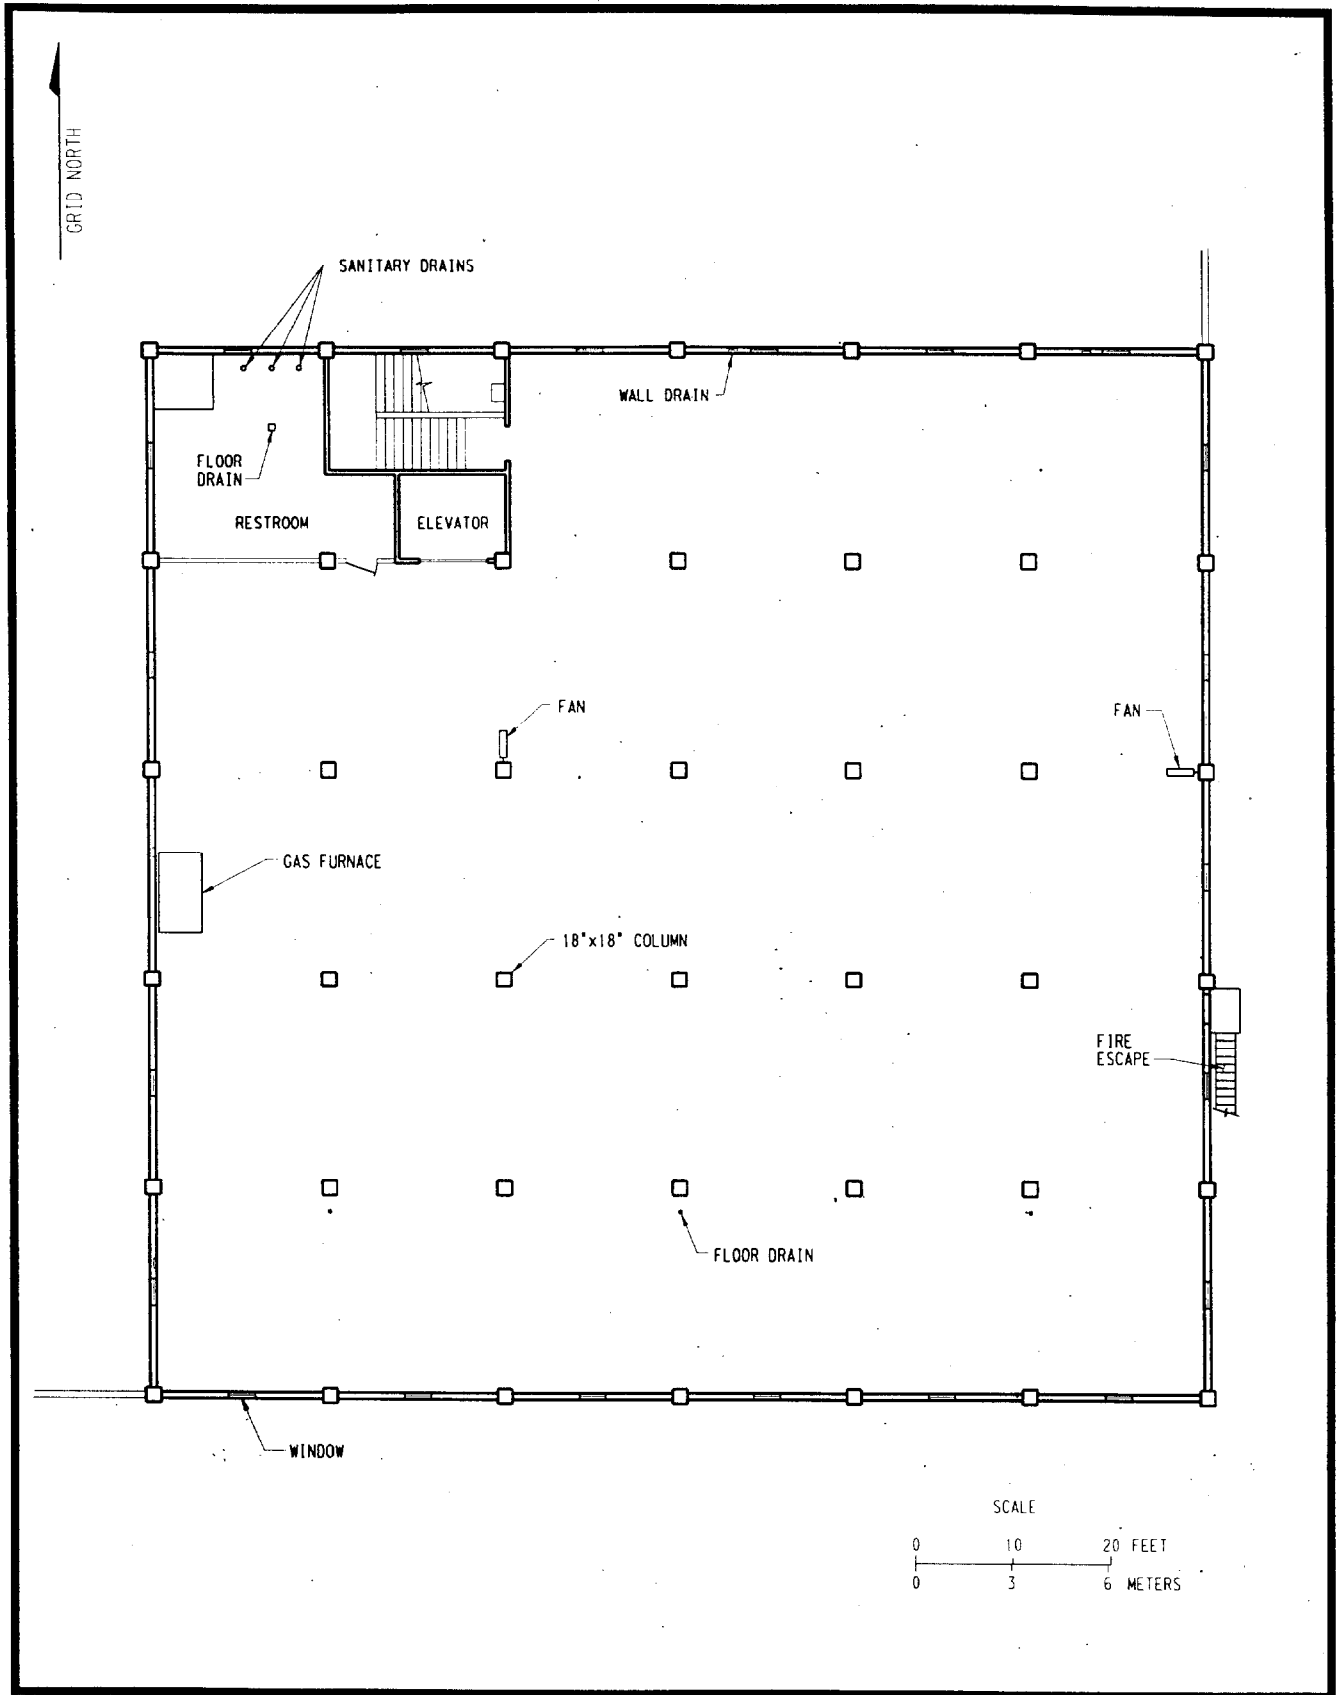
Figure I-3
 Herring-Hall-Marvin Safe Facility
 Layout of Third Floor

Radiological surveys performed in 1988 and 1989 on the first and second floors verified that radioactive contamination had been removed from those areas during previous decontamination efforts. A survey was performed in 1993 on the third floor [including the stairwell and elevator operations room above the elevator (Figure I-4)], and areas of radioactive contamination above DOE release criteria were detected.
