9.0 Lakeview, Oregon, Disposal Site

The Lakeview, Oregon, Uranium Mill Tailings Radiation Control Act (UMTRCA) Title I Disposal Site was inspected June 30, 2021. No changes were observed on the disposal cell or in the associated drainage features. Inspectors identified minor maintenance needs but no cause for a follow-up or contingency inspection.

Figure 9-1. 2021 Annual Inspection Drawing for the Lakeview, Oregon, Disposal Site

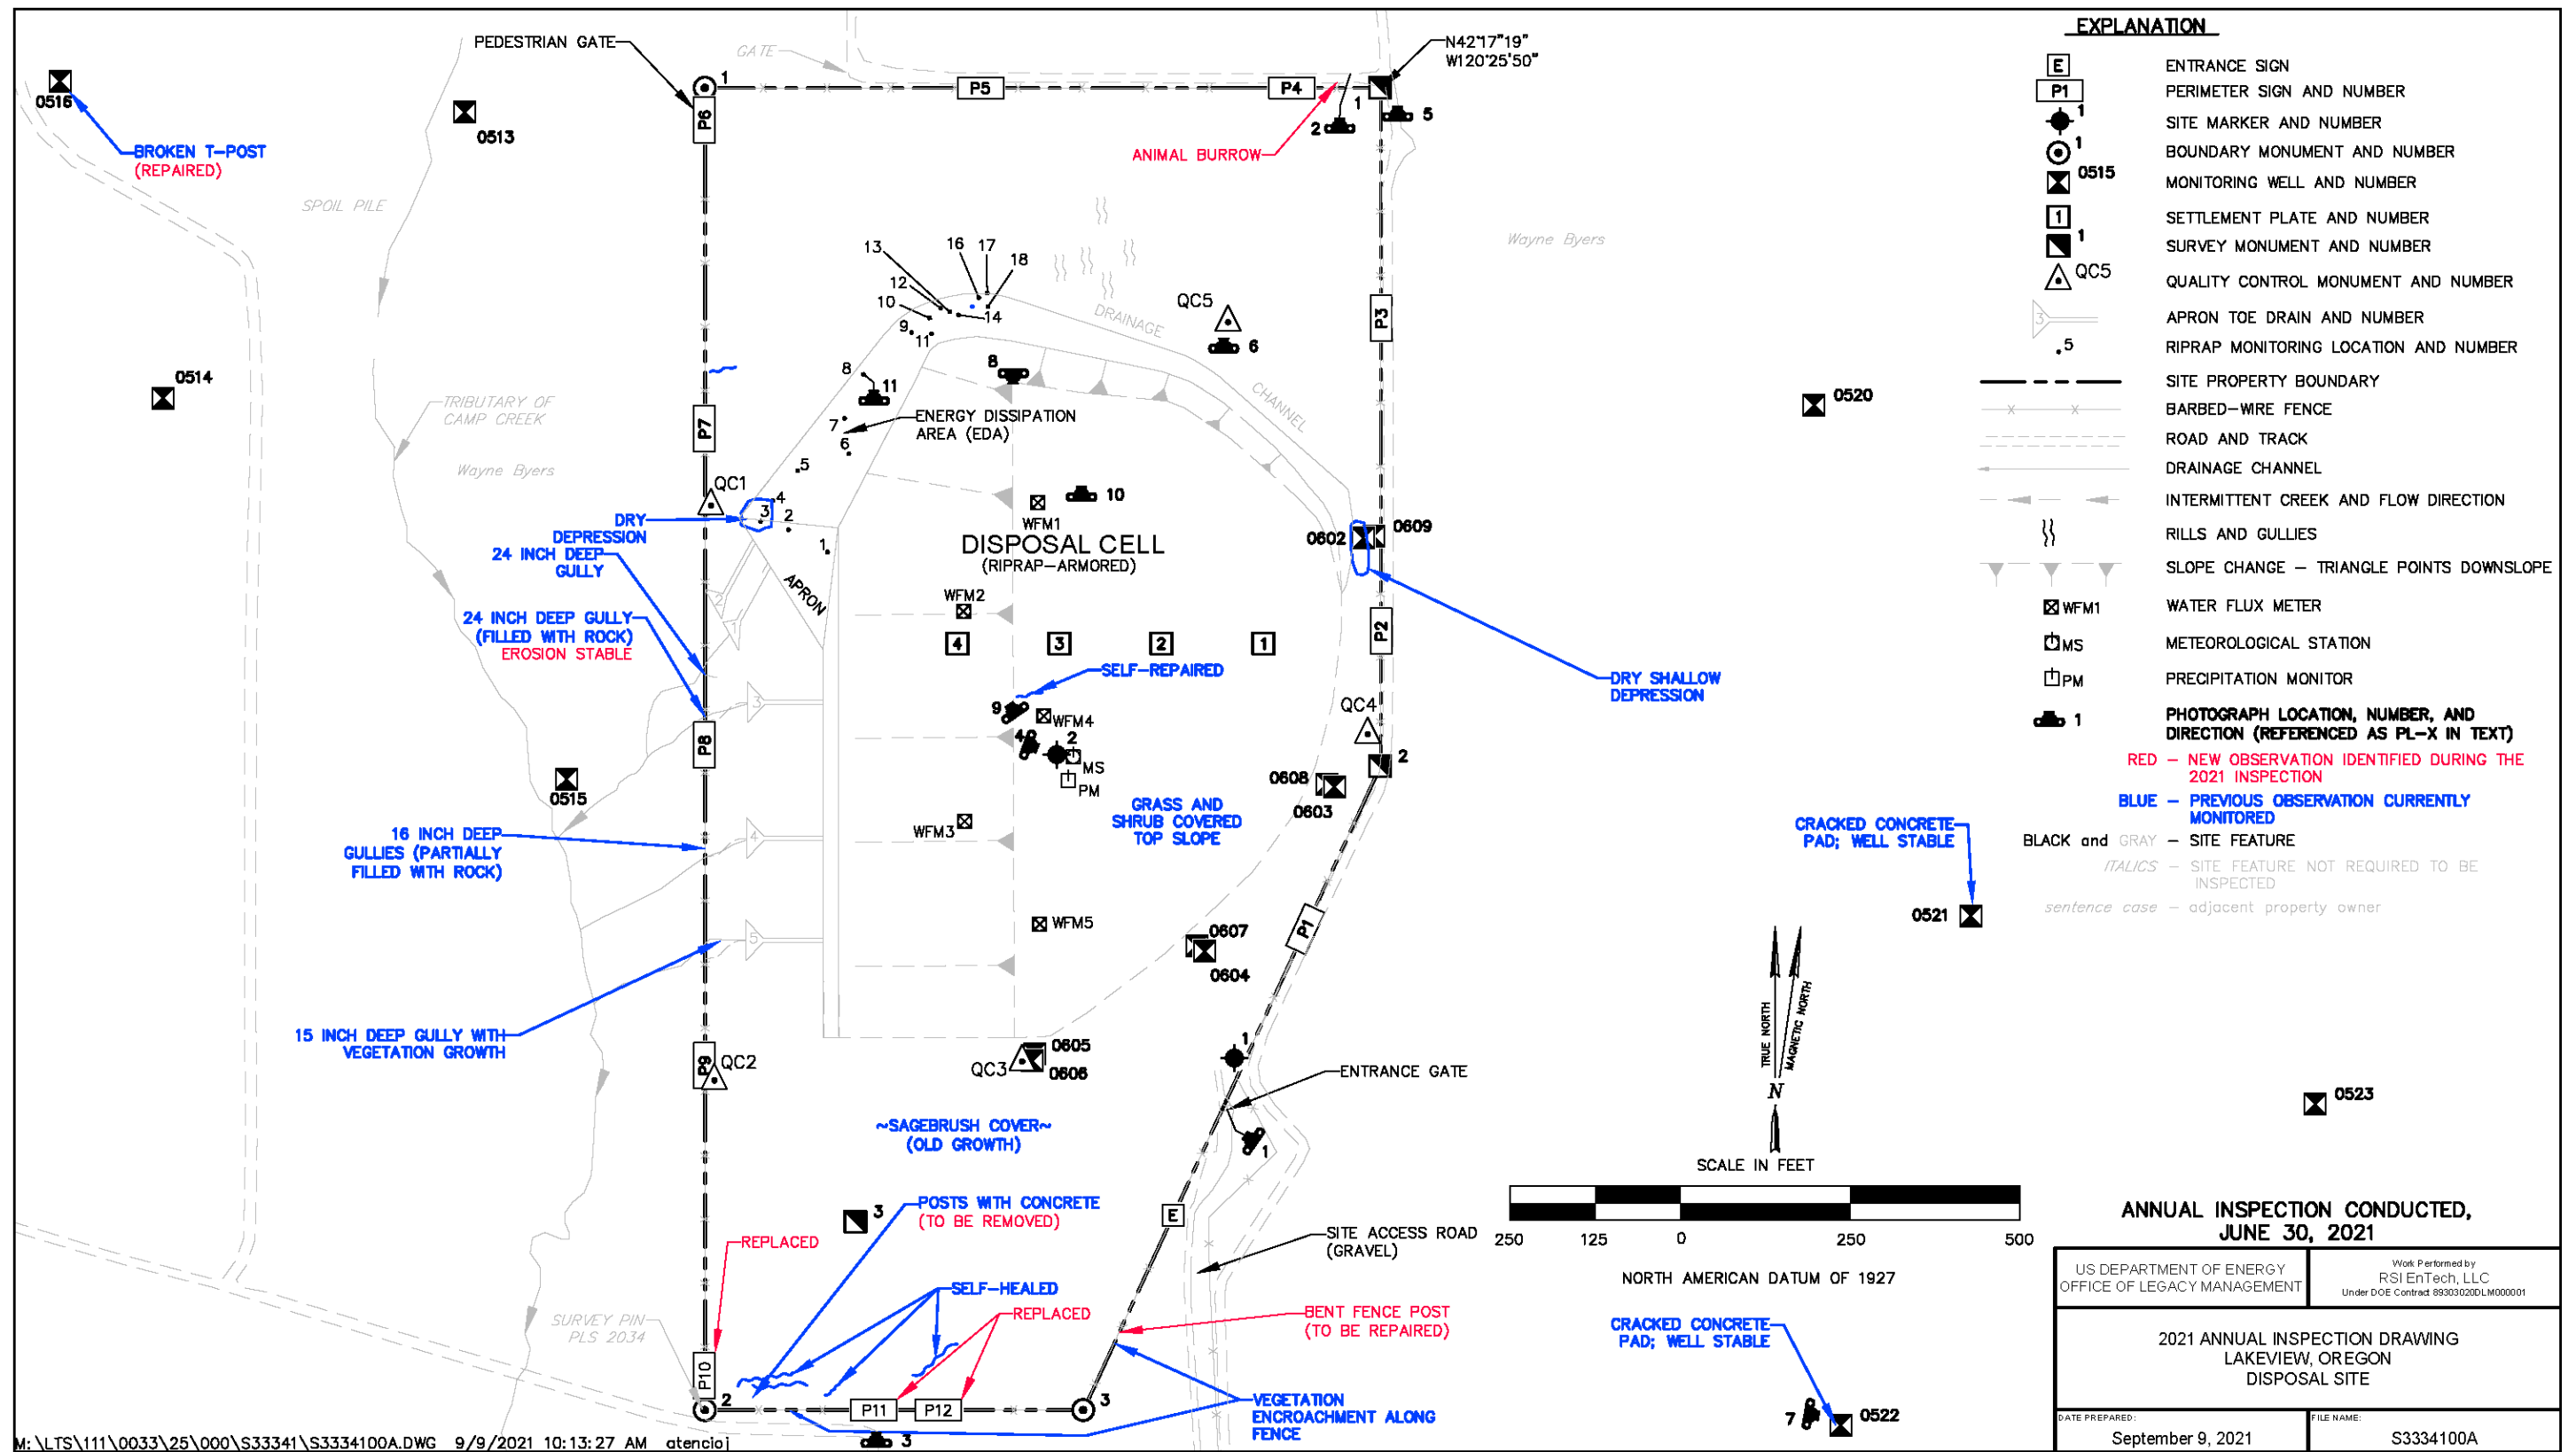
Figure 9-1 shows the locations of site features, including site surveillance features and inspection areas, in black and gray font. Site features that are present but not required to be inspected are shown in italic font. Observations from previous inspections that are currently monitored are shown in blue text, and new observations identified during the 2021 annual inspection are shown in red. Inspection results and recommended maintenance activities associated with site surveillance features are included in the following subsections. Photographs that support specific observations are identified in the text and in Figure 9-1 by photograph location (PL) numbers. The photographs and photograph log are presented in Section 9.10.

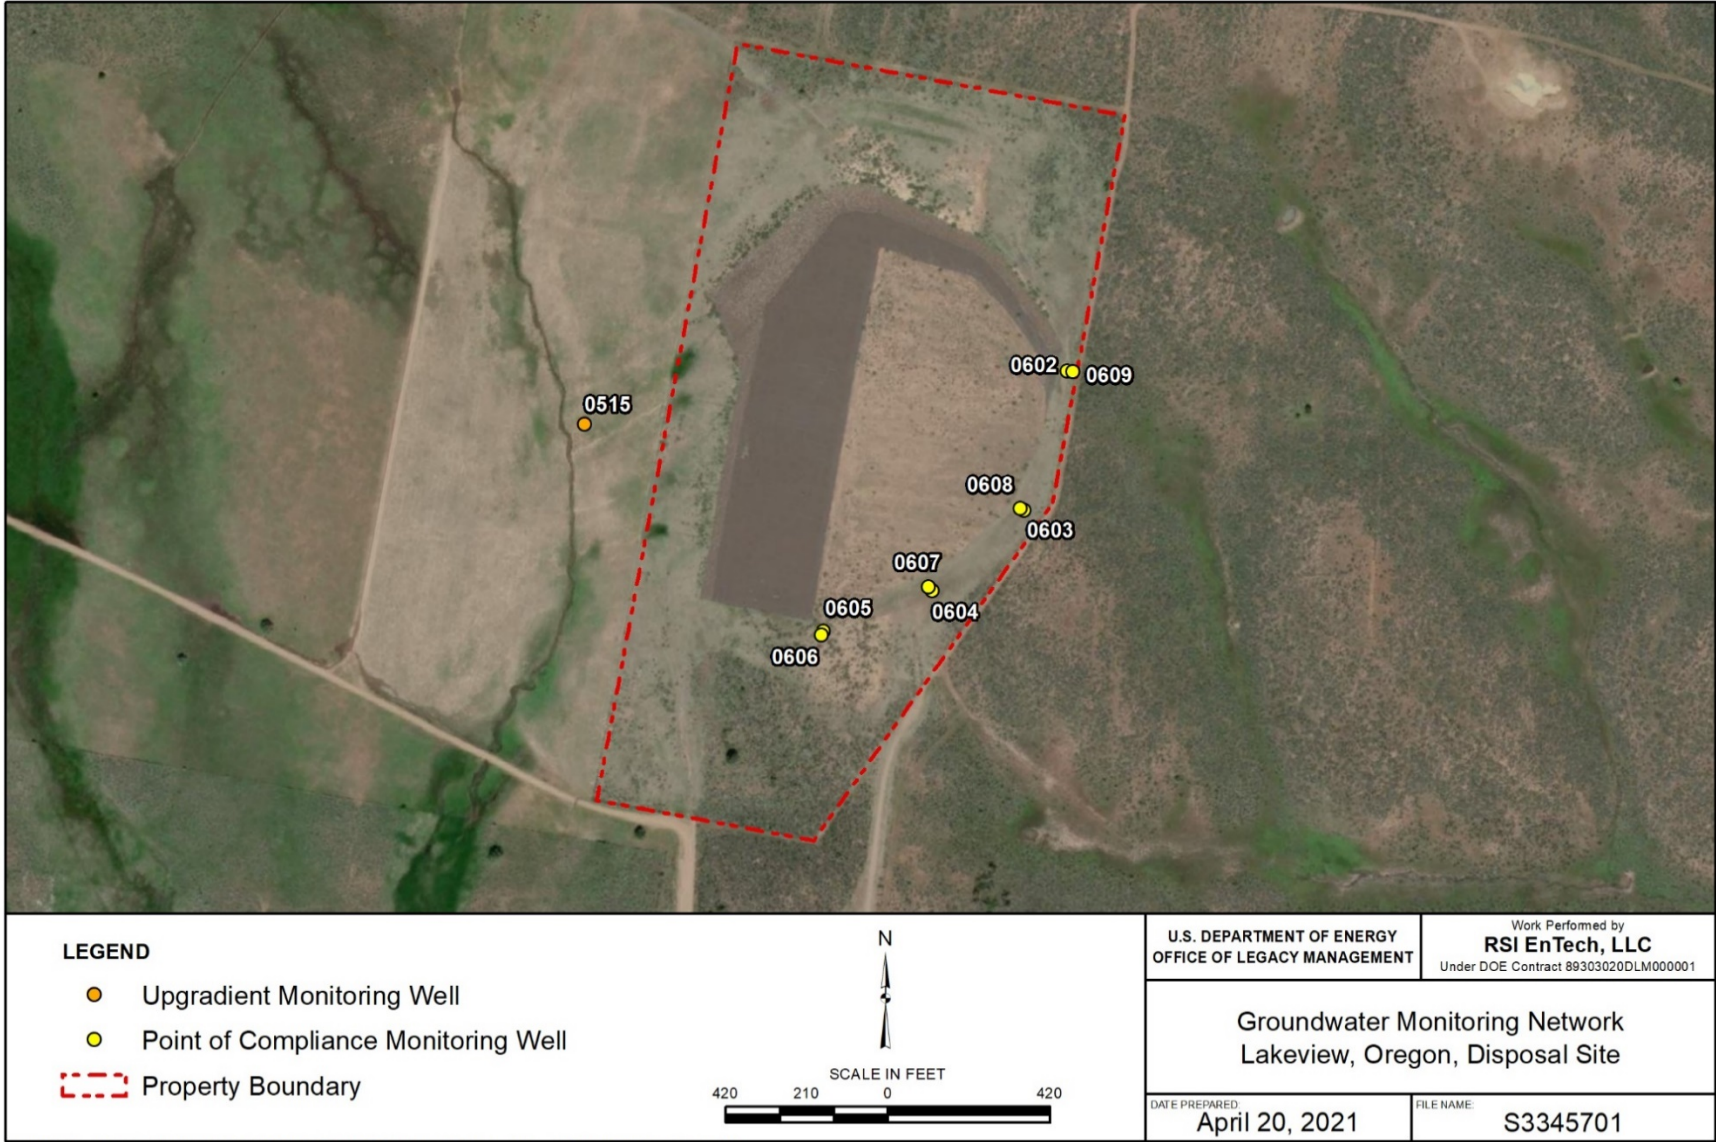
Figure 9-2. Groundwater Monitoring Network, Lakeview, Oregon, Disposal Site

The groundwater monitoring network consists of nine monitoring wells, including eight downgradient point of compliance (POC) wells and one upgradient background monitoring well (Table 9-2 and Figure 9-2). Four of the nine monitoring wells were observed to be dry on June 13, 2019, and could not be sampled. Seven additional LM-owned monitoring wells (wells 0513, 0514, 0516, 0520, 0521, 0522, and 0523) are on private property adjacent to the site but are no longer required to be sampled as identified in the LTSP (Figure 9-1). The constituents monitored in site groundwater are arsenic, cadmium, and uranium. EPA established MCLs for these analytes in groundwater in 40 CFR 192 Table 1 Subpart A (Table 9-3).
