9.0 Lakeview, Oregon, Disposal Site

9.1 Compliance Summary

Figure 9-1. 2022 Annual Inspection Drawing for the Lakeview, Oregon, Disposal Site

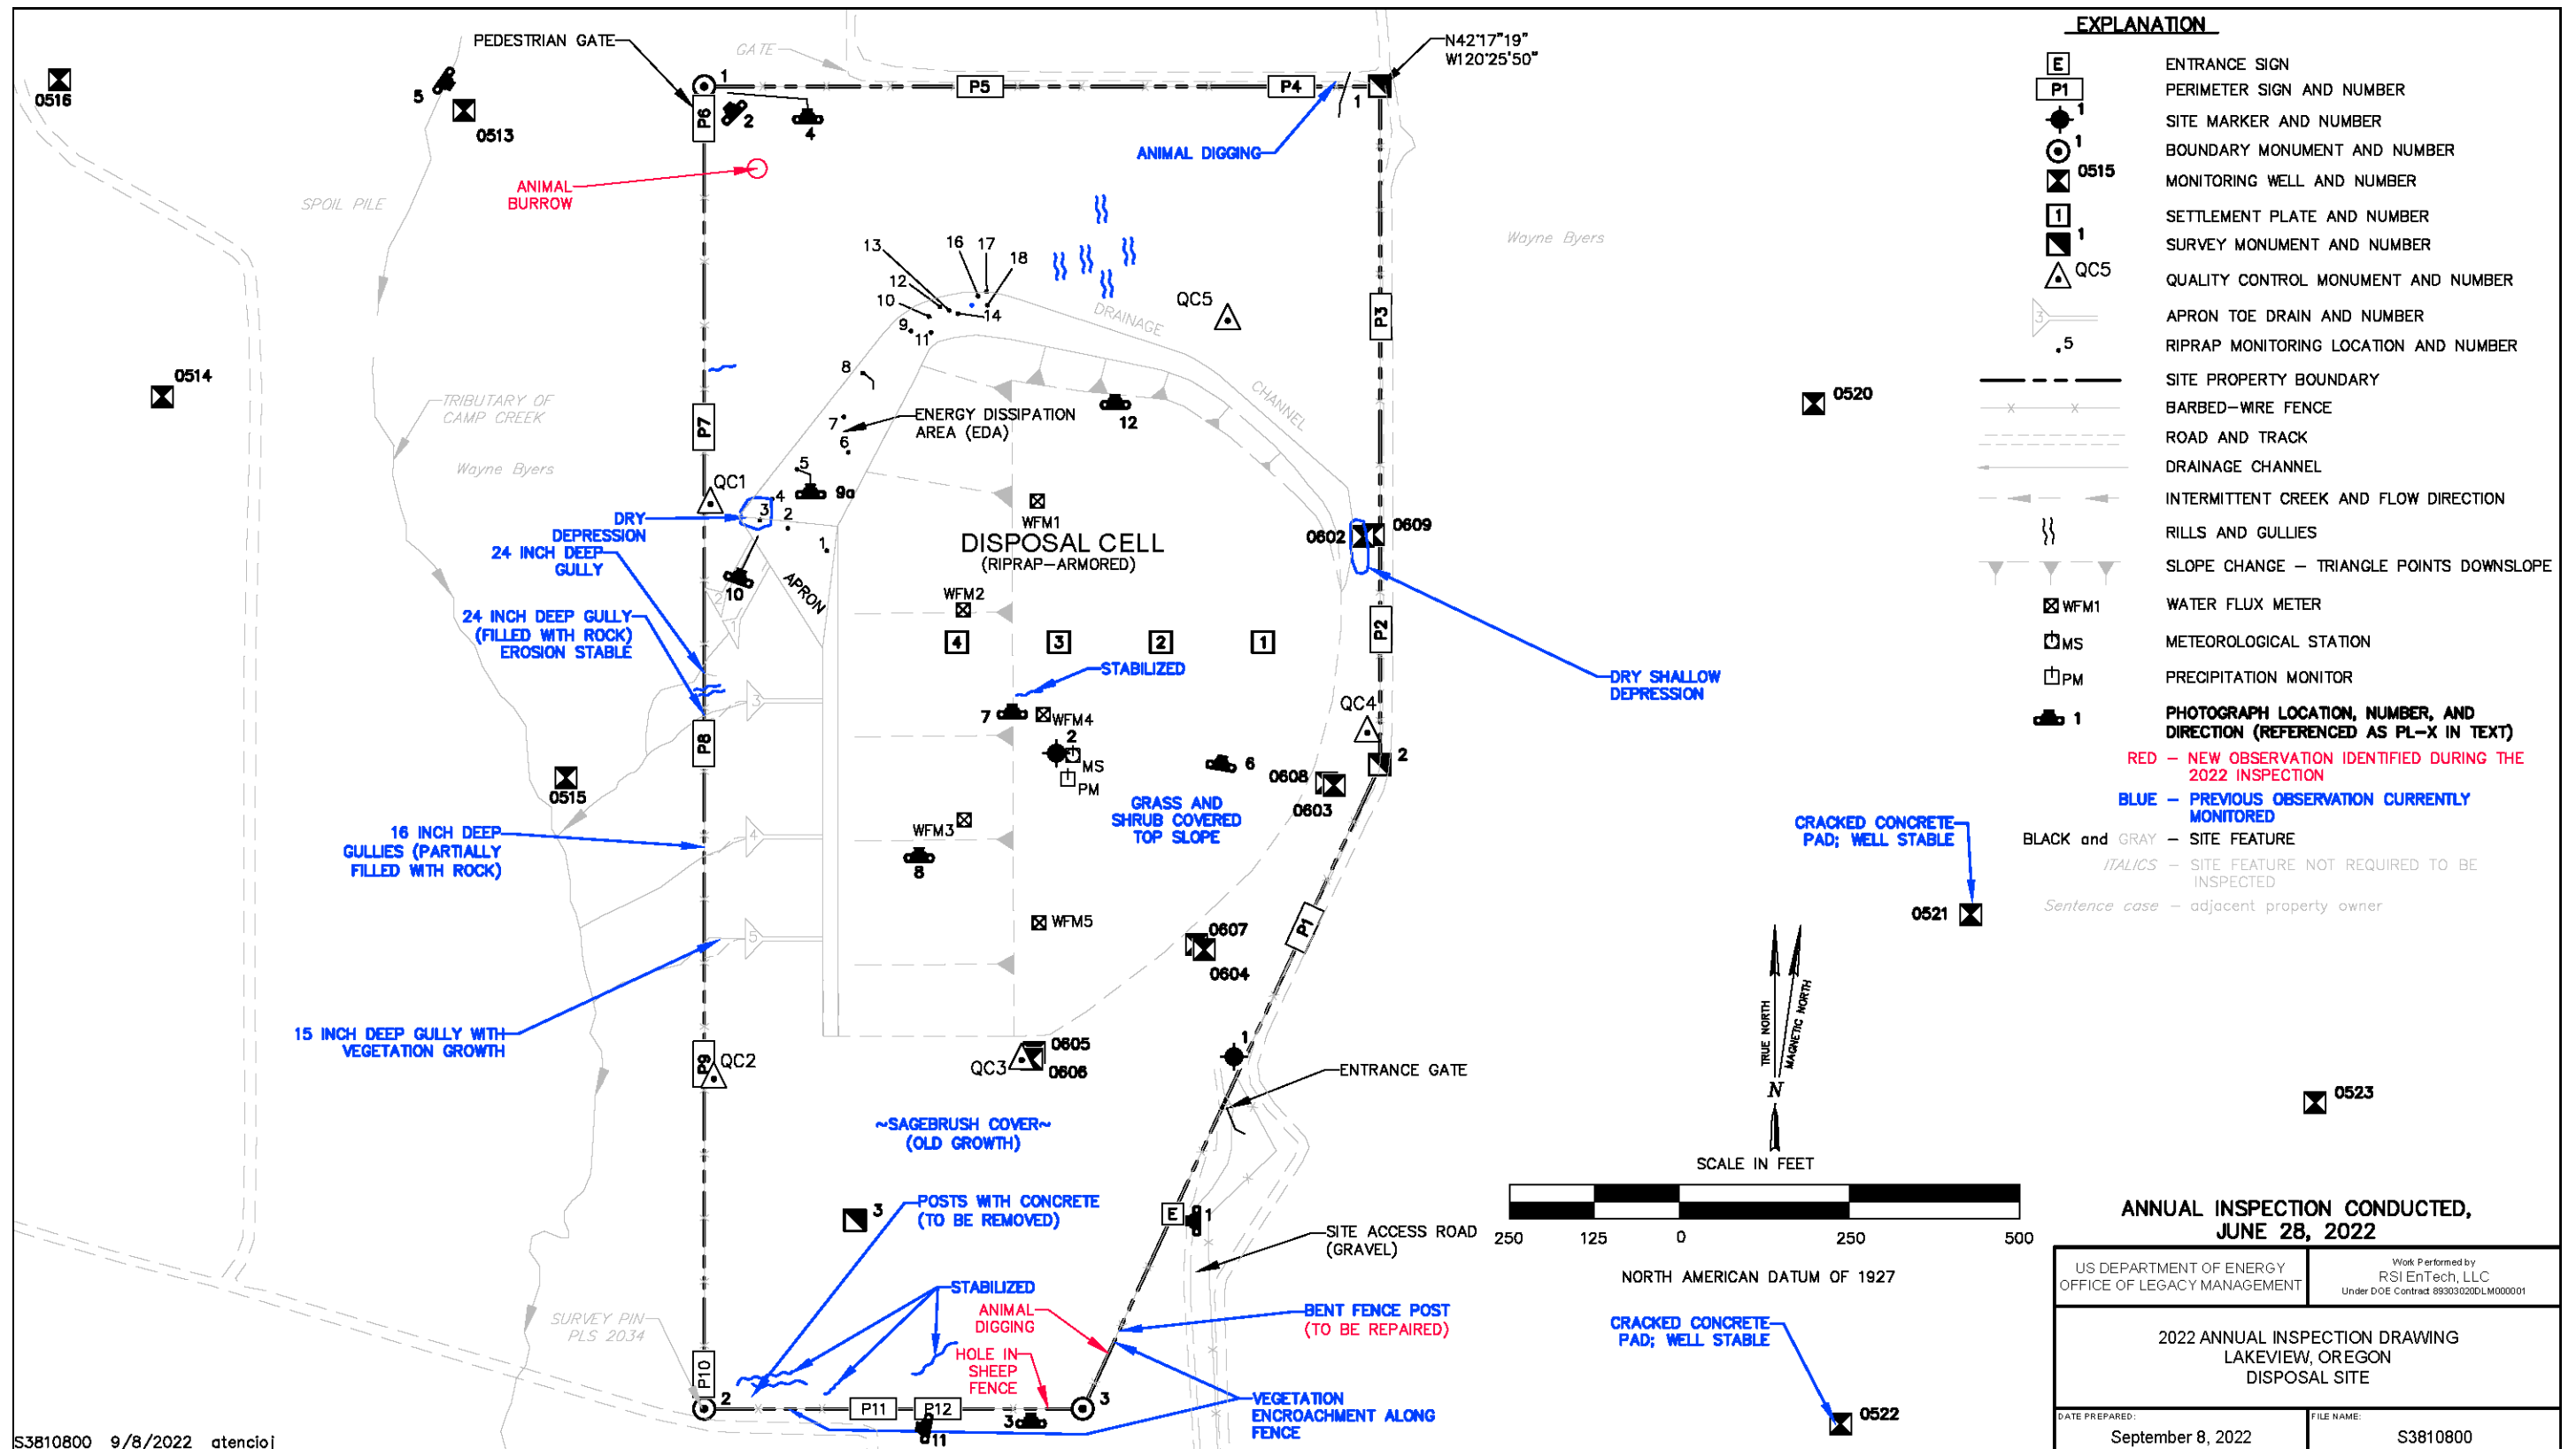
Figure 9-1 shows the locations of site features, including site surveillance features and inspection areas, in black and gray font. Some site features that are present but not required to be inspected are shown in italic font. Observations from previous inspections that are currently monitored are shown in blue, and new observations identified during the 2022 annual inspection are shown in red. Inspection results and recommended maintenance activities associated with site surveillance features are described in the following subsections. Photographs to support specific observations are noted in the text and in Figure 9-1 by photograph location (PL) numbers. The photographs and photograph log are presented in Section 9.10.

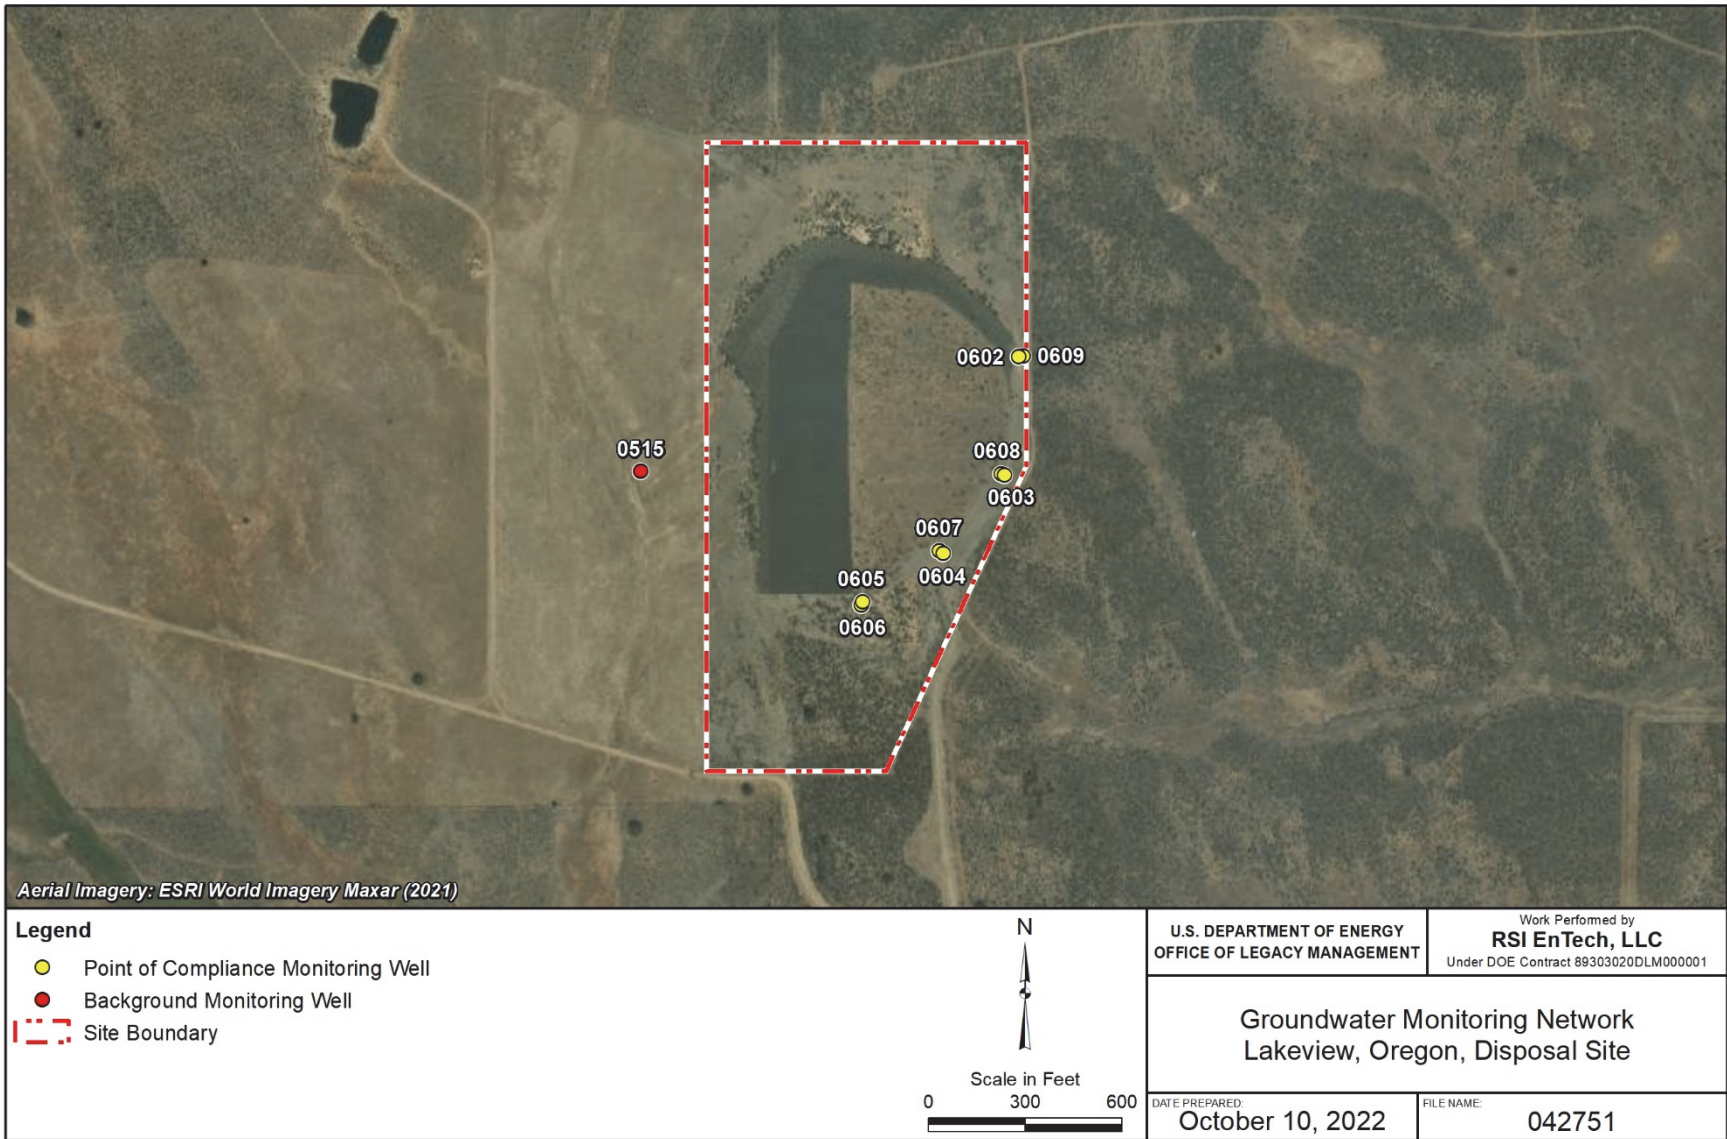
Figure 9-2. Groundwater Monitoring Network, Lakeview, Oregon, Disposal Site

The groundwater monitoring network consists of nine monitoring wells, including eight downgradient point of compliance (POC) wells and one upgradient background monitoring well (Table 9-2 and Figure 9-2). Four of the nine monitoring wells were observed to be dry on June 13, 2019, and could not be sampled.
