9.0 Lakeview, Oregon, Disposal Site

The Lakeview, Oregon, Uranium Mill Tailings Radiation Control Act (UMTRCA) Title I Disposal Site was inspected on July 10, 2024. No changes were observed on the disposal cell or in the drainage features. Inspectors identified minor maintenance needs but found no cause for a follow-up or contingency inspection.

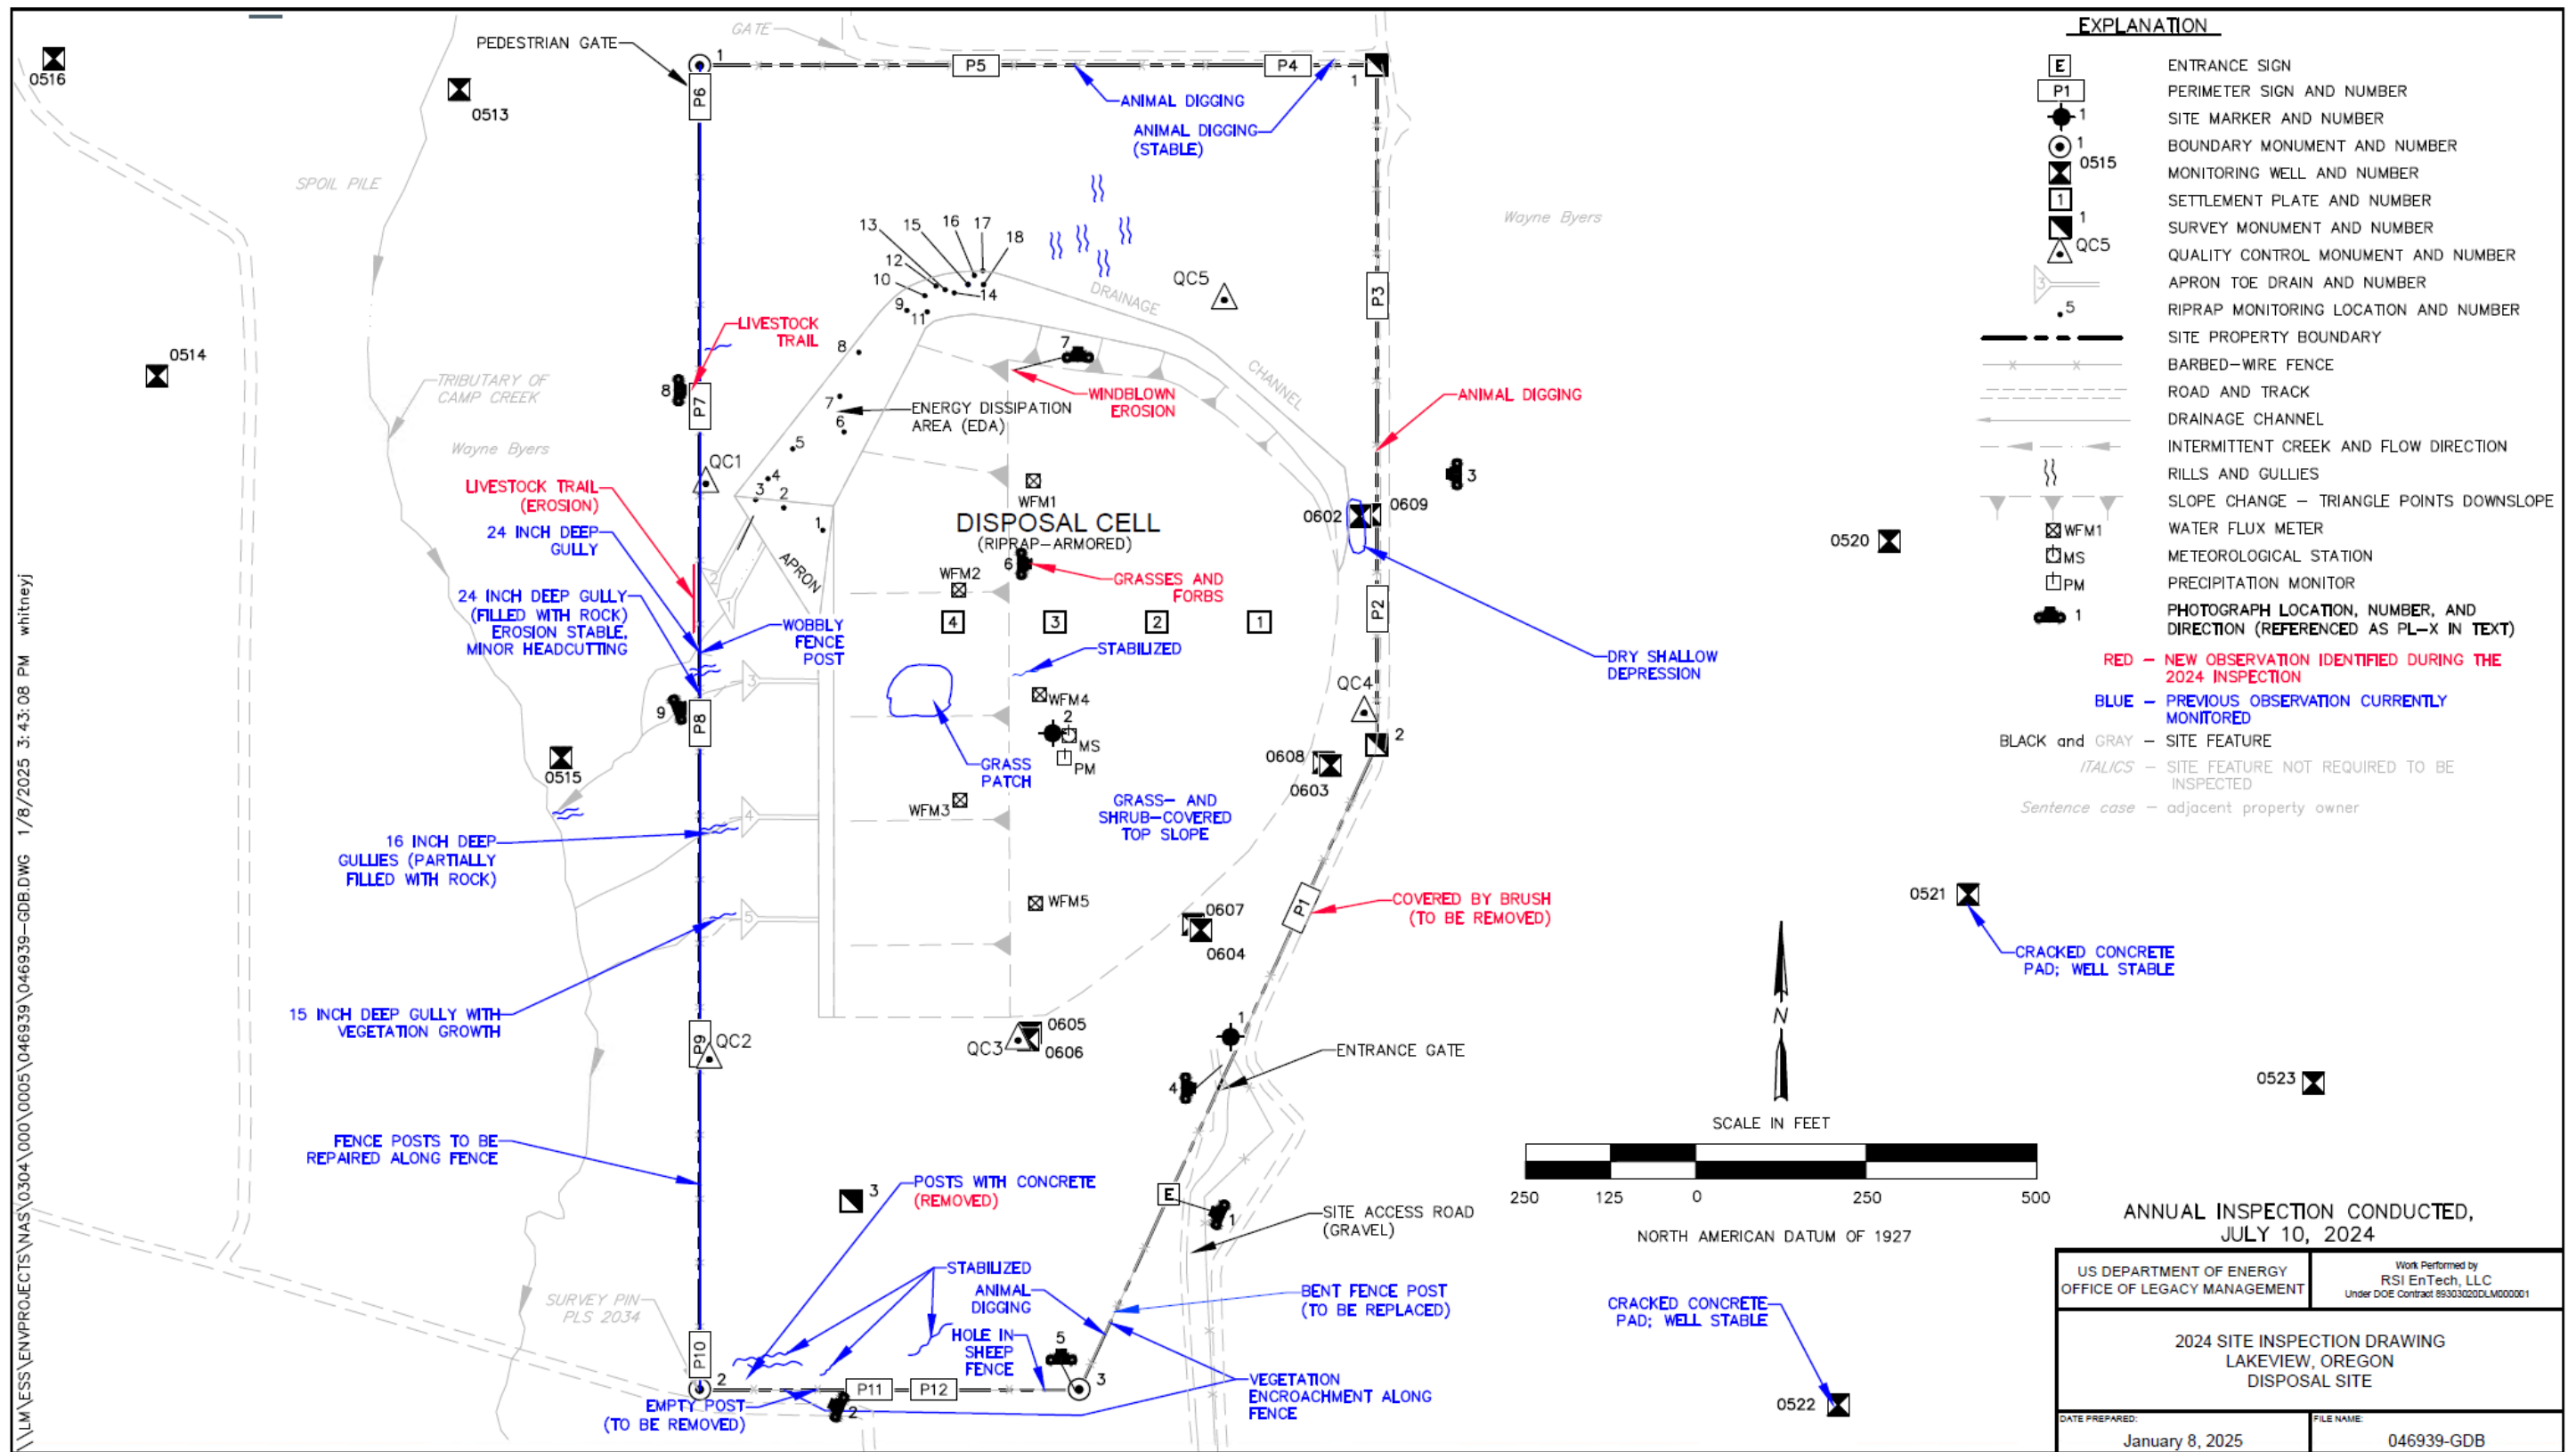
Figure 9-1. 2024 Annual Inspection Drawing for the Lakeview, Oregon, Disposal Site

A sheep fence and four- or five-strand barbed wire enclose the site. Sheep fencing is on the southeastern and southern boundaries of the site. Some juniper trees and other vegetation are growing near, or entangled in, the perimeter fence line (PL-2), but the fence appears stable and remains functional. An empty post was found near the southern fence and will be removed in the future. A small hole in the sheep fence was observed in the southern fence line. The hole appears to be man-made, possibly to help small animals escape through the fence. Evidence of minor erosion from animals digging under the fence was identified near the southeast corner of the fence line and along the northern fence line during the 2022 and 2023 inspections, but these areas are not a concern to site security or the integrity of the fence. New evidence of animal digging was observed along the eastern fence line during the 2024 inspection (PL-3).

There are 12 perimeter signs attached to steel posts set in concrete and positioned along the property boundary. Perimeter sign P1 has brush growing around the signpost and the perimeter sign that will need to be removed. No other maintenance needs were identified.

Offsite downgradient wells 0521 and 0522 have surficial concrete bases around the well casing that are cracked, but the wellhead protectors remain stable. A dry, shallow depression remains near onsite well 0602, as noted in previous inspections. The wellhead protectors were locked and undamaged. No maintenance needs were identified.

Wind erosion of the soil is evident in places on the disposal cell cover. In these areas, the roots of vegetation have been exposed as wind carries the soil away (PL-7). Previously identified erosional features such as small rills were not observed in 2024 and are assumed to have stabilized through natural processes. No structural or disposal cell performance concerns are associated with soil erosion because the riprap rock cover is continuous beneath the top slope soil cover, slope crests, and side slopes. Inspectors will continue to monitor this condition.

The contact boundary between the disposal cell top and side slopes was inspected and generally appears stable and uniform. Windblown erosion was observed during the 2024 inspection at the northwest corner of the crest on the west side slope and the disposal cell top slope; both appear to be stable. Inspectors will continue to monitor the transition zone between the disposal cell top slope and the west side slope for erosion development. There was no evidence of settling, slumping, erosion, or any other modifying process on the top of the disposal cell that might affect the integrity of the disposal cell.

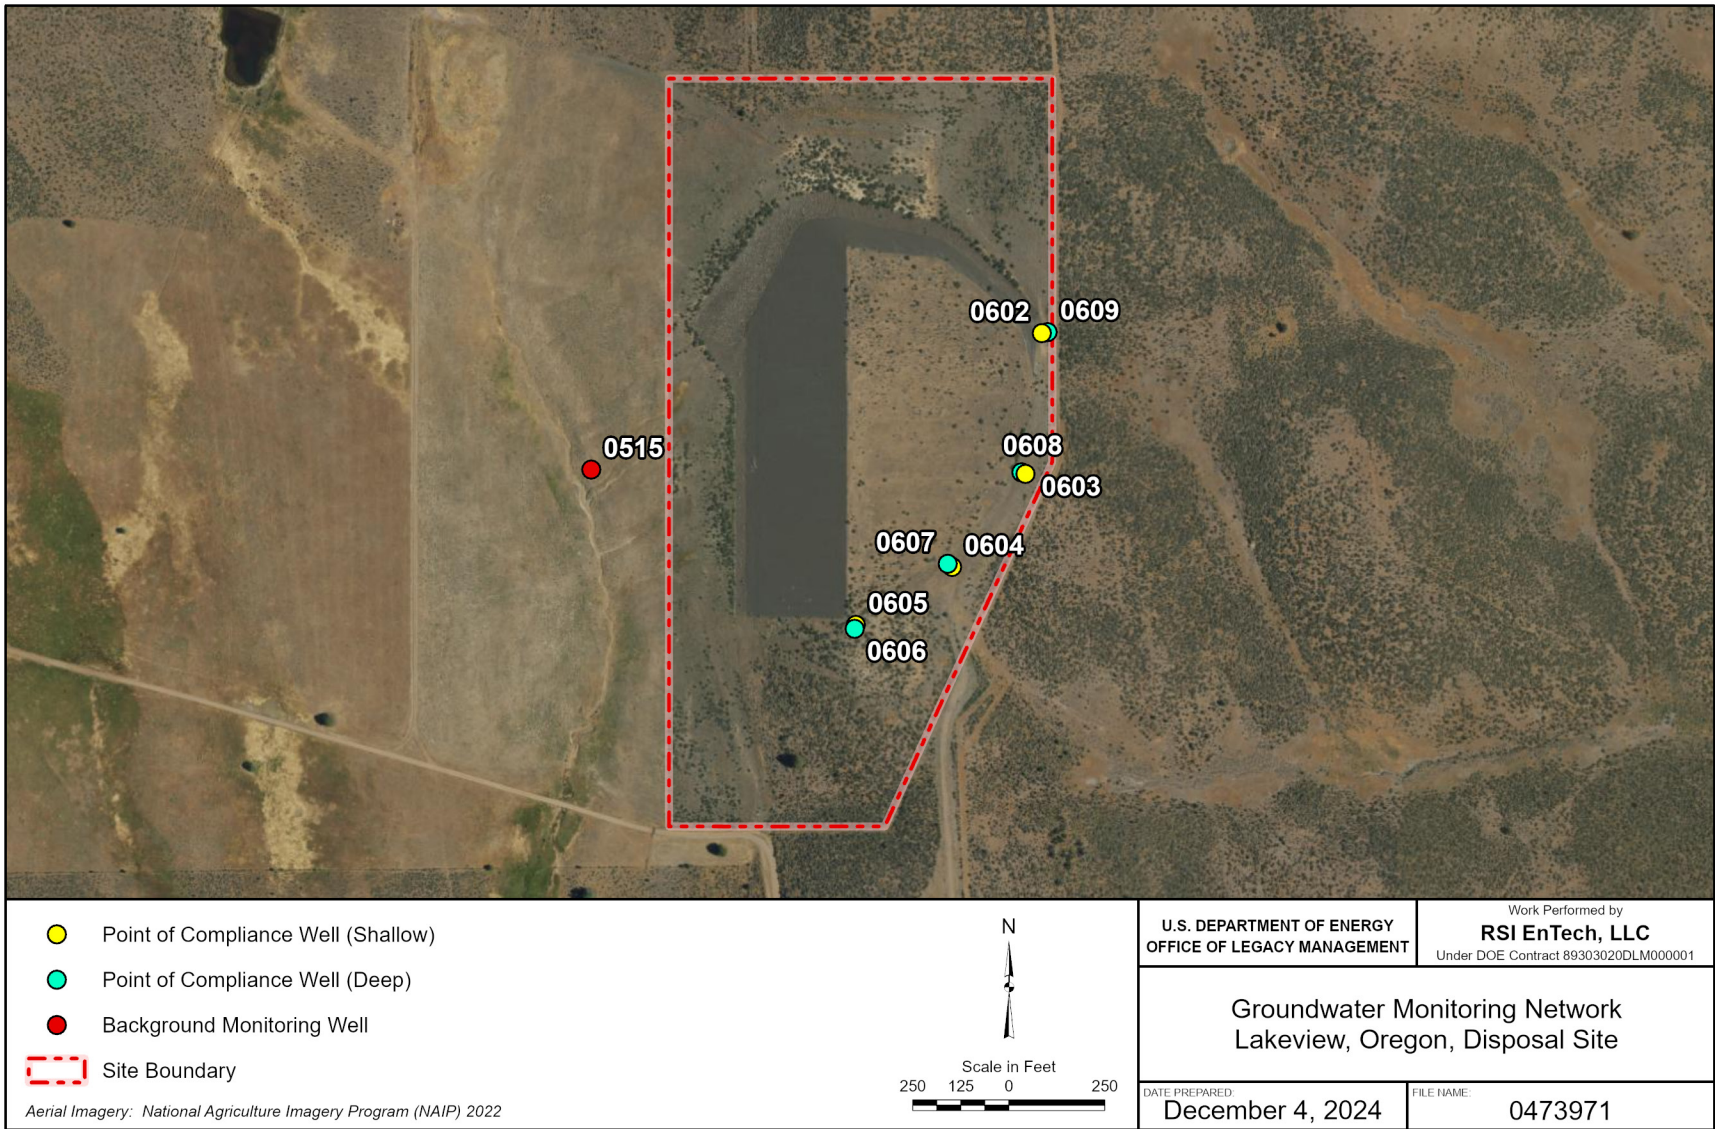
Figure 9-2. Groundwater Monitoring Network, Lakeview, Oregon, Disposal Site

In accordance with the LTSP, LM conducts groundwater monitoring every 5 years to demonstrate compliance with established groundwater quality protections standards. The most recent sampling event occurred on July 9, 2024, and the next event will occur in 2029. The groundwater monitoring network consists of nine monitoring wells, including eight downgradient point of compliance (POC) wells installed in four clusters of two wells (one shallow and one deep) and one upgradient background monitoring well (Table 9-2 and Figure 9-2).
