**DR. MODESTO IRIARTE TECHNOLOGICAL
MUSEUM (FORMER BONUS FACILITY)**

**2018 ANNUAL RADIOLOGICAL SURVEY REPORT -
DRAFT**

**RINCON
PUERTO RICO**

December 2018

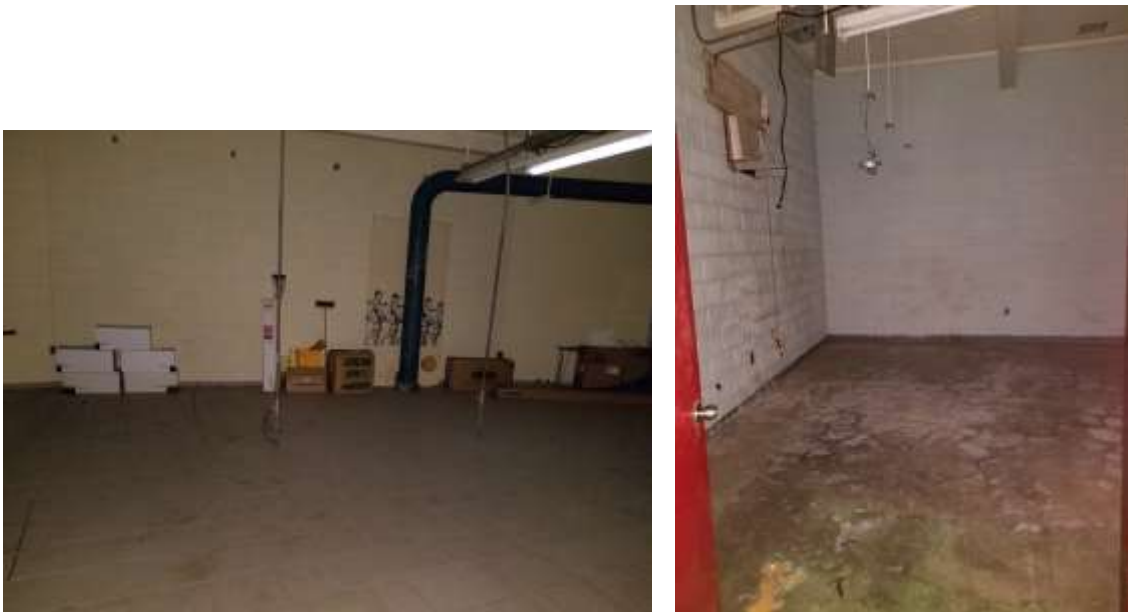
Figure 14. Main Level (Museum Area) – Locked and Controlled Access to Machine Shop (Left) and Electrical Shop (Right) Former File Storage

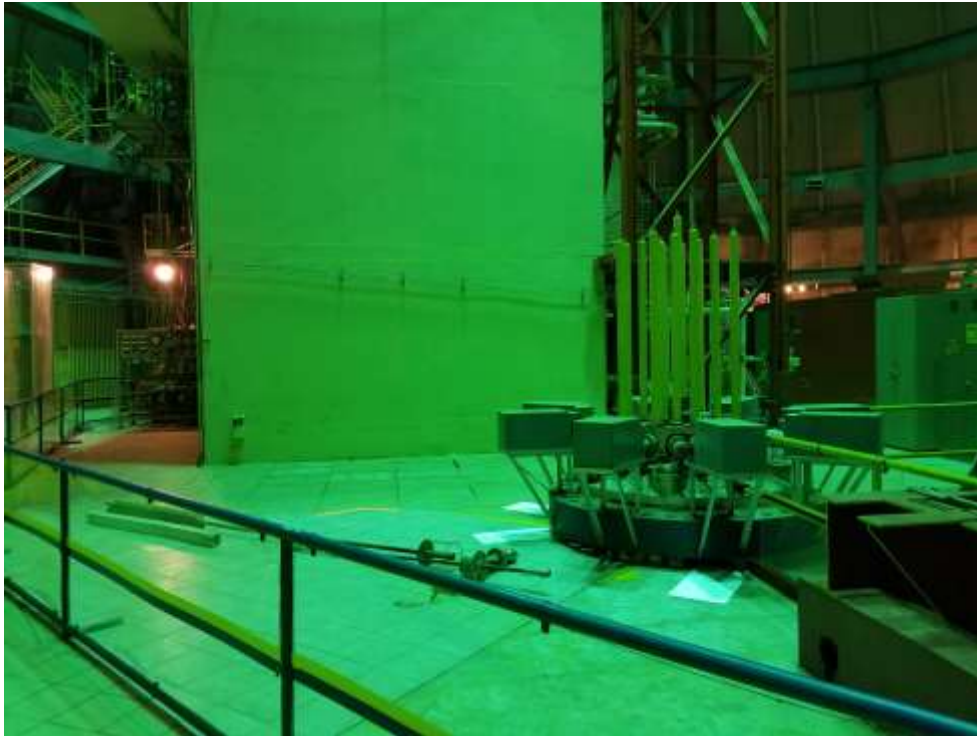
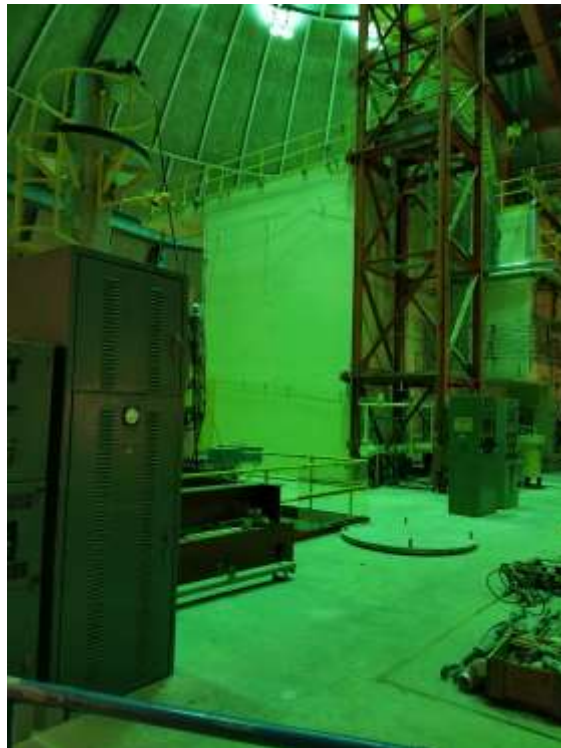
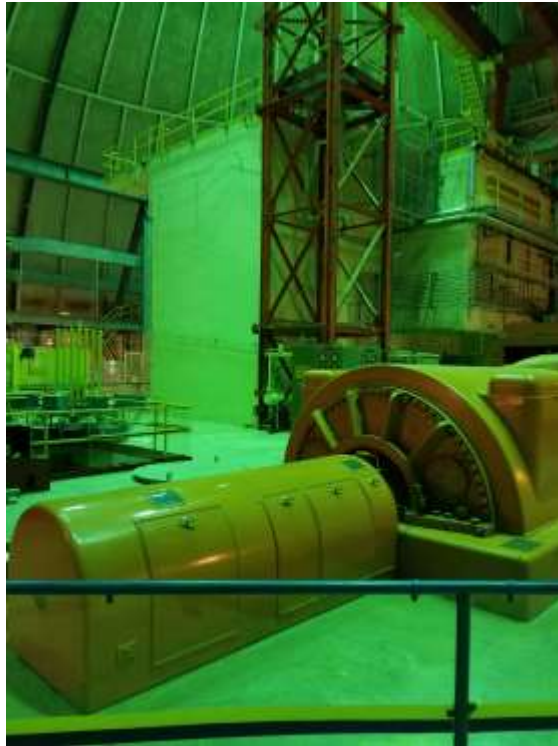
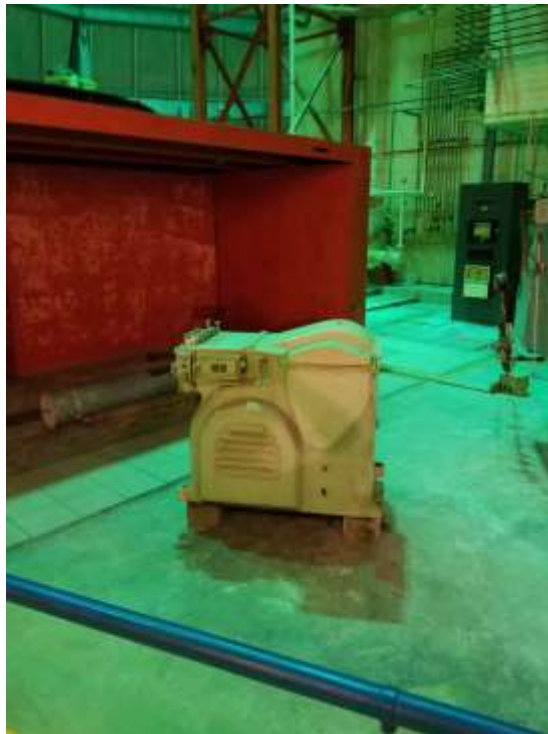
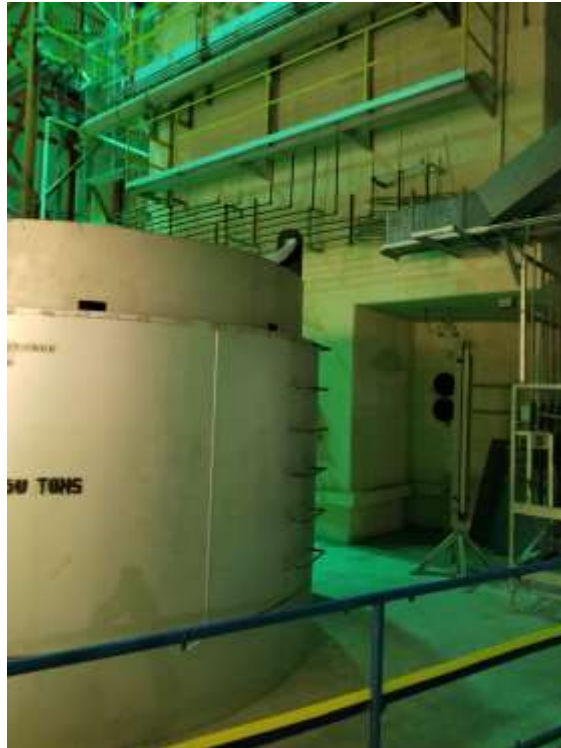
- **Dome-Main Level:** The Main Level (Controlled Area) is that portion of the Main Level that is not accessible to the public (Appendix A, Figures 16 through 20). The two historical contamination sites remain covered with floor tiles; the tile work is in good condition and is effective in reducing the dose levels. One area adjacent to the north side of the Monolith is also covered with lead bricks, which is effective in reducing elevated dose rate levels in this area (Appendix A, Figure 21). Ongoing and routine assessment of the floor tile and lead bricks in this area is recommended. There is also no discernible evidence of work and/or damage affecting the control measures (floor tiles) on the Main Level, Museum Area (Appendix A, Figures 4 through 10 and 14). The safety guard along the railing (Appendix A, Figure 17), which protects from falls to the Basement Level below, is in good condition and access control signs are properly placed along the railing. The pad lock on the gate within the railing system, which provides access from the

Figure 16. Main Level (Controlled Area) – Southeast Side

Figure 17. Main Level (Controlled Area) – East Side

Figure 18. Main Level (Controlled Area) –Northeast Side

Figure 19. Main Level (Controlled Area) – North Side

Figure 20. Main Level (Controlled Area) – Northwest Side

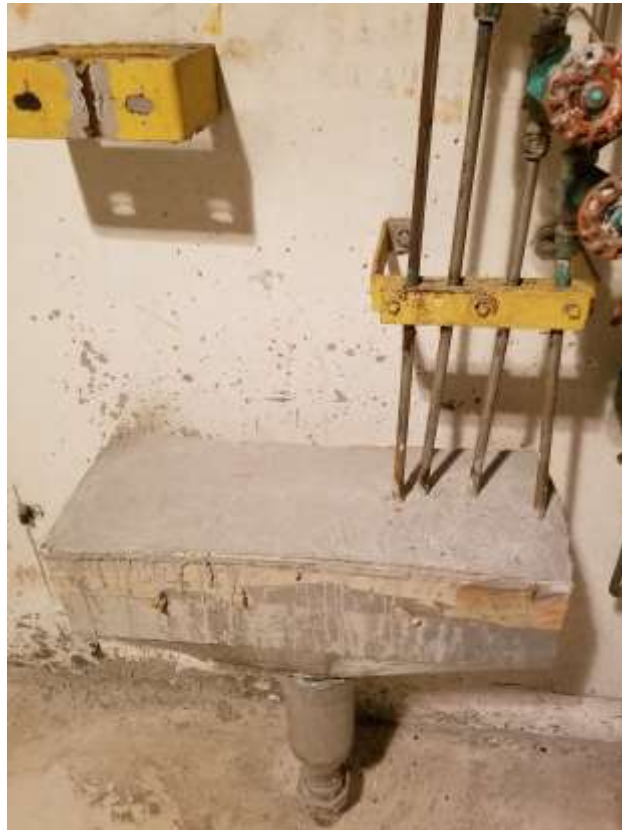
Control measures (fixed with paint and concrete layer in some places), which were previously implemented, were inspected (Appendix A, Figures 26, 28, 29, and 30). PREPA personnel applied a fresh coat of yellow paint since the 2016 survey on the Liquid Water Retention Tanks per previous recommendations. The concrete wall coating at Sample Locations 40A and 40B is showing signs of cracking and deterioration, but remains effective. Ongoing and routine assessment of accessible surfaces in the basement is recommended to evaluate the continued effectiveness of the concrete cover flooring and control measures (e.g., paint) emplaced on previous contamination areas. Although immediate action is not critical, it is recommended that an additional layer of concrete be placed over Sample Locations 40A and 40B within the next two years (Appendix A, Figure 30). Access to areas with historical removable contamination is being effectively controlled.

Figure 26. Basement Level – Concrete Filled Sink

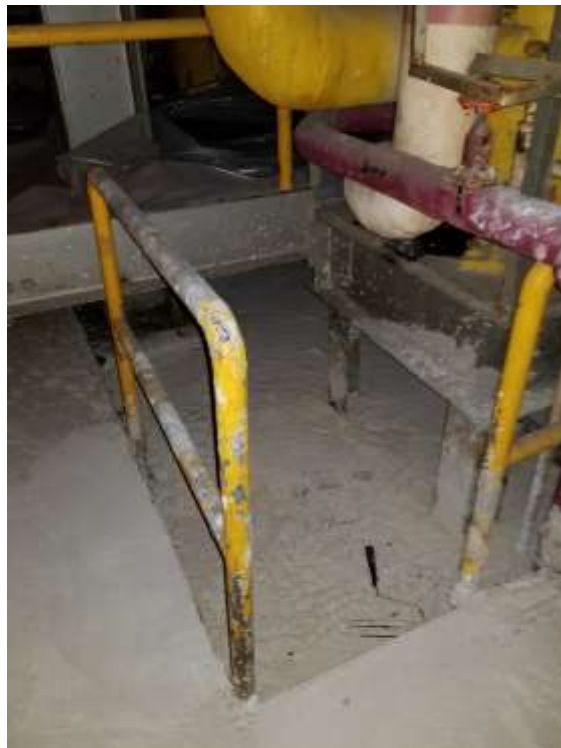
- **Dome-Basement Level Flooding:** Inspection of this level revealed no standing water on the floors. Storm water drains appear to be functioning properly, but silt/mud remains in the sump from historical events (Appendix A, Figure 27).

Figure 27. Basement Level – Lowest Point in Basement with No Standing Water

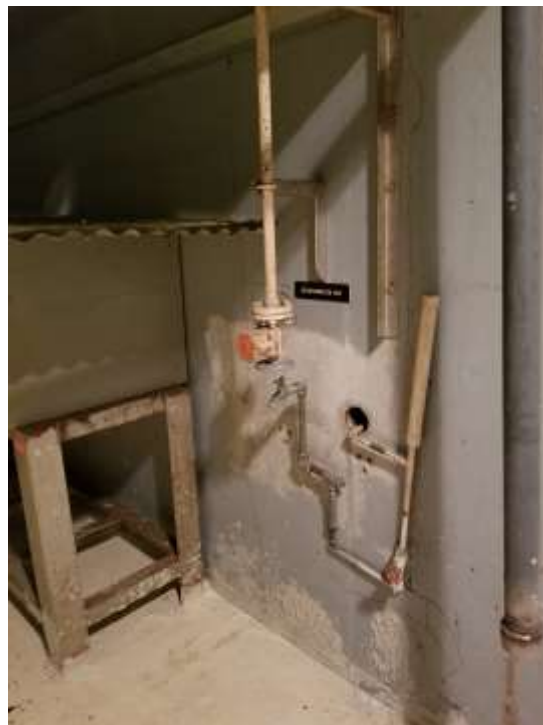
Figure 29. Basement Level – Painted Flange (Engineering Controls) at Former Decontamination Sink Location

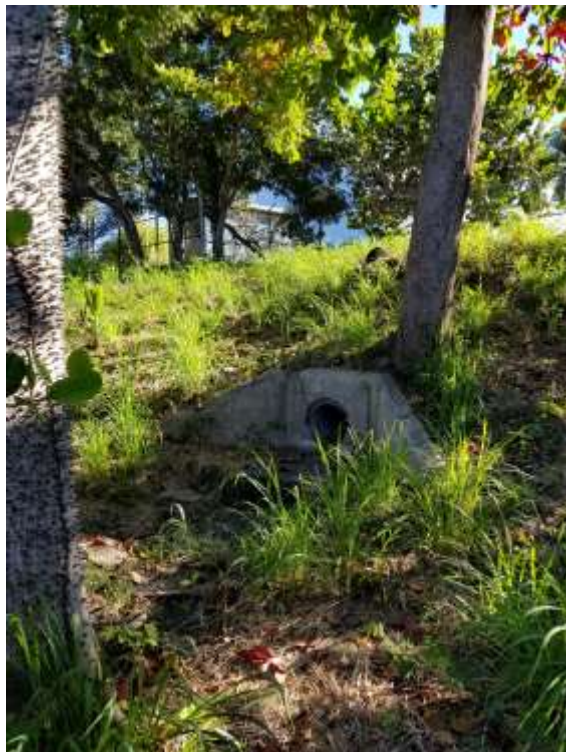
- **Dome-External Piping Systems:** Inspection of accessible external piping systems revealed no significant indications of deterioration. Outfall pipes on the west side of the property (on the beach outside of perimeter fence) were inspected (Appendix A, Figure 34). Outfall pipes on the south side of the property (outside of perimeter fence) could not be accessed due to overgrown vegetation. One of the drainage pipes on the west side, where it passes under the main access road, is significantly obstructed with silt and debris – likely due to the 2017 hurricane season (Appendix A, Figure 35). It is recommended that the accumulated silt and debris be removed.

Figure 34. Dome Structure – Drainage Outfall Points and Ditches (Southern Outfall)
