1.0 Ambrosia Lake, New Mexico, Disposal Site

1.1 Compliance Summary

The Ambrosia Lake, New Mexico, Uranium Mill Tailings Radiation Control Act (UMTRCA) Title I Disposal Site (site) was inspected on September 11, 2020. No changes were observed on the disposal cell or in the associated drainage features. Inspectors identified several minor maintenance needs but found no cause for a follow-up or contingency inspection.

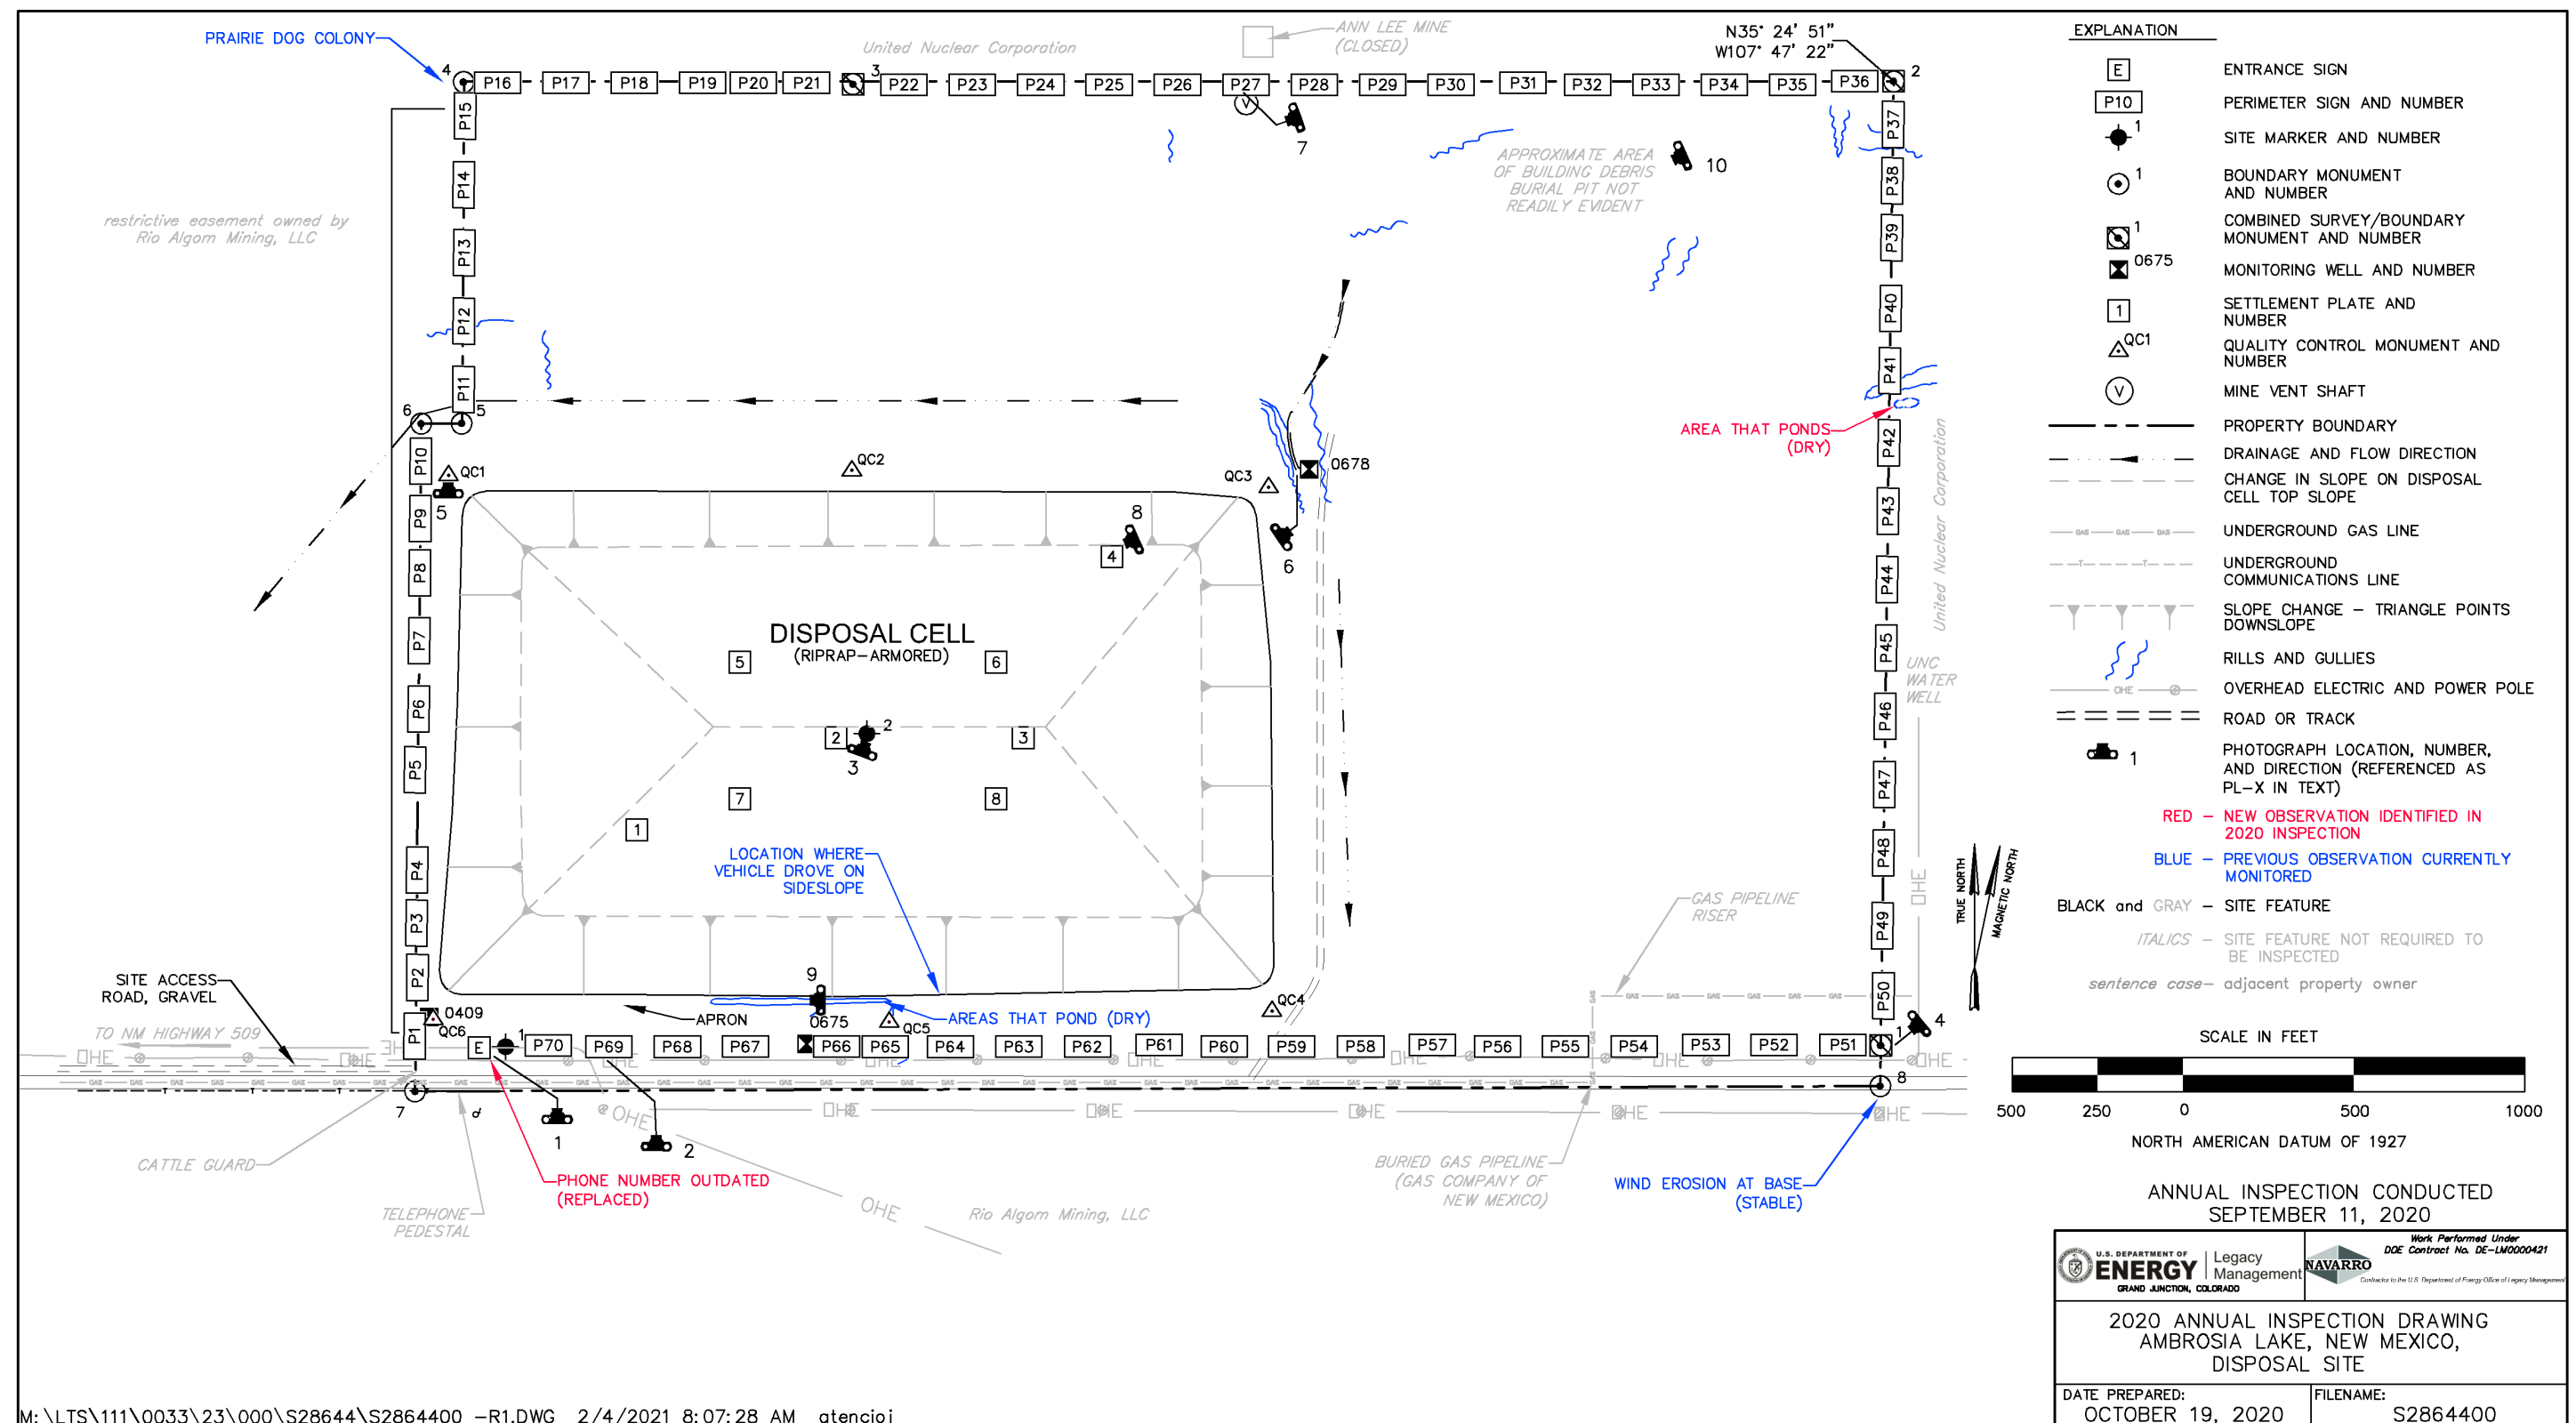
Figure 1-1. 2020 Annual Inspection Drawing for the Ambrosia Lake, New Mexico, Disposal Site

Figure 1-1 shows the locations of site features in black and gray font, including site surveillance features and inspection areas. Site features that are present but not required to be inspected are shown in italic font. Observations from previous inspections that are currently monitored are shown in blue text, and new observations identified during the 2020 annual inspection are shown in red. Inspection results and recommended maintenance activities associated with site surveillance features are included in the following subsections. Photographs to support specific observations are identified in the text and in Figure 1-1 by photograph location (PL) numbers. The photographs and photograph log are presented in Section 1.10.
