## 2.0 Burrell, Pennsylvania, Disposal Site

### 2.1 Compliance Summary

Figure 2-1. 2020 Annual Inspection Drawing for the Burrell, Pennsylvania, Disposal Site

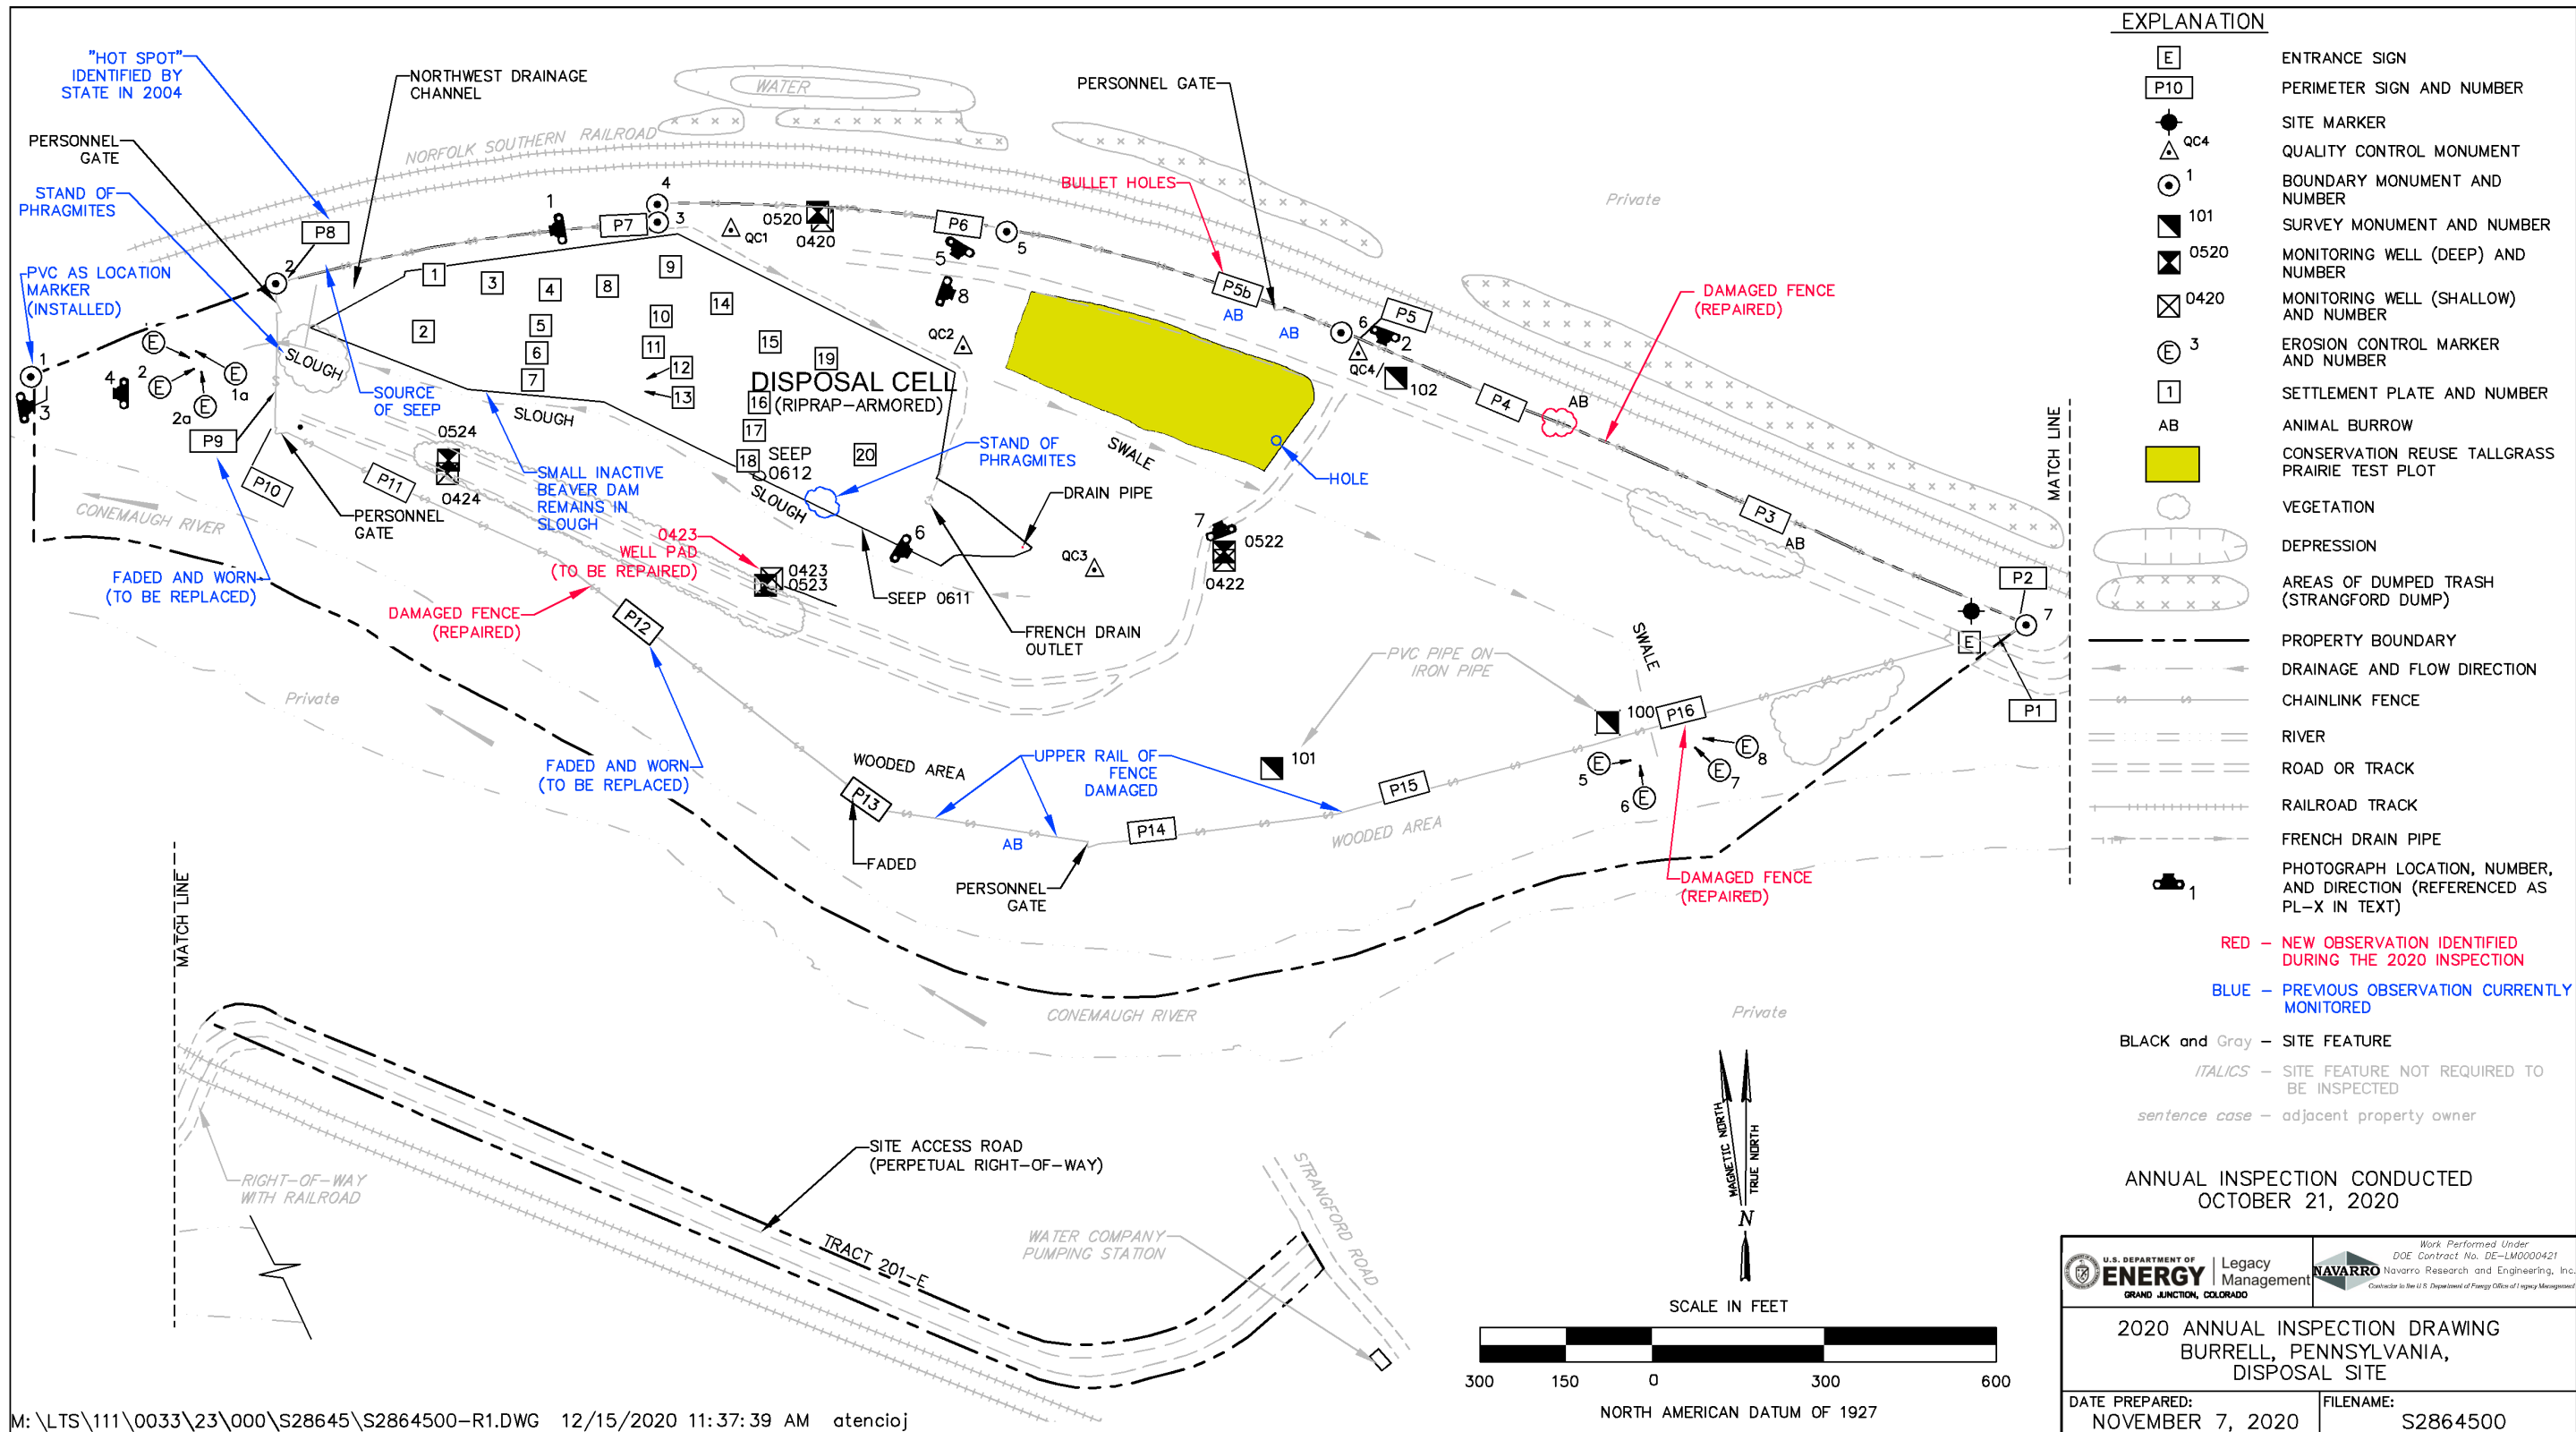
Figure 2-1 shows the locations of site features in black and gray font, including site surveillance features and inspection areas. Site features that are present but not required to be inspected are shown in italic font. Observations from previous inspections that are currently monitored are shown in blue text, and new observations identified during the 2020 annual inspection are shown in red. Inspection results and recommended maintenance activities associated with site surveillance features are included in the following subsections. Photographs to support specific observations are identified in the text and in Figure 2-1 by photograph location (PL) numbers. The photographs and photograph log are presented in Section 2.10.
