3.0 Canonsburg, Pennsylvania, Disposal Site

3.1 Compliance Summary

The Canonsburg, Pennsylvania, Uranium Mill Tailings Radiation Control Act (UMTRCA) Title I Disposal Site (site) was inspected on October 20, 2020. No changes were observed on the disposal cell or in the associated drainage features. Inspectors identified a few minor maintenance needs.

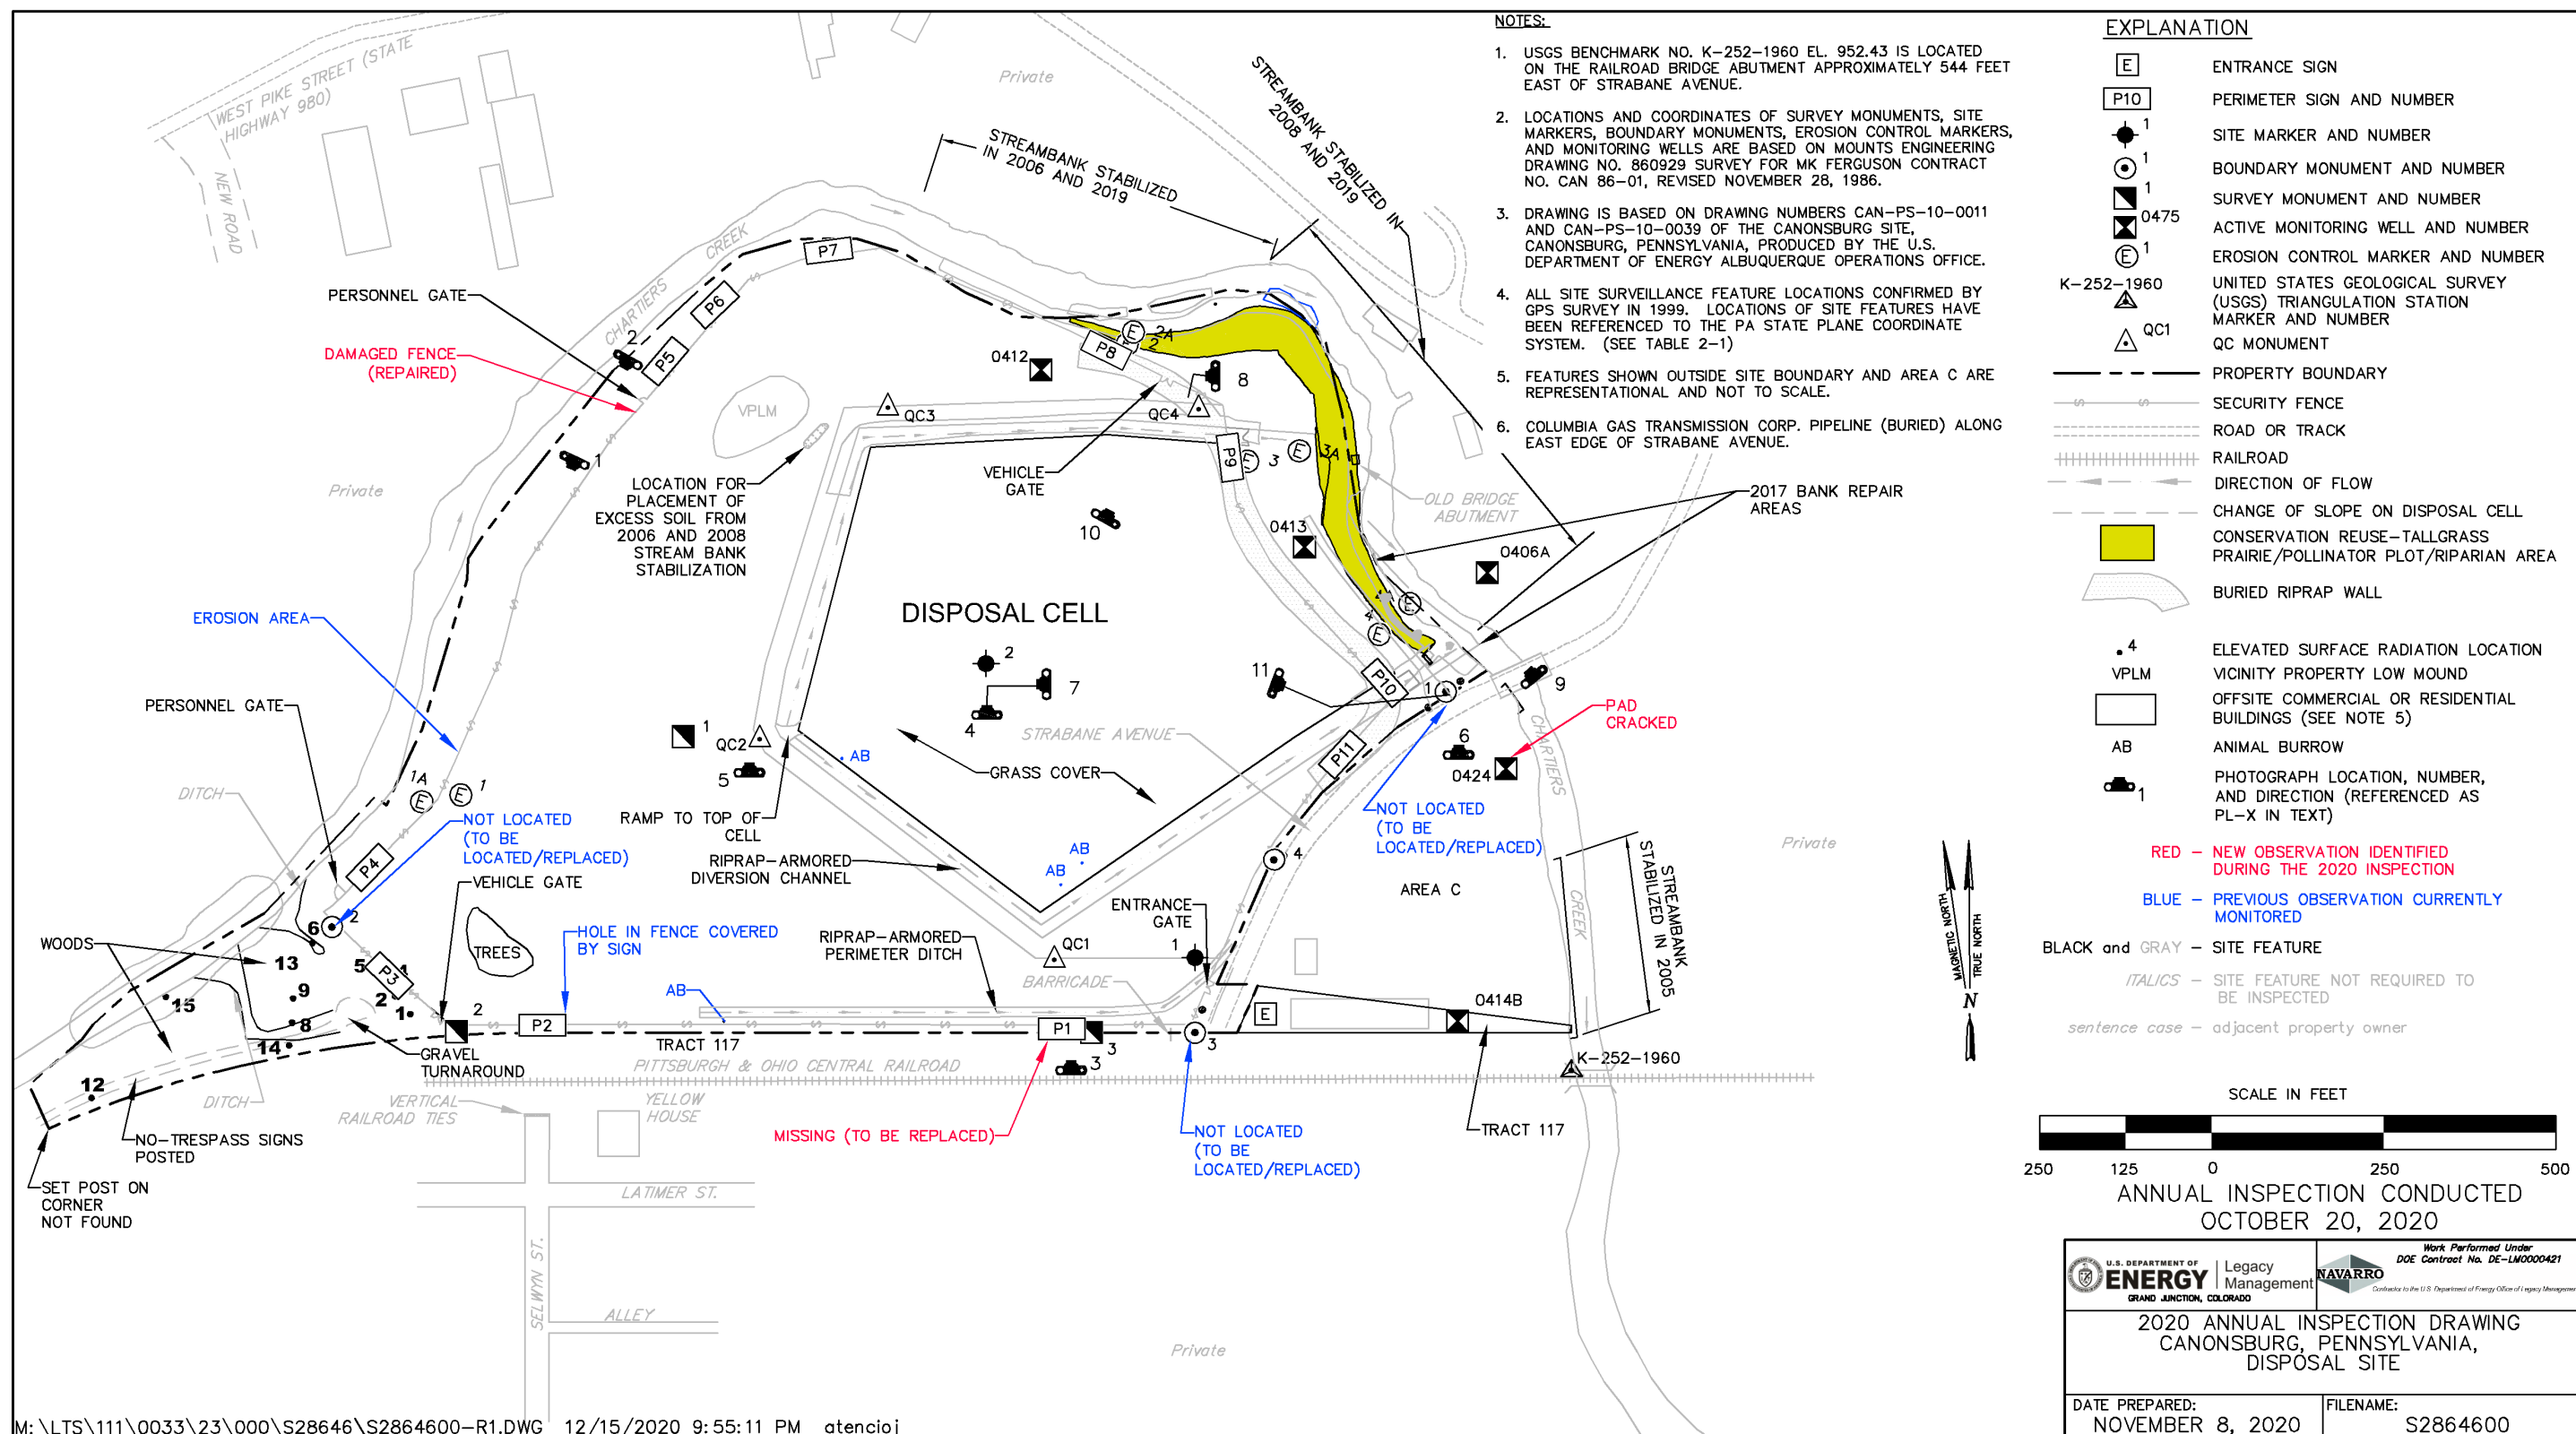
Figure 3-1. 2020 Annual Inspection Drawing for the Canonsburg, Pennsylvania, Disposal Site

Figure 3-1 shows the locations of site features in black and gray font, including site surveillance features and inspection areas. Site features that are present but not required to be inspected are shown in italic font. Observations from previous inspections that are currently monitored are shown in blue text, and new observations identified during the 2020 annual inspection are shown in red. Inspection results and recommended maintenance activities associated with site surveillance features are included in the following subsections. Photographs to support specific observations are identified in the text and in Figure 3-1 by photograph location (PL) numbers. The photographs and photograph log are presented in Section 3.10.

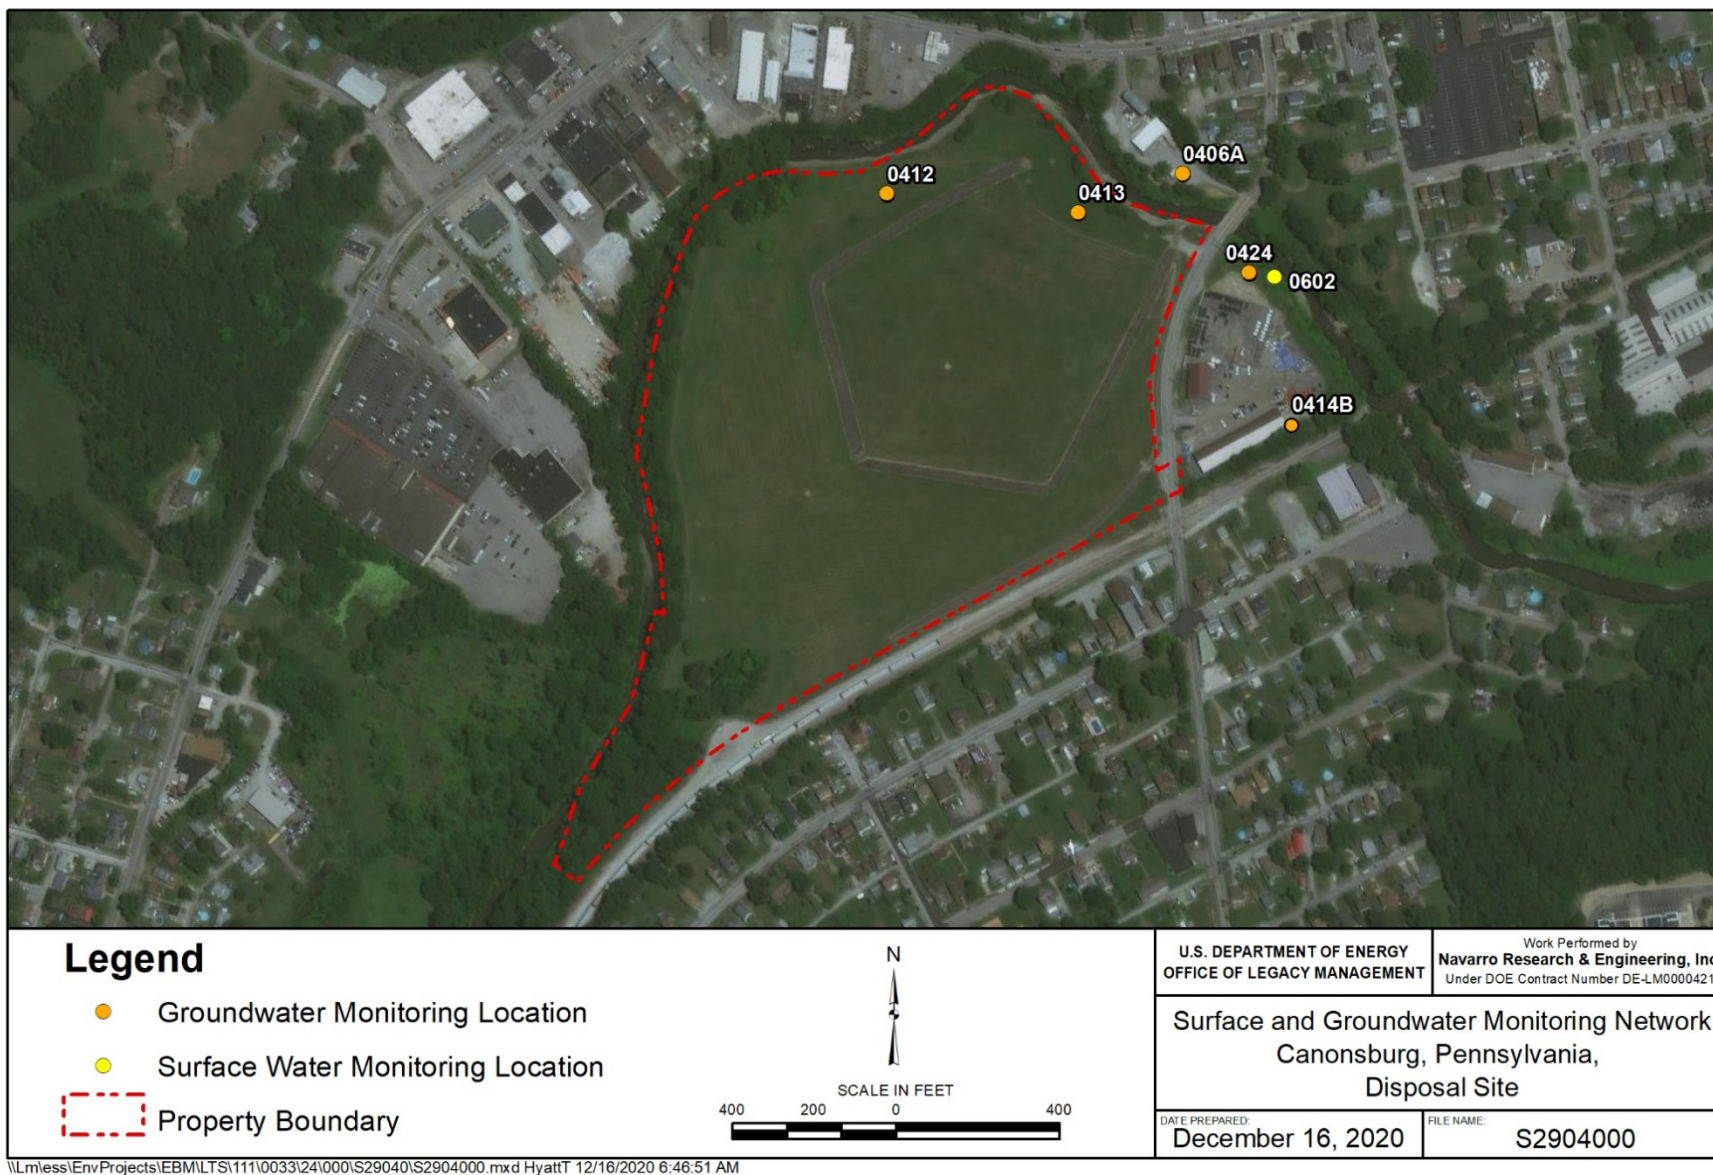
Figure 3-2. Groundwater and Surface Water Monitoring Network for the Canonsburg, Pennsylvania, Disposal Site

The groundwater monitoring network consists of five monitoring wells, including three POC wells and two best management practice wells (Table 3-2 and Figure 3-2). All monitoring wells are completed in the uppermost aquifer (shallow, unconsolidated materials). Groundwater is sampled and analyzed for the one constituent of concern, uranium. The ACL is 1 milligram per liter (mg/L) at the POC wells. With the exception of monitoring wells 0412 and 0413, uranium concentrations in 2018 were also below the UMTRCA maximum concentration limit (MCL) of 0.044 mg/L.

One surface location, 0602, is the POE for Chartiers Creek and is sampled and analyzed for uranium. In 2018, the uranium concentration from location 0602 had a concentration of 0.00096 mg/L, significantly below the MCL.
