4.0 Durango, Colorado, Disposal Site

The U.S. Department of Energy (DOE) Office of Legacy Management (LM) conducted the Durango, Colorado, Uranium Mill Tailings Radiation Control Act (UMTRCA) Title I Disposal Site (site) annual inspection on June 16, 2020, and the annual groundwater monitoring event in June 2020. No cause for a follow-up inspection was identified.

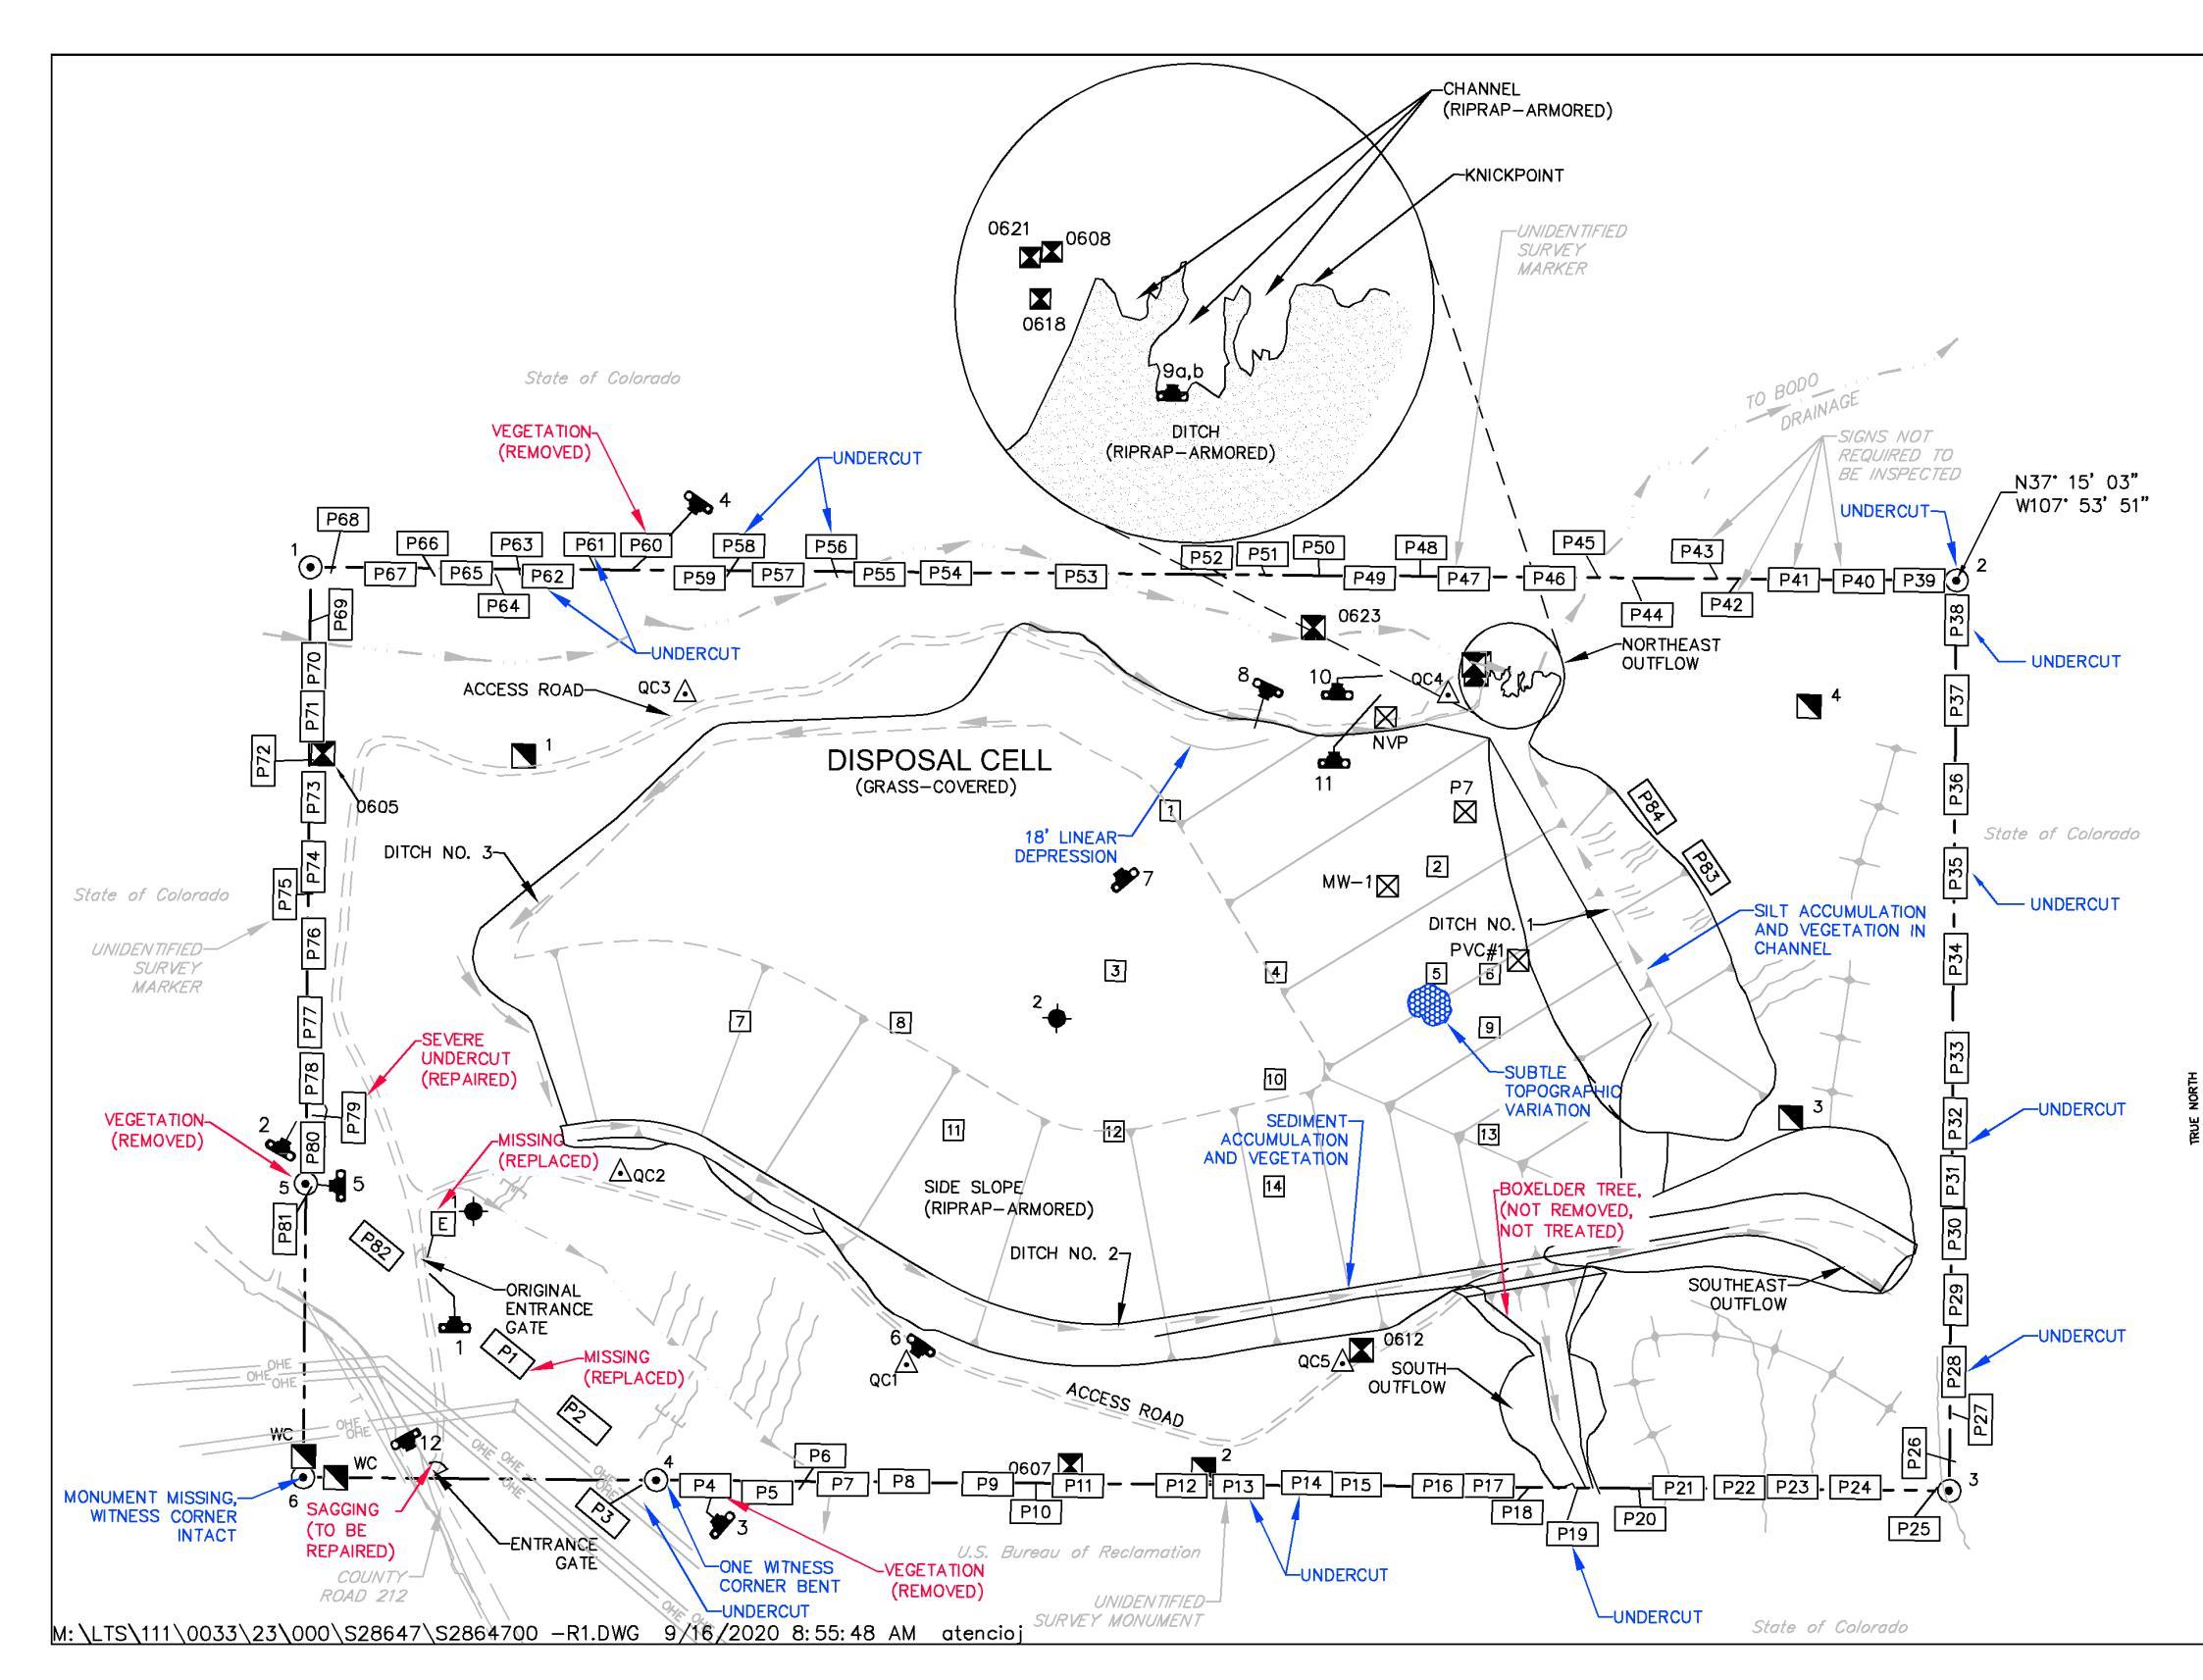
Figure 4-1. 2020 Annual Inspection Drawing for the Durango, Colorado, Disposal Site

Figure 4-1 shows the locations of site features in black and gray font, including site surveillance features and inspection areas. Site features that are present but not required to be inspected are shown in italic font. Observations from previous inspections that are currently monitored are shown in blue text, and new observations identified during the 2020 annual inspection are shown in red. Inspection results and recommended maintenance activities associated with site surveillance features are described in the following subsections. Photographs to support specific observations are identified in the text and in Figure 4-1 by photograph location (PL) numbers. The photographs and photograph log are presented in Section 4.11.

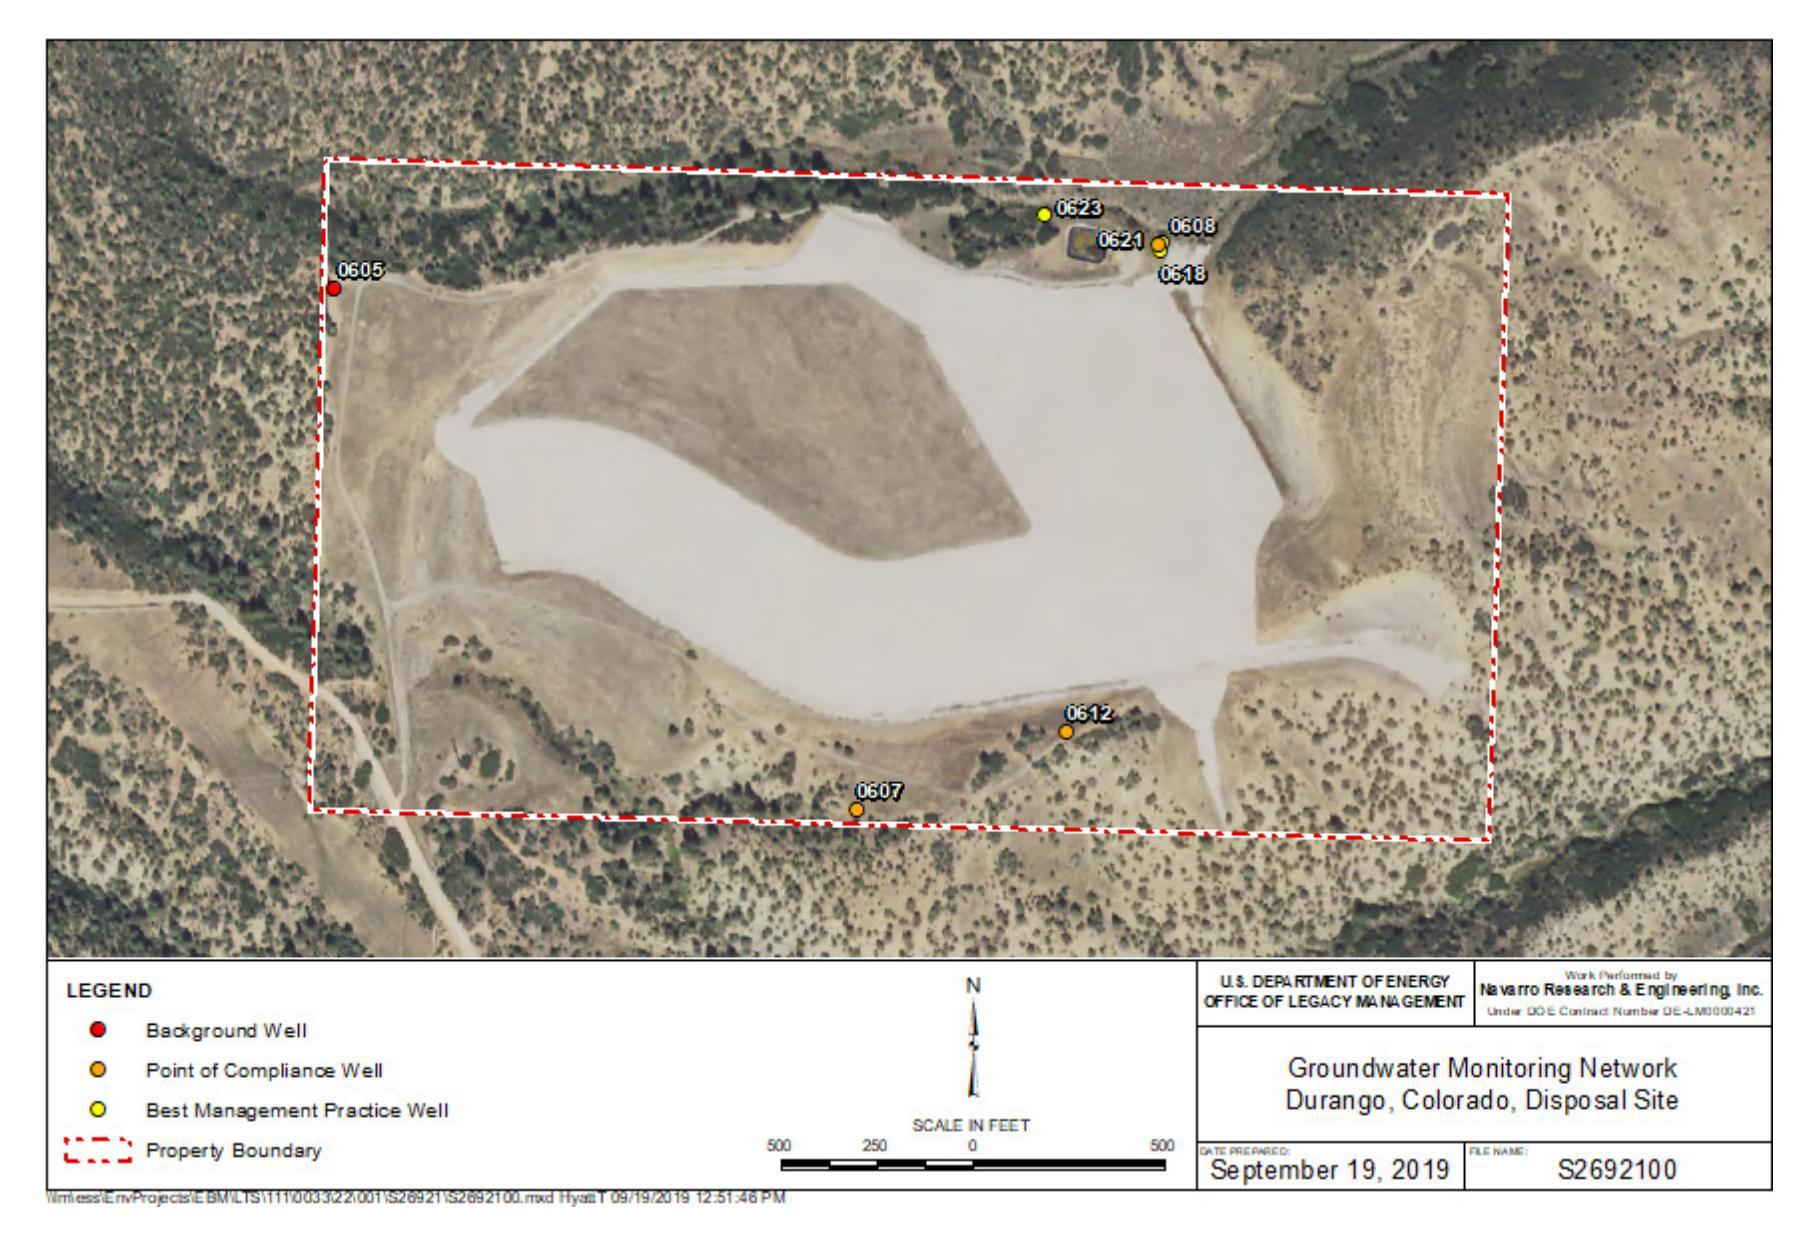
Figure 4-2. Groundwater Monitoring Network for the Durango, Colorado, Disposal Site

Three additional monitoring wells are completed in the alluvium and monitored as a BMP. The LTSP describes the Cliff House/Menefee aquifer as the uppermost aquifer because of the limited area of the alluvial system saturation under natural conditions beneath the disposal cell. Table 4-2 and Figure 4-2 show the current groundwater monitoring network at the site.
