2.0 Edgemont, South Dakota, Disposal Site

2.1 Compliance Summary

Figure 2-1. 2020 Annual Inspection Drawing for the Edgemont, South Dakota, Disposal Site

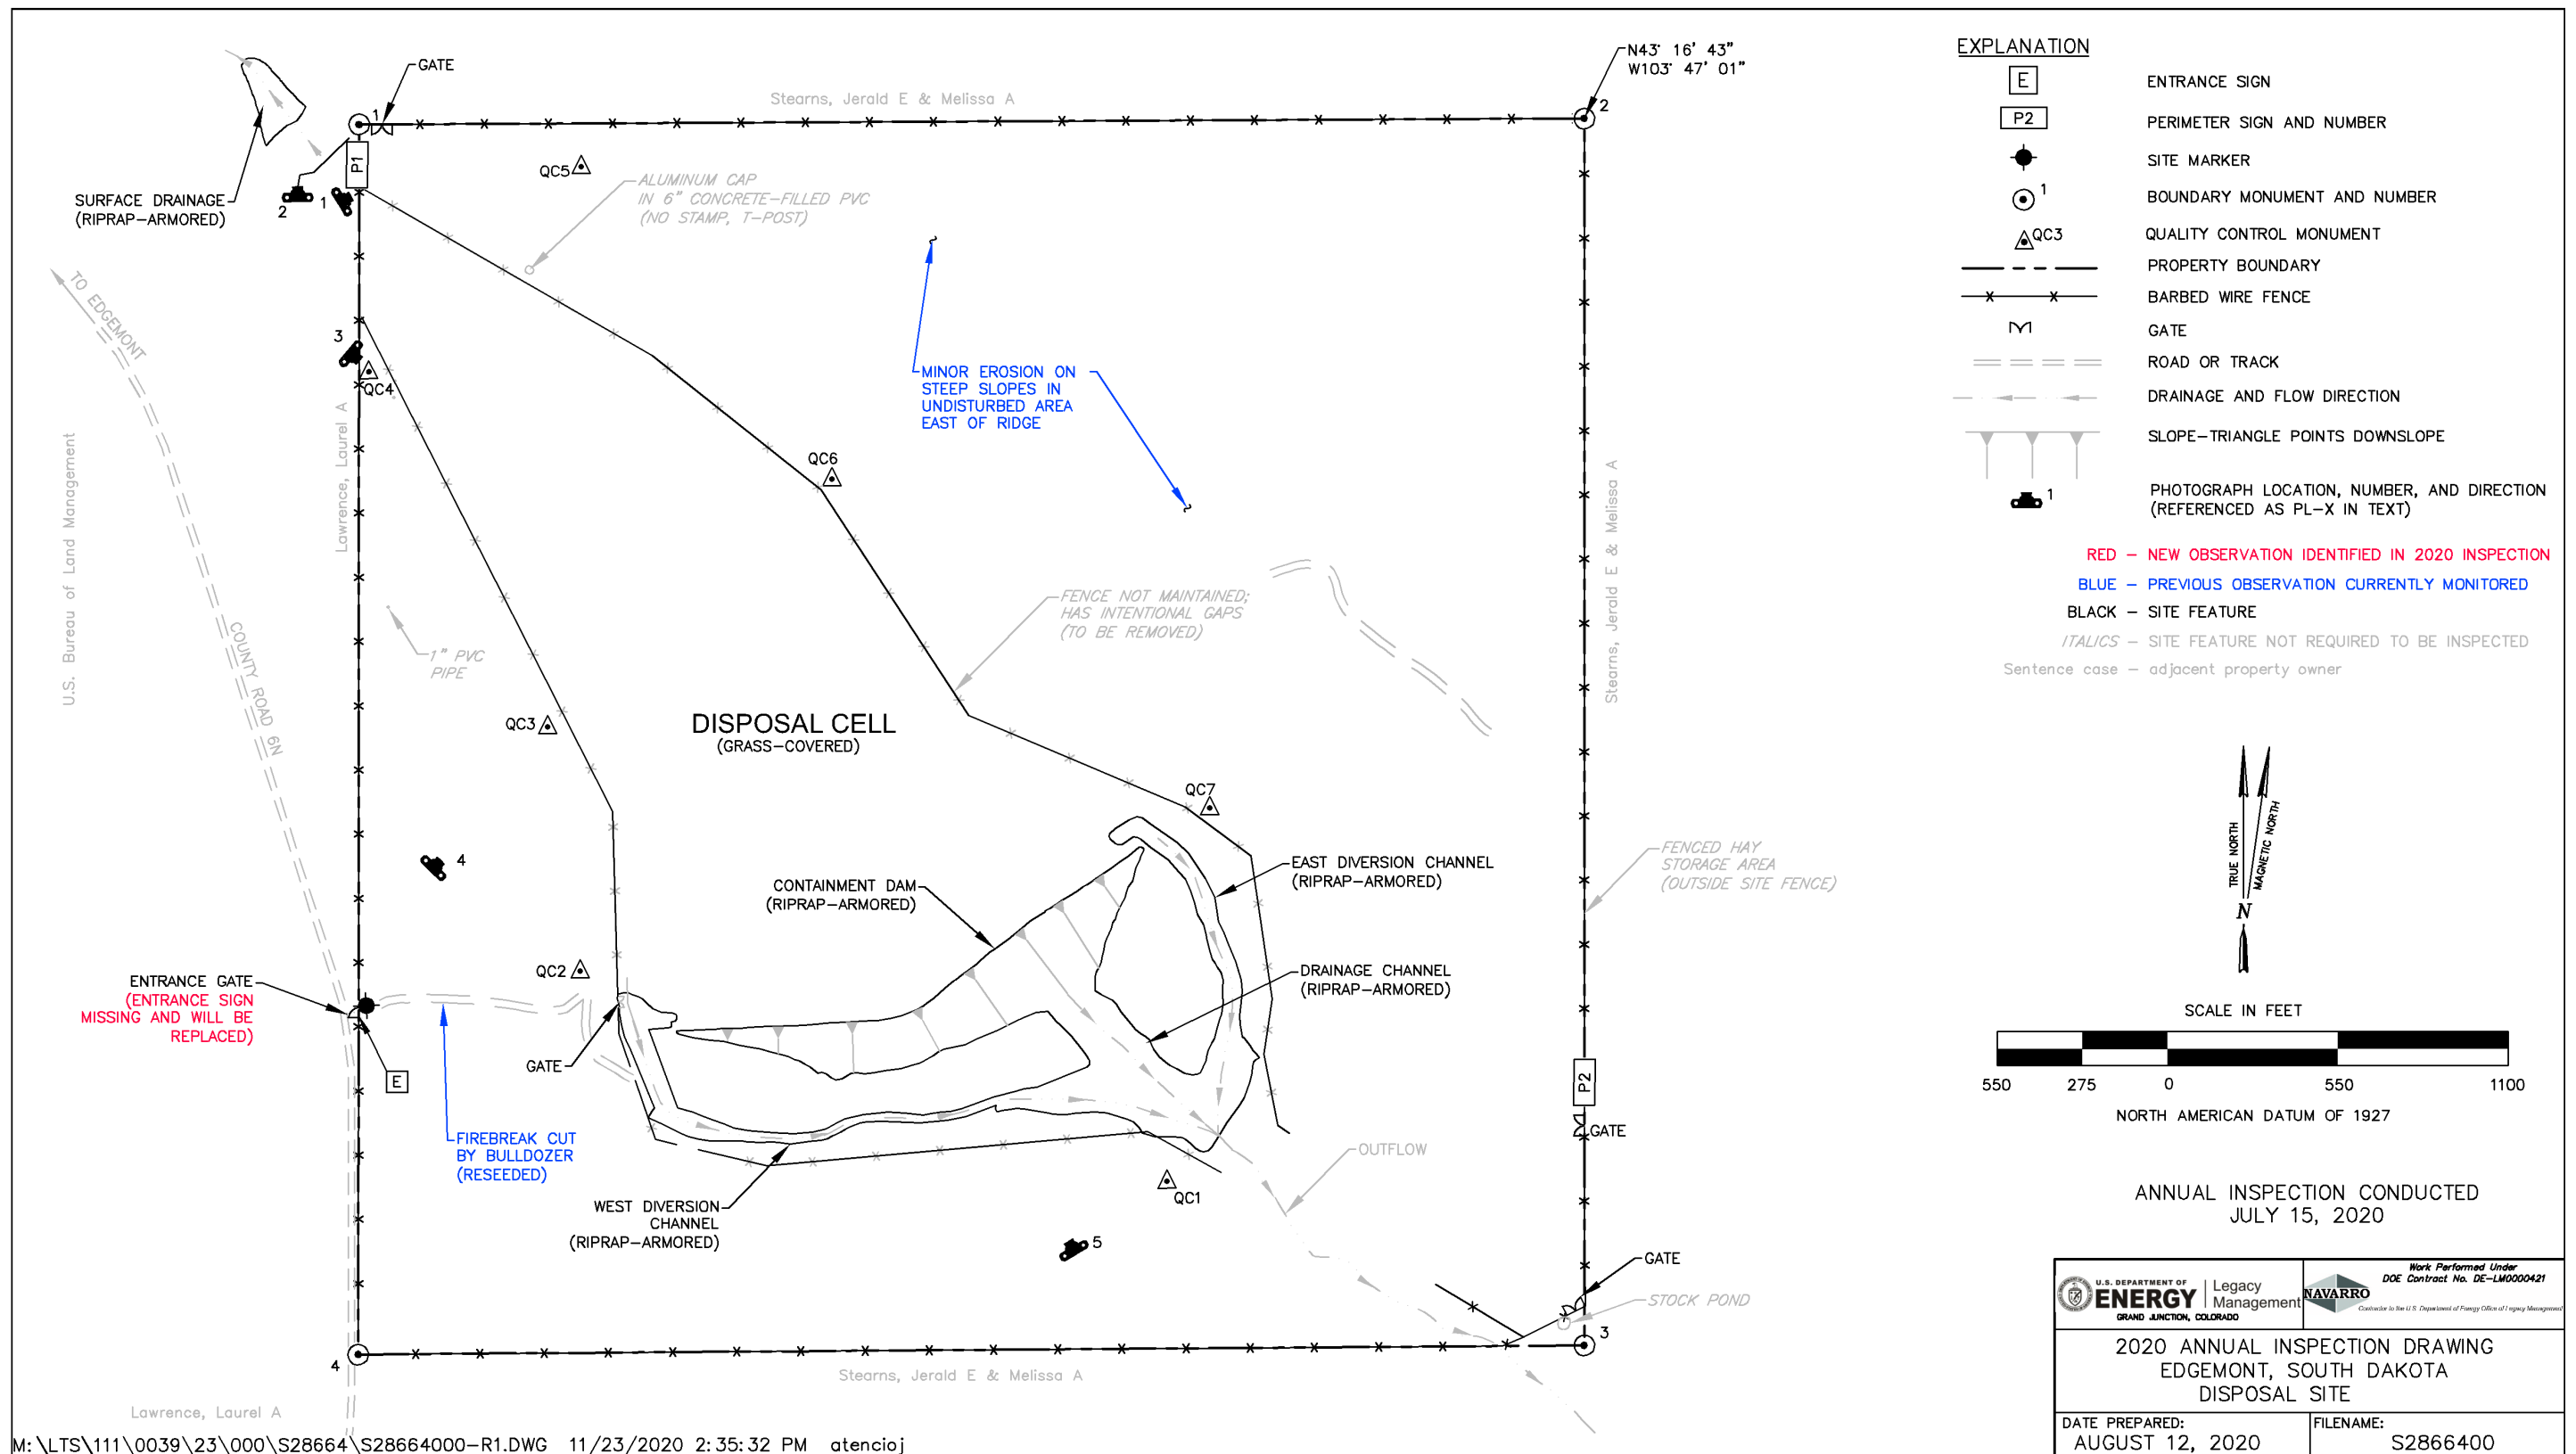
Figure 2-1 shows the locations of site features in black and gray font, including site surveillance features and inspection areas. Site features that are present but not required by the LTSP to be inspected are shown in italic font. Observations from previous inspections that are currently monitored are shown in blue text, and new observations identified during the 2020 annual inspection are shown in red. Inspection results and recommended maintenance activities associated with site surveillance features are included in the following subsections. Photographs to support specific observations are identified in the text and in Figure 2-1 by photograph location (PL) numbers. The photographs and photograph log are presented in Section 2.9.
