5.0 Falls City, Texas, Disposal Site

5.1 Compliance Summary

Figure 5-1. 2020 Annual Inspection Drawing for the Falls City, Texas, Disposal Site

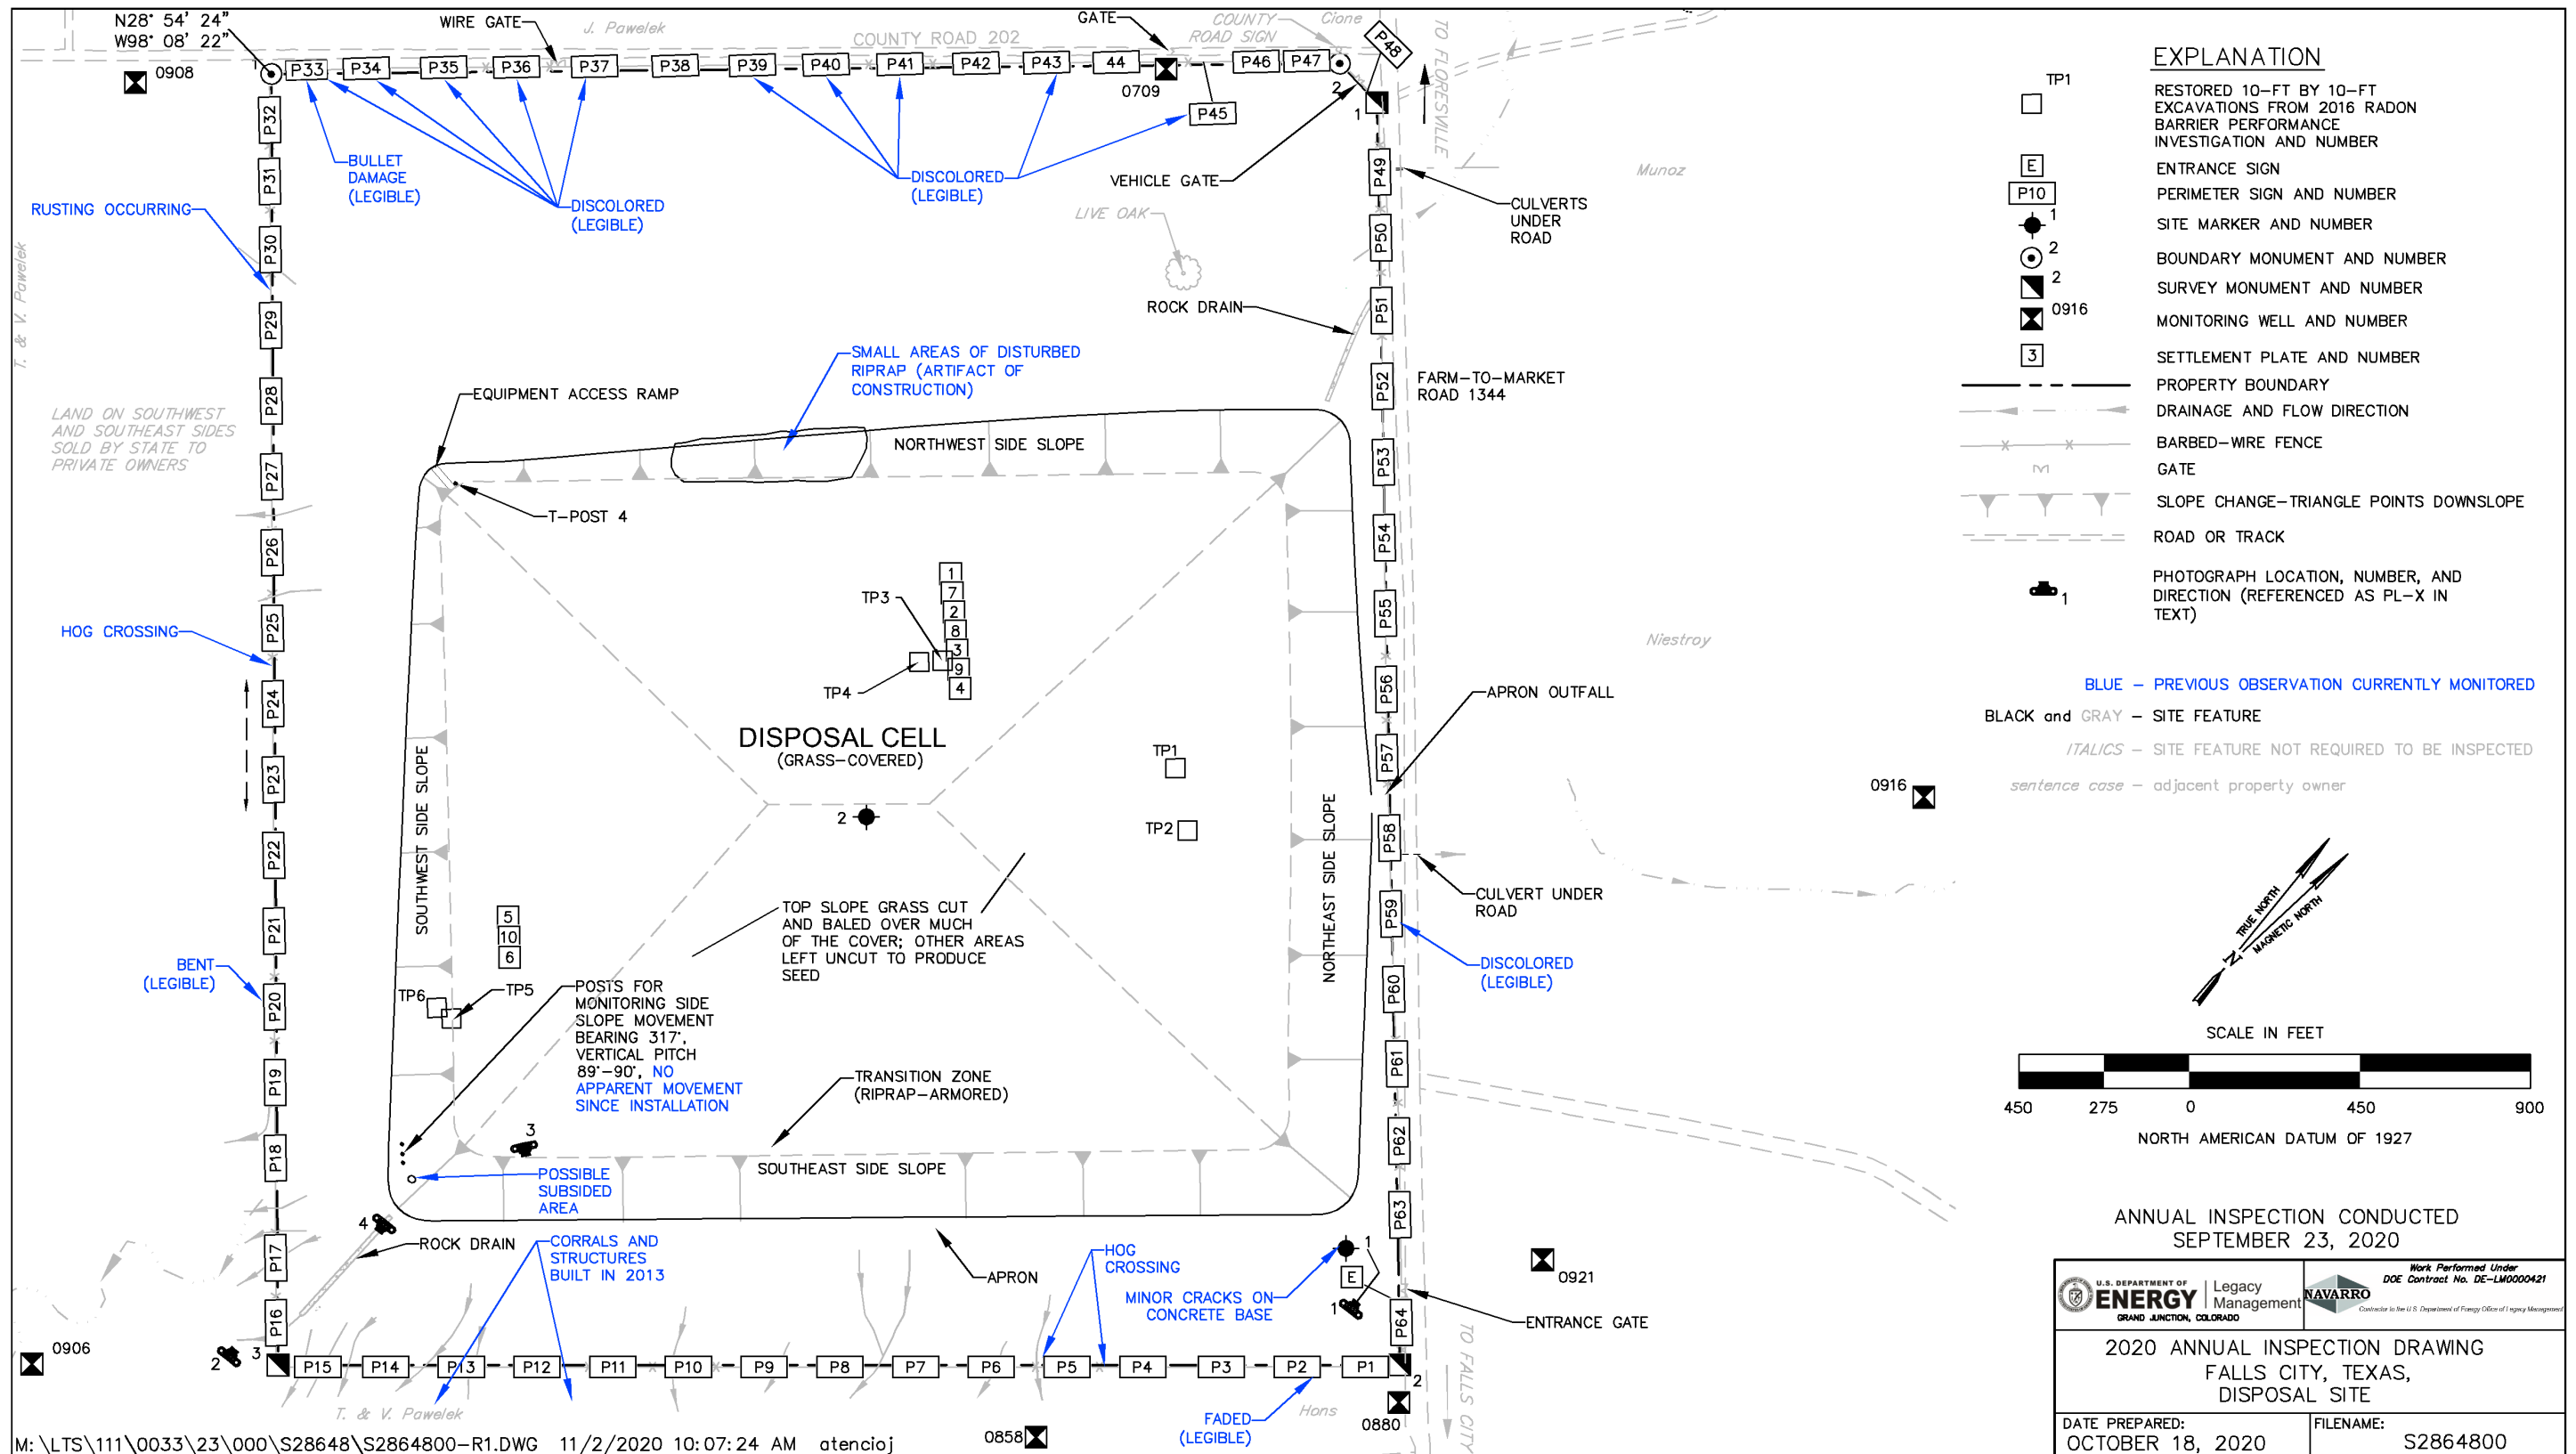
Figure 5-1 shows the locations of site features in black and gray font, including site surveillance features and inspection areas. Site features that are present but not required to be inspected are shown in italic font. Observations from previous inspections that are currently monitored are shown in blue text. There are no new observations in 2020. Photographs to support specific observations are noted in the text and in Figure 5-1 by photograph location (PL) numbers. The photographs and photograph log are presented in Section 5.10.

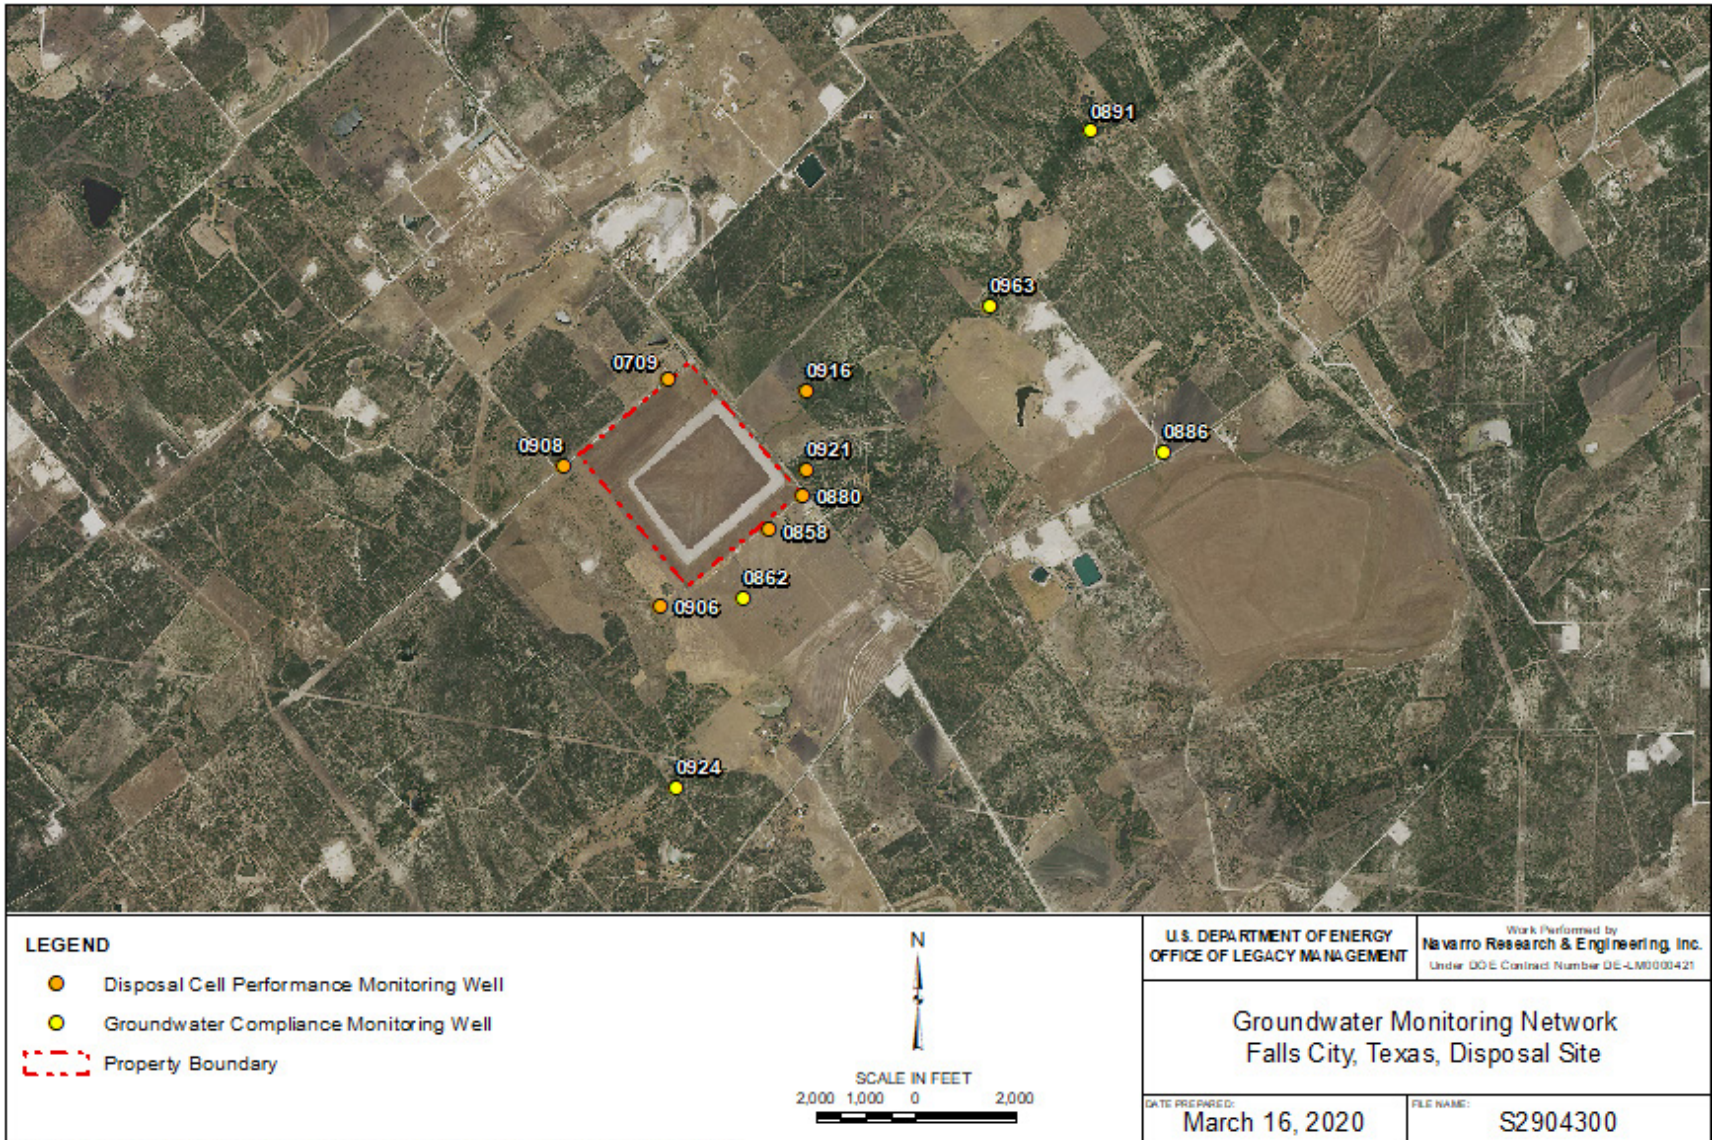
Figure 5-2. Groundwater Monitoring Well Network at the Falls City, Texas, Disposal Site

Table 5-2 and Figure 5-2 describe and illustrate the groundwater monitoring network at the site, which includes the groundwater compliance monitoring wells and the disposal cell performance monitoring wells. The disposal cell performance monitoring wells are near the disposal cell and are all completed in the Deweesville and Conquista units. The groundwater compliance monitoring wells are downgradient of the site and completed in the Deweesville and Conquista units and the Dilworth unit.

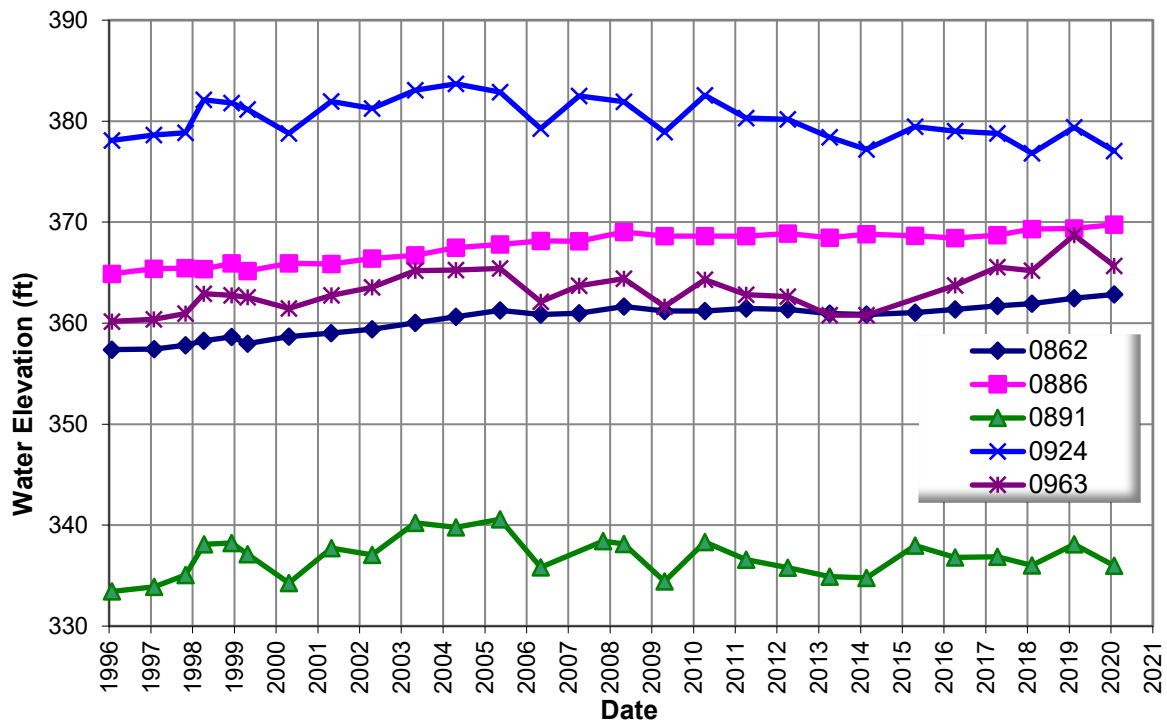
Figure 5-4. Water-Level Measurements at Groundwater Compliance Monitoring Wells at the Falls City, Texas, Disposal Site

Water levels in all disposal cell performance wells had significant decreasing trends since 1996 based on Mann Kendall trend analyses (Figure 5-3). Water levels in these wells appear to have stabilized since 2014. Wells 0709, 0880, and 0906 have had apparent increase in water level since 2014. Groundwater compliance wells 0862, 0886, and 0963 had significant increasing water level trends since 1996, and wells 0891 and 0924 had no statistically significant trend (Figure 5-4). Wells with increasing water level trends each had a water elevation increase of about 5 ft since 1996.
