6.0 Grand Junction, Colorado, Disposal Site

The Grand Junction, Colorado, Uranium Mill Tailings Radiation Control Act (UMTRCA) Title I Disposal Site (site) was inspected on December 9, 2020. No changes were observed on the disposal cell or in the associated drainage features. Inspectors identified minor maintenance needs that will be handled during the next routine maintenance event, but no cause for a follow-up inspection was identified.

Figure 6-1. 2020 Annual Inspection Drawing for the Grand Junction, Colorado, Disposal Site

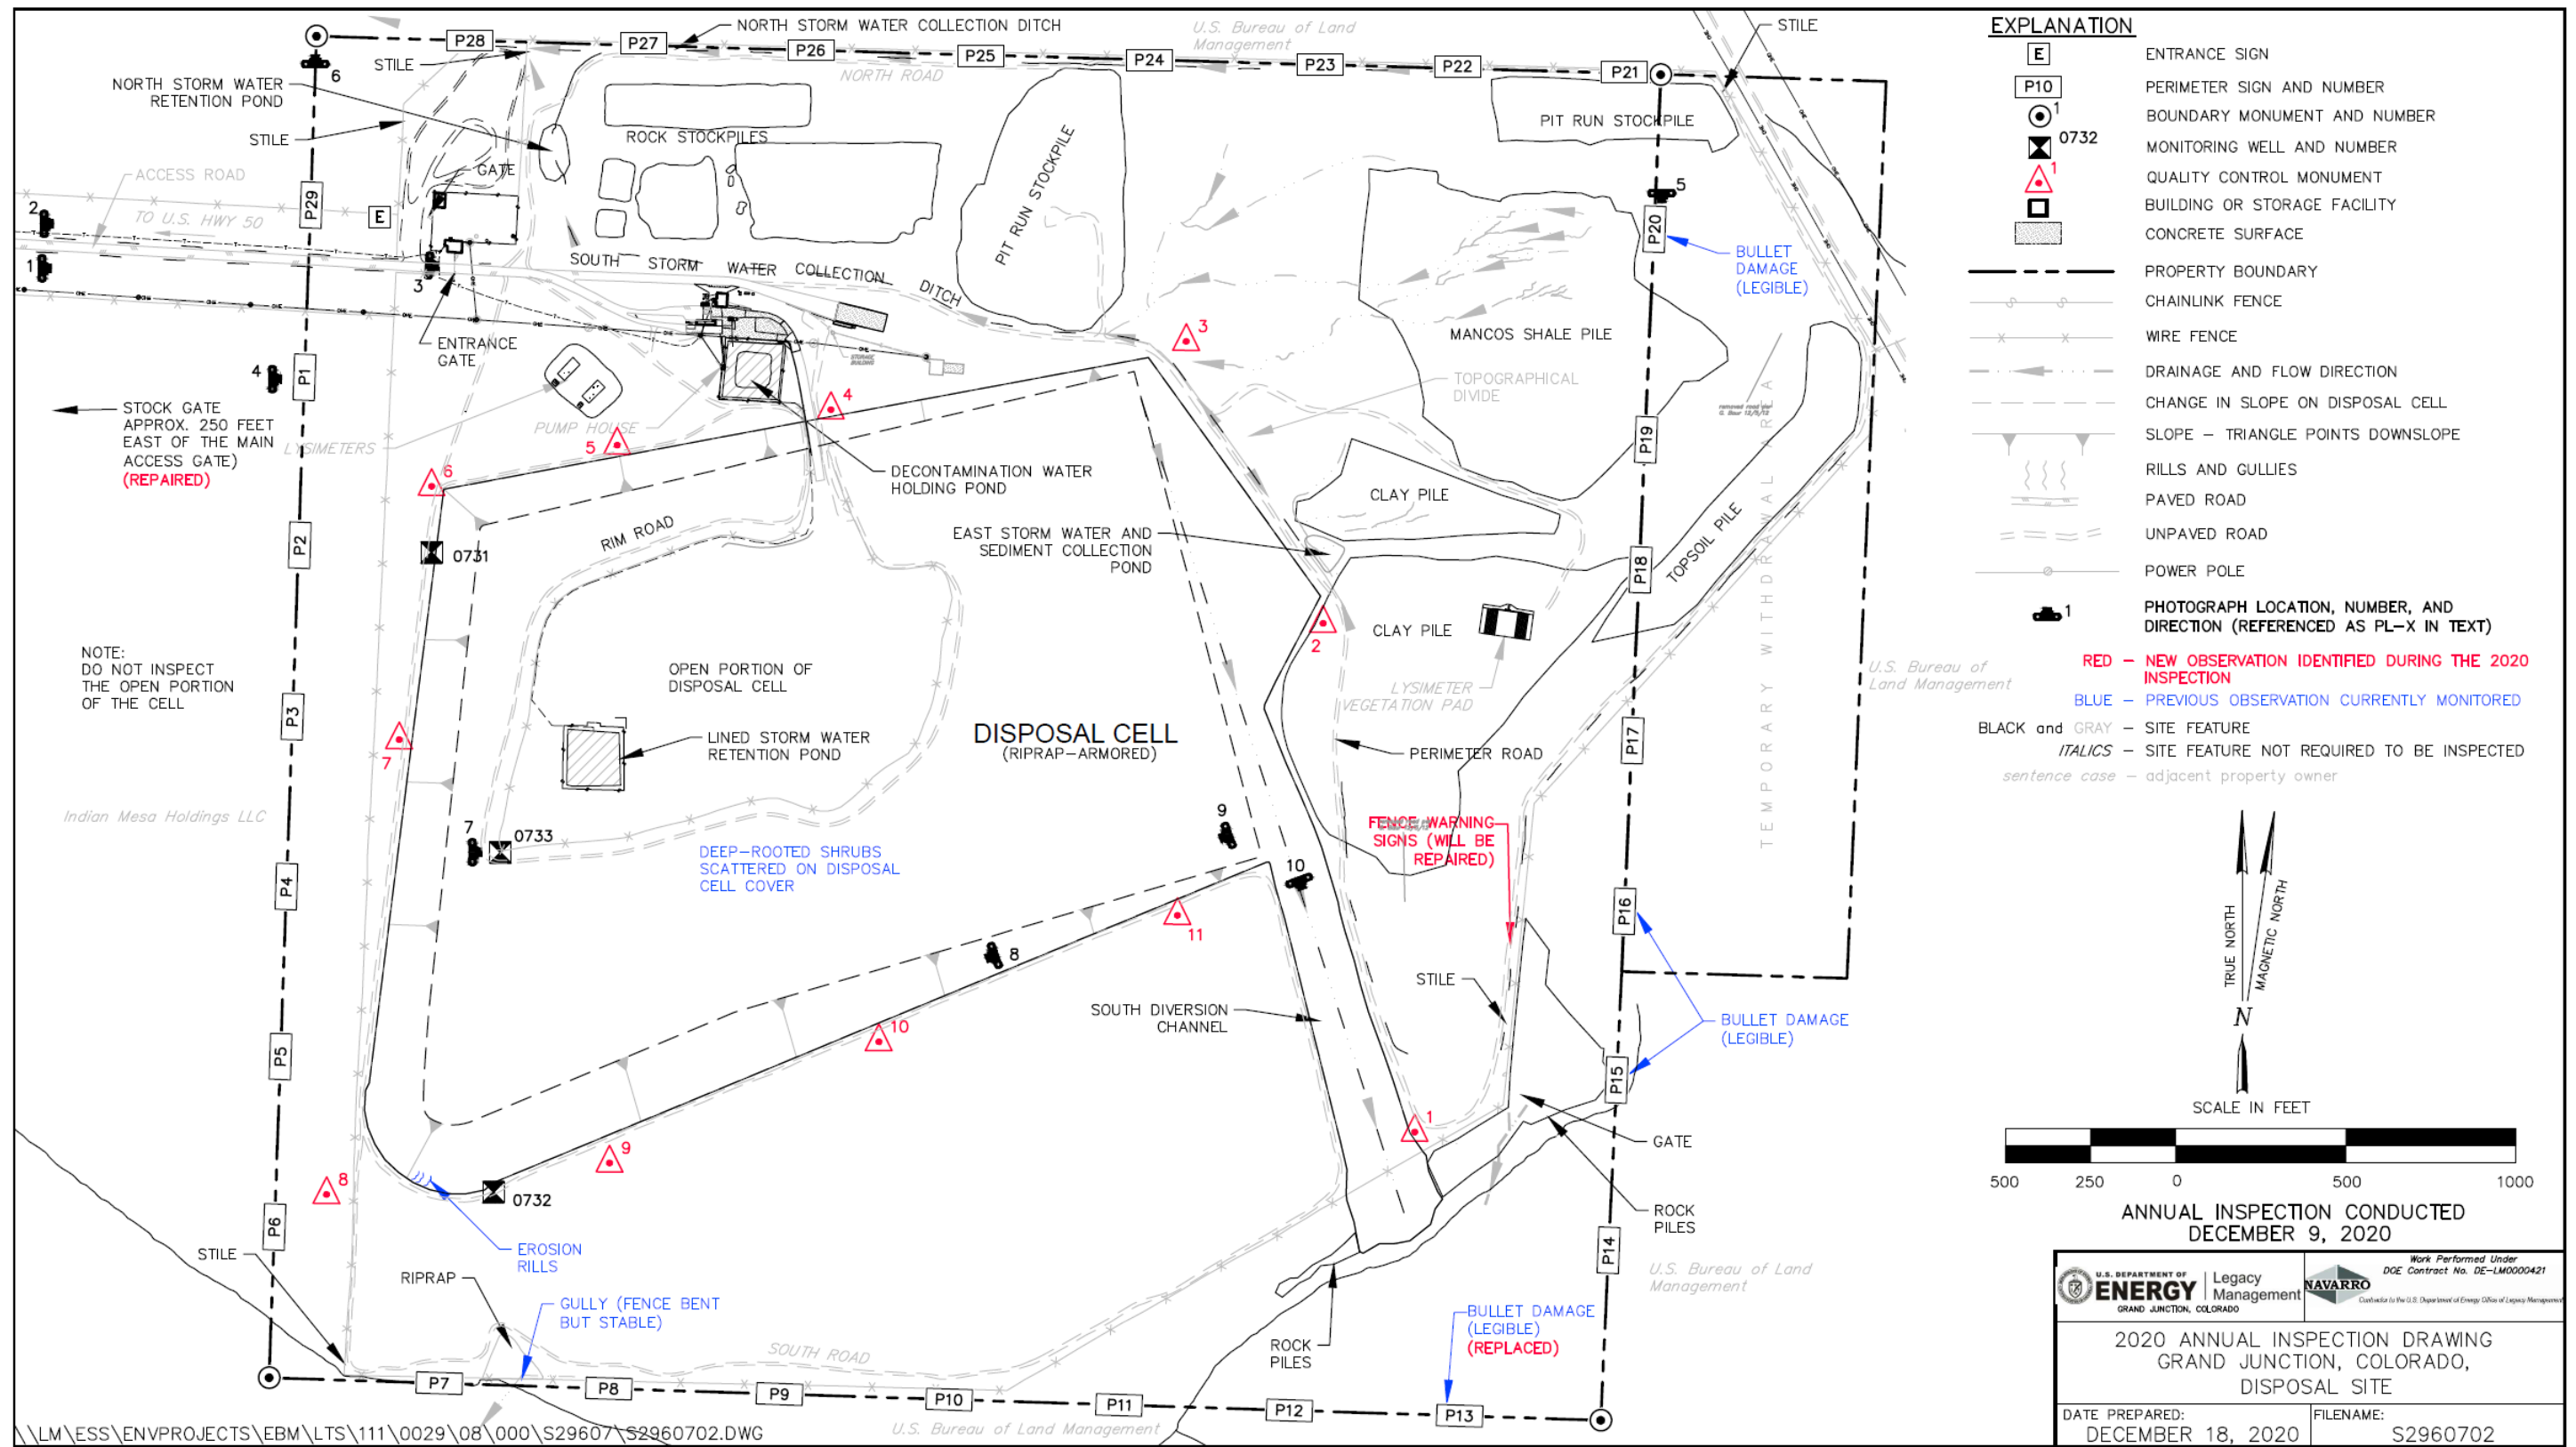
Figure 6-1 shows the locations of site features in black and gray font, including site surveillance features and inspection areas. Site features that are present but not required to be inspected are shown in italic font. Observations from previous inspections that are currently monitored are shown in blue text, and new observations identified during the 2020 annual inspection are shown in red. Inspection results and recommended maintenance activities associated with site surveillance features are described in the following subsections. Photographs to support specific observations are identified in the text and in Figure 6-1 by photograph location (PL) numbers. The photographs and photograph log are presented in Section 6.10.
