8.0 Gunnison, Colorado, Disposal Site

8.1 Compliance Summary

The U.S. Department of Energy (DOE) Office of Legacy Management (LM) conducted the Gunnison, Colorado, Uranium Mill Tailings Radiation Control Act (UMTRCA) Title I Disposal Site (site) inspection on September 15, 2020. No cause for a follow-up inspection was identified.

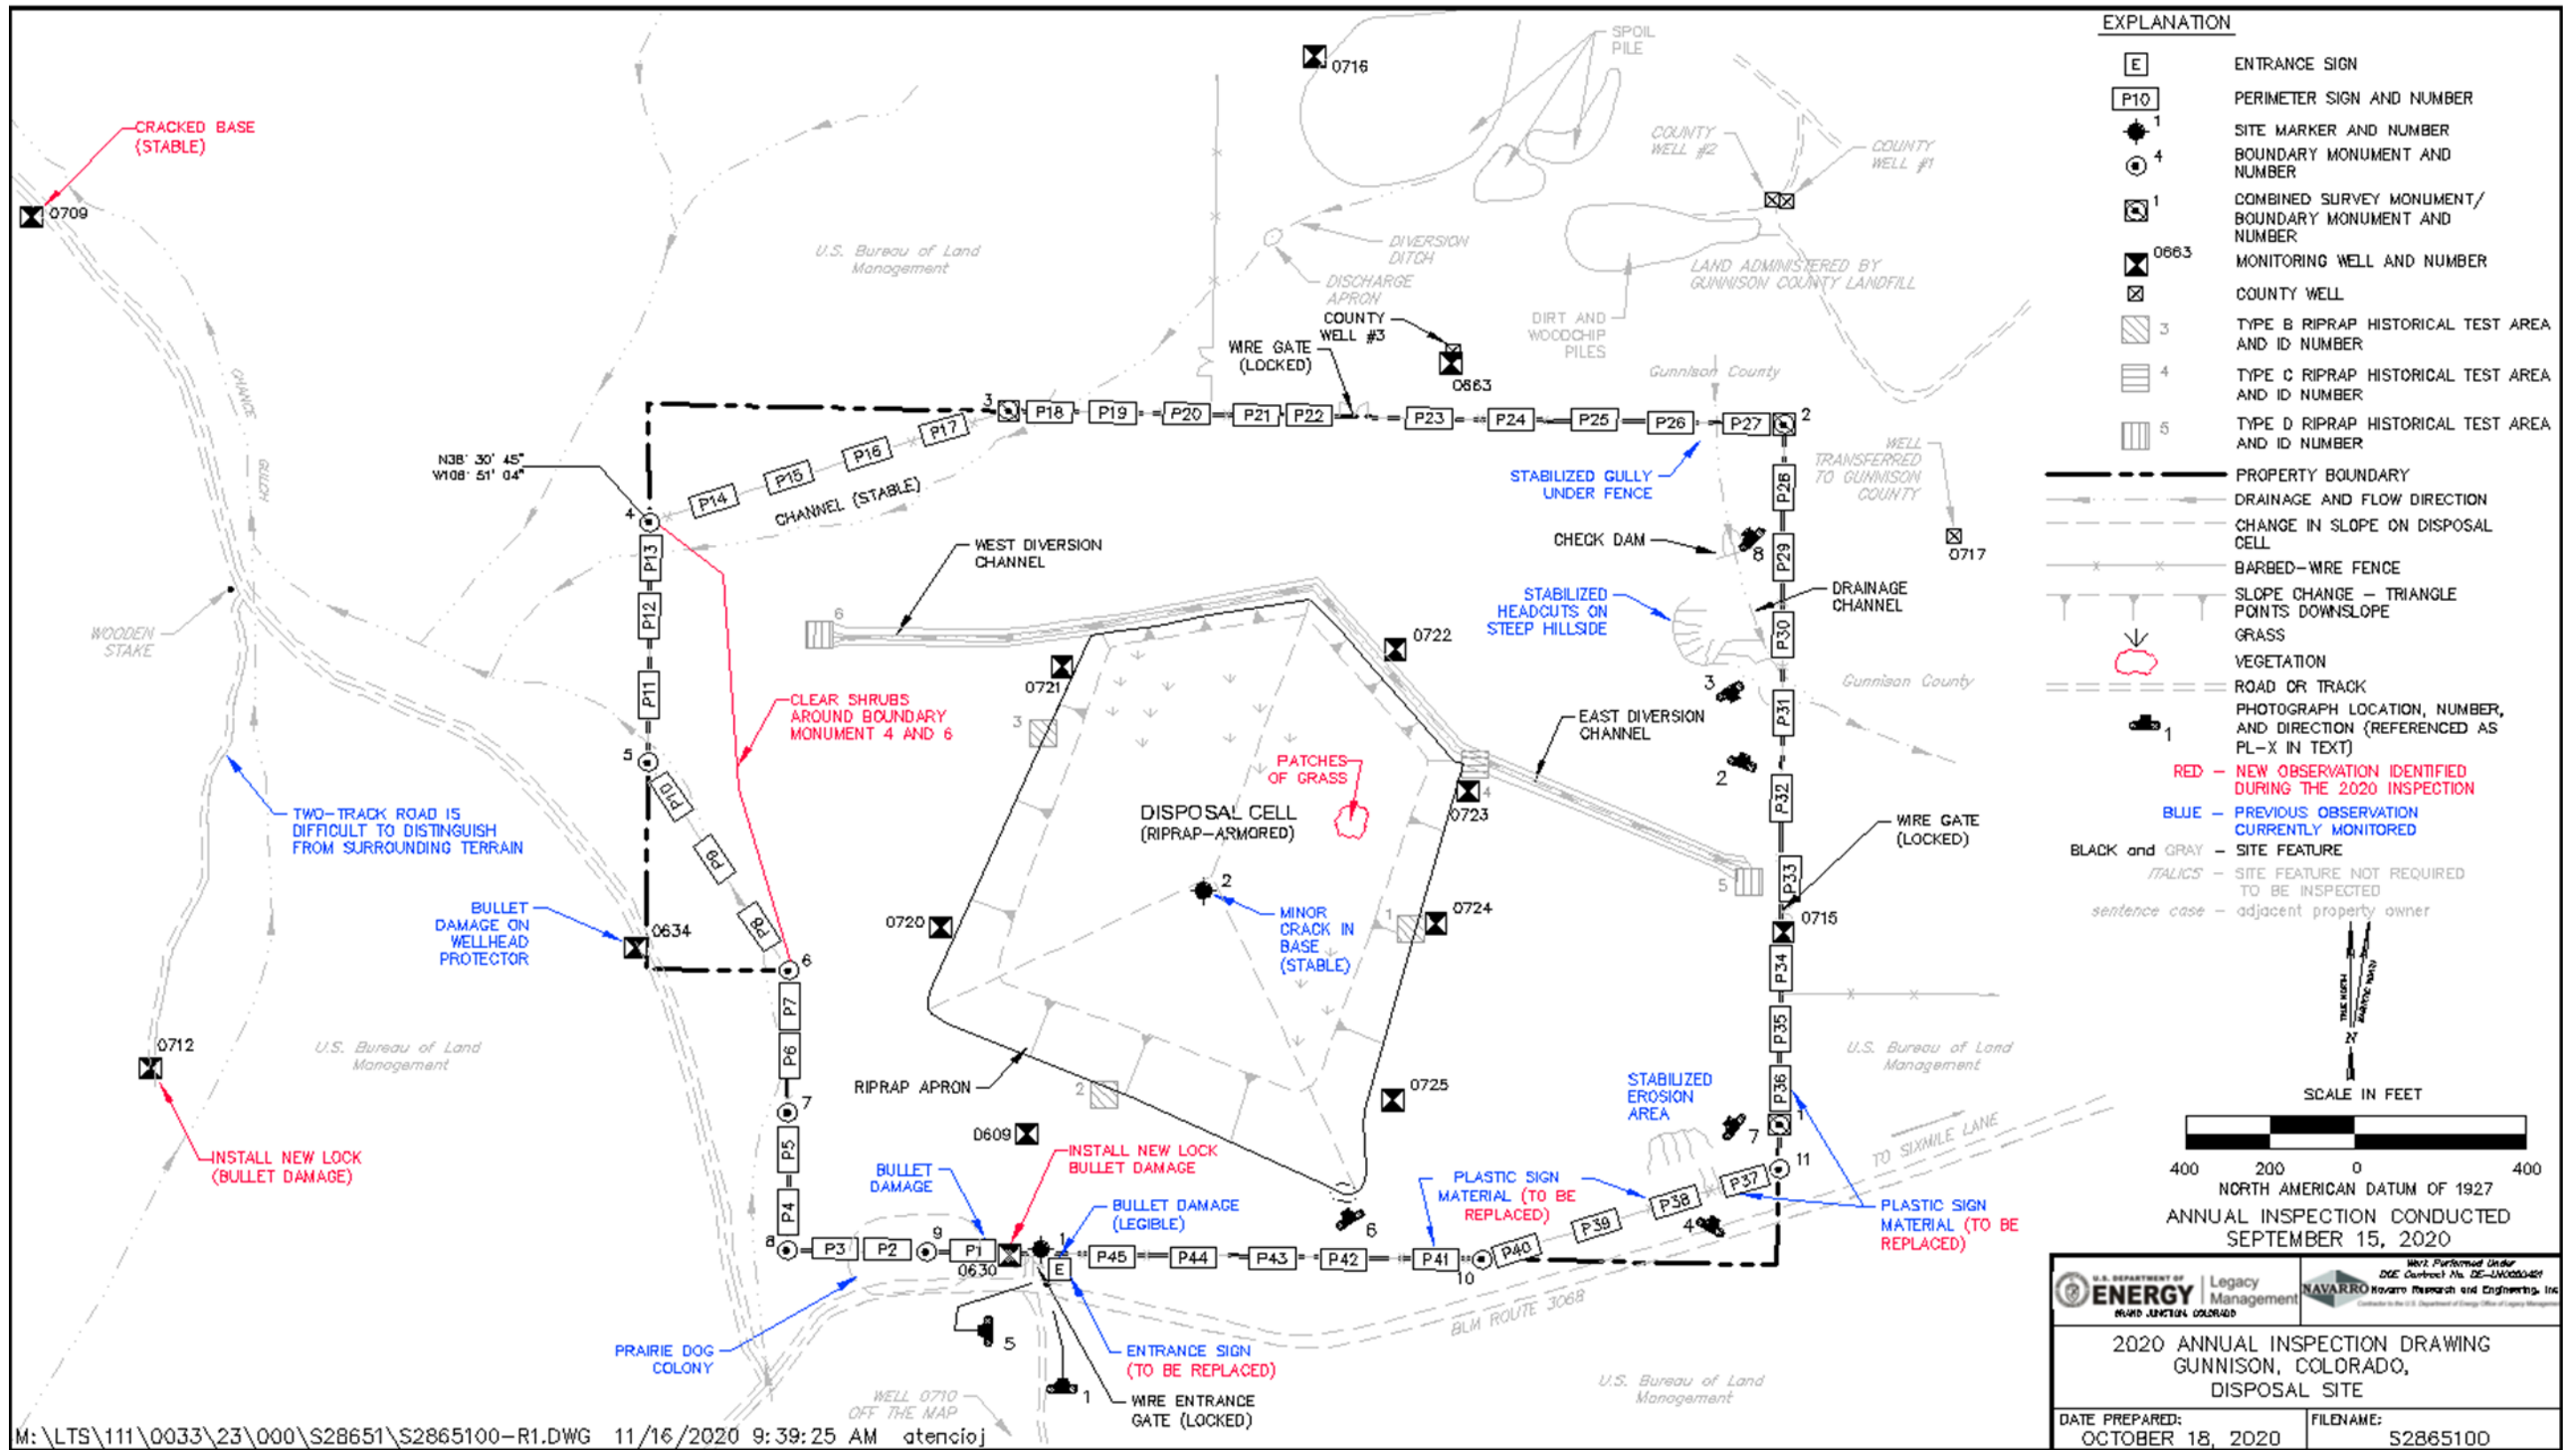
Figure 8-1. 2020 Annual Inspection Drawing for the Gunnison, Colorado, Disposal Site

Figure 8-1 shows the locations of site features in black and gray font, including site surveillance features and inspection areas. Site features that are present but not required to be inspected are shown in italic font. Observations from previous inspections that are currently monitored are shown in blue text, and new observations identified during the 2020 annual inspection are shown in red. Inspection results and recommended maintenance activities associated with site surveillance features are included in the following subsections. Photographs to support specific observations are identified in the text and in Figure 8-1 by photograph location (PL) numbers. The photographs and photograph log are presented in Section 8.10.

There are 45 perimeter signs bolted to the perimeter fence posts. Several perimeter signs have bullet damage but remain legible. In 2020, perimeter signs P4–P13 along the west perimeter fence were replaced. Perimeter signs P36, P37 (PL-4), P38, and P41 are constructed of plastic and are faded and curling. The plastic signs have been rescheduled for replacement with metal signs in 2021. All new signs will include the words “Gunnison Site.” Other perimeter signs that are damaged and showing wear will be replaced over the next 2 years. No other maintenance needs were identified.

The site has two granite site markers. Site marker SMK-1 is just inside the entrance gate, and site marker SMK-2 is on the top slope of the disposal cell. The base of site marker SMK-2 has a small, insignificant crack and remains stable. No maintenance needs were identified.

The site has 16 groundwater monitoring wells. The wellhead protectors were locked and properly labeled. Bullet damage is present on the locks of monitoring wells 0630 (PL-5) and 0712 and on the wellhead protector of monitoring well 0634. Both wells are secure, though new locks will be installed on both monitoring wells. Gunnison County landfill operators have placed concrete barriers to protect monitoring well 0716, which is on landfill property, from landfill activities. The edge of an adjacent spoil pile, although close to the concrete barriers, does not impair access to monitoring well 0716. The base of monitoring well 0709 is cracked but remains stable. Inspectors will continue to monitor these features. No maintenance needs were identified.

Stormwater runoff from the disposal cell occasionally ponds in a low-lying area at the southeast corner of the disposal cell; standing water was present at the time of the inspection (PL-6). The riparian-type vegetation that has become established there indicates that the area retains moisture. Water collection in this area does not pose a problem because the disposal cell surfaces are designed to drain to the southeast, and any water that ponds there is below the elevation of tailings placed under the engineered cover. No maintenance needs were identified.

In 2020, perimeter signs P4–P13 along the west perimeter fence were replaced.
