12.0 Mexican Hat, Utah, Disposal Site

12.1 Compliance Summary

The Mexican Hat, Utah, Uranium Mill Tailings Radiation Control Act (UMTRCA) Title I Disposal Site (site) was inspected on September 15, 2020.

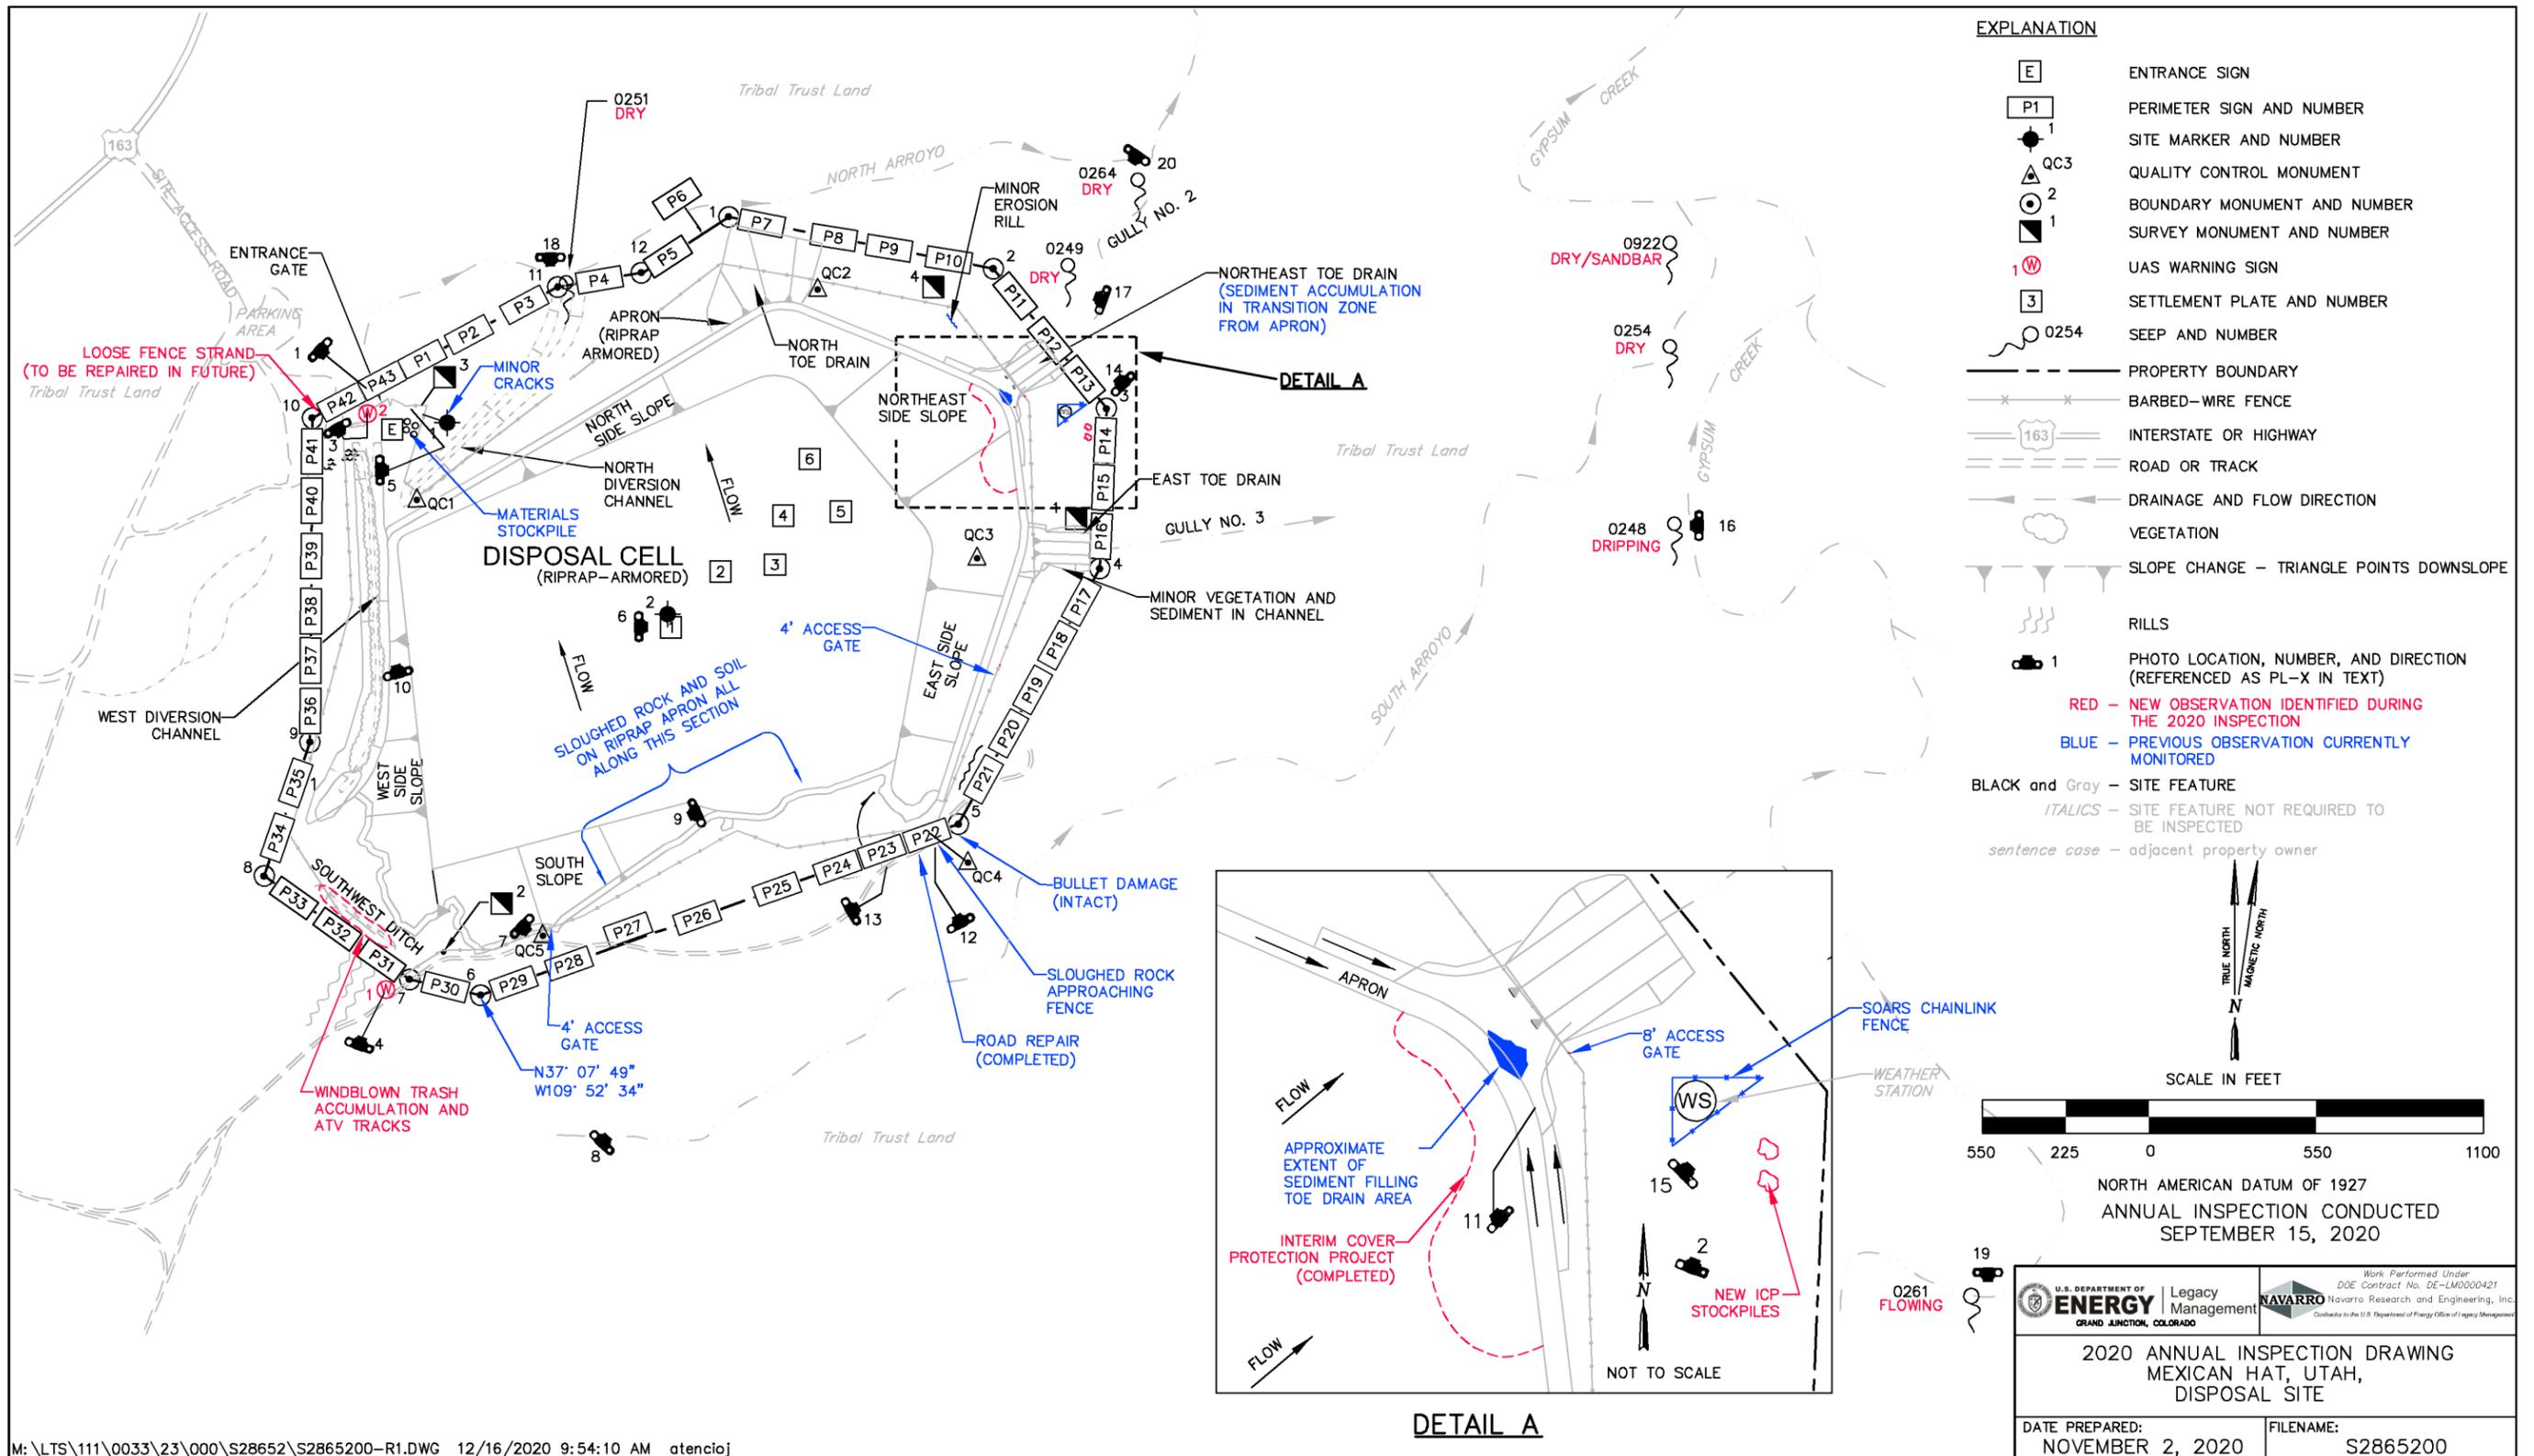
Figure 12-1. 2020 Annual Inspection Drawing for the Mexican Hat, Utah, Disposal Site

Figure 12-1 shows the locations of site features in black and gray font, including site surveillance features and inspection areas. Site features that are present but not required to be inspected are shown in italic font. Observations from previous inspections that are currently monitored are shown in blue text, and new observations identified during the 2020 annual inspection are shown in red. Inspection results and recommended maintenance activities associated with site surveillance features are included in the following subsections. Photographs to support specific observations are identified in the text and in Figure 12-1 by photograph location (PL) numbers. The photographs and photograph log are presented in Section 12.10.

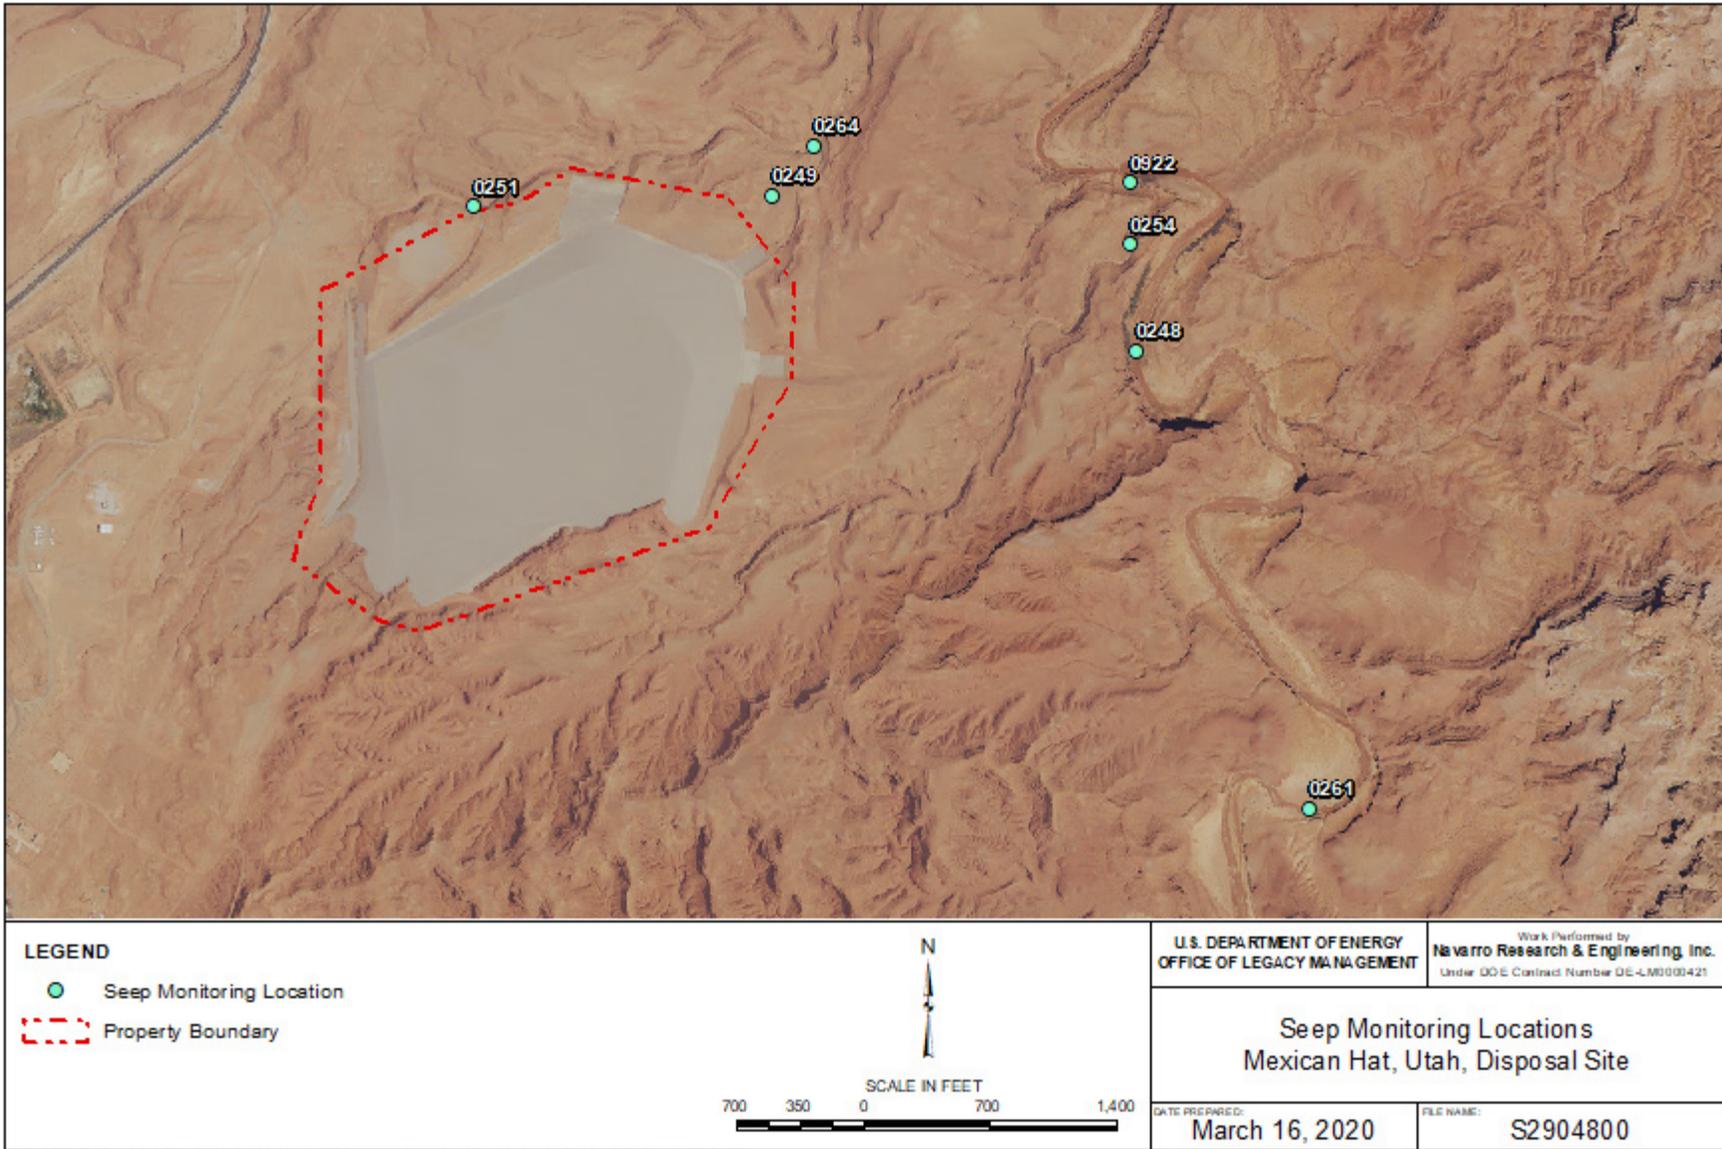
Figure 12-2. Seep Monitoring Locations at the Mexican Hat, Utah, Disposal Site

In accordance with Section 3.7.2 of the LTSP, LM conducts observational monitoring of seven designated seeps during annual inspections as specified in an approved monitoring plan (DOE 2019c). Observational monitoring consists of visual observations and photographic documentation of the seven seep locations specified in the LTSP. The observed seep locations, shown in Figure 12-2, are primarily the result of the infiltration of precipitation into the surrounding formation or perched water that leaked from the former processing site tailings pond. Most seeps have exhibited dry conditions over the past 11 years of observational monitoring.
