11.0 Maybell, Colorado, Disposal Site

11.1 Compliance Summary

The Maybell, Colorado, Uranium Mill Tailings Radiation Control Act (UMTRCA) Title I Disposal Site (site) was inspected on September 3, 2020. No changes were observed on the disposal cell or in the associated drainage features. Inspectors identified several minor maintenance needs but found no cause for a follow-up inspection. Groundwater monitoring is not required.

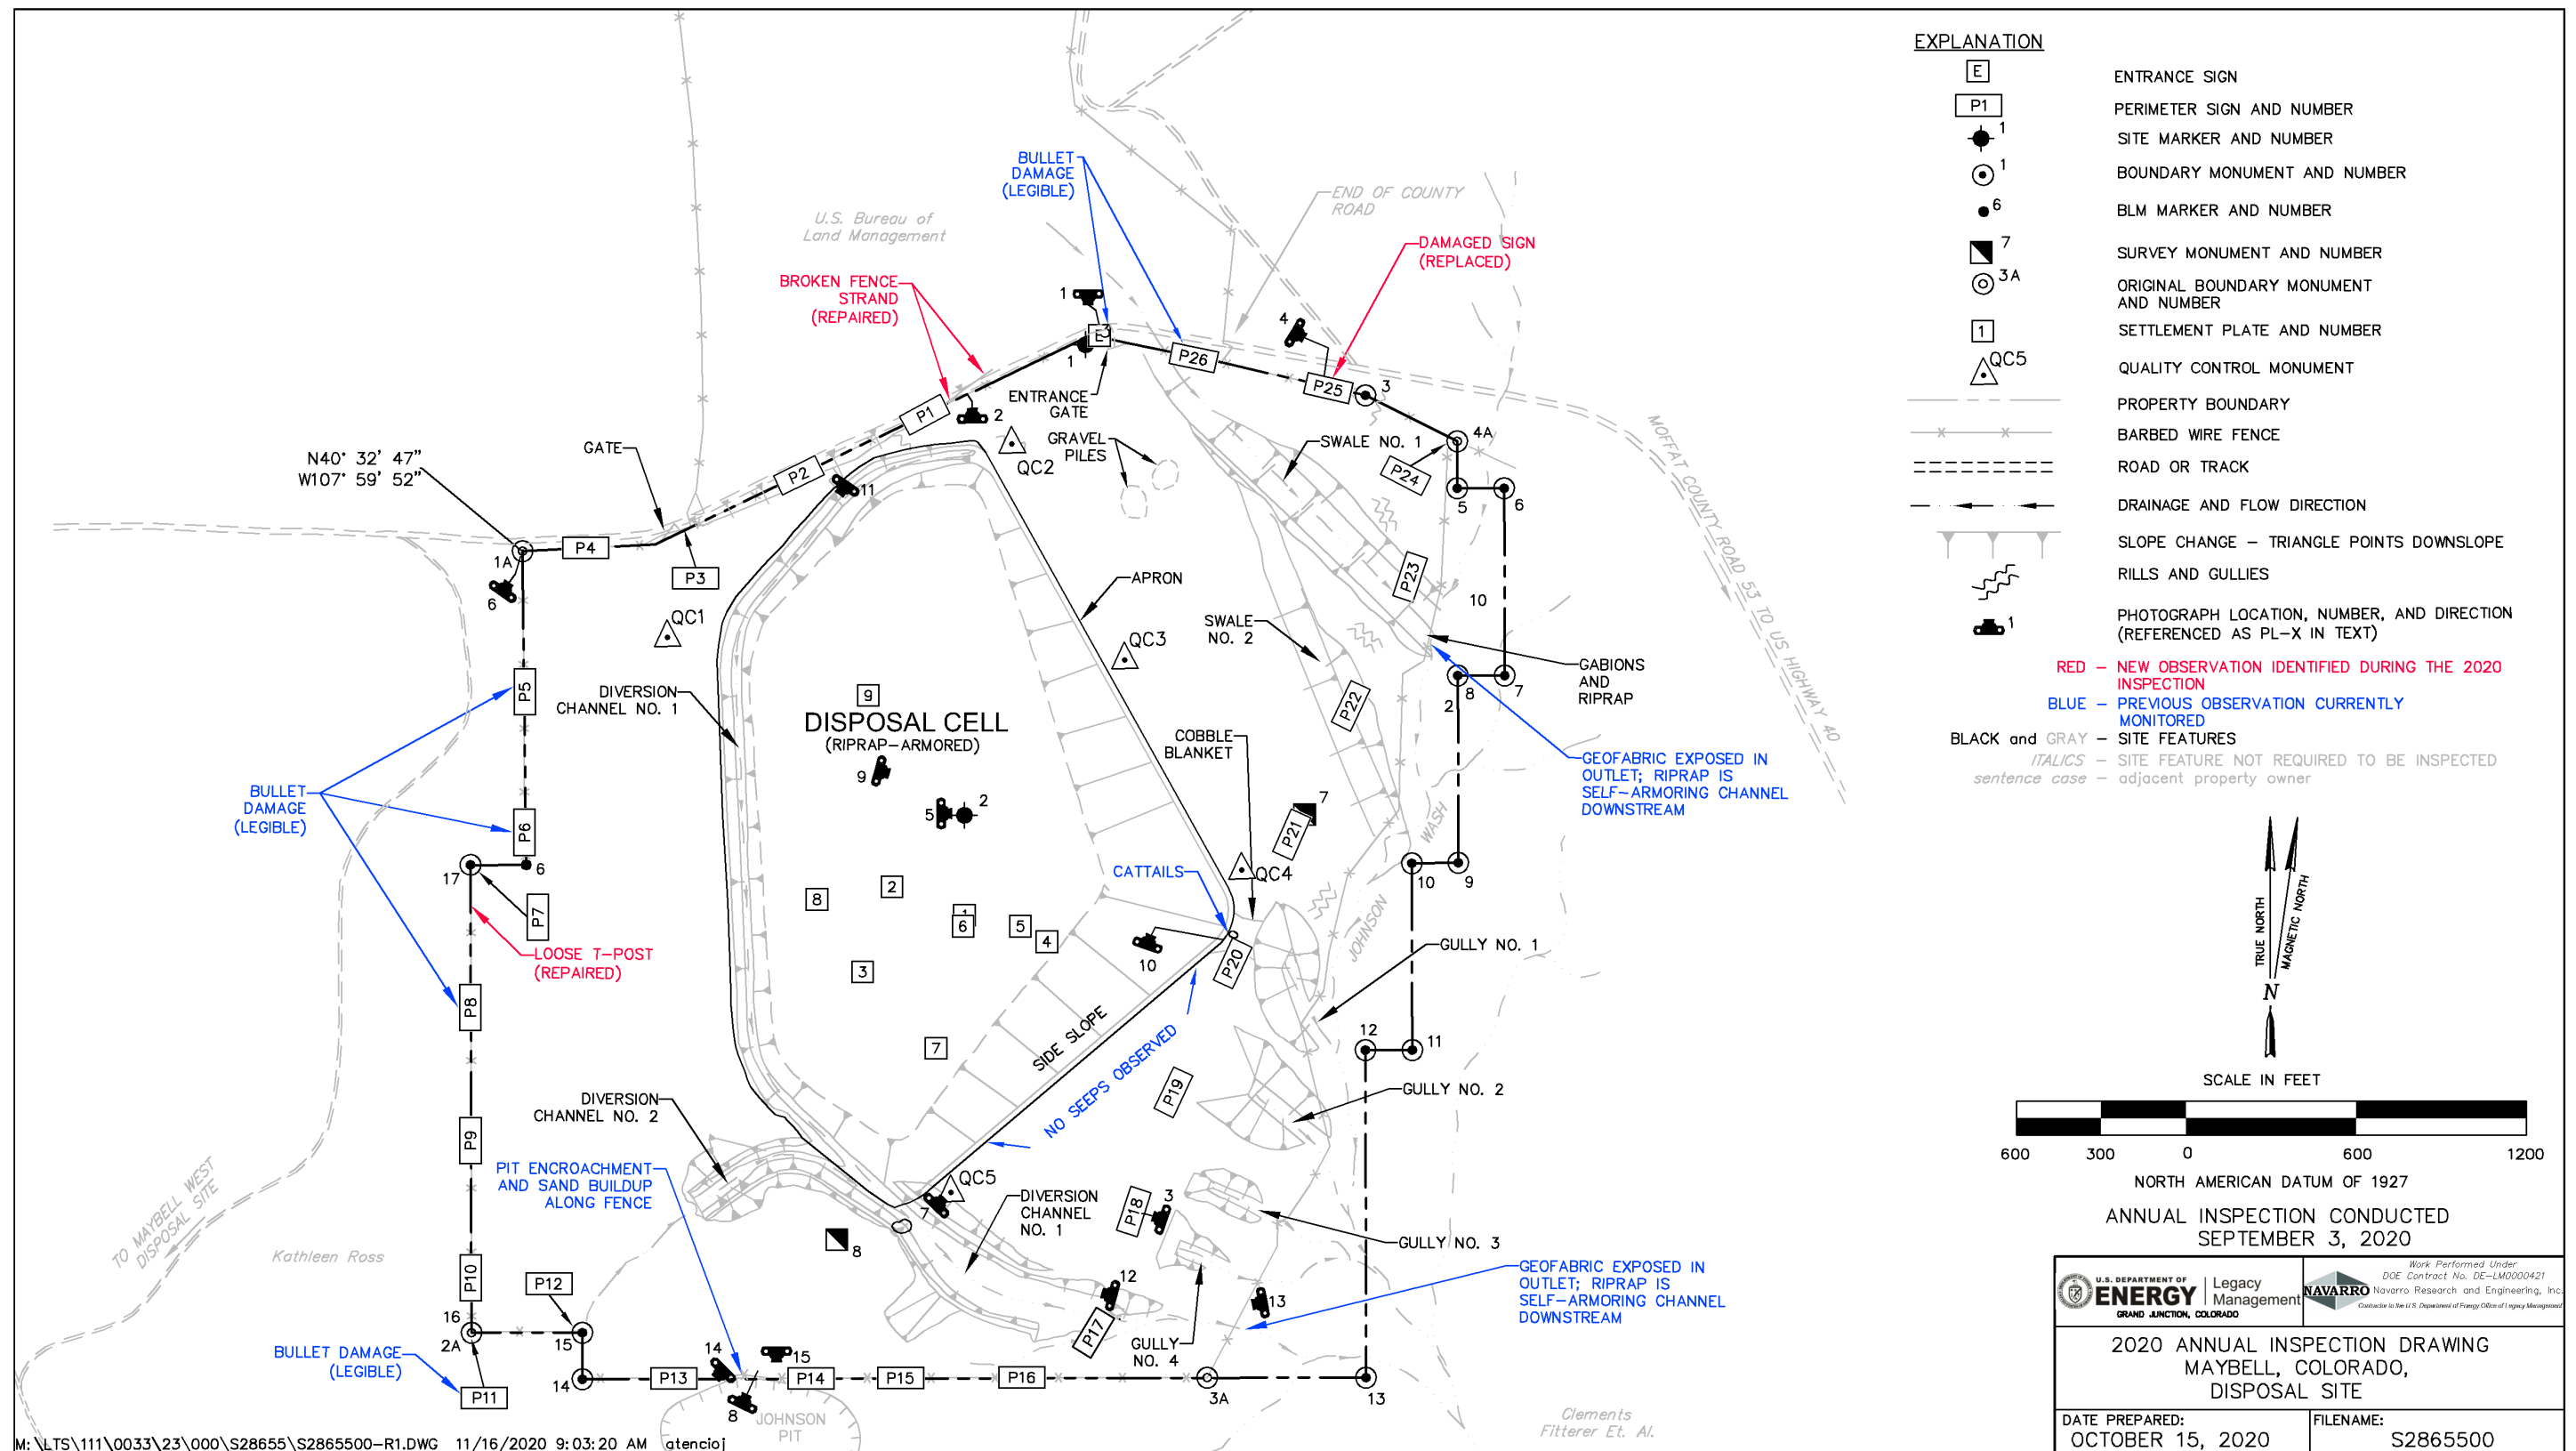
Figure 11-1. 2020 Annual Inspection Drawing for the Maybell, Colorado, Disposal Site

Figure 11-1 shows the locations of site features in black and gray font, including site surveillance features and inspection areas. Site features that are present but not required to be inspected are shown in italic font. Observations from previous inspections that are currently monitored are shown in blue text, and new observations identified during the 2020 annual inspection are shown in red. Inspection results and recommended maintenance activities associated with site surveillance features are included in the following subsections. Photographs to support specific observations are identified in the text and in Figure 11-1 by photograph location (PL) numbers. The photographs and photograph log are presented in Section 11.10.
