13.0 Naturita, Colorado, Disposal Site

13.1 Compliance Summary

The Naturita, Colorado, Uranium Mill Tailings Radiation Control Act (UMTRCA) Title I Disposal Site (site) was inspected on June 10, 2020. No changes were observed on the disposal cell or in the associated drainage features. Inspectors identified several minor maintenance needs but found no cause for a follow-up inspection.

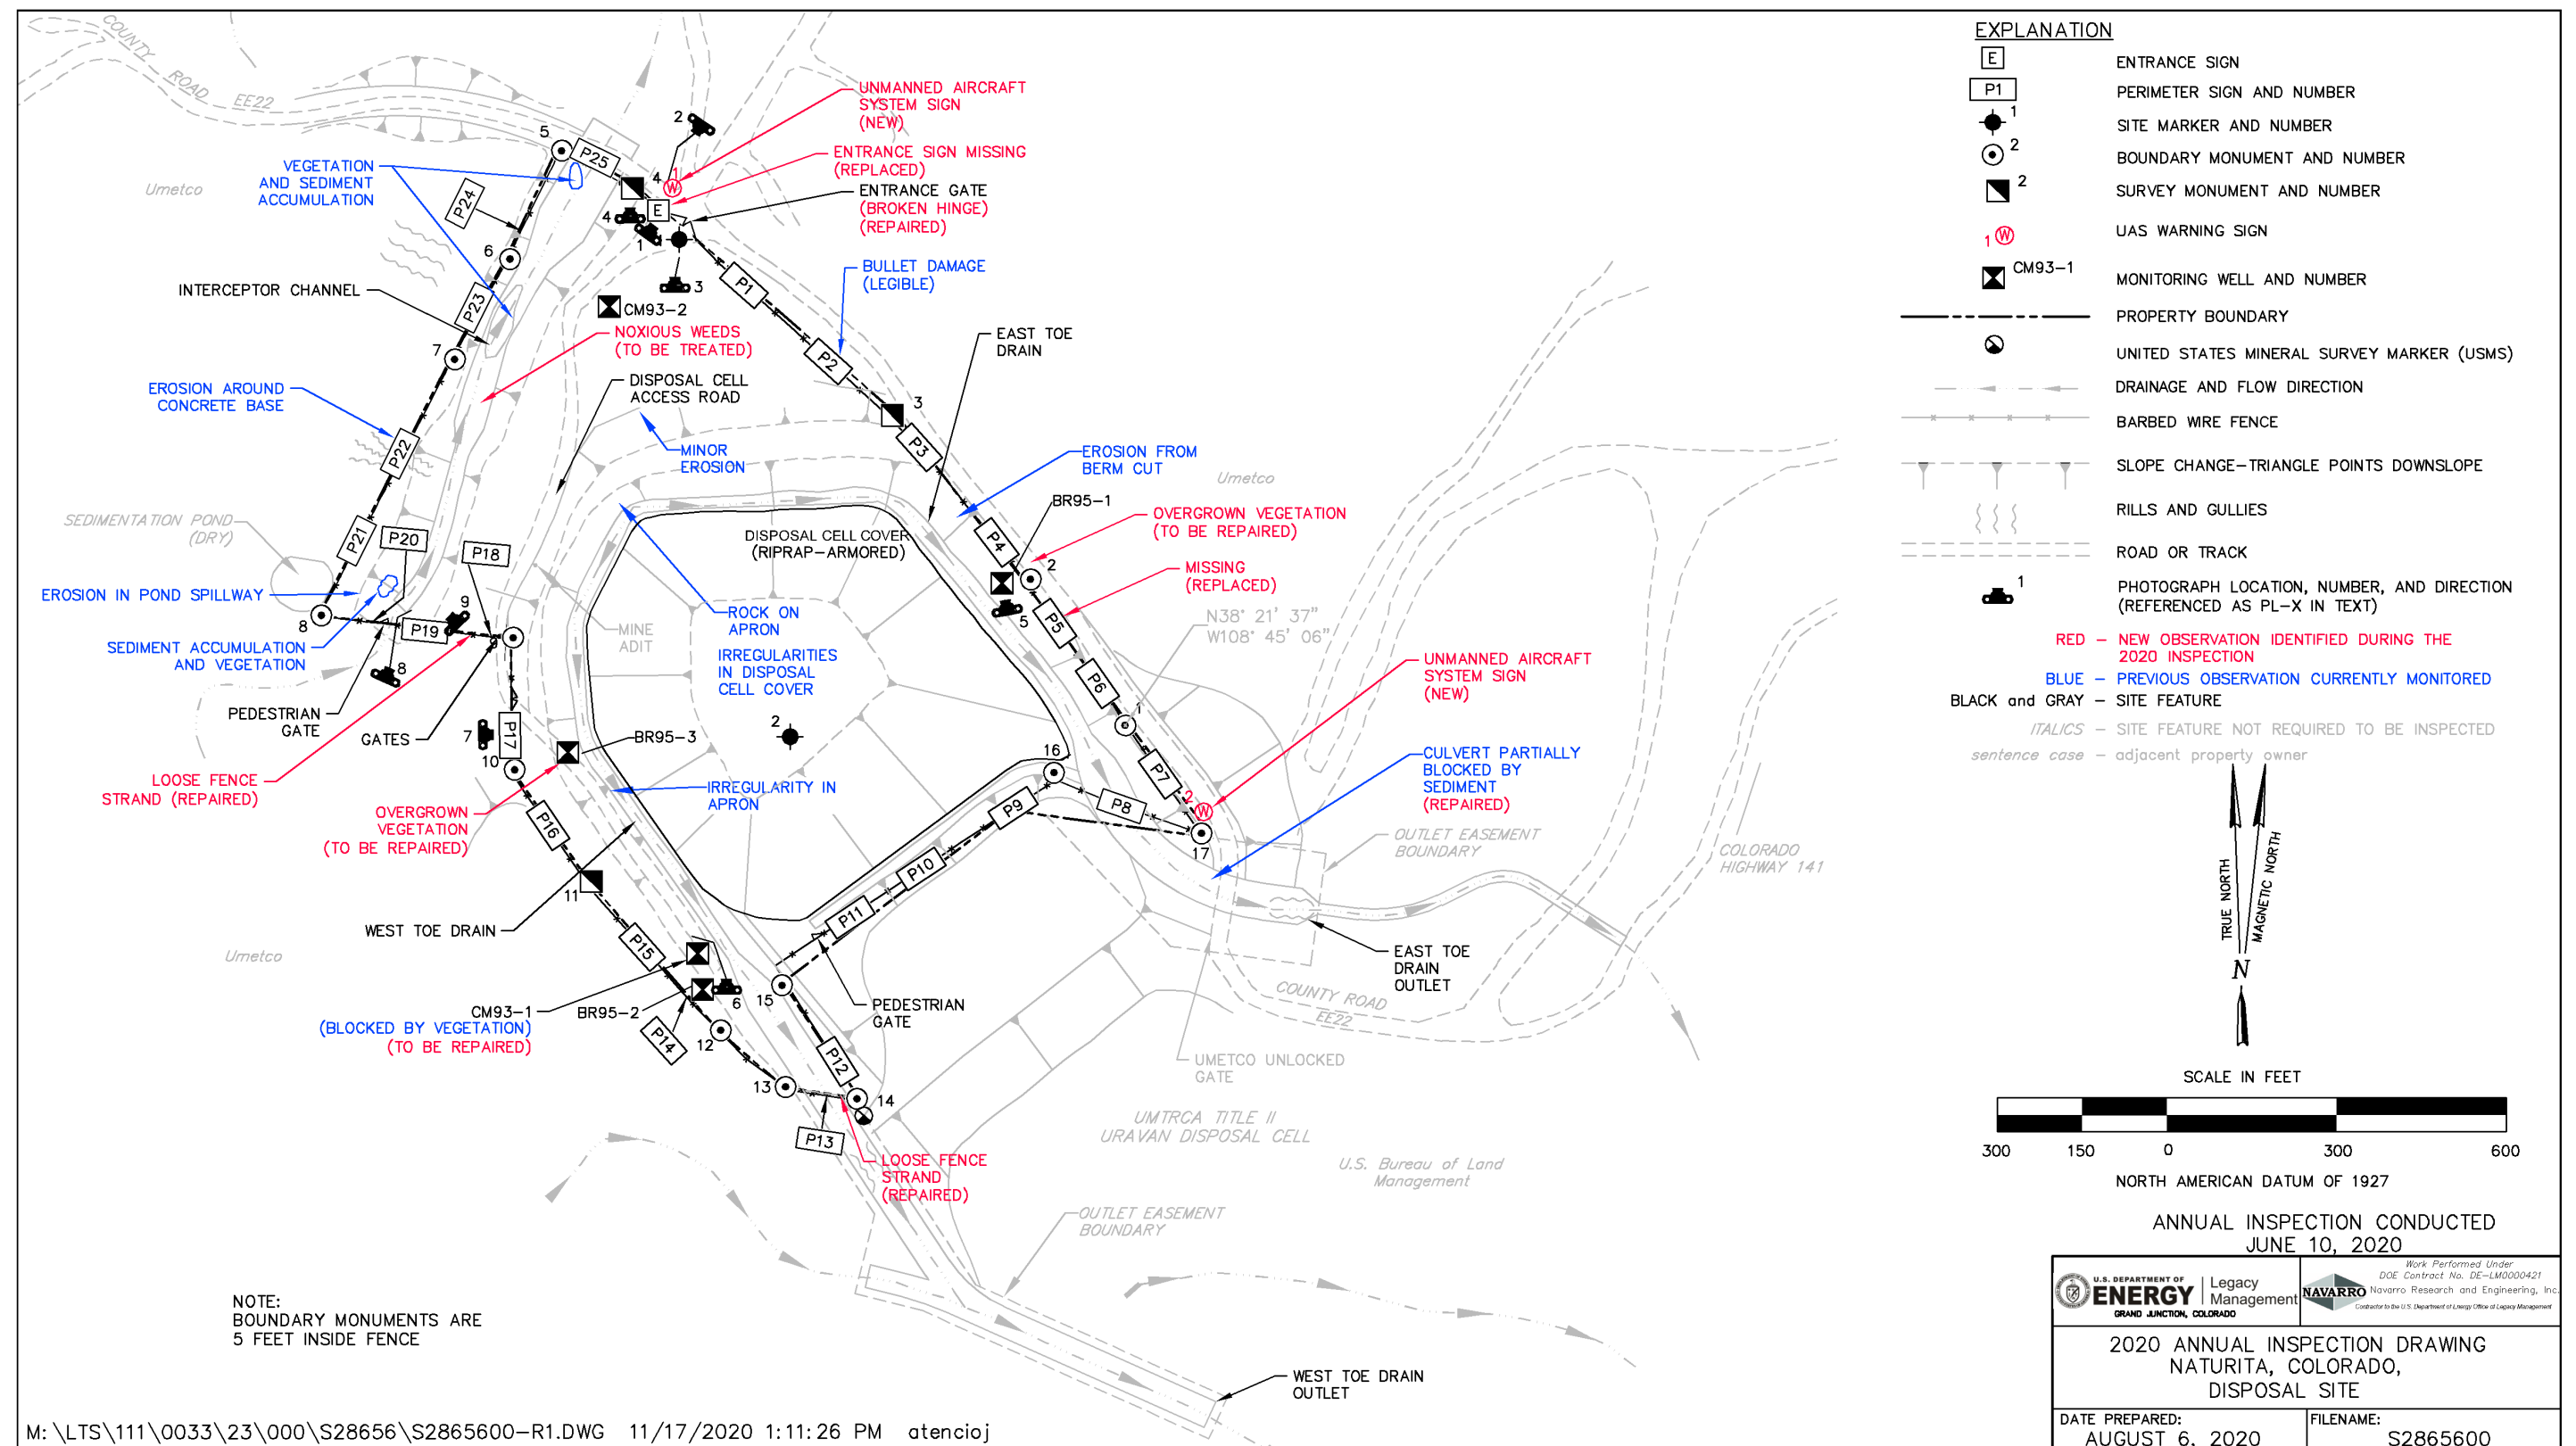
Figure 13-1. 2020 Annual Inspection Drawing for the Naturita, Colorado, Disposal Site

The 26.65-acre site, identified by the property boundary shown in Figure 13-1, is owned by the United States and was accepted under the NRC general license in 1999. DOE is the licensee, and in accordance with the requirements for UMTRCA Title I sites, is responsible for the custody and long-term care of the site. Institutional controls (ICs) at the site include federal ownership of the property, administrative controls, and the following physical ICs that are inspected annually: the disposal cell and associated drainage features, entrance gate and sign, perimeter fence and signs, site markers, survey and boundary monuments, and wellhead protectors.

Figure 13-1 shows the locations of site features in black and gray font, including site surveillance features and inspection areas. Site features that are present but not required to be inspected are shown in italic font. Observations from previous inspections that are currently monitored are shown in blue text, and new observations identified during the 2020 annual inspection are shown in red font. Inspection results and recommended maintenance activities associated with site surveillance features are described in the following subsections. Photographs to support specific observations are identified in the text and in Figure 13-1 by photograph location (PL) numbers. The photographs and photograph log are presented in Section 13.10.
