15.0 Salt Lake City, Utah, Disposal Site

15.1 Compliance Summary

Figure 15-1. 2020 Annual Inspection Drawing for the Salt Lake City, Utah, Disposal Site

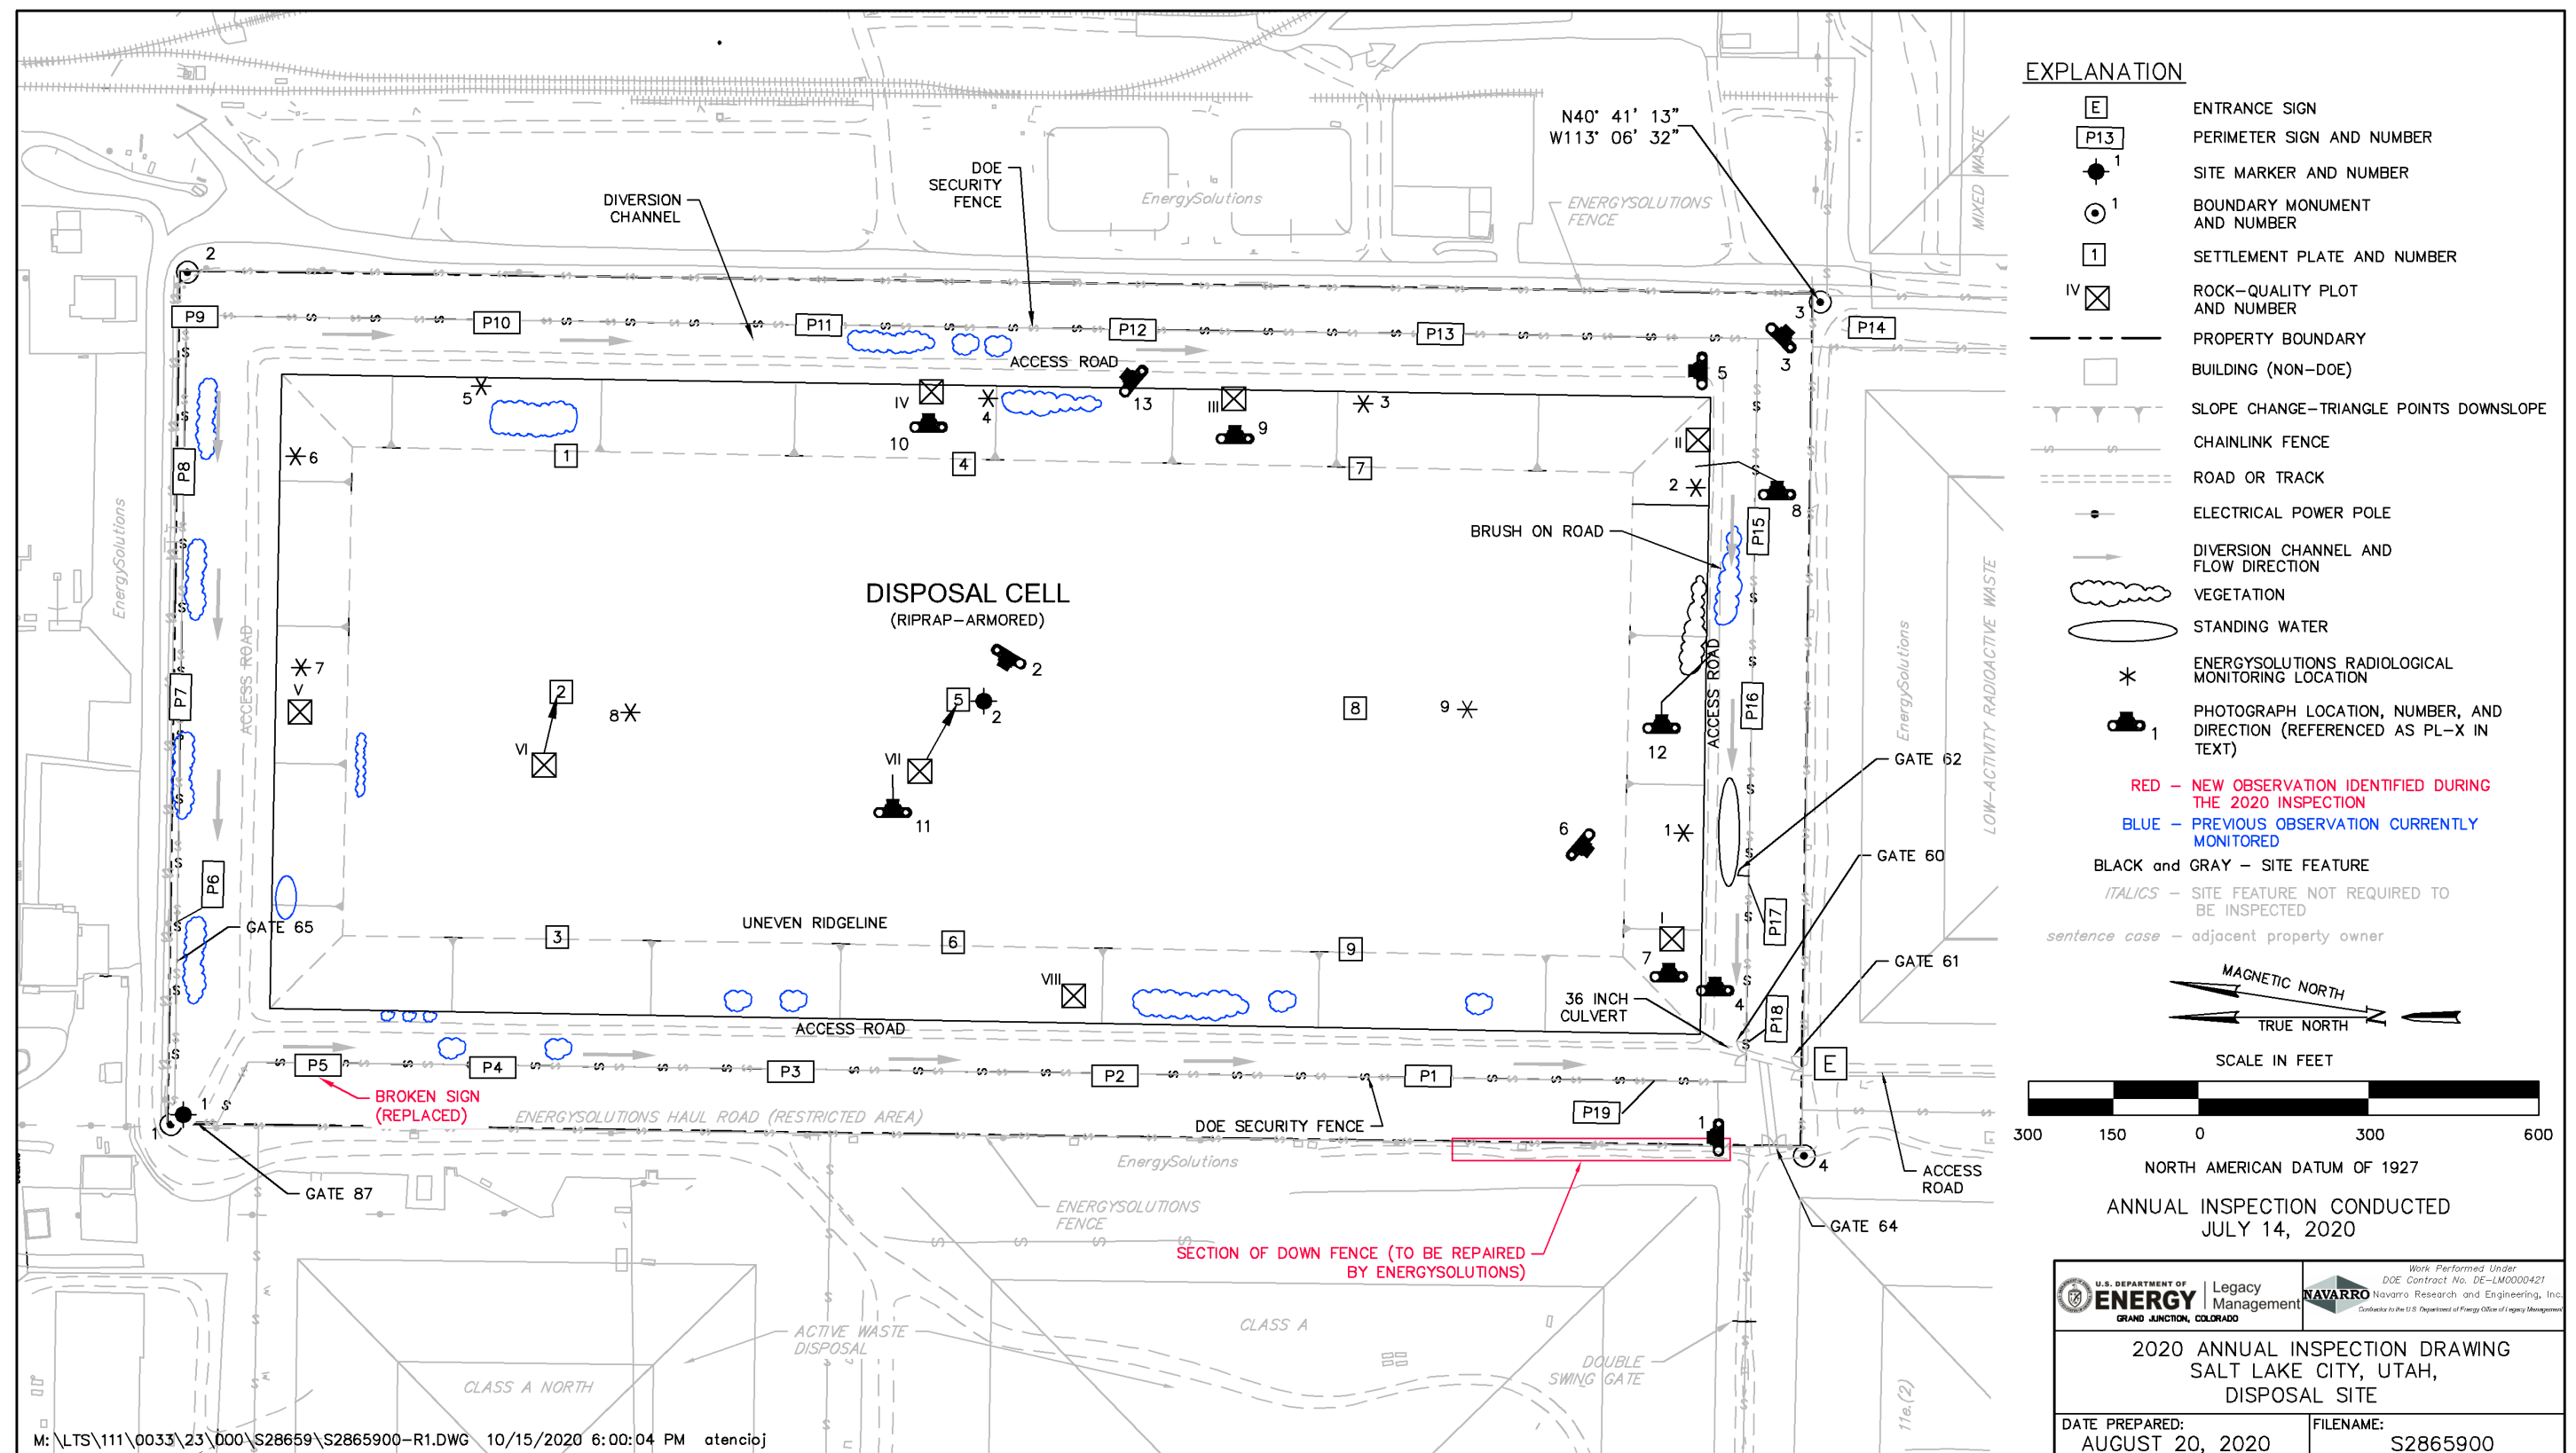
Figure 15-1 shows the locations of site features in black and gray font, including site surveillance features and inspection areas. Site features that are present but not required to be inspected are shown in italic font. Observations from previous inspections that are currently monitored are shown in blue text, and new observations identified during the 2020 annual inspection are shown in red. Inspection results and recommended maintenance activities associated with site surveillance features are described in the following subsections. Photographs to support specific observations are identified in the text and in Figure 15-1 by photograph location (PL) numbers. The photographs and photograph log are presented in Section 15.10.

One of several types of rock used for the disposal cell erosion-protection riprap layer has exhibited minor degradation since the disposal cell was constructed. As a result, eight rock-quality monitoring plots, each measuring 1 square meter (indicated by Roman numerals I–VIII in Figure 15-1), were established in 2010 to monitor for continued rock degradation.
