17.0 Slick Rock, Colorado, Disposal Site

17.1 Compliance Summary

Figure 17-1. 2020 Annual Inspection Drawing for the Slick Rock, Colorado, Disposal Site

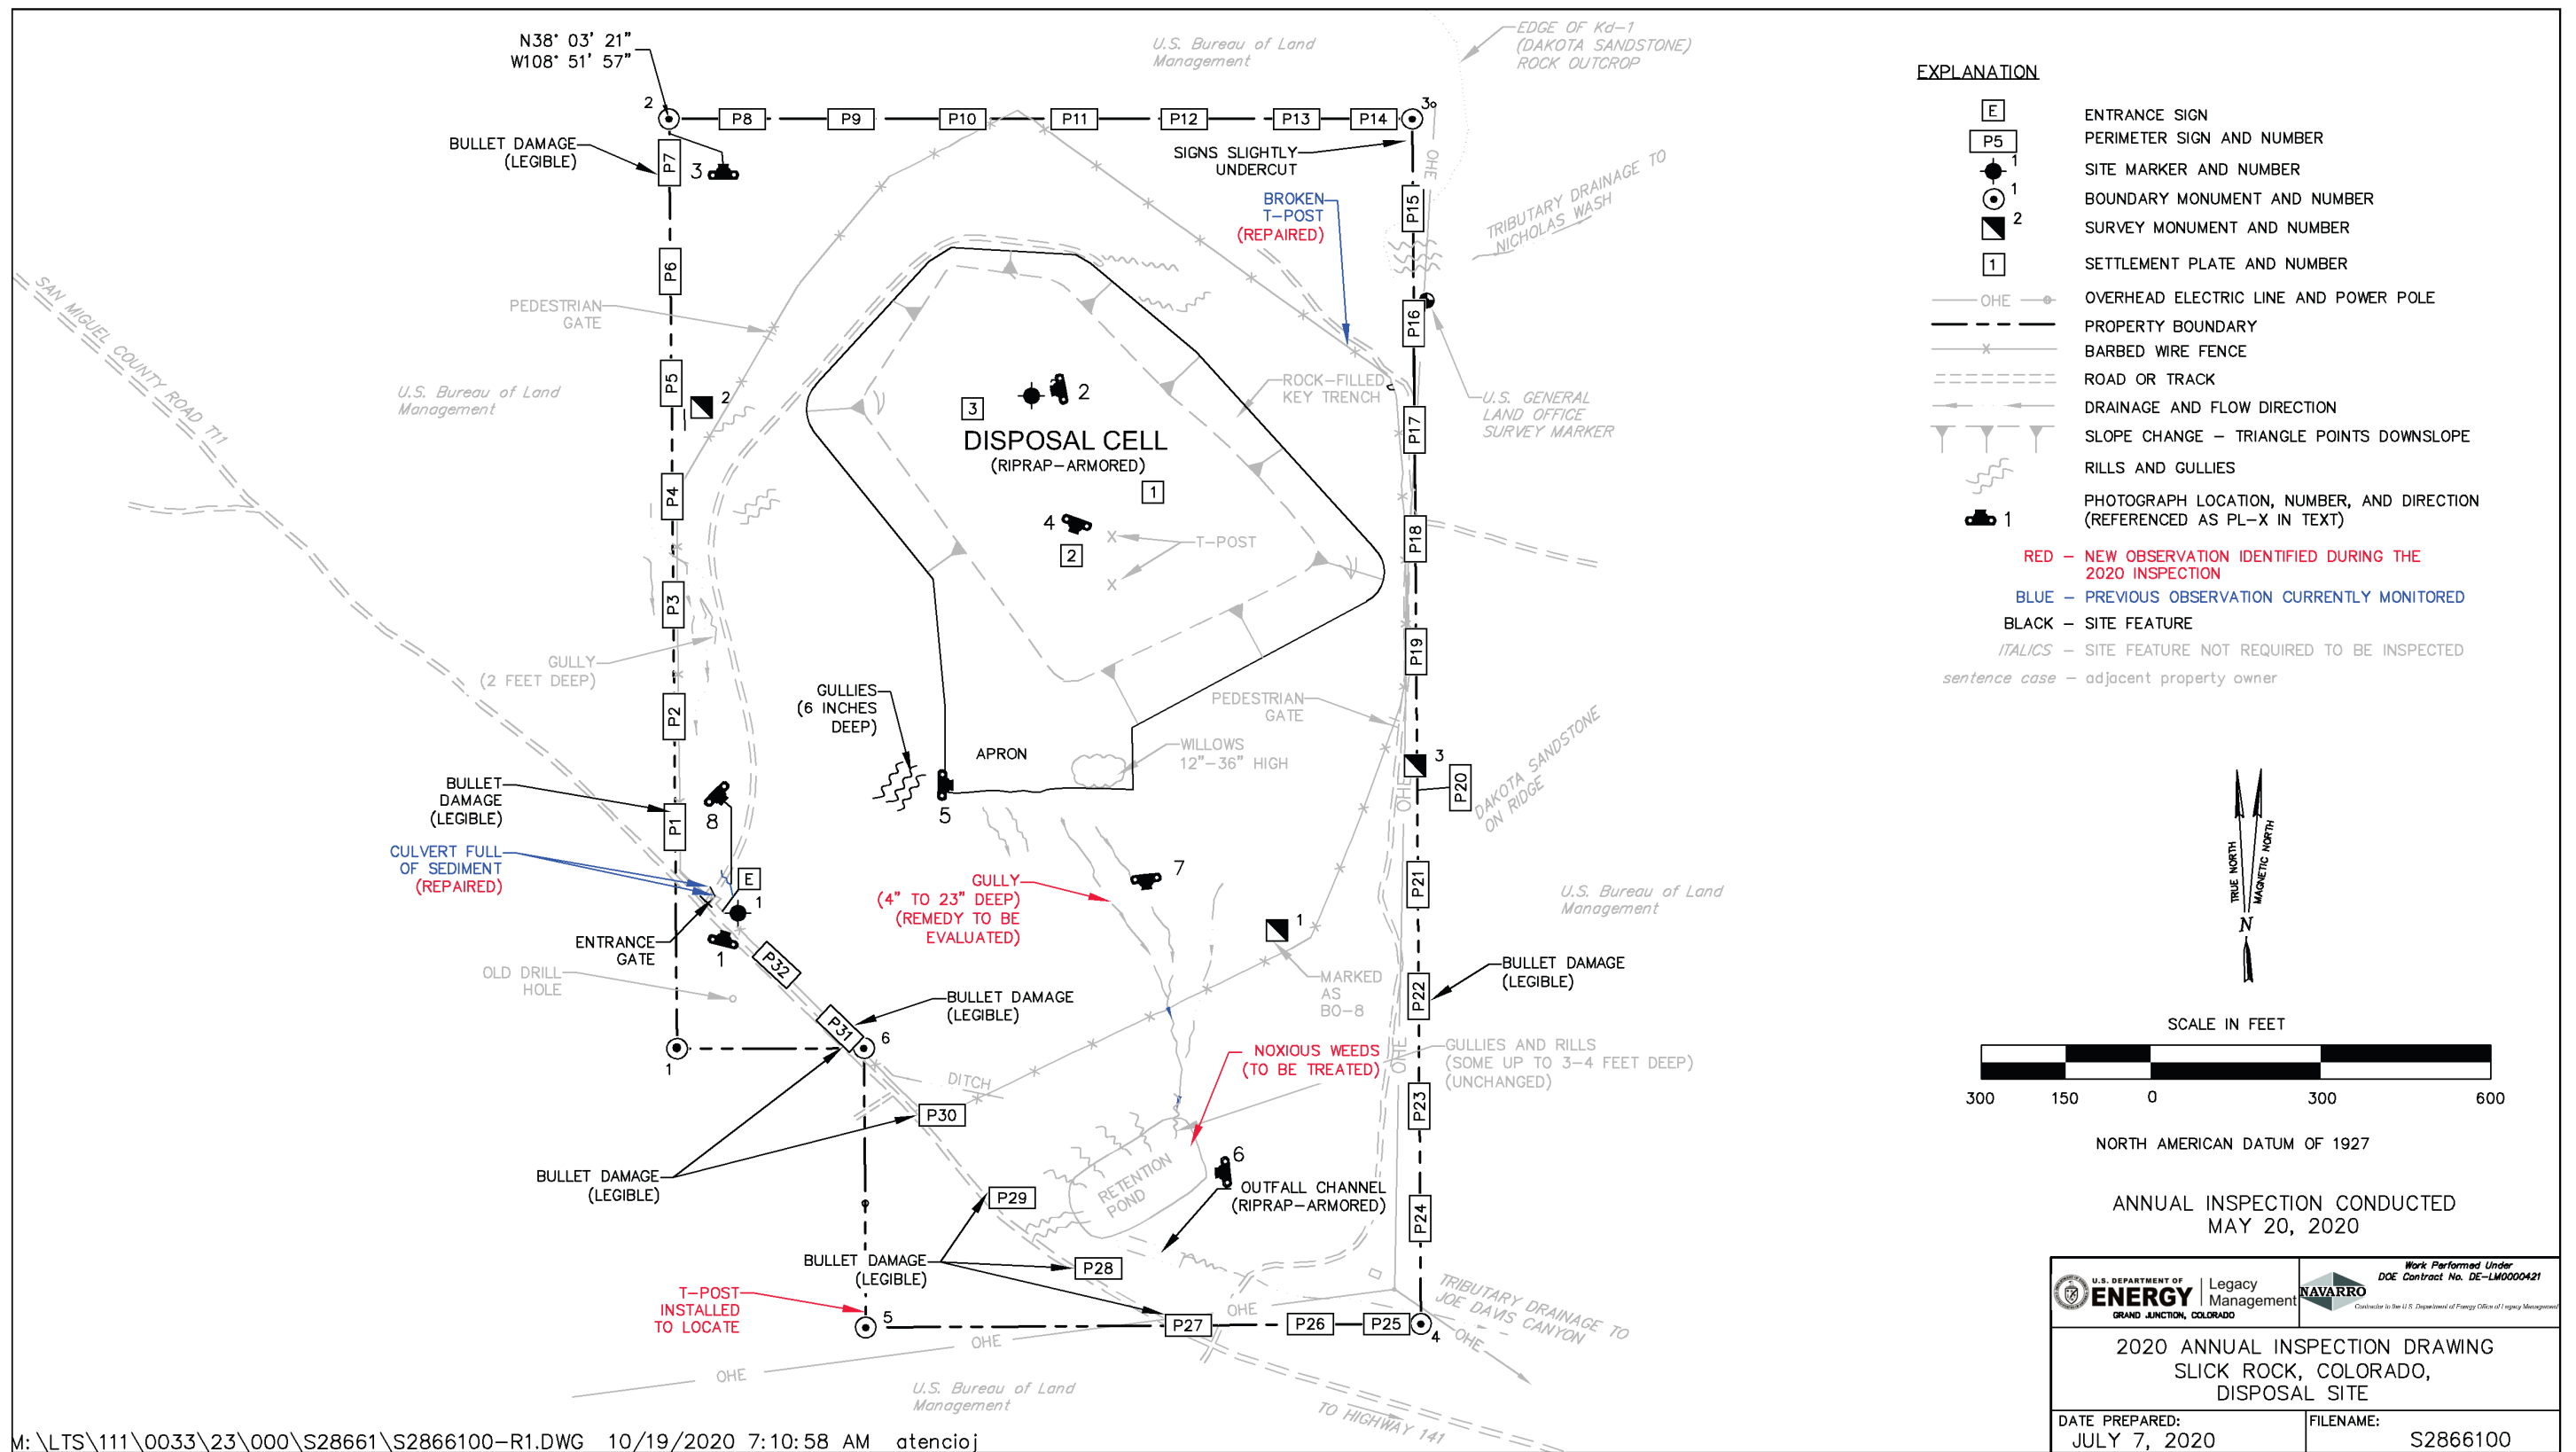
Figure 17-1 shows the locations of site features in black and gray font, including site surveillance features and inspection areas. Site features that are present but not required to be inspected are shown in italic font. Observations from previous inspections that are currently monitored are shown in blue text, and new observations identified during the 2020 annual inspection are shown in red. Inspection results and recommended maintenance activities associated with site surveillance features are described in the following subsections. Photographs to support specific observations are identified in the text and in Figure 17-1 by photograph location (PL) numbers. The photographs and photograph log are presented in Section 17.10.
