19.0 Tuba City, Arizona, Disposal Site

19.1 Compliance Summary

Figure 19-1. 2020 Annual Inspection Drawing for the Tuba City, Arizona, Disposal Site

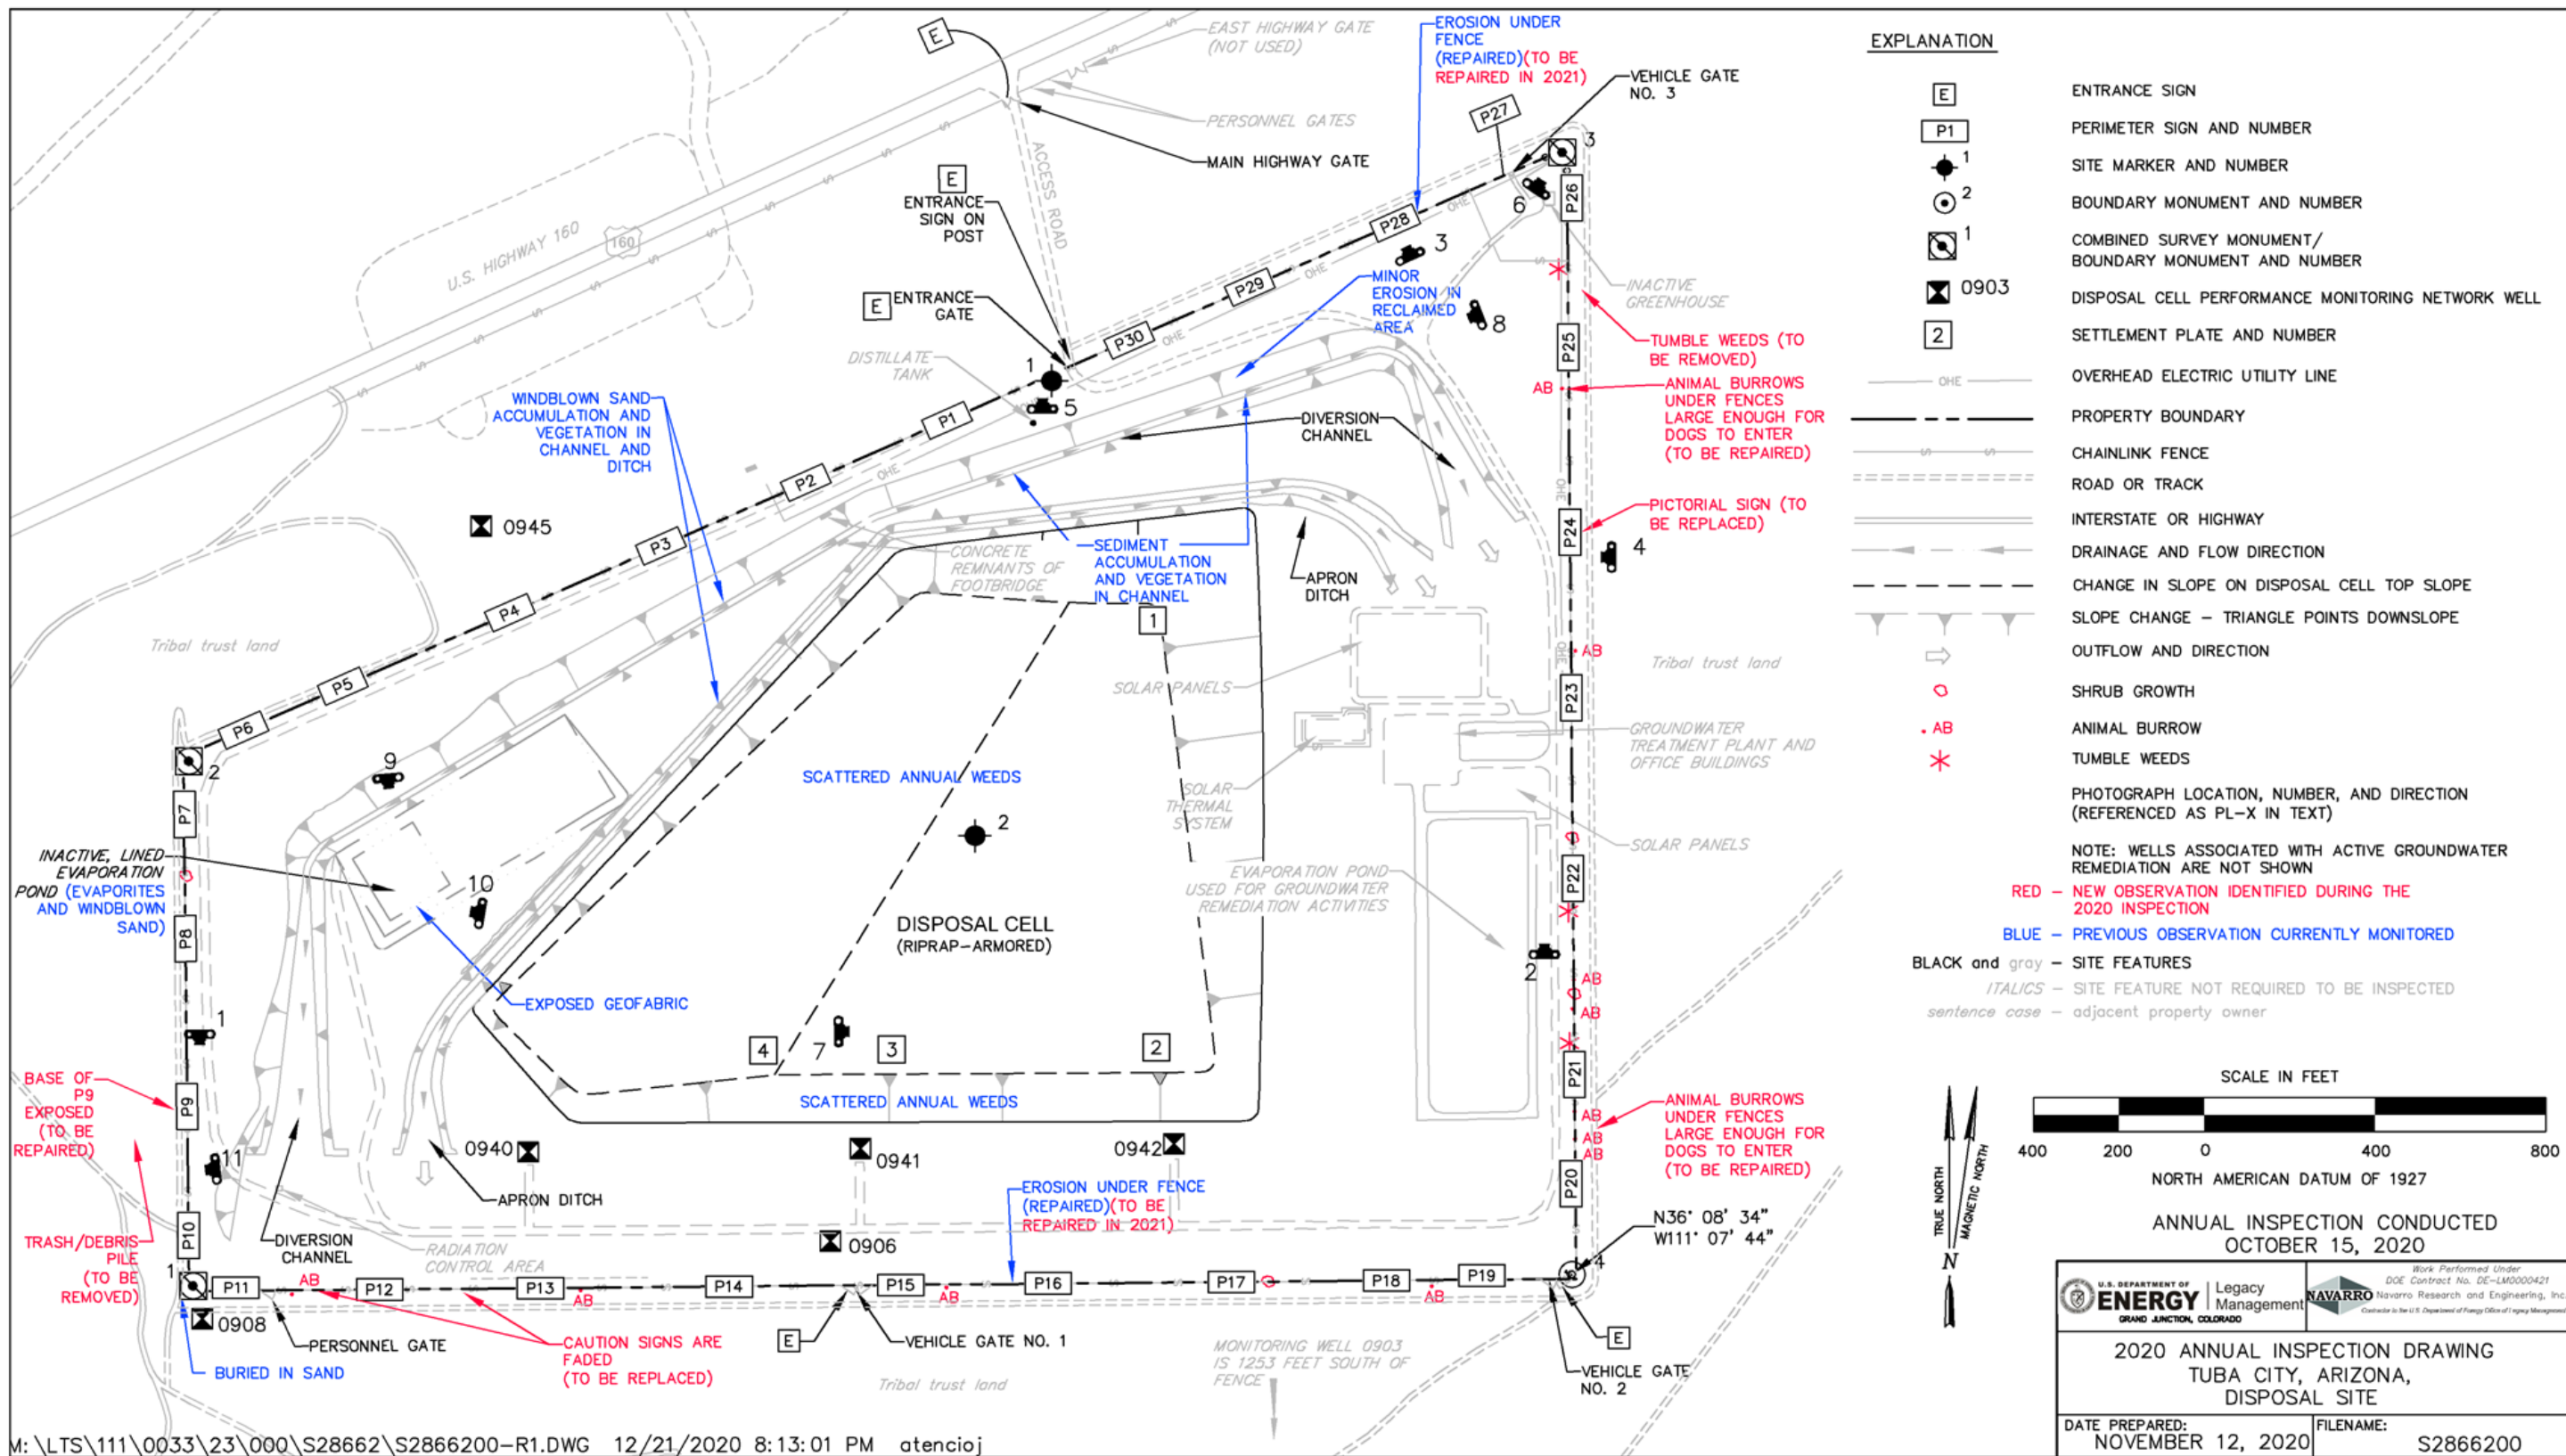
Figure 19-1 shows the locations of site features, including site surveillance features and inspection areas, in black and gray font. Site features that are present but not required to be inspected are shown in italic font. Observations from previous inspections that are currently monitored are shown in blue, and new observations identified during the 2020 annual inspection are shown in red font. Inspection results and recommended maintenance activities associated with site surveillance features are included in the following subsections. Photographs to support specific observations are identified in the text and in Figure 19-1 by photograph location (PL) numbers. The photographs and photograph log are presented in Section 19.10.
