2019 Annual Inspection Report for the DOE Monticello, Utah, Mill Tailings Site and Monticello Vicinity Properties

December 2019

U.S. DEPARTMENT OF
ENERGY

Legacy
Management

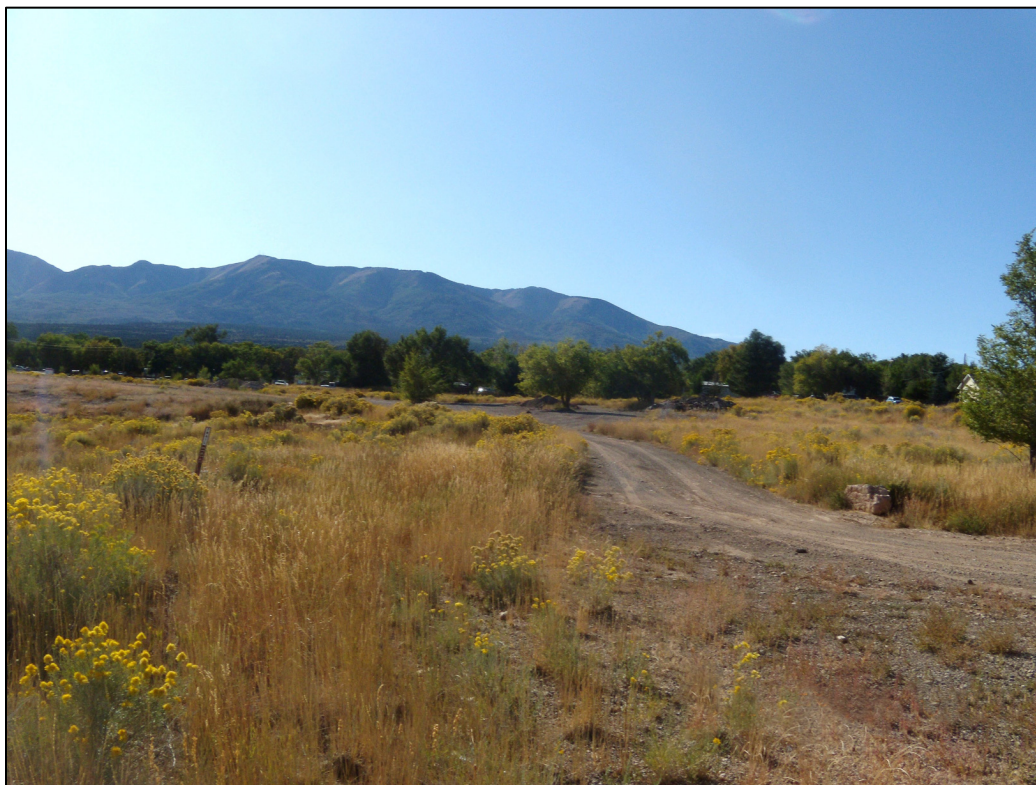
PL-25. City Property MP-00211

All riprap-armored structures, dams, check dams, berms, and runoff control drainages (Figure 4) were intact and functional. PL-25 shows a portion of City-owned property MP-00211, and PL-26 shows a portion of the access road near Deer Draw Dam. Both photographs illustrate the well-vegetated and intact soils that characterize the City-owned properties.

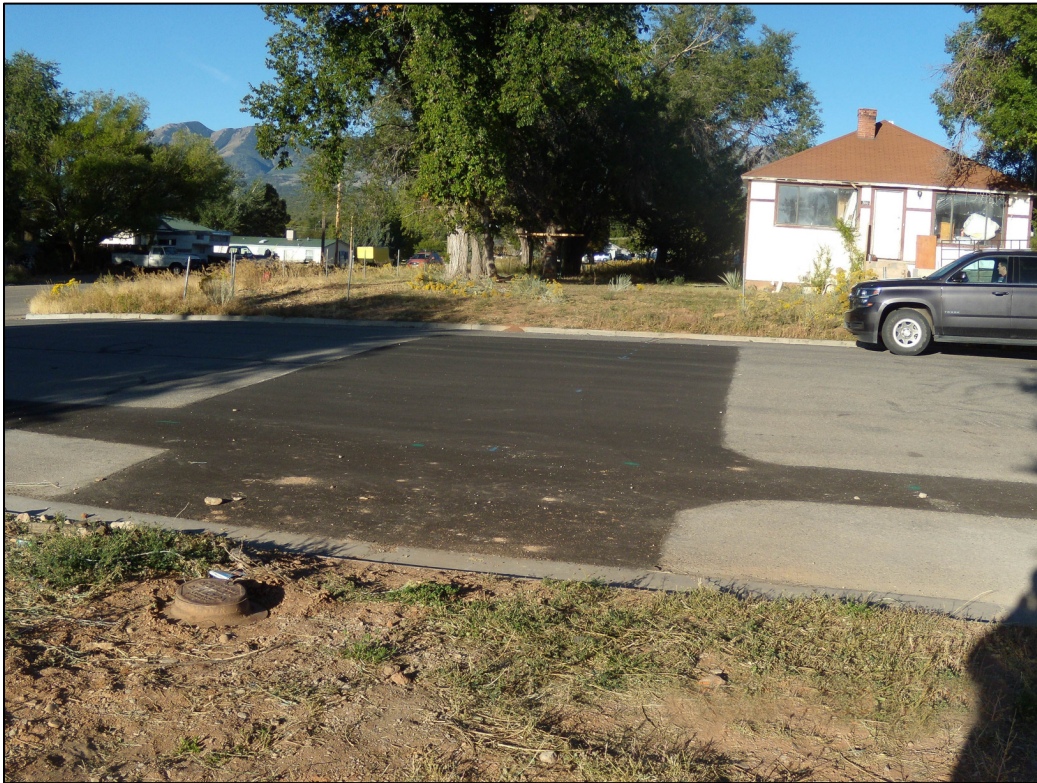
PL-30. Completed Sewer Line Replacement at 517 South and 100 West Street

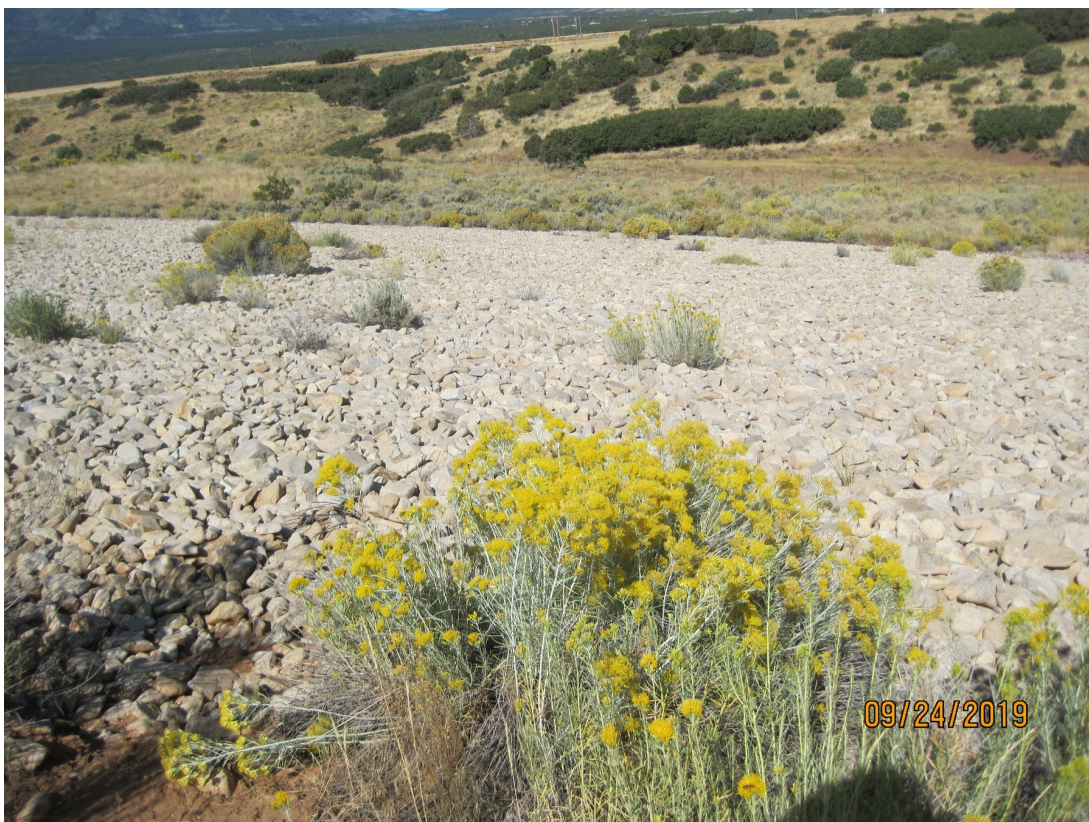
The northwest riprap side slope was initially visited and found to be in excellent condition as evident in Figure No. 2. The slope is protected against erosion by diorite riprap (as shown in Figure No. 3), and materials were in excellent condition. Shallow channels with occasional shallow rills were found on the soil/rock interface of the side slope, above the riprap slope indicating surface flow probably from melting snow cover and/or precipitation. These features do not currently pose any difficulties, however continued monitoring is needed to ensure erosional problems are not created.

Figure No. 3, Northwest riprap side slope
