2020 Annual Inspection Report for the DOE Monticello, Utah, Mill Tailings Site and Monticello Vicinity Properties

December 2020

U.S. DEPARTMENT OF
ENERGY

Legacy
Management

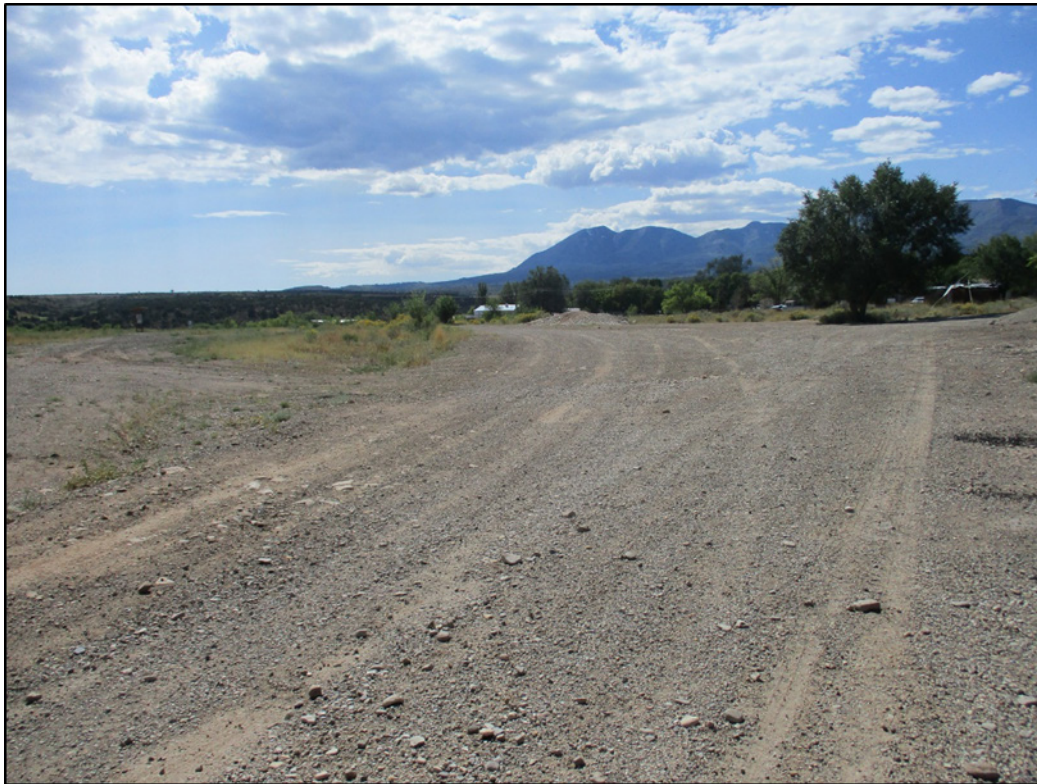
PL-24. City Property MP-00211

All riprap-armored structures, dams, check dams, berms, and runoff control drainages (Figure 4) were intact and functional. PL-24 shows a portion of City-owned property MP-00211, and PL-25
