Rocky Flats Site, Colorado, Report Summary

First Quarter 2023

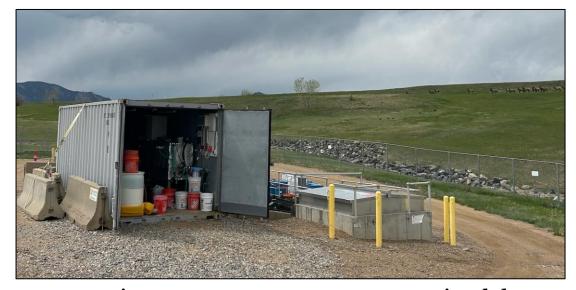
- Solar Ponds Plume Treatment System
 - Continued uranium treatment testing
 - Sub-zero cold snaps caused freezing of some components, but supported planned testing under extreme conditions
 - Design of full-scale uranium treatment component scheduled to begin in late 2023
 - Planning for subsurface effluent discharge gallery maintenance in April 2023 (see CR 2022-05)

Uranium treatment component testing lab at the SPPTS
