**2025 Annual Land-Use Covenant
Inspection Report
for DOE Areas at the Laboratory
for Energy-Related Health
Research/Old Campus
Landfill Superfund Site
University of California, Davis**

January 2026

U.S. DEPARTMENT OF
ENERGY

Legacy
Management

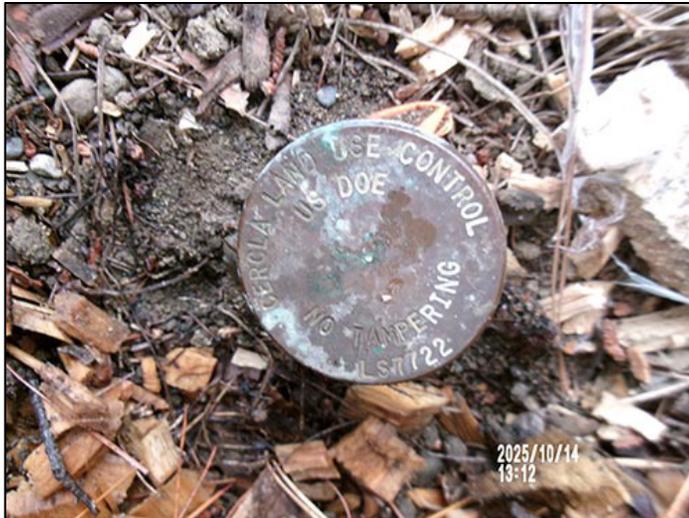
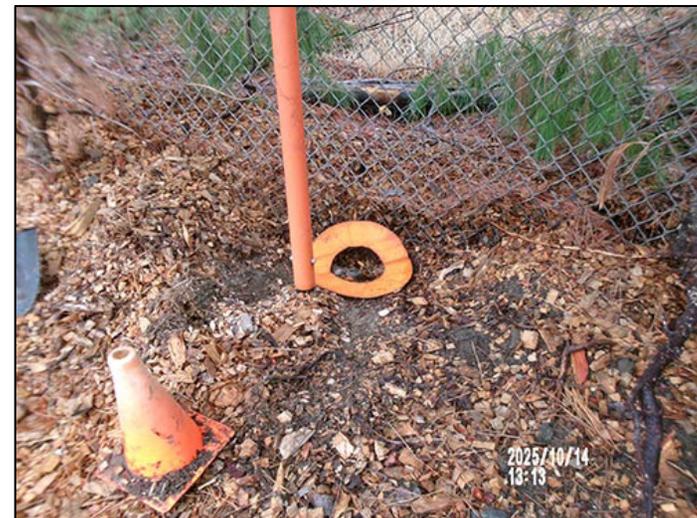
Monument 18: Southeast Corner of Eastern Remediation Support Area (Photo No. 150)

All 24 survey monuments (Figure 2) were found in good condition on October 14, 2025, as documented in the checklists and photographs in Appendixes A and B, respectively. Monument 18, which was covered by a stockpile of wood chips during the 2024 inspection, was found in good condition during this inspection, as shown in the photograph of this monument provided in Appendix B. The location delineator for monument 19, which was found in a disturbed condition during the 2024 inspection, was reinstalled as documented in Appendix F.

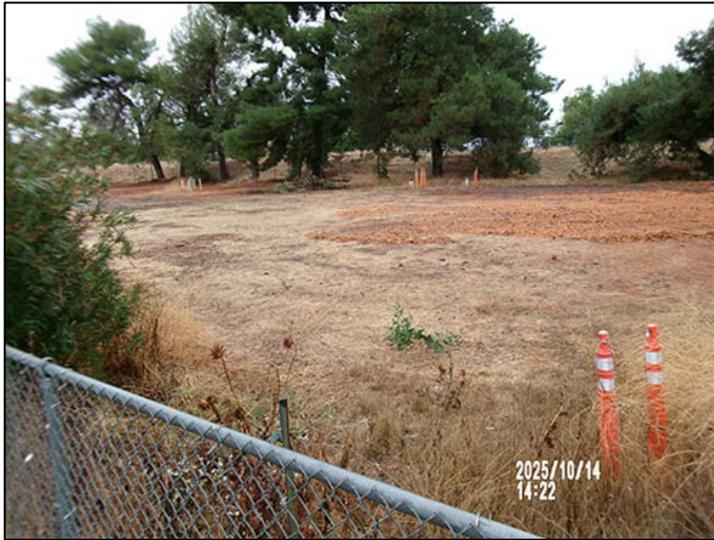
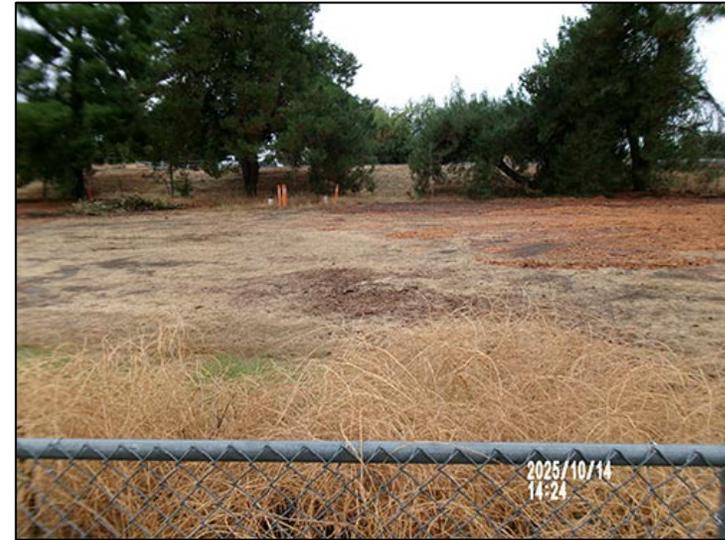
Photograph Description	Photo No.	Comments
View southeast of Southwest Trenches Area: North Levee of the South Fork of Putah Creek in background.	179	As observable in <i>photographs 179 and 181</i> , a thin layer (less than 6 inches thick) of wood chips remains in various locations in the Southwest Trenches Area where vegetation stockpiles were staged during the 2024 reporting period prior to their off haul and disposal during this reporting period.
View south of Southwest Trenches Area: North Levee of the South Fork of Putah Creek in background.	181	
View southeast of Southwest Trenches Area from northwest corner: North Levee of the South Fork of Putah Creek in Background.	166	
View west of Southwest Trenches Area: Shoulder of Old Davis Road in background.	155	
View northwest of Southwest Trenches Area.	160	Soil and vegetation pile described in inspection item 1 in center.
View north of Southwest Trenches Area: Buildings H-215 and H-216 in background.	178

View Southeast of SWT Area: North Levee of South Fork of Putah Creek in Background (Photo No. 179)

View South of SWT Area: North Levee of South Fork of Putah Creek in Background (Photo No. 181)

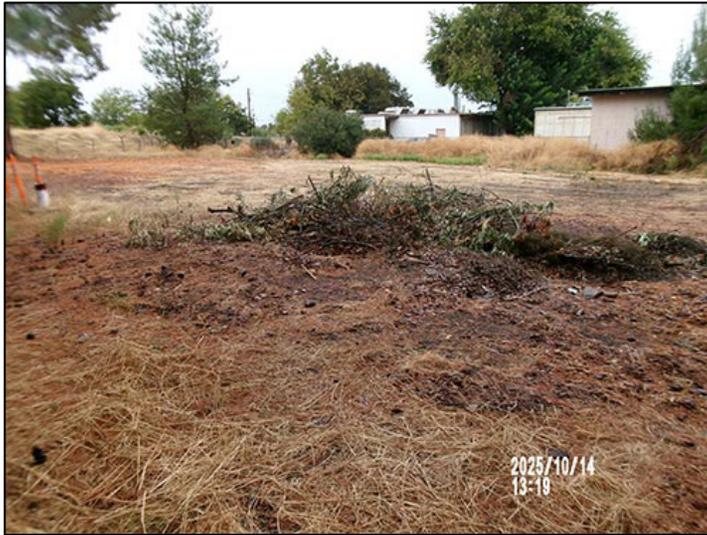
*View Northwest of SWT Area: Ra/Sr Treatment Systems Area
Tree and Soil Debris in Center of Photo (Photo No. 160)*

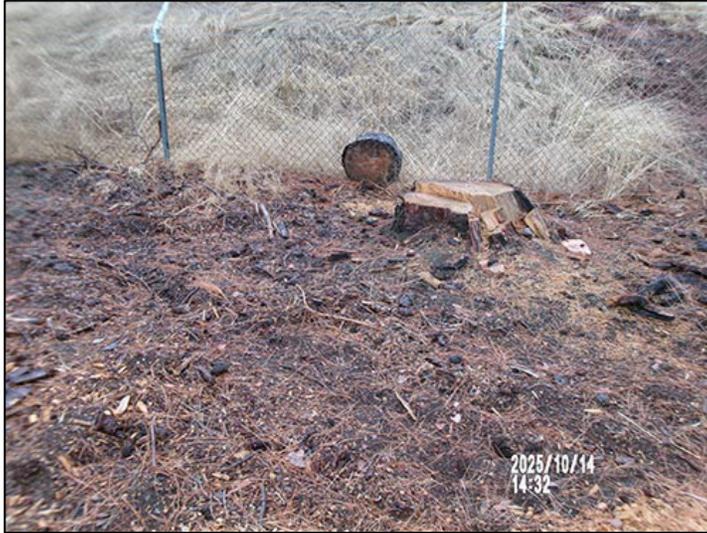
October 14, 2025, View West from West End of SWT Area, Tree 16220 Trunk Section on Old Davis Road Side of West Perimeter Fence (Photo No. 184)

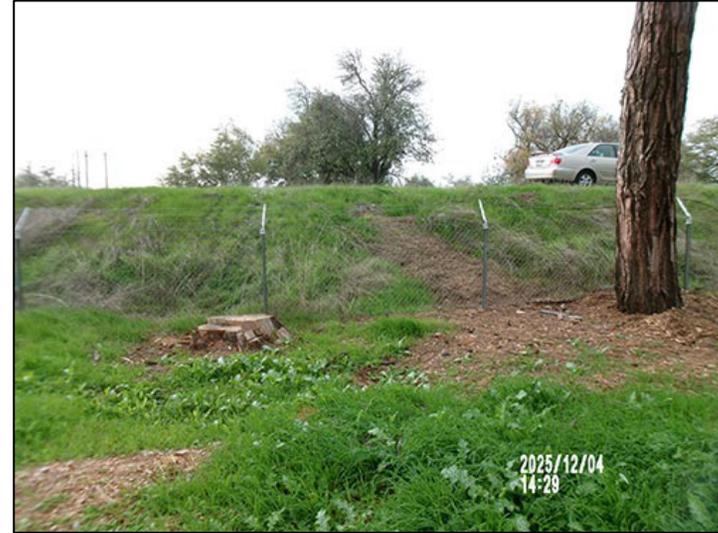
December 4, 2025, View West from West End of SWT Area, Tree 16220 Trunk Section removed from Old Davis Road Side of West Perimeter Fence (Photo No. 414)

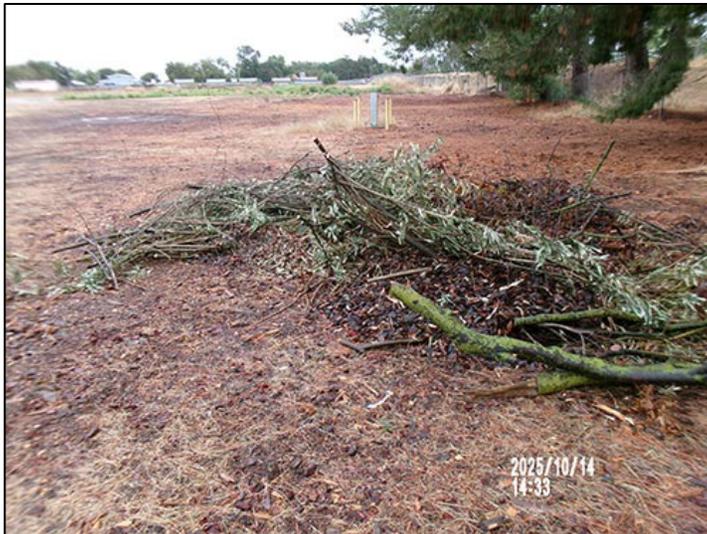
Prior to the October 15, 2025, walkthrough inspection, these materials were staged in the southwest corner of the southwest trenches (Appendix C, photo 185) pending sampling and analysis for disposal in accordance with the SMP. On December 4, 2025, DOE installed stanchions and rope surrounding this staging area (Appendix C, photo 410).

October 14, 2025, View East of Vegetation and Soil Originating from the Ra/Sr Treatment Systems Area and WRS Area, Respectively, Stockpiled near the Southeast Corner of the SWT Area (Photo No. 185)

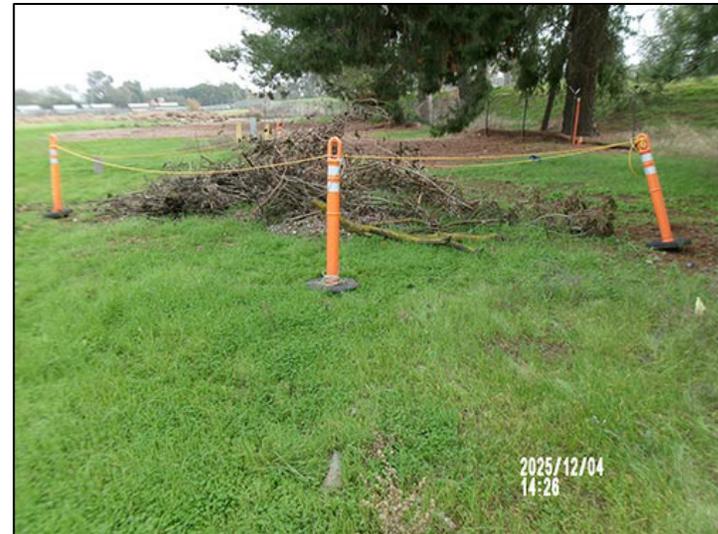
lower limbs of DSS 3 Area tree 16211 under a vegetation removal permit approved on December 11, 2024. Because the tree stumps were left in place and not disturbed, a soil disturbance permit was not required. Vegetation waste from these trees was staged in the SWT Area vegetation stockpiles and disposed of during this reporting period, as discussed in Section 3.3. A trunk section from tree 16220, which fell during the previous reporting period (Appendix C, photo 184), was located on the west side of the west perimeter fence during the October 14, 2025, site inspection. On December 4, 2025, DOE moved the trunk section from this location (Appendix C, photo 414) and placed it in a staging area in the southwest corner of the SWT Area (Appendix C, photo 410) pending sampling and analysis for disposal in accordance with the SMP (See Appendix F Table F1).

December 4, 2025, View East of Vegetation and Soil Stockpiled near the Southeast Corner of the SWT Area with Tree 16220 Trunk Section and DSS3 Tree limbs added to Stockpile (Photo No. 410)

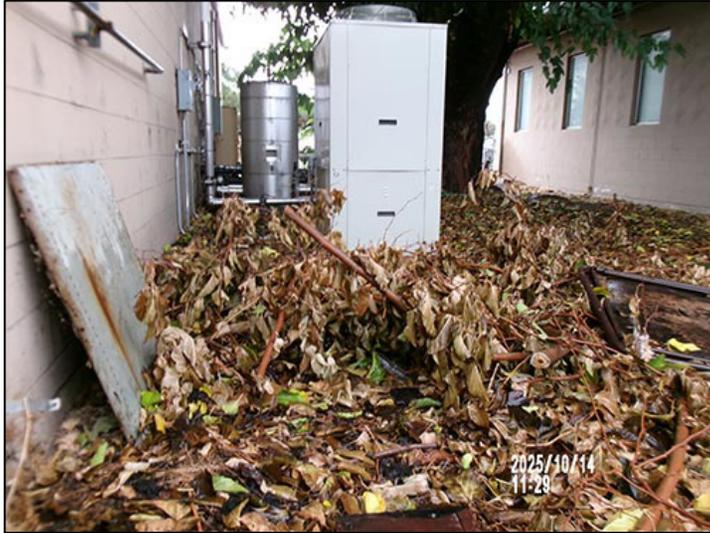
On October 14, 2025, a small quantity of tree limbs and debris was observed to remain in the east end of the septic tank part of the DSS 3 Area (Appendix C, photo 114) and is assumed to be associated with the trimming of lower limbs of tree 16211. On December 4, 2025, DOE removed the small quantity of tree limbs from the DSS 3 Area (Appendix C, photo 419) and placed them in the staging area in the southwest corner of the SWT Area (Appendix C, photo 410). These tree limbs and debris will be managed in accordance with the SMP.

October 14, 2025, View South of Cut Tree Limbs and Debris in East End of Septic Tank Part of DSS 3 Area: Building H-216, Left; Building H-215, Right (Photo No. 114)

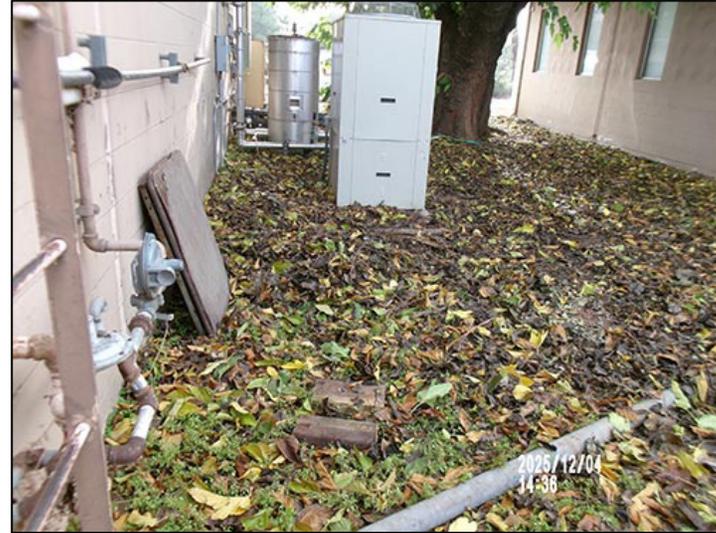
December 4, 2025, View South of Removed Tree Limbs and Remaining Debris in East End of Septic Tank Part of DSS 3 Area: Building H-216, Left; Building H-215, Right (Photo No. 419)

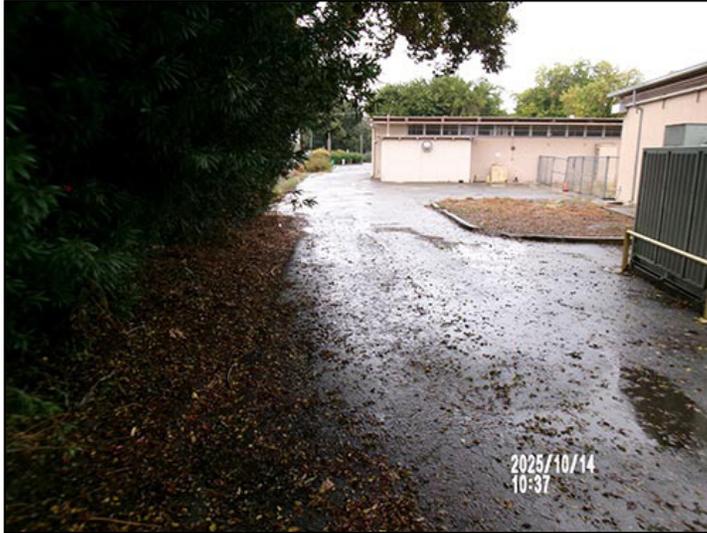
View North of Middle Portion of Ra/Sr Treatment Systems Area: Building Cooling Unit and Building H-218 Roof Line, Top Right; Building H-219 in Background (Photo No. 71)

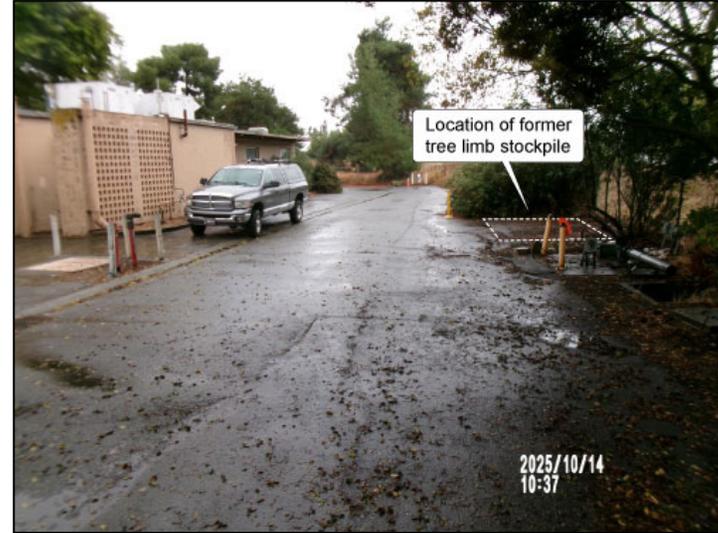
View South of Southern Portion of Ra/Sr Treatment Systems Area: Building H-215, Left; Location of Removed Tree Limb Stockpile, Right (Photo No. 72)

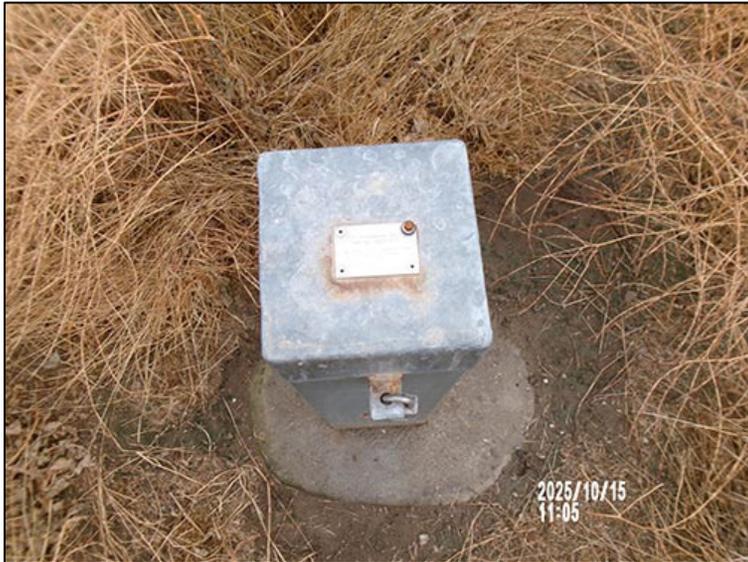
UCD1-063 Wellhead (Photo No. 333)

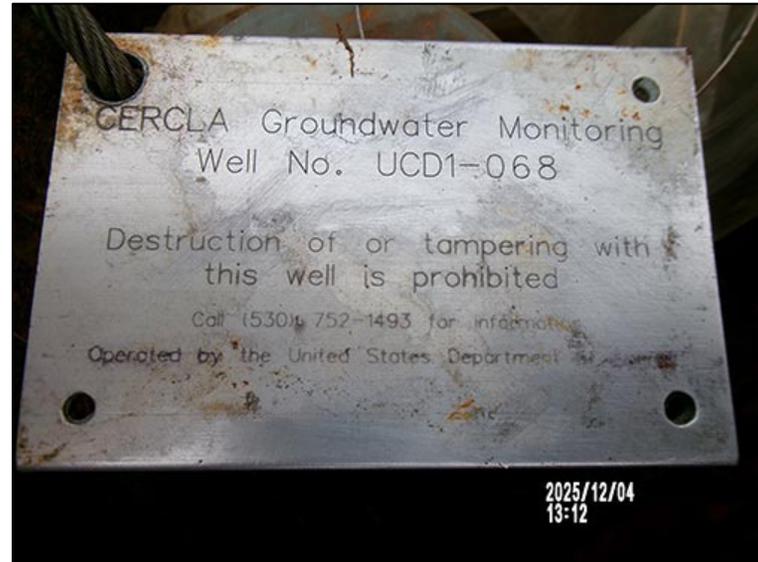
UCD1-068 Interior ID Plate (Photo No. 399)

Well UCD1-068: Inner vault ID plate is becoming illegible	10/15/2025	Repair completed: Cleaned ID plate	12/4/2025	399
Well UCD1-069: Inner vault ID plate is becoming illegible	10/15/2025	Repair completed: Replaced ID plate	12/4/2025	387
Well UCD1-069: Inner vault ID plate cable is wearing out	10/15/2025	Repair planned: Repair or install new ID plate cable	TBD	NA
Well UCD1-069: Vault lid gasket not sealing	10/15/2025	Repair planned: Install new vault lid gasket	TBD	NA

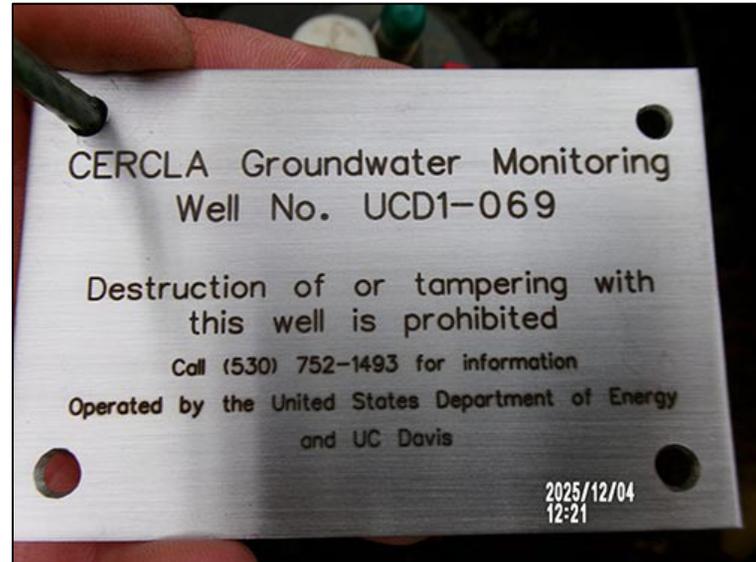
UCD1-069 Interior ID Plate (Photo No. 387)

Photo F-13. Well UCD1-069: Inner Vault ID Plate Replaced (Photo No. 0387)

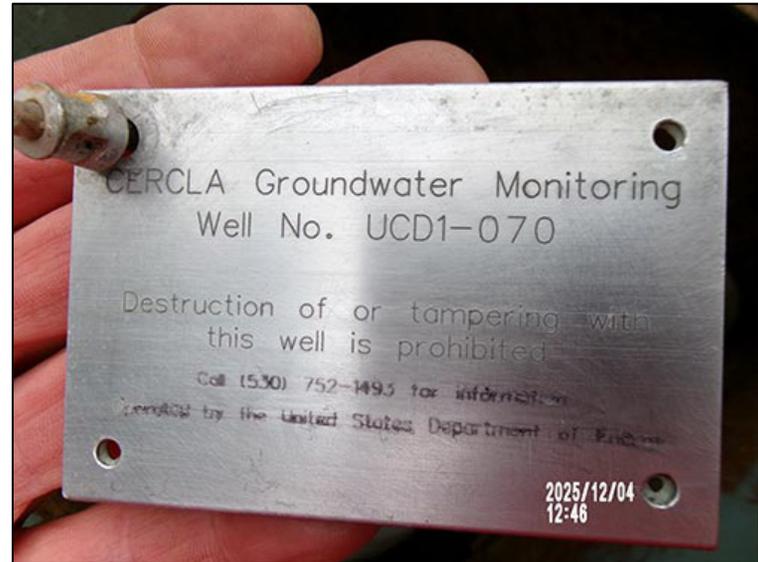
UCD1-070 Interior ID Plate (Photo No. 390)

Maintenance Item	Date Identified	Description of Completed or Planned Action	Date Completed	Completion Photo No.
Well UCD1-070: Inner vault ID plate is becoming illegible	10/15/2025	Repair completed: Cleaned ID plate	12/4/2025	390
Well UCD1-071: Vault lid ID plate is becoming illegible	10/15/2025	Repair completed: Cleaned ID plate	12/4/2025	403
Well UCD1-072: Vault lid gasket not sealing	10/15/2025	Repair planned: Install new vault lid gasket	TBD	NA
Shrubs 16203 and 16209: Tags inaccessible for photography due to new growth of shrubs	10/15/2025	Repair planned: Locate and move tags to accessible locations or install new tags	TBD	NA
Tree Tag 056: Tag difficult to access for photography due to new growth of lower tree limbs	10/15/2025, 12/4/2025	Repair planned: Move tag to accessible location	TBD	NA
New sapling over 6 feet in height found in Ra/Sr Treatment Systems Area	10/15/2025	Repair planned: Install tag on new sapling	TBD	NA
