## 4.0 Maybell West, Colorado, Disposal Site

### 4.1 Compliance Summary

Figure 4-1. 2024 Annual Inspection Drawing for the Maybell West, Colorado, Disposal Site

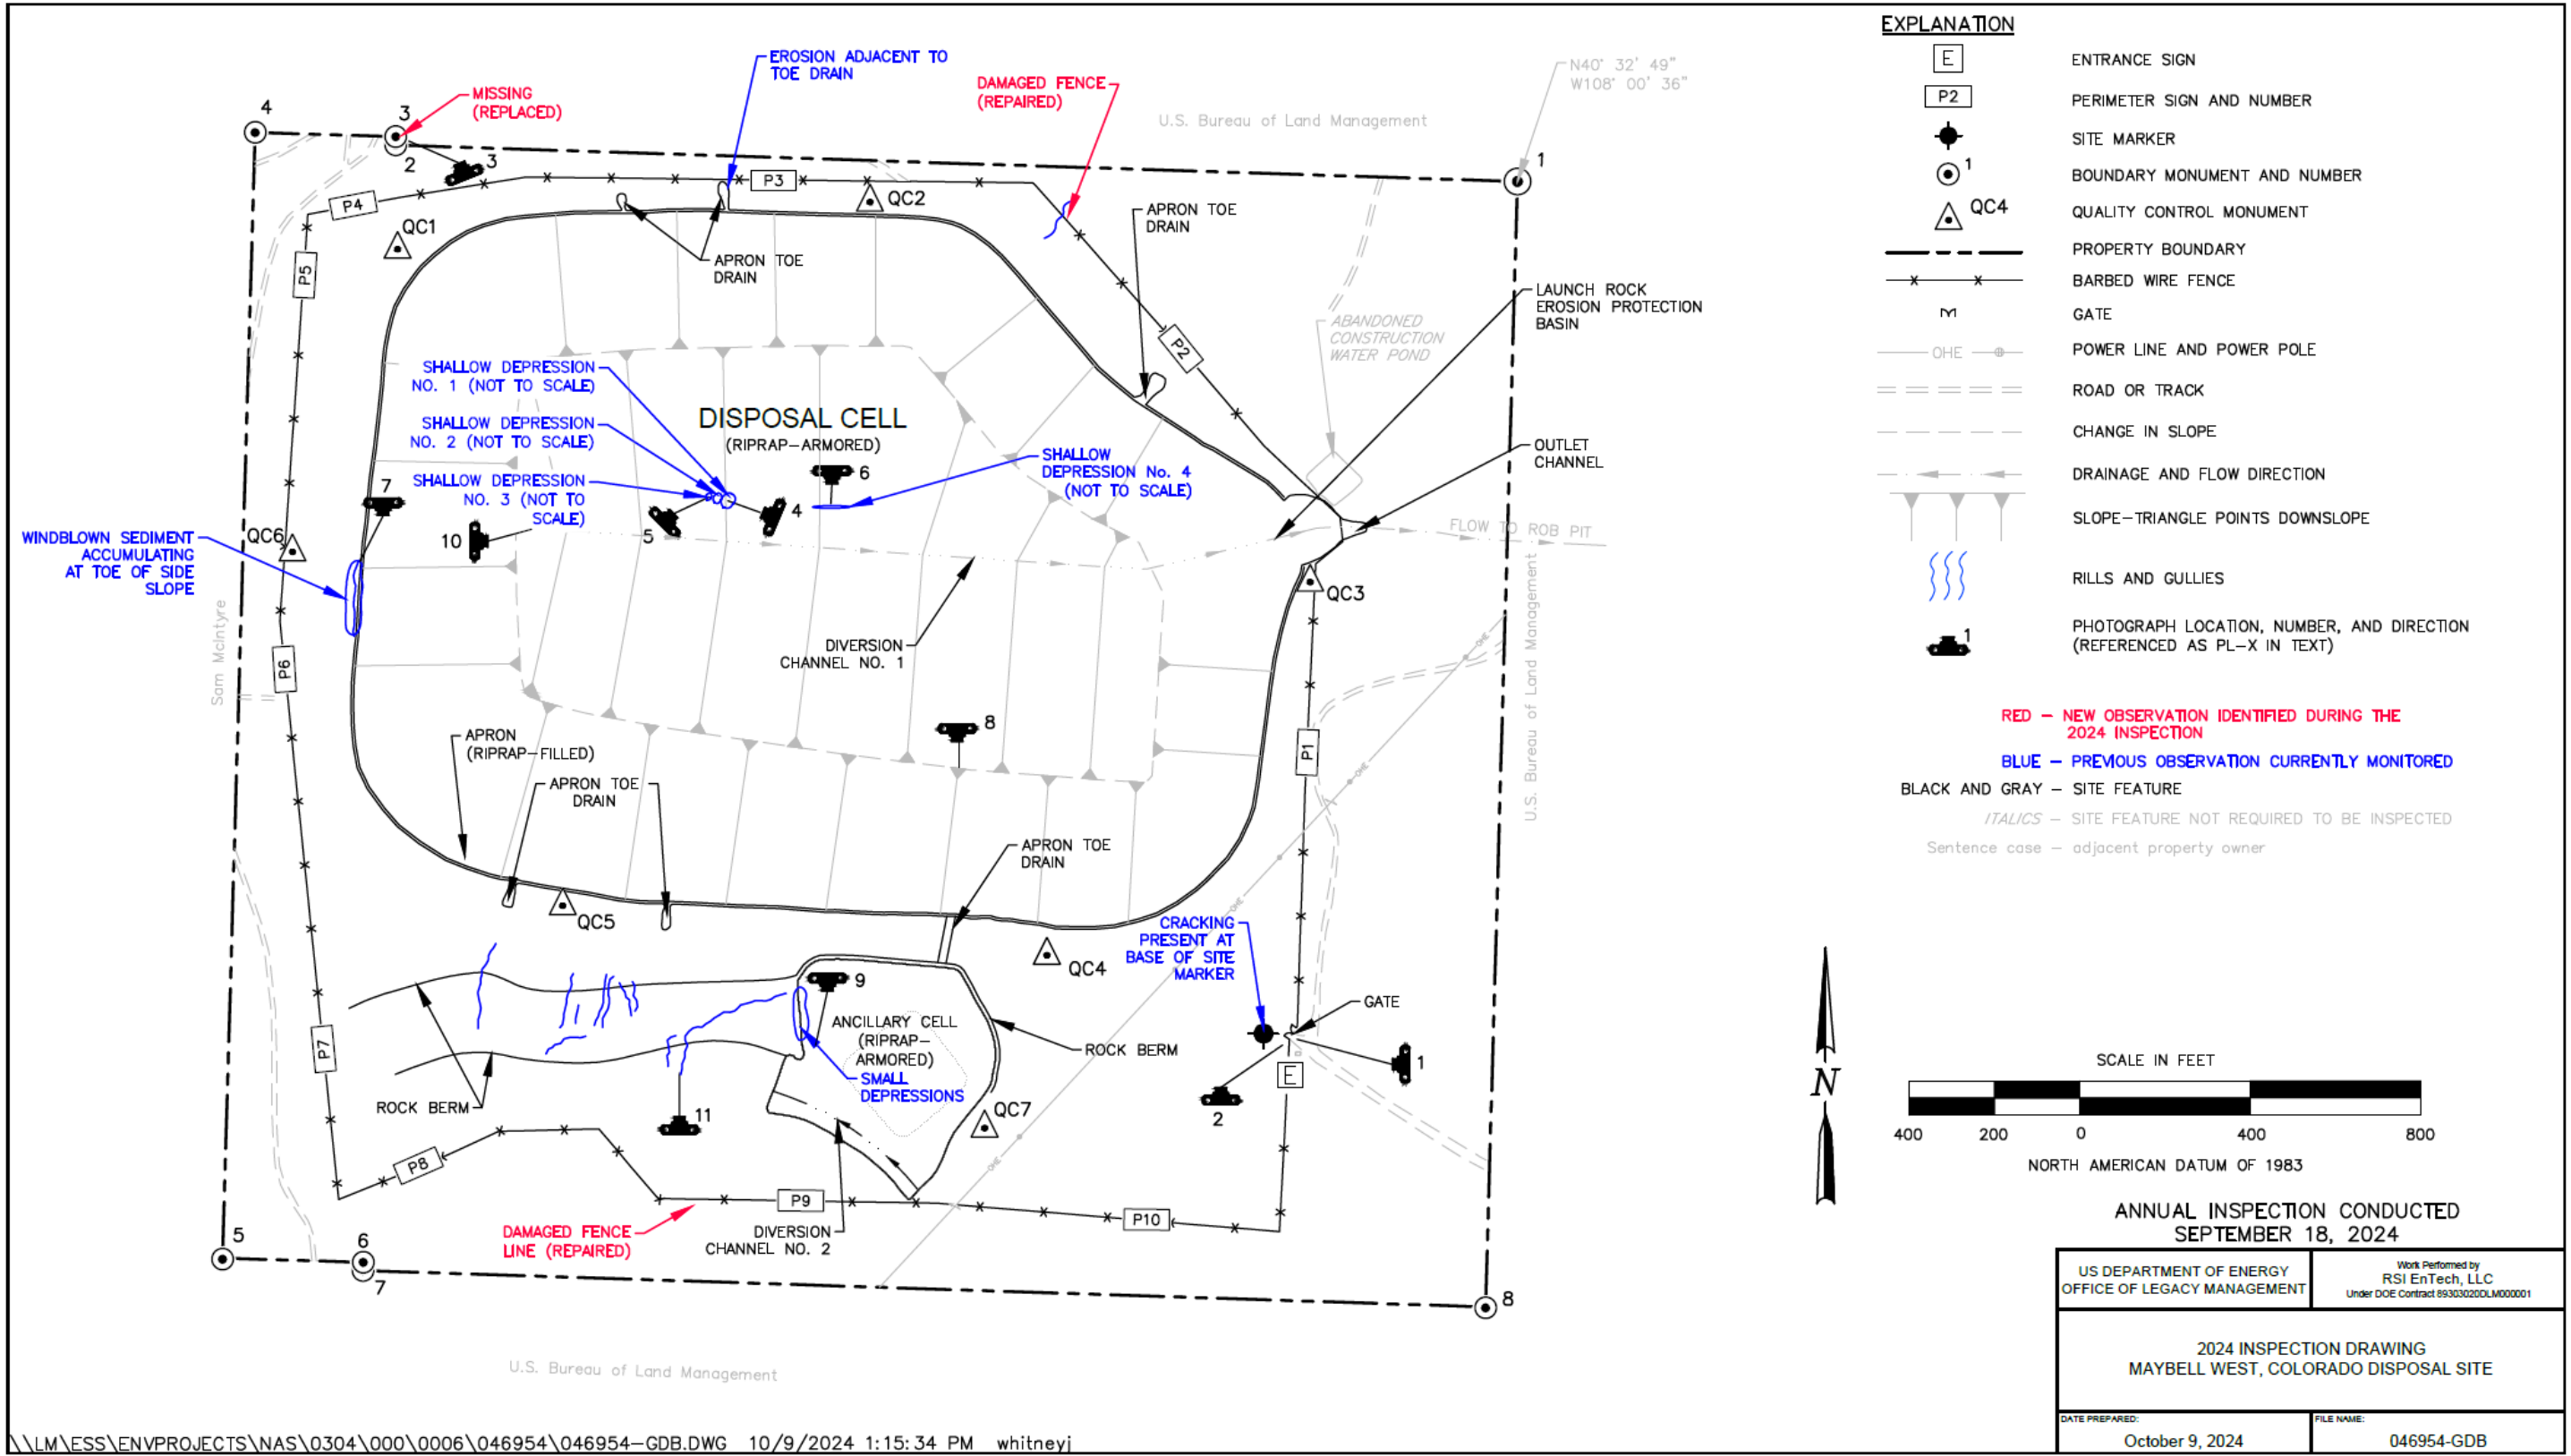
Figure 4-1 shows the locations of site features, including site surveillance features and inspection areas, in black and gray font. Some site features that are present but not required to be inspected are shown in italic font. Observations from previous inspections that are currently monitored are shown in blue, and new observations identified during the 2024 annual inspection are shown in red. Inspection results and recommended maintenance activities associated with site surveillance features are described in the following subsections. Photographs to support specific observations are noted in the text and in Figure 4-1 by photograph location (PL) numbers. The photographs and photograph log are presented in Section 4.9.
