Long-Term Surveillance Plan for the UMTRCA Title I Lakeview, Oregon, Disposal Site

January 2026

**U.S. DEPARTMENT OF
ENERGY**

Legacy
Management

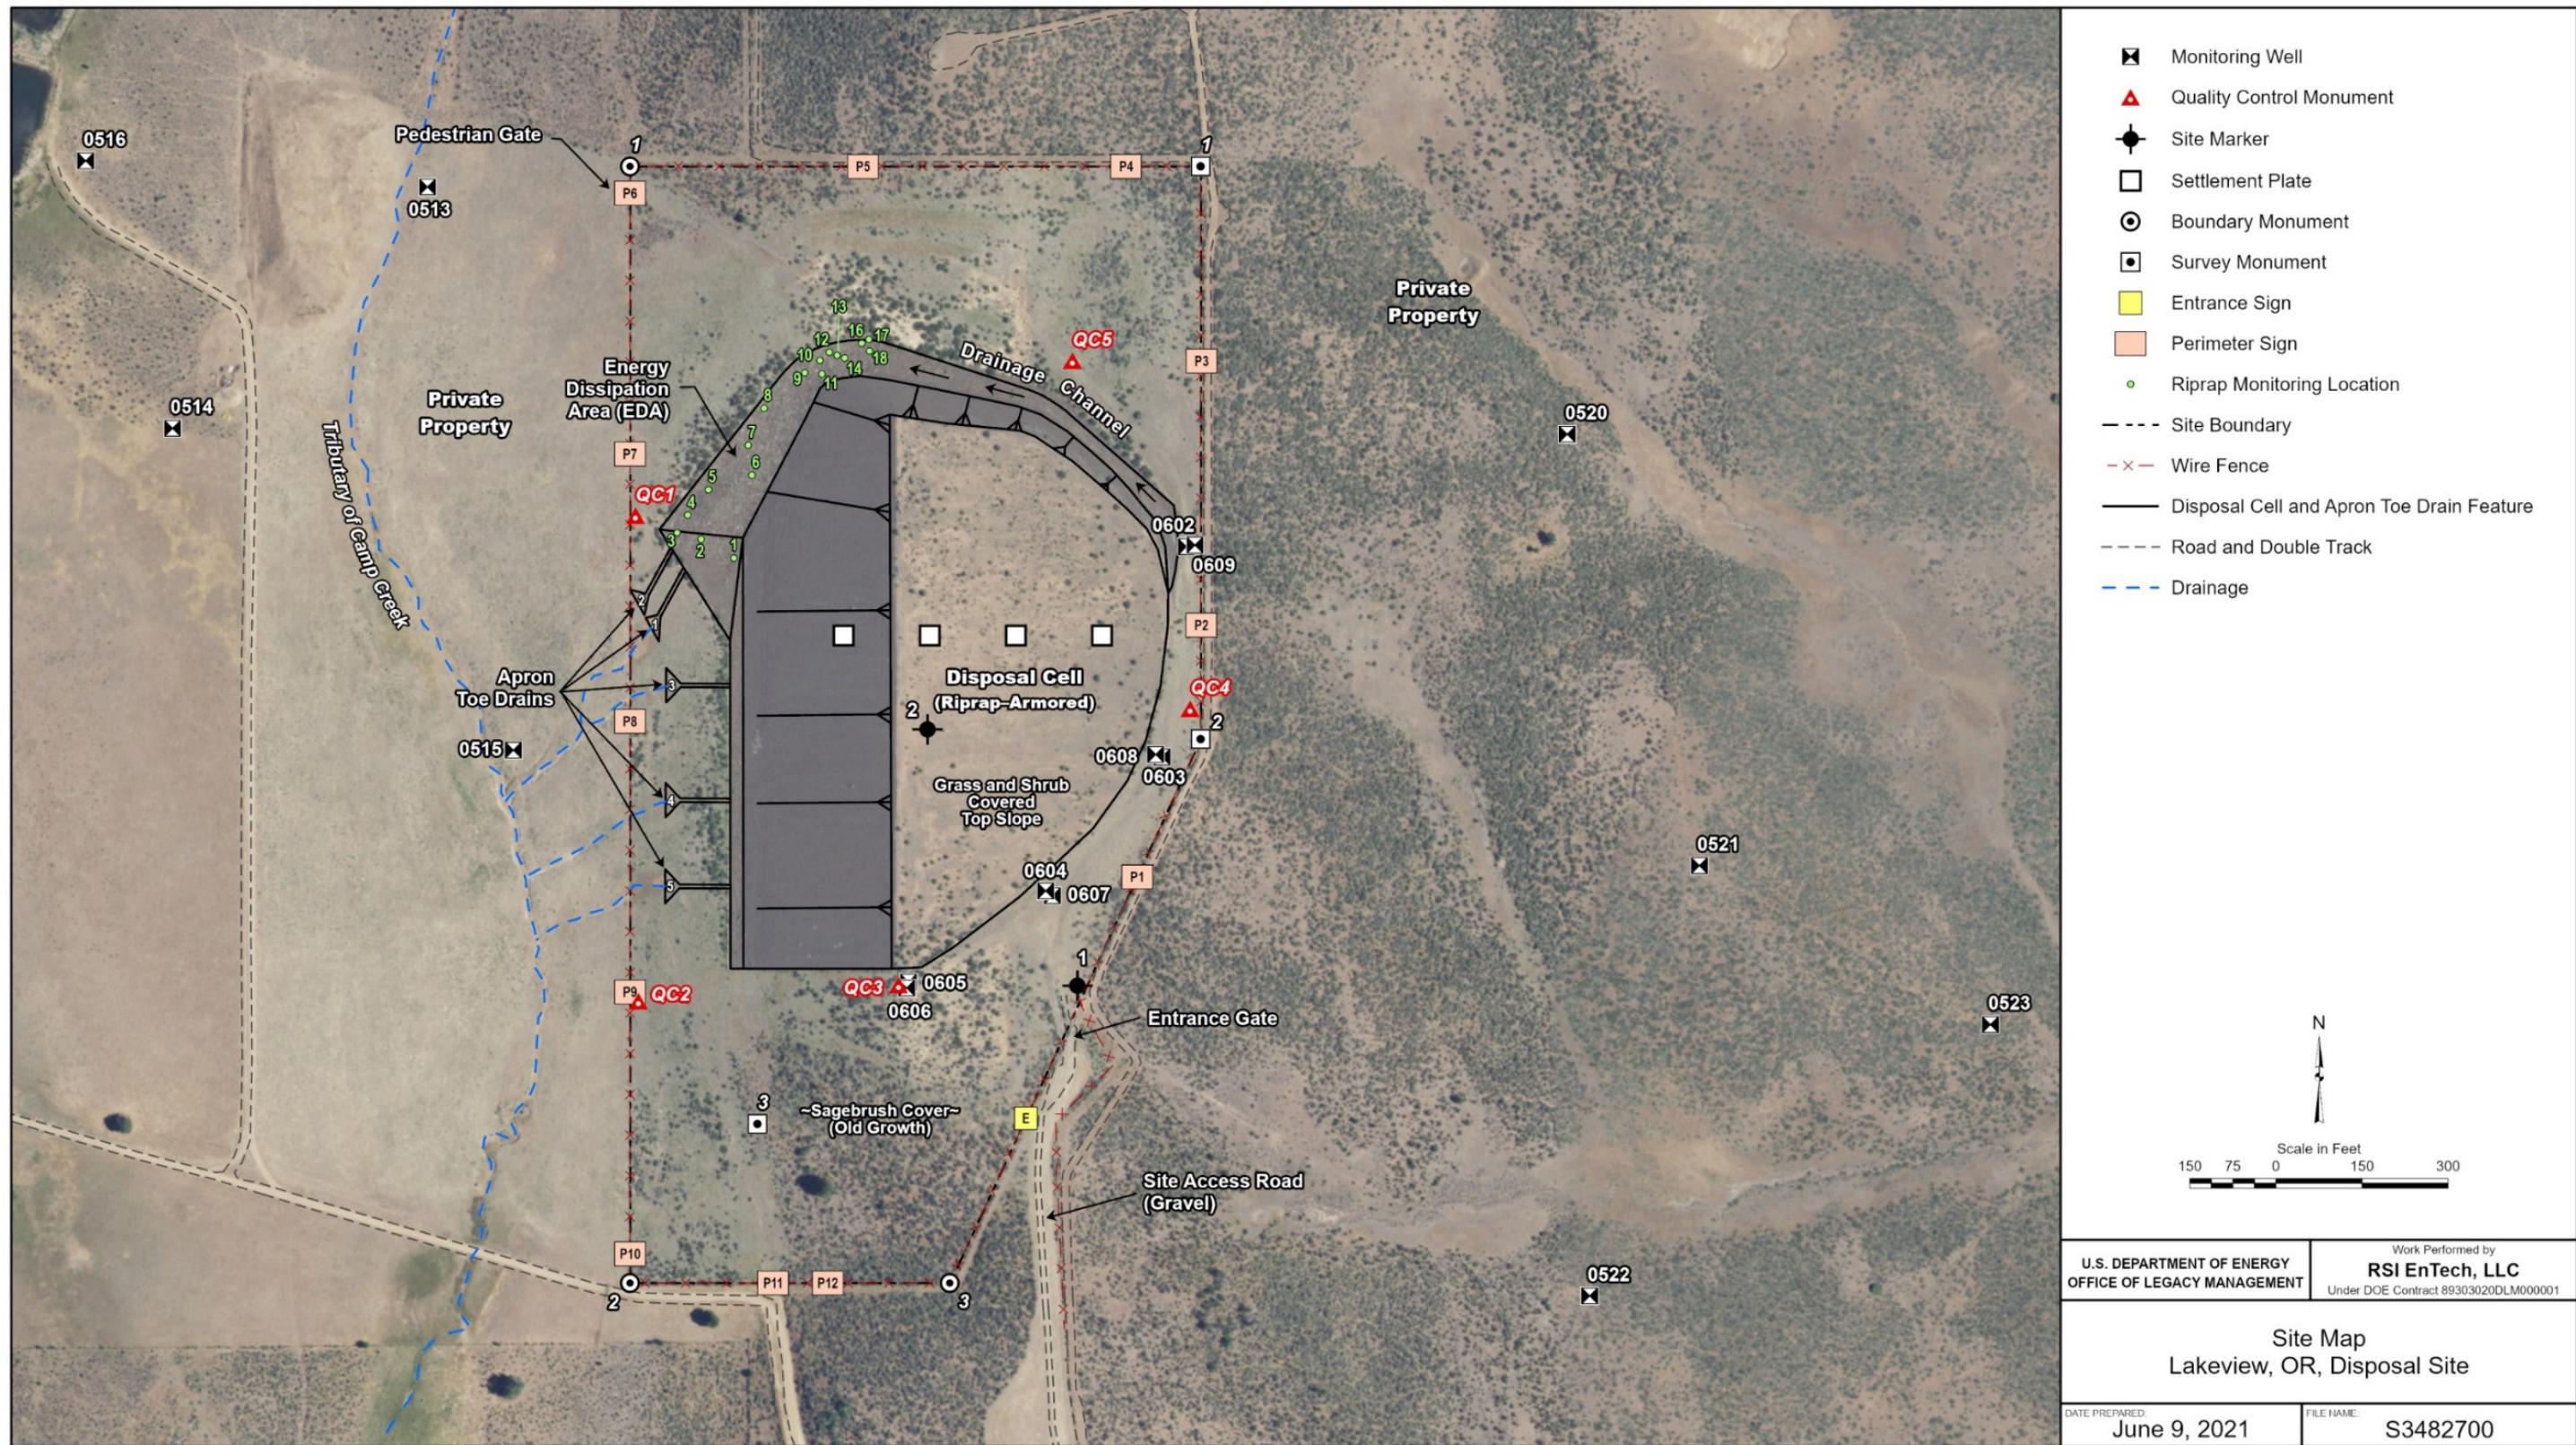
Figure 2. Site Map for Lakeview, Oregon, Disposal Site

Abbreviation: QC = quality control

Pursuant to Section 104 of UMTRCA, the State of Oregon acquired the site from a private interest through a civil action suit. This acquisition provided a 40-acre site and perpetual access to the site across a private ranch from Lake County Road 2-16B. The legal description of the site and a brief history of the acquisition are in Appendix A. The site boundary is shown in Figure 2.

Monitoring, as established by the initial LTSP (DOE 1994), will be every 5 years at one upgradient and eight downgradient monitoring wells (Table 4; Figure 2). The downgradient wells are approximately 50 ft downgradient from the edge of the disposal cell to provide early detection should the disposal cell no longer perform as an effective containment system. The downgradient wells are in four pairs. In each pair, one well is screened at shallow depth (approximately 100 ft) and one deeper (approximately 150 ft). Upgradient well MW-0515 is screened at approximately 100 ft and is used as a reference and to detect changes in regional (upgradient) groundwater chemistry.

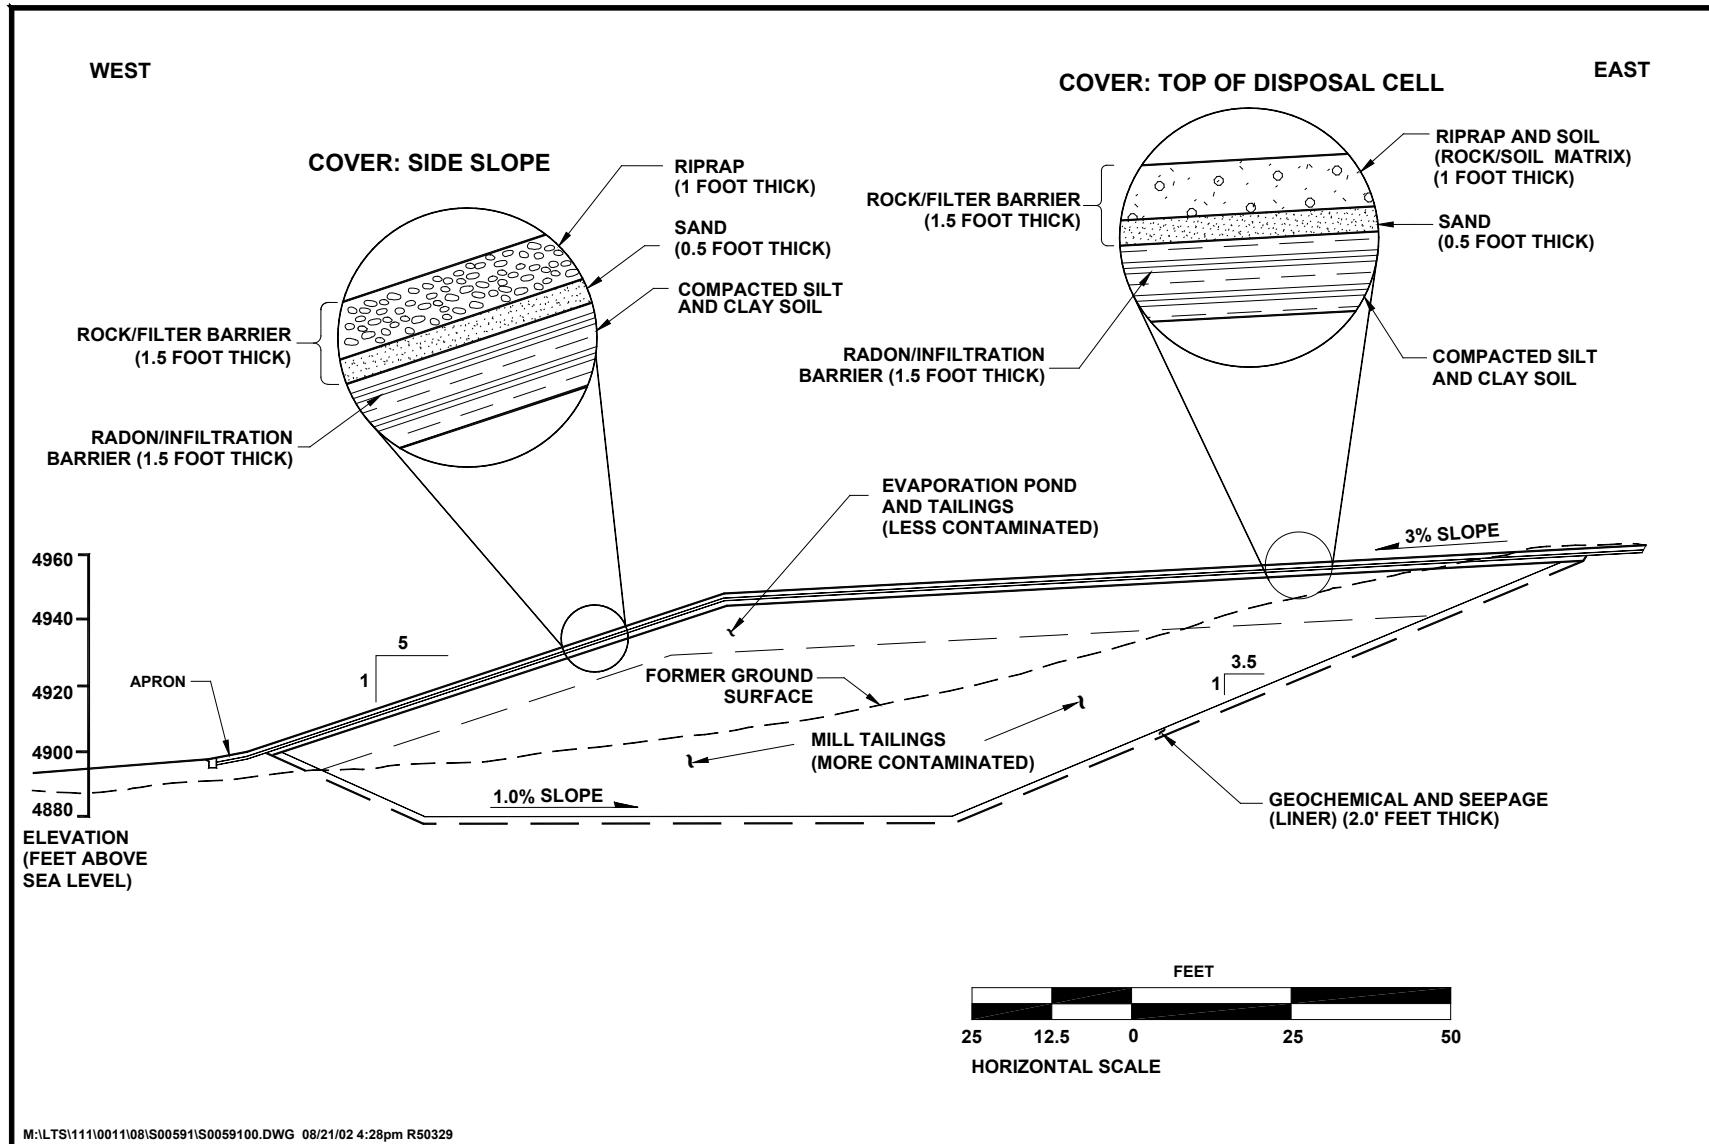
Figure 3. Cross Section of the Lakeview, Oregon, Disposal Cell

As stated above, the disposal cell is partly below grade (Figure 3). During construction, a footprint as much as 40 ft deep was excavated in the side of the hill to increase the capacity of the disposal cell and to reduce the above-grade profile of the cell.

The cover consists of two layers: a lower radon-and-infiltration barrier and an upper rock-and-filter layer. The rock-and-filter layer is composed of two sublayers: sand at the bottom and riprap at the top.

The lowest layer in the cover is a highly compacted radon-and-infiltration barrier (radon barrier). It rests directly on the underlying tailings. The radon barrier is approximately 1.5 ft thick and constructed of the same natural silt and clay soils used for the footprint liner.

Like the liner, the radon barrier was compacted to achieve a hydraulic conductivity of less than 1×10^{-7} cm/s. The purpose of this very low permeability is (1) to prevent the release of high levels of radon to the atmosphere (radon flux) and (2) to prevent the infiltration of precipitation through the cover. The tight compaction also helps to keep the radon barrier from drying out. Moisture in the radon barrier further retards the movement of radon through the cover. Within the disposal cell, less contaminated materials from the evaporation ponds and windblown deposits were placed over the more contaminated mill tailings as an additional control on upward movement of radon.

The radon barrier is overlain and protected by a 1.5-foot-thick rock-and-filter layer. At the bottom of the rock-and-filter layer is a sublayer of 0.5-foot-thick sand (filter layer). This highly permeable layer protects the radon barrier from erosion and provides a means of shedding runoff rapidly from the disposal cell with minimal infiltration.

Above the sandy filter layer is a 1-foot-thick layer of coarse riprap. The riprap prevents erosion from large or severe storms. The mean diameter (D_{50}) of the riprap, as installed, was 2.7 inches (range: 2.7 to 3.9 inches). D_{50} is a measure such that 50% of the rock by weight is a certain size or larger. Rock of this size was calculated to be sufficient to prevent erosion in the event of a flood from a probable maximum precipitation (PMP) event. PMP is a theoretically “worst possible” storm. As such, the probability of occurrence is extremely small. Since the disposal cell was completed in 1989, surficial weathering has caused some of the riprap to break. For the response to this issue, see Sections 3.3.2 and 3.6.

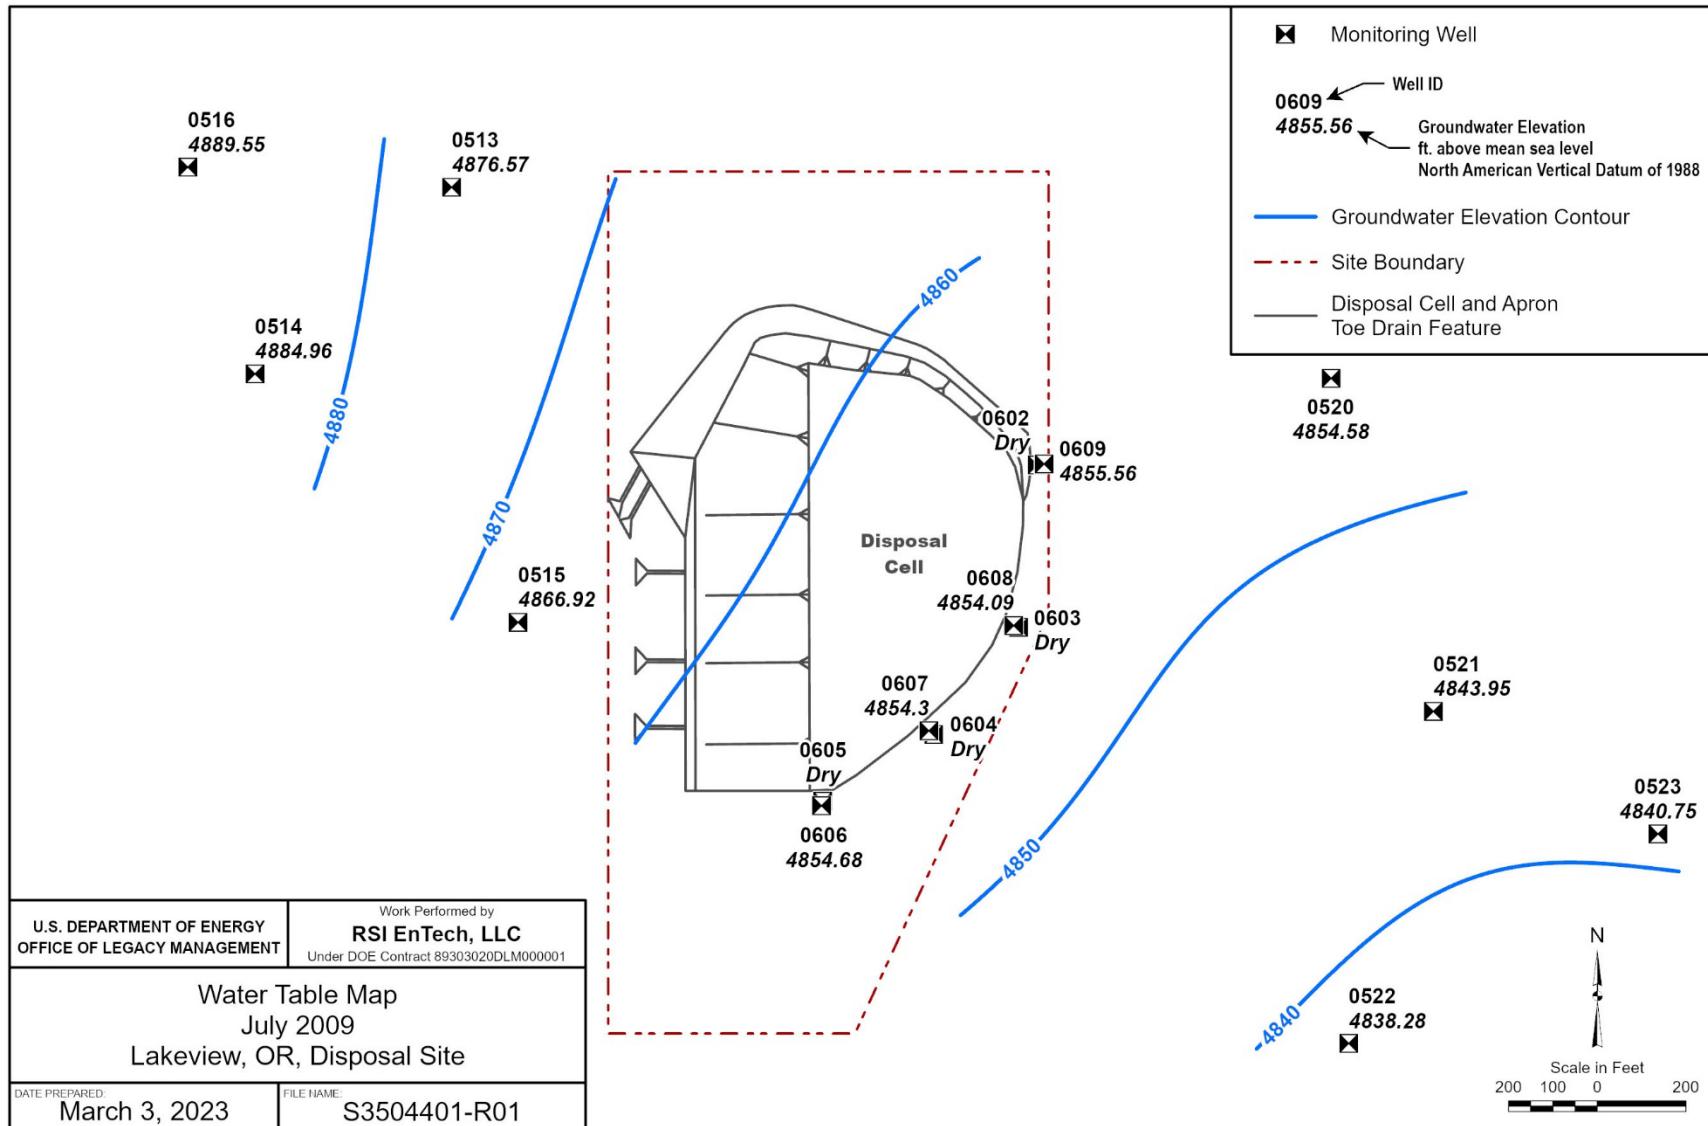
Figure 4. Water Table Map, Lakeview, Oregon, Disposal Site, July 2009

Data from the July 2009 sampling event show that groundwater flows from northwest to southeast under unconfined to semiconfined conditions (Figure 4). Groundwater recharge is primarily regional with little or no recharge through soils or unsaturated sediments near the site, although Camp Creek undoubtedly loses some water that may reach the unconfined aquifer. Recharge occurs along silty or sandy layers, on or between clay-rich layers.

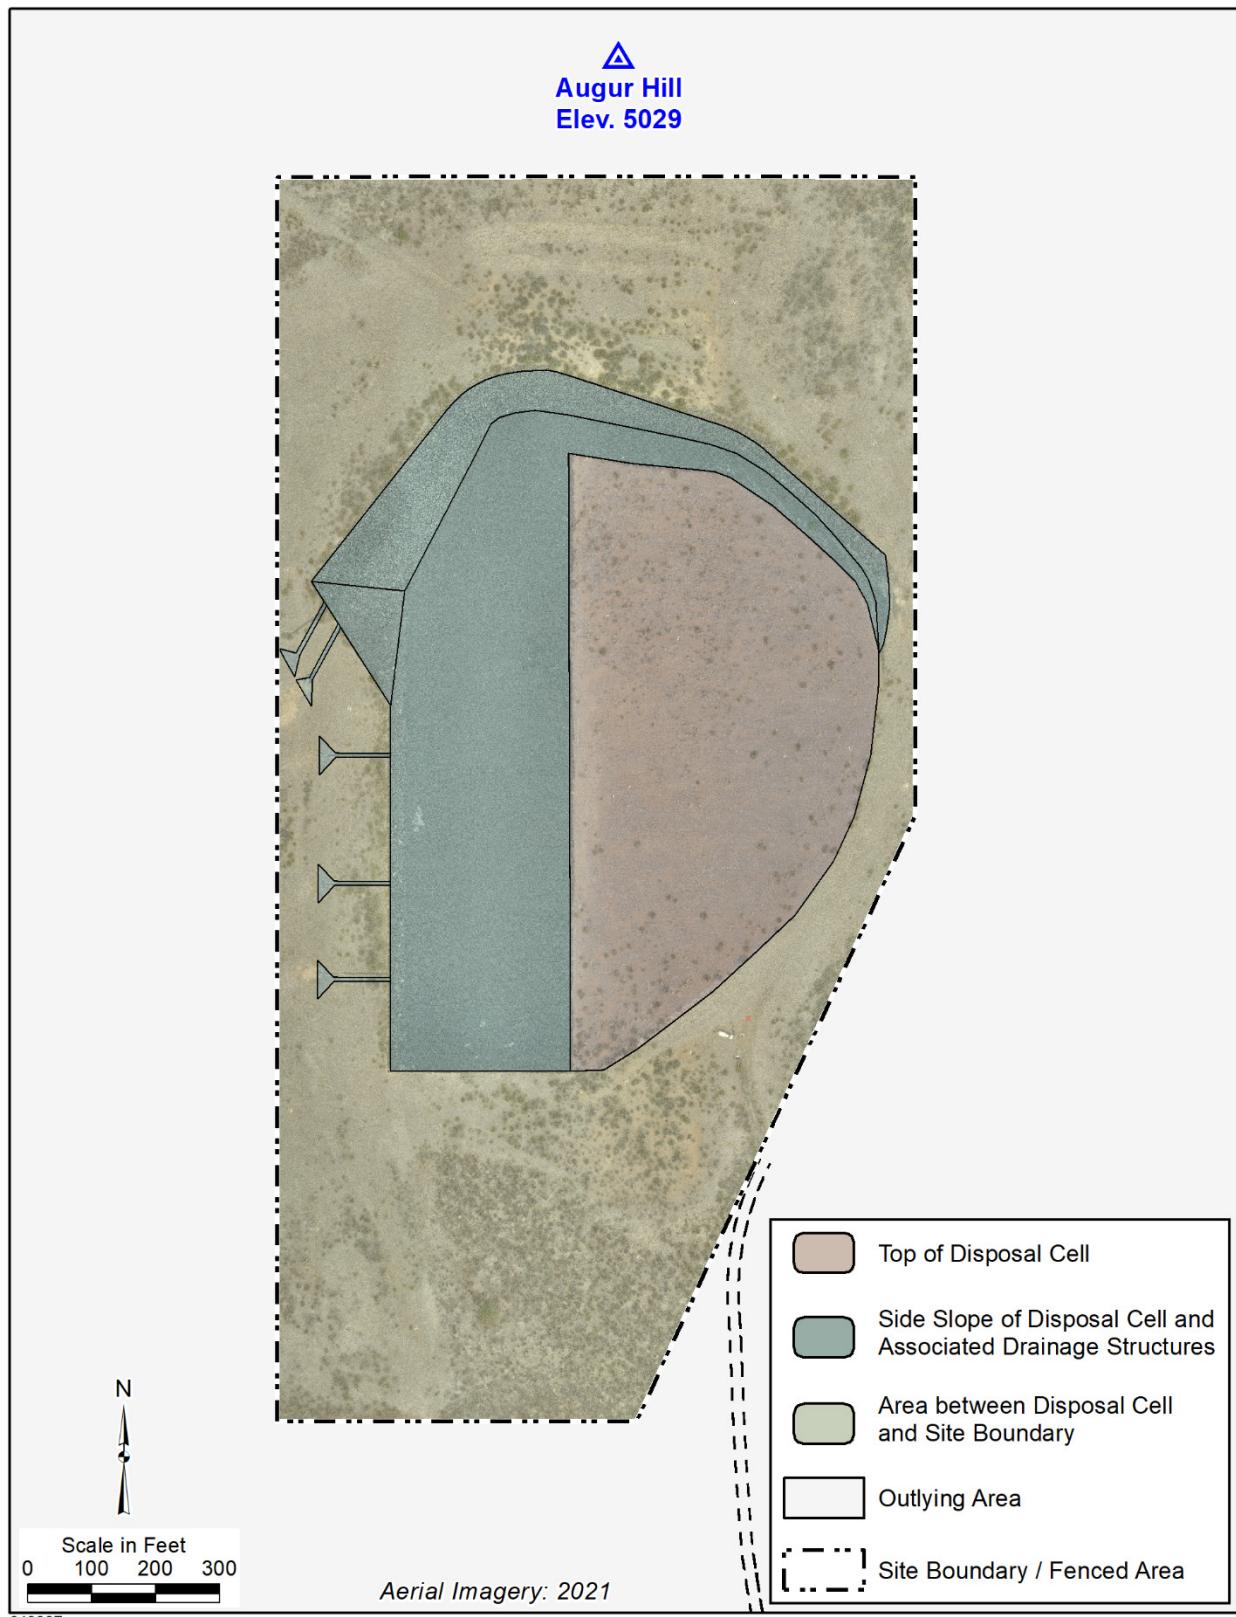
Figure 5. Inspection Areas Used During Inspection of the Lakeview, Oregon, Disposal Site

For the purpose of the inspection, the site will be divided into four different inspection areas. Inspection areas are inspected by walking or driving a series of unspecified transects across each area so the entire site is inspected (Figure 5). Within each area, inspectors examine specific site surveillance features, such as boundary monuments, signs, site markers, and other features listed on the inspection checklist (Appendix B). Table 2 lists the inspection areas for the site.

Abbreviation: Elev. = elevation
