Long-Term Surveillance and Maintenance Plan for the Boiling Nuclear Superheater (BONUS) Reactor Facility, Rincón, Puerto Rico

August 2023

Legacy
Management

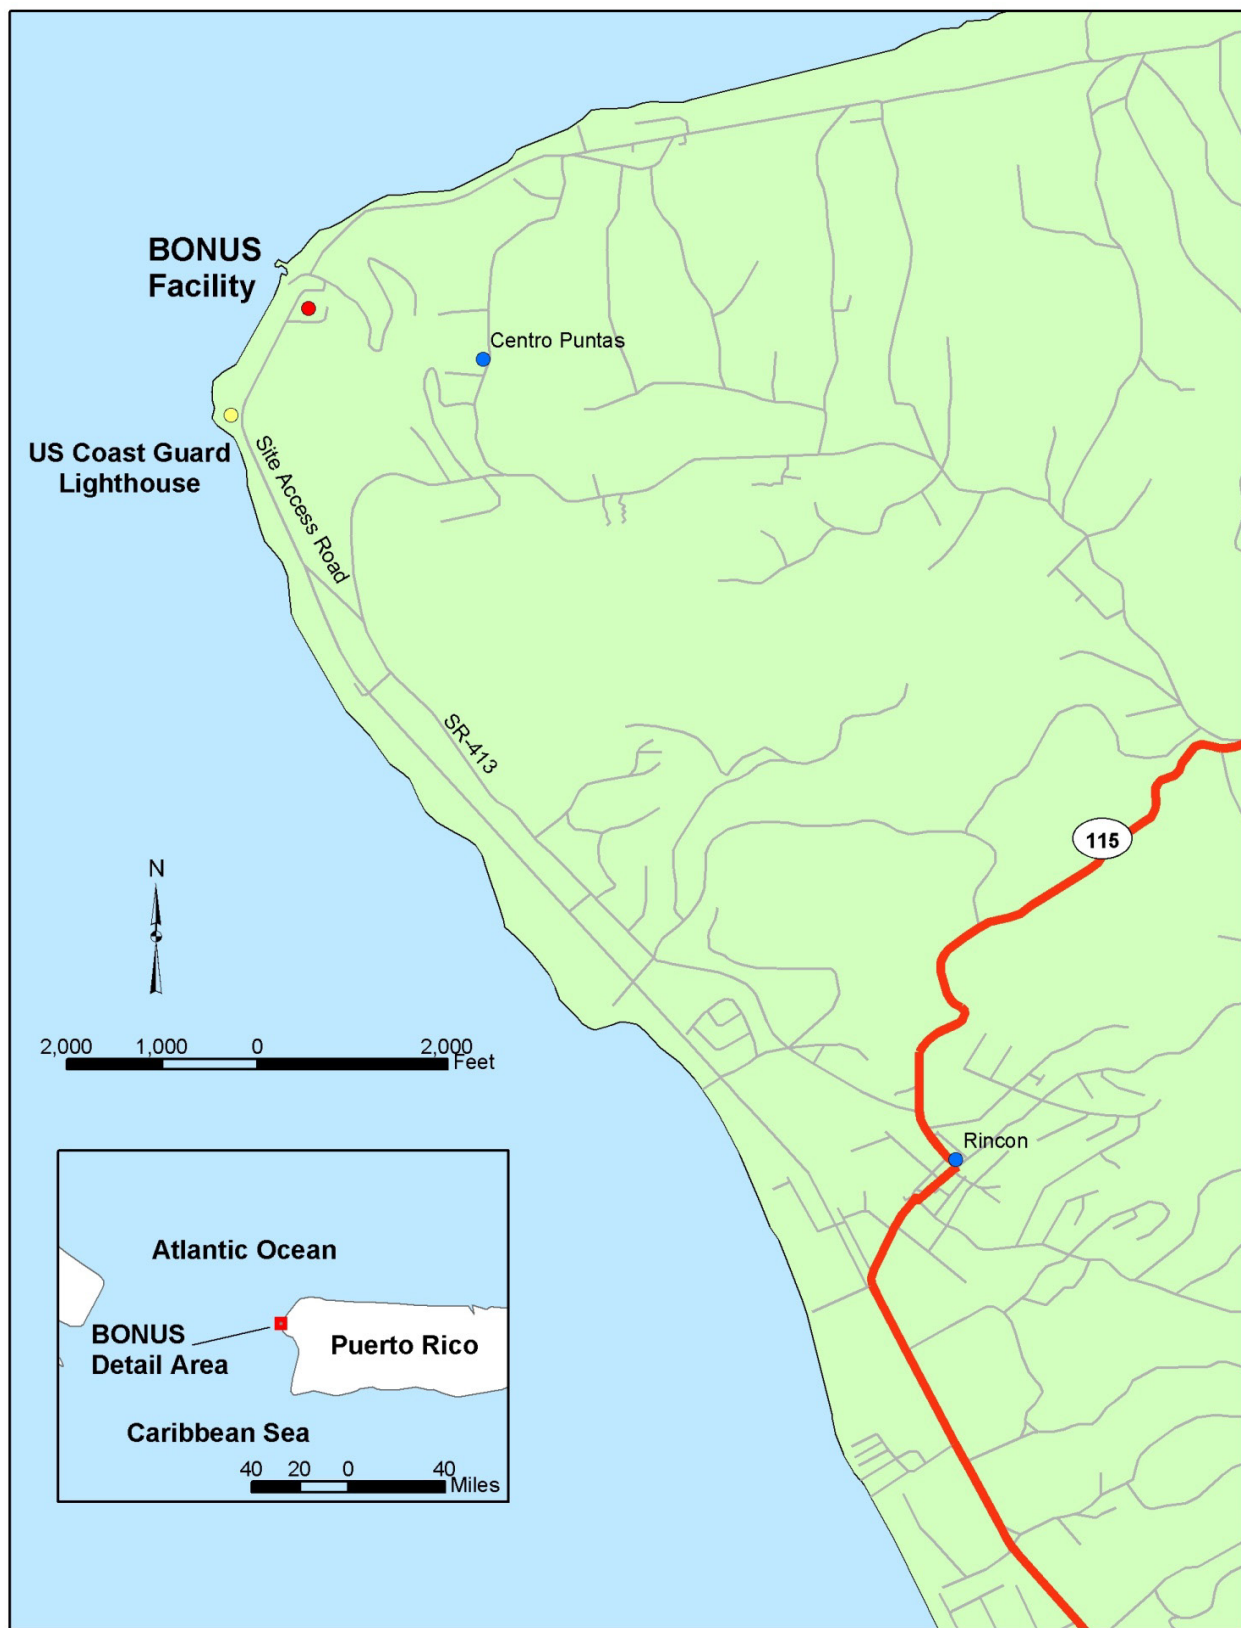
Figure 1. Location of the BONUS Facility, Rincón, Puerto Rico

The BONUS facility is on the westernmost coastal point (Punta Higuera) of Puerto Rico near a U.S. Coast Guard lighthouse (Figure 1). The facility lies within a 5-acre (2-hectare) fenced area surrounded by 137 acres (55 hectares) of undeveloped land primarily vegetated with brush, native pasture, and woodland. Formally known as the BONUS site (owned by PREPA), this area served primarily as a buffer zone when the plant was in operation. The chlorination plant, warehouses, and water tanks were also in this area. The 6-foot-high (1.8-meters [m]) chainlink security fence is topped with three strands of barbed wire.

Figure 1 shows the location of the site in relation to local features and roads. Access to the site is granted by PREPA. The contact for accessing the site is:
