# 1.0 Bluewater, New Mexico, Disposal Site

#### **1.1 Compliance Summary**

The Bluewater, New Mexico, Uranium Mill Tailings Radiation Control Act (UMTRCA) Title II Disposal Site was inspected on March 18–20, 2024. This inspection included the engineered disposal cells and the areas around the disposal cells. The monitoring well network and monitoring well access roads, perimeter road, and boundary monuments were inspected on May 7–9, August 22, and September 24, 2024, respectively. Minor settlements on the side slopes of the main tailings disposal cell, as well as settlements on the north portion of the top slope continue to be observed. No new areas of concern were identified during the inspection, and previously observed features of concern had no significant changes. Inspectors found no cause for a follow-up or contingency inspection.

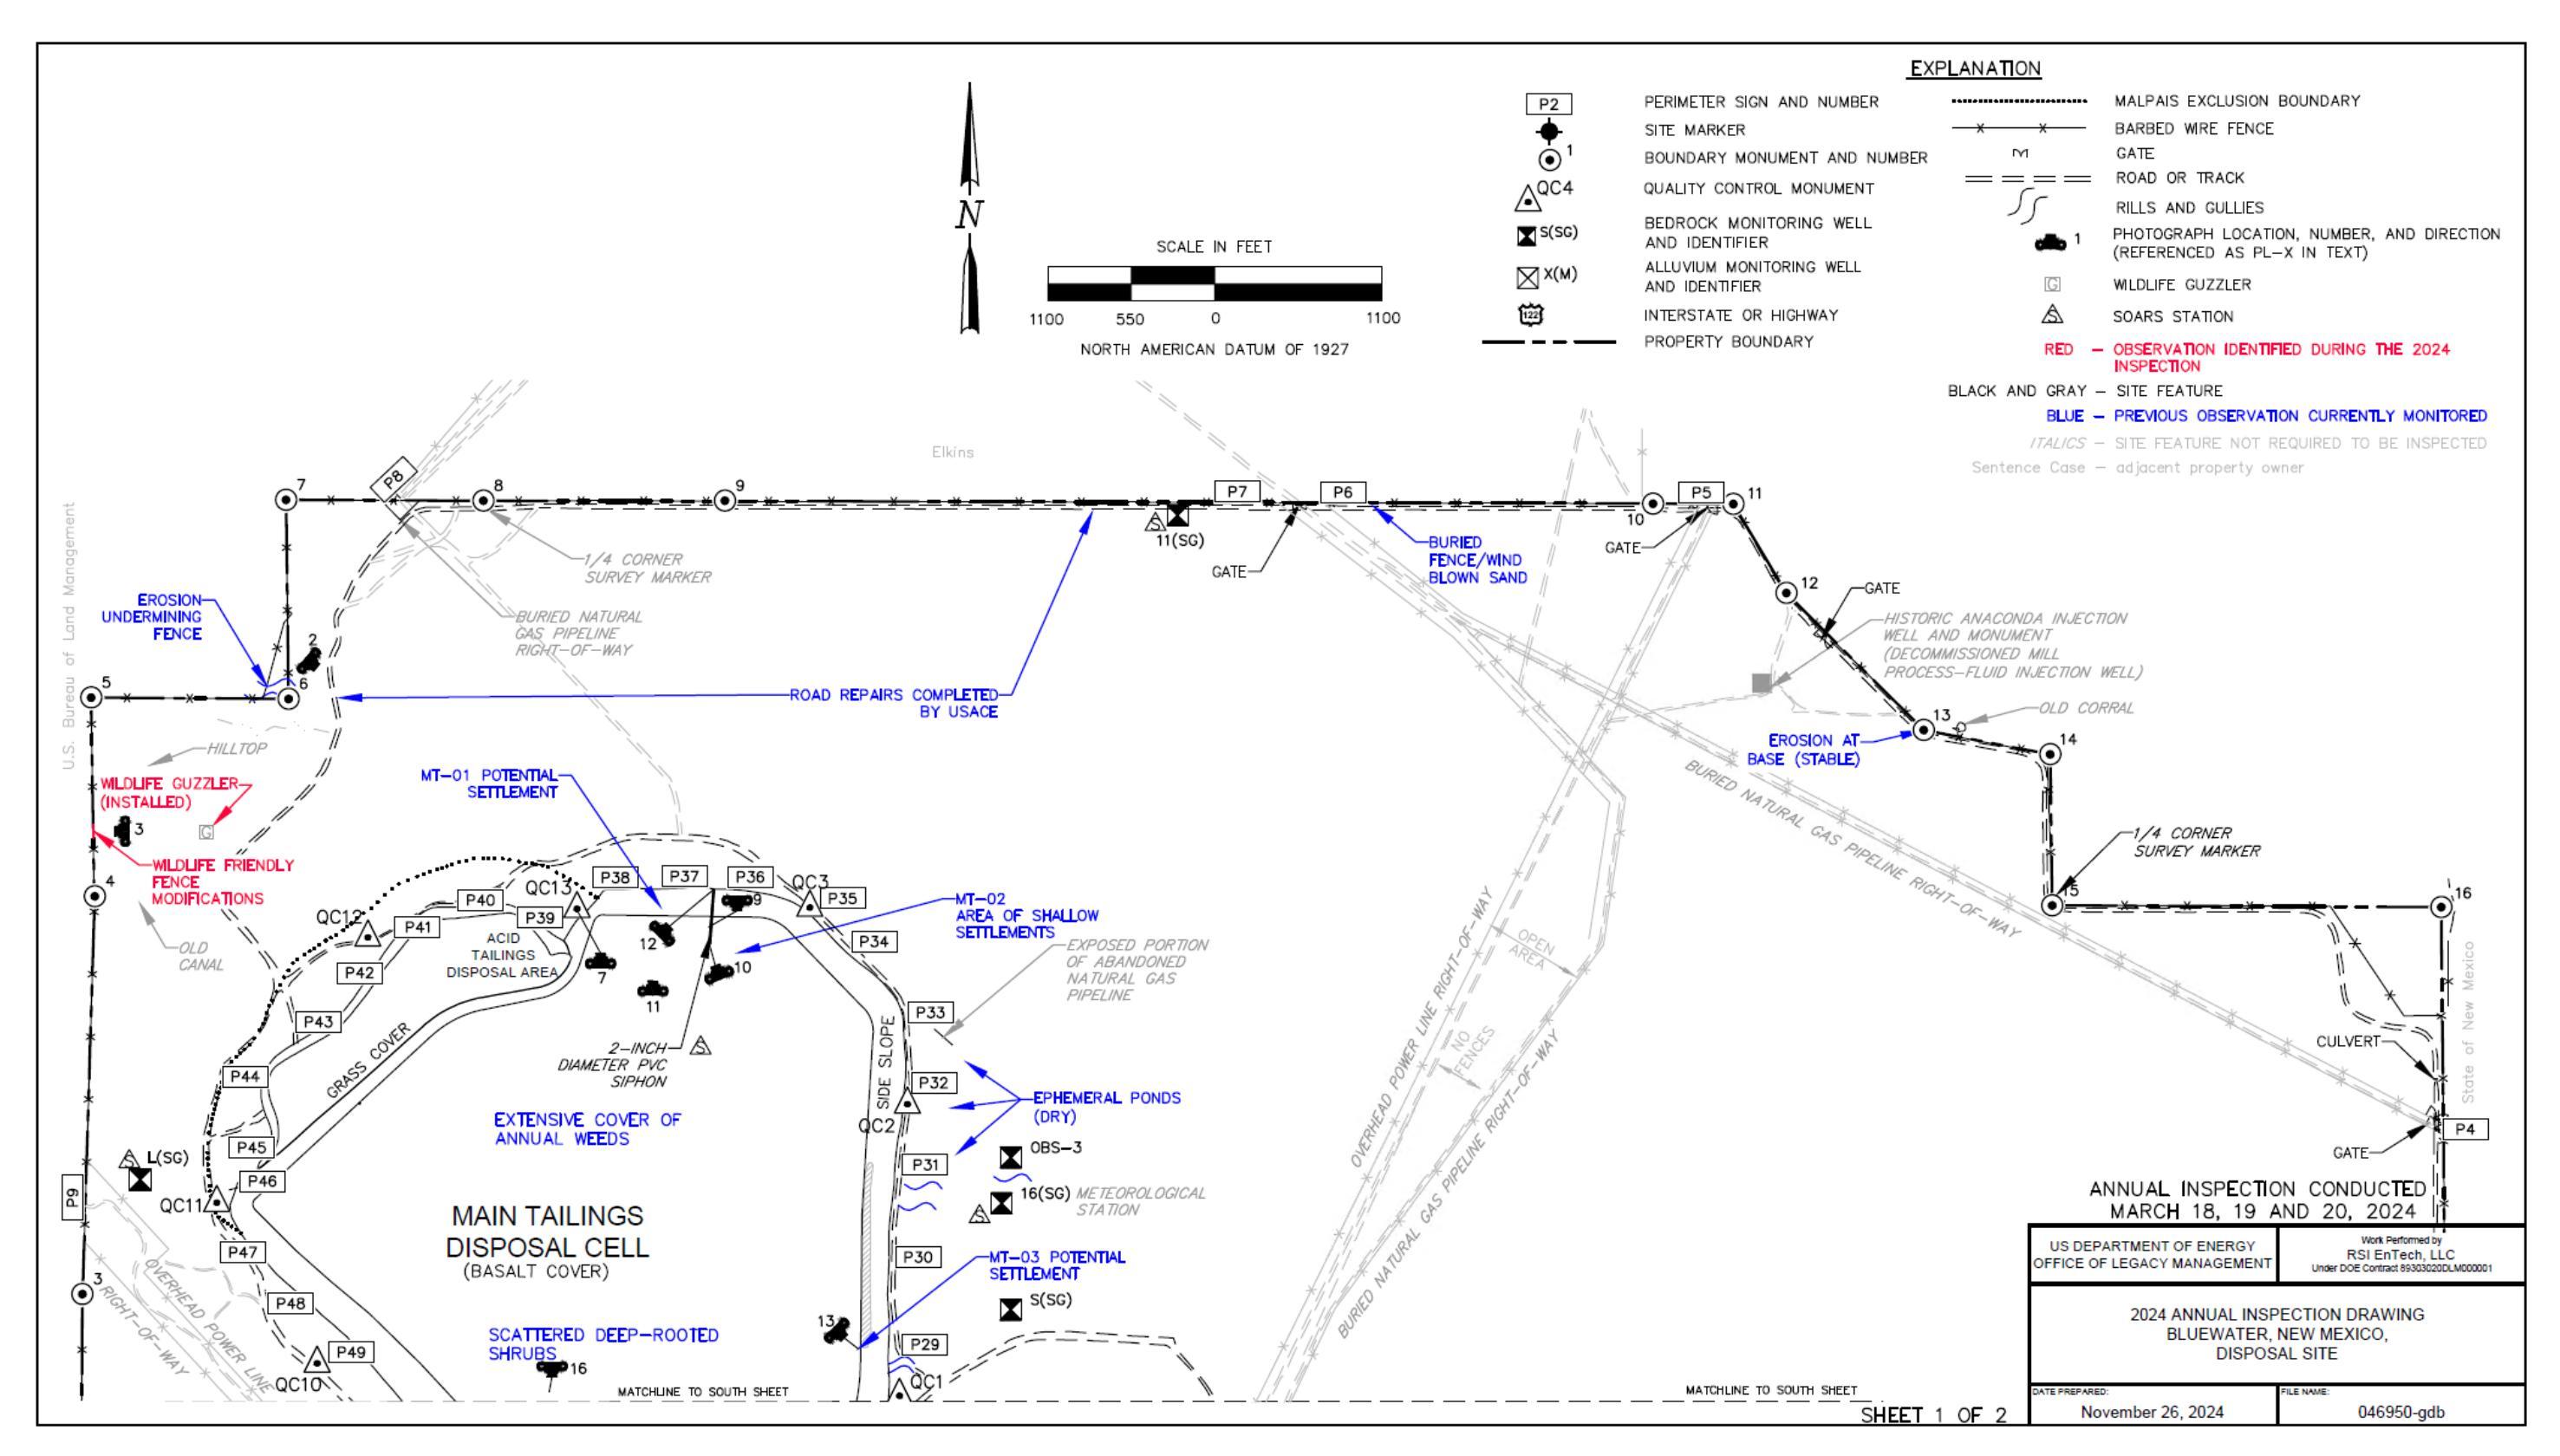
Figure 1-1. 2024 Annual Inspection Drawing for the Bluewater, New Mexico, Disposal Site (Northern Area)

Figure 1-1 and Figure 1-2 show the locations of site features, including site surveillance features and inspection areas, in black and gray font. Some site features that are present but not required to be inspected are shown in italic font. Observations from previous inspections that are currently monitored are shown in blue, and new observations identified during the 2024 annual inspection are shown in red. Inspection results and recommended maintenance activities associated with site surveillance features are described in the following subsections. Photographs to support specific observations are noted in the text and in Figure 1-1 and Figure 1-2 by photograph location (PL) numbers. The photographs and photograph log are presented in Section 1.9.

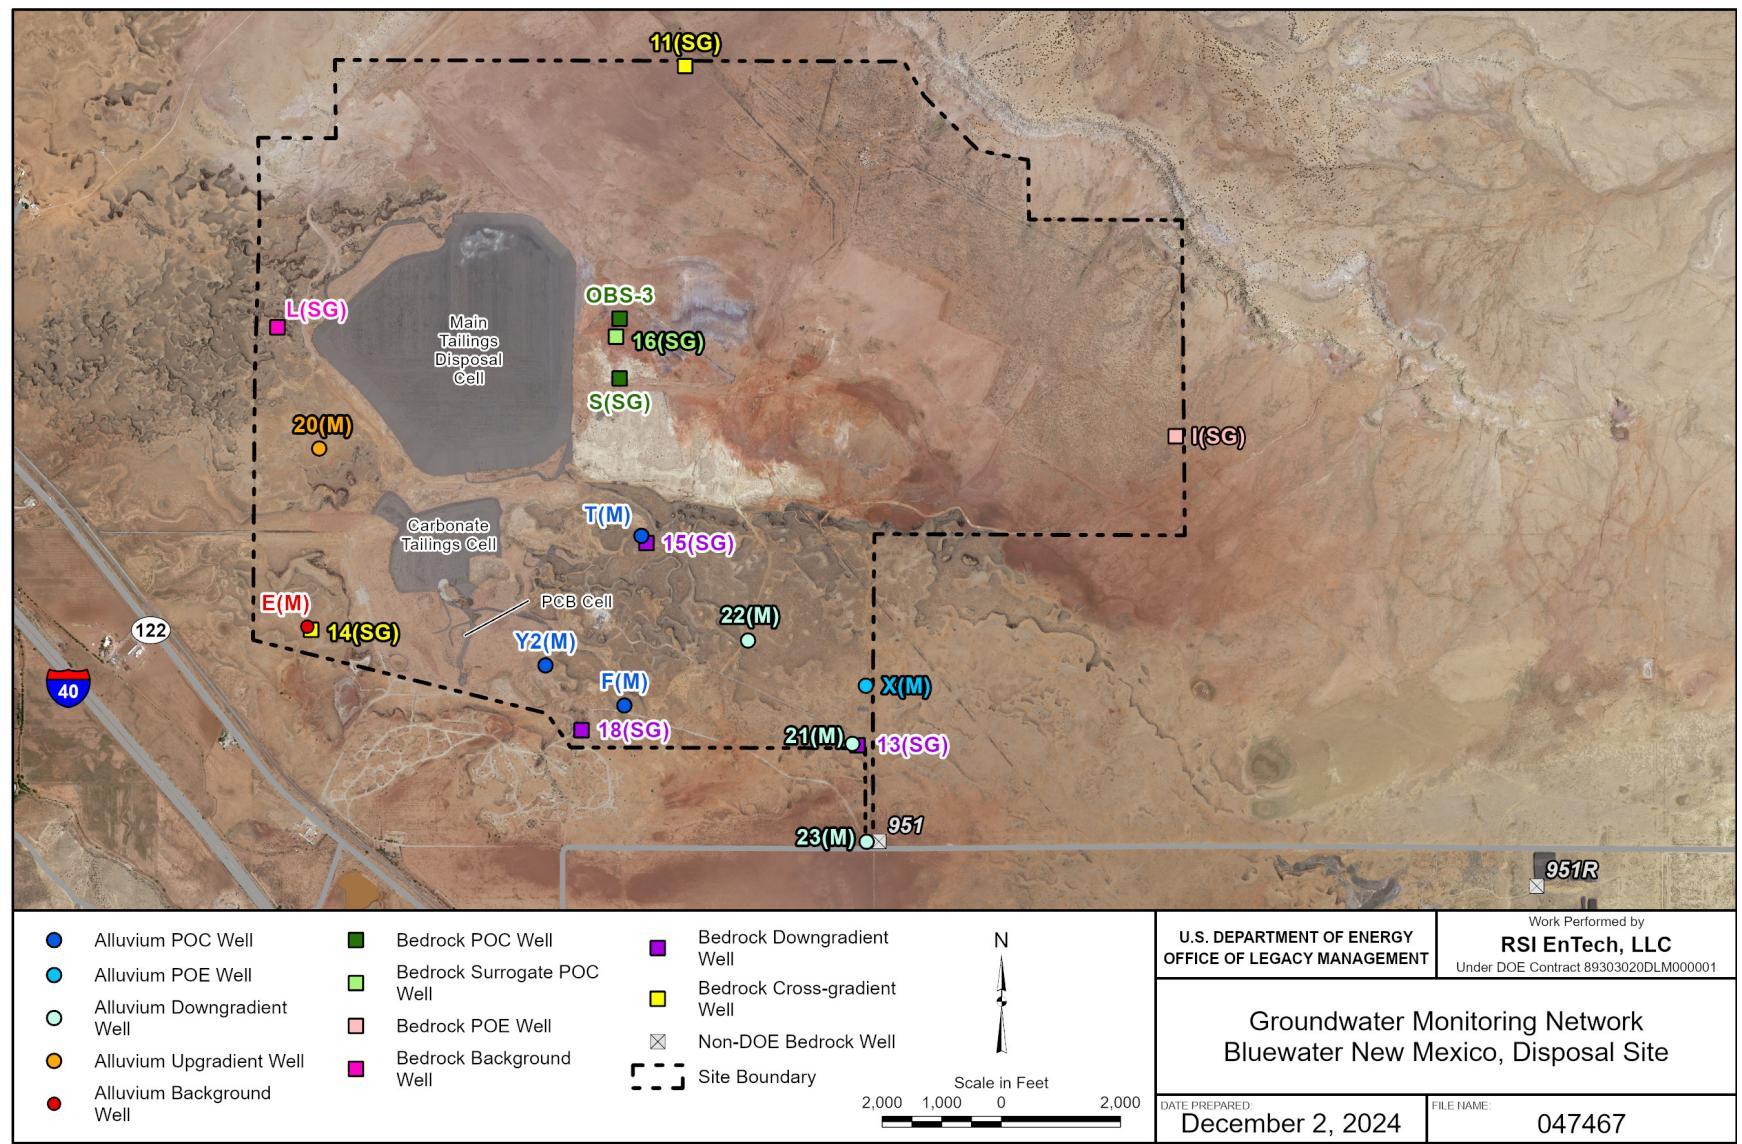
Figure 1-3. Groundwater Monitoring Network at the Bluewater, New Mexico, Disposal Site

The current groundwater monitoring network, including the 10 additional wells installed in 2011–2012, is shown in Figure 1-3. Currently, all 19 site wells, including POC and POE wells, are sampled semiannually for an expanded list of constituents as described in the following sections. Because of the lack of variation between spring and fall sample results observed in the 2010–2022 dataset, LM notified NRC in August 2023 of its intent to reduce the sampling frequency to annually (DOE 2023). LM will continue semiannual sampling until it receives concurrence from NRC.

**Notes:** Well T(M) has been dry or had insufficient water to sample since November 2012; well X(M) has been dry since May 2021. Well Y2(M) was identified as a POC for PCB monitoring given proximity to the PCB cell. Based on provisions in the LTSP (no detectable levels), PCB monitoring was discontinued in 2018.

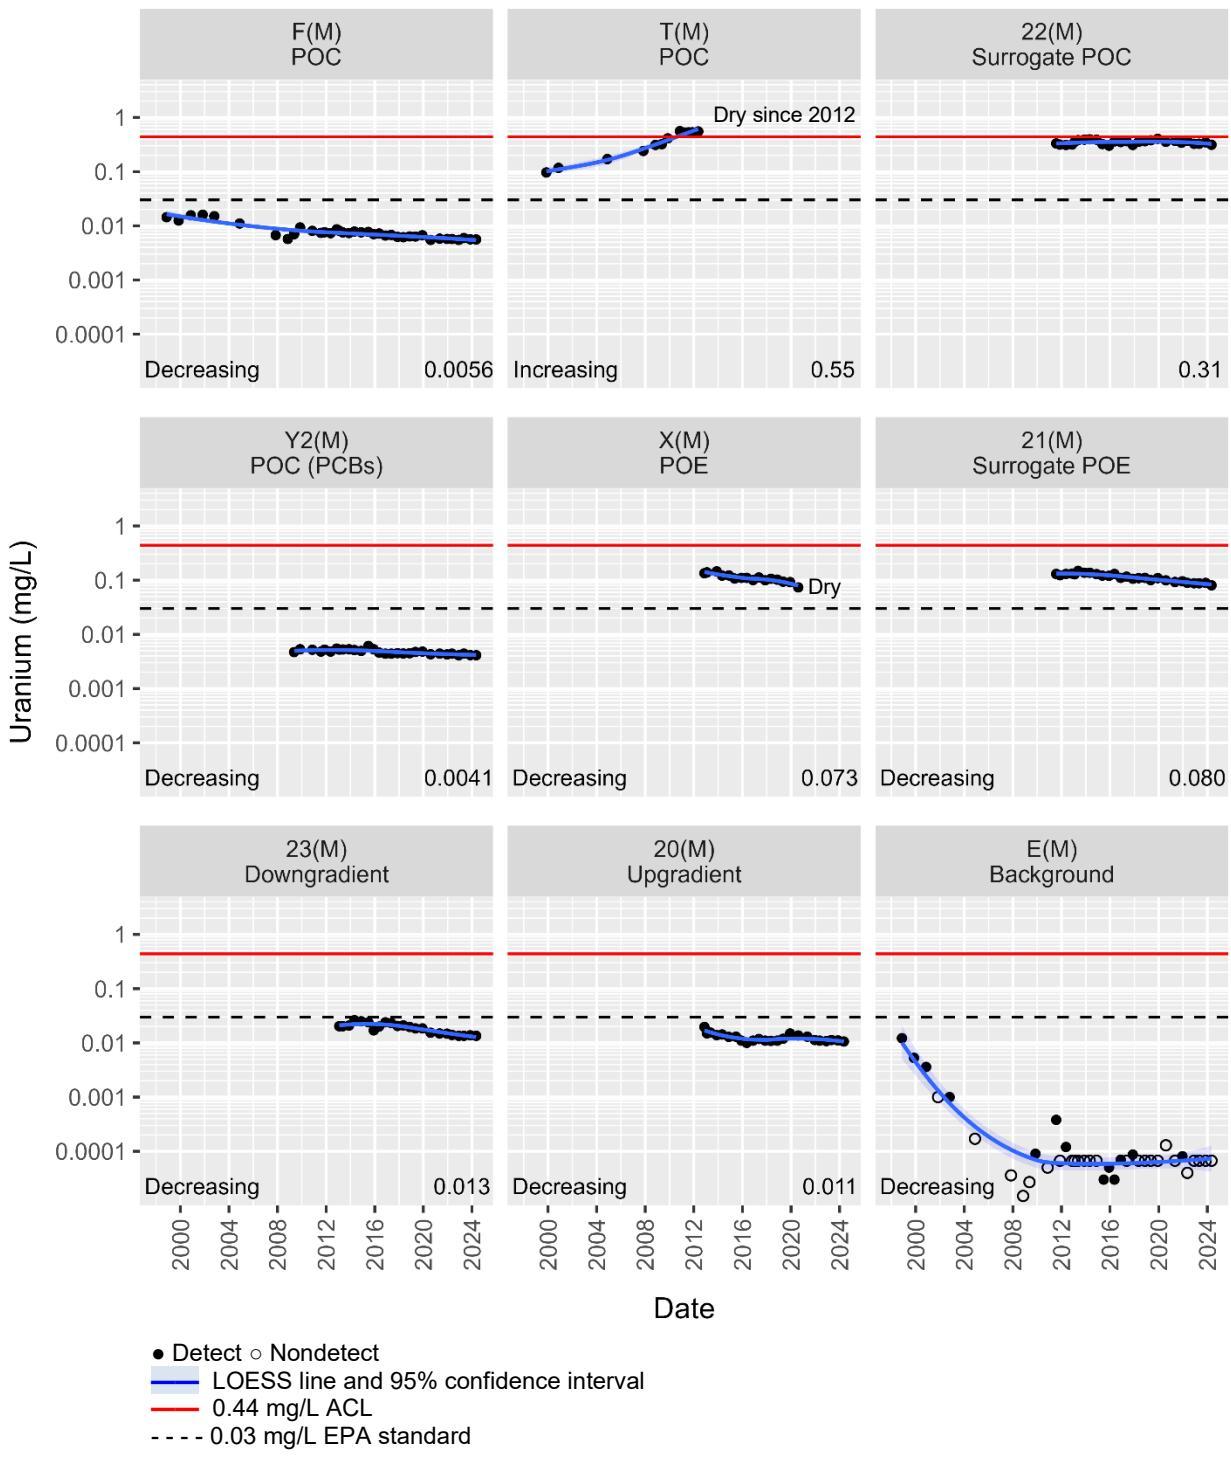
**Notes:** The most recent results, excluding nondetects, are labeled in the lower right corner of each plot. For wells with statistically significant trends (see Table 1-7), the direction of the trend is also indicated. Wells are ordered by purpose: POC and POE wells are listed first, followed by the remaining alluvial wells.

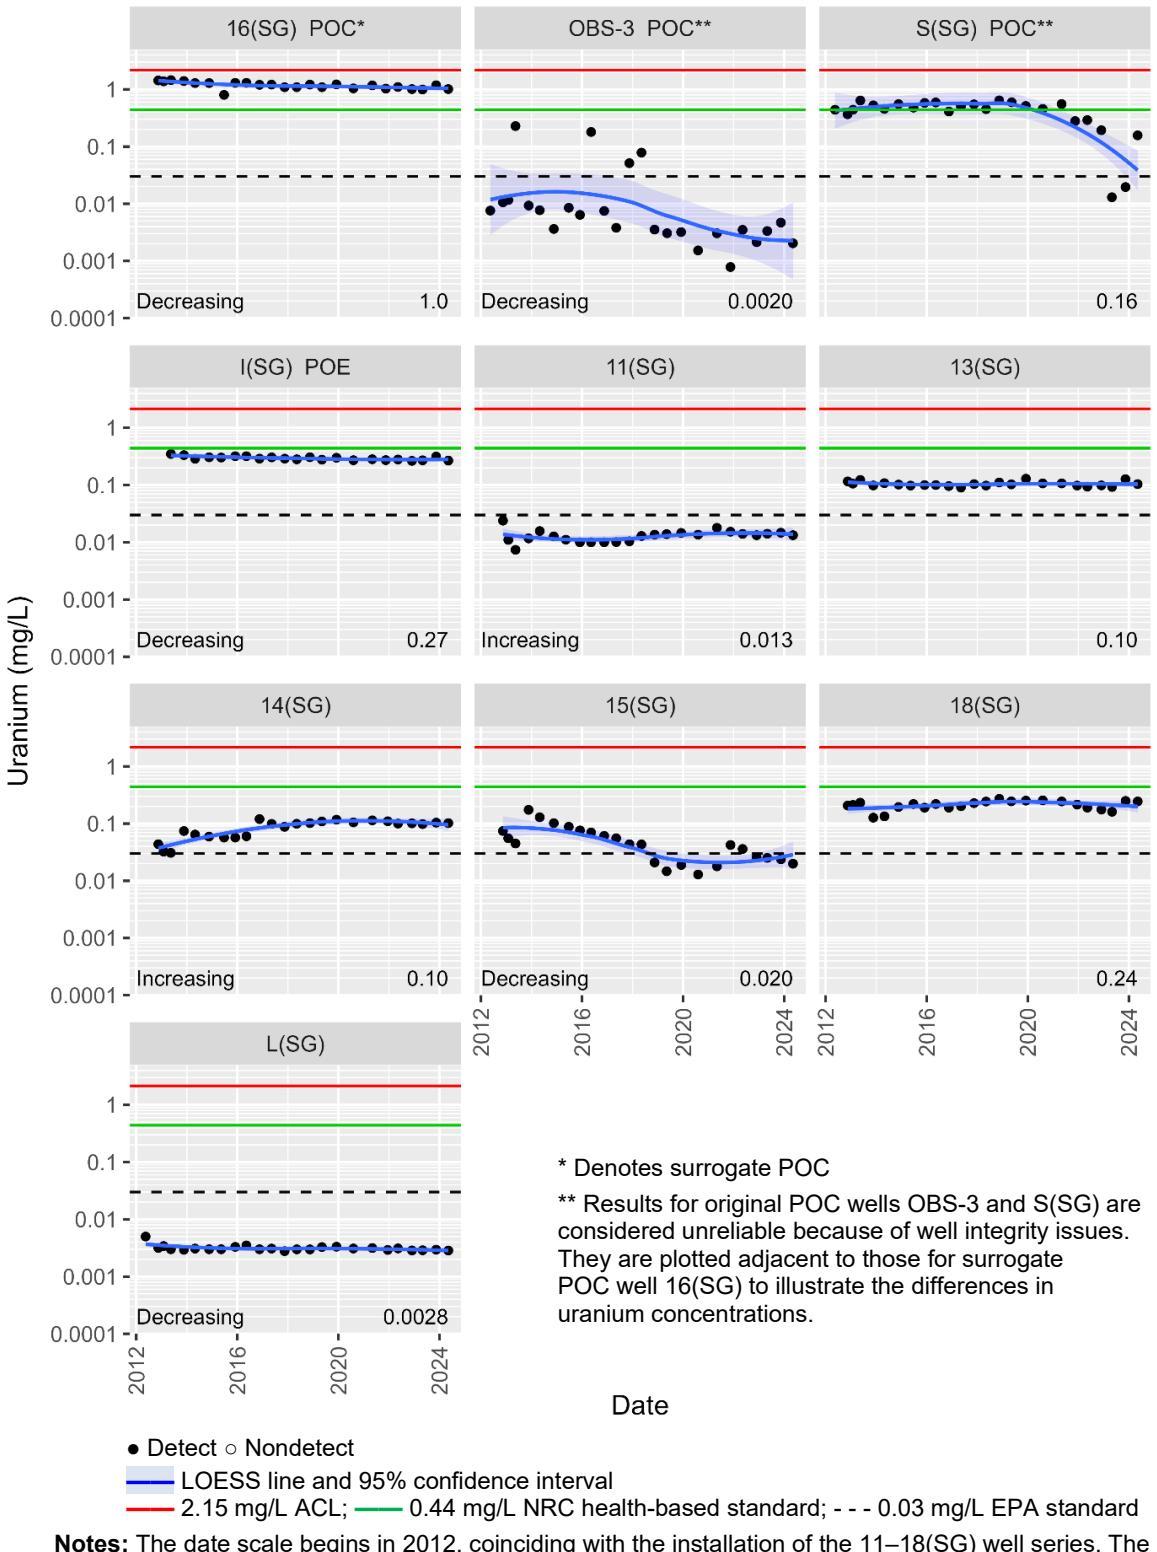
Figure 1-6. Uranium Concentrations in the SAG Aquifer at the Bluewater, New Mexico, Disposal Site

**Notes:** The date scale begins in 2012, coinciding with the installation of the 11–18(SG) well series. The most recent results are labeled in the lower right corner of each plot. For wells with statistically significant trends (see Table 1-9), the direction of the trend is also indicated.

Wells are ordered by purpose: POC and POE wells are listed first, followed by the remaining wells; data for background well L(SG) are plotted last.

Statistically significant increasing trends in uranium concentrations were identified for two SAG wells: cross-gradient wells 11(SG) (northern site boundary) and 14(SG), at the southwestern site boundary. The significant increase in well 14(SG) reflects an increase from 0.031 mg/L in 2013 to 1.2 mg/L in November 2016, but since then, concentrations have remained relatively constant at about 0.1 mg/L; the most recent result was 0.10 mg/L. No significant trend was found for three wells: 13(SG), 18(SG), and S(SG) (Table 1-9).

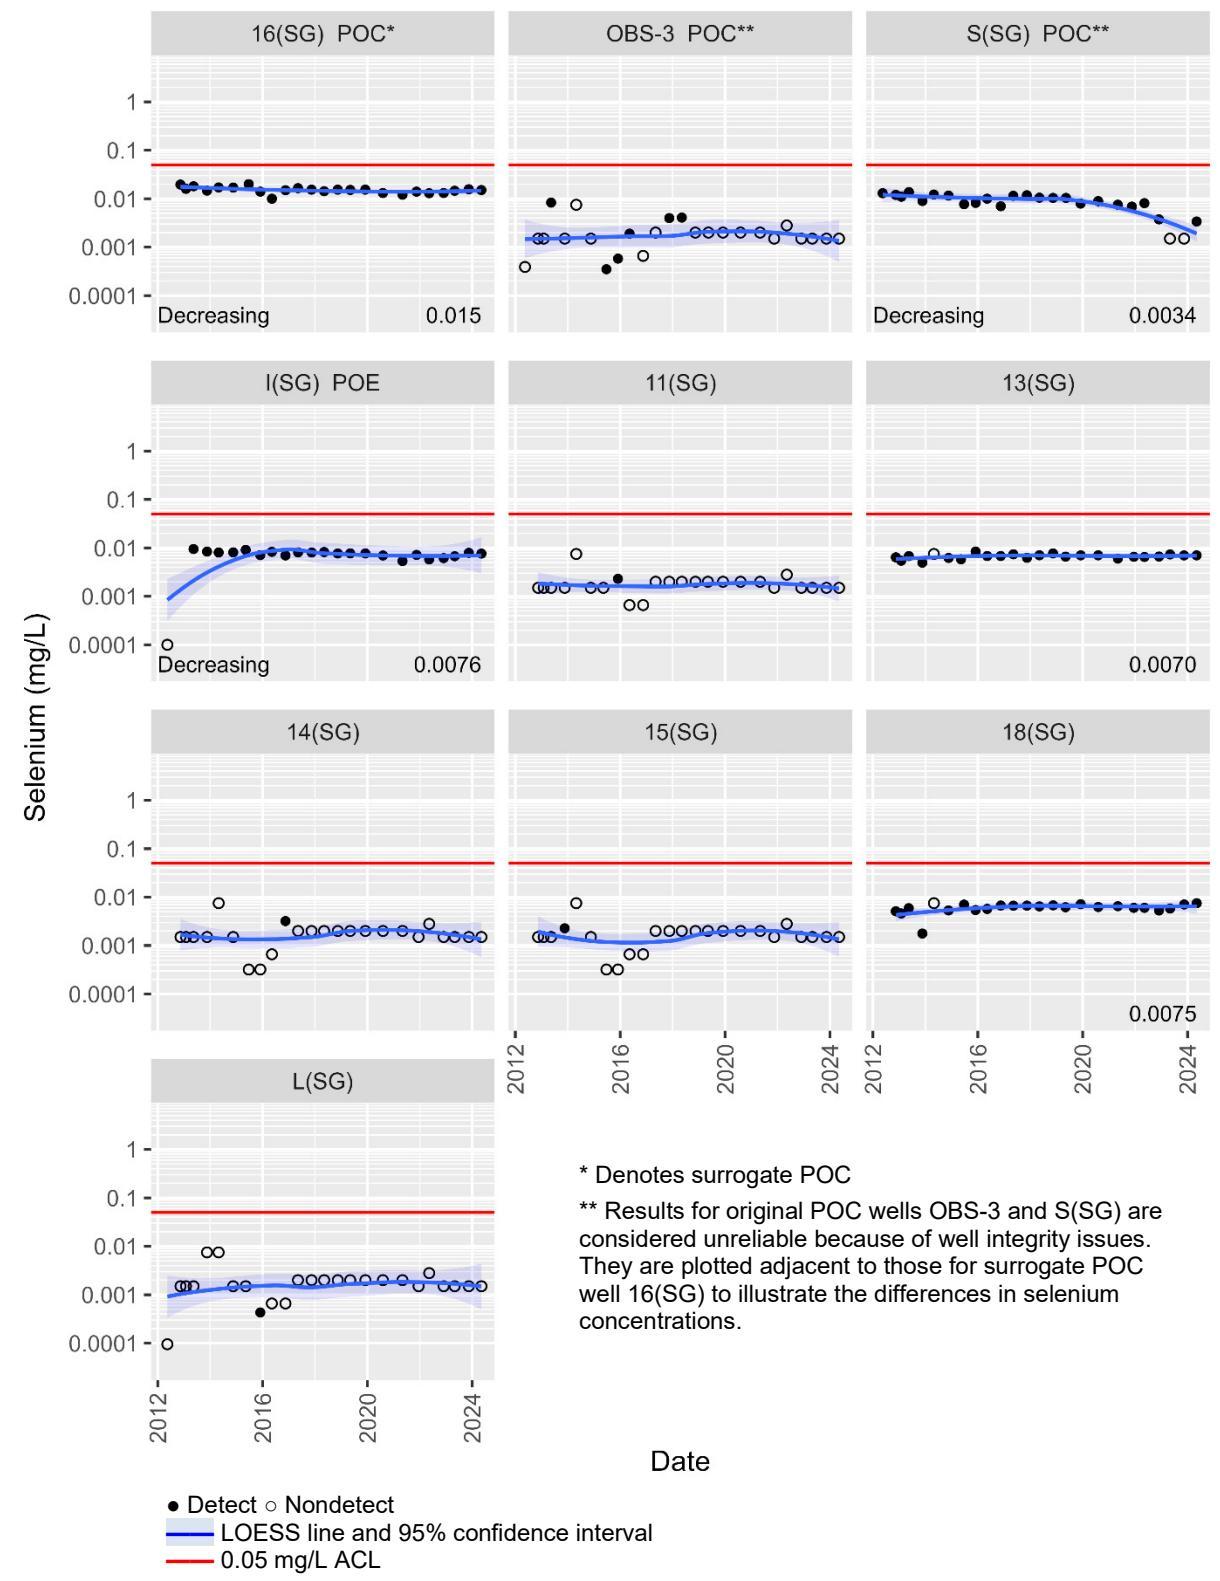
Figure 1-7. Selenium Concentrations in the SAG Aquifer at the Bluewater, New Mexico, Disposal Site

**Notes:** The date scale begins in 2012, coinciding with the installation of the 11–18(SG) well series. For results above the detection limit, the most recent selenium concentrations are labeled in the lower right corner of each plot. For wells with statistically significant trends (see Table 1-9), the direction of the trend is also indicated. Wells are ordered by purpose: POC and POE wells are listed first, followed by the remaining wells listed in Table 1-4; data for background well L(SG) are plotted last.

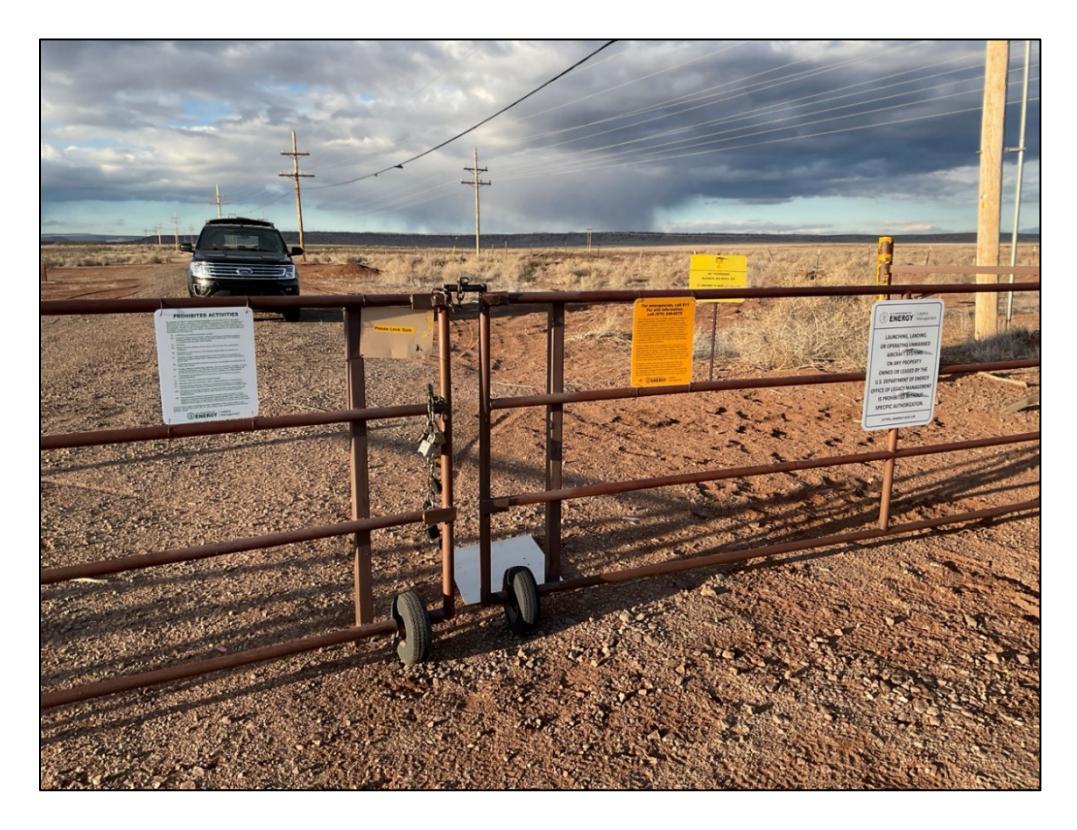
PL-1. Entrance Gate with New Signs

Access to the site is obtained from gravel-surfaced Cibola County Road 63 (also known as Anaconda Road); no private property is crossed to gain site access. The entrance gate is a tubular steel, double-swing gate secured by a chain and locks belonging to LM and the various utility companies that have rights-of-way across the site. Three new signs were installed on the entrance gate this year, which include a list of prohibited activities, information addressing uncrewed aircraft systems, and additional emergency site information (PL-1). The site access road is surfaced with crushed basalt and extends northward along a narrow strip of LM property for approximately 1700 feet (ft) from the entrance gate to the main site access road gate. Two culverts allow drainage of surface runoff under the road.

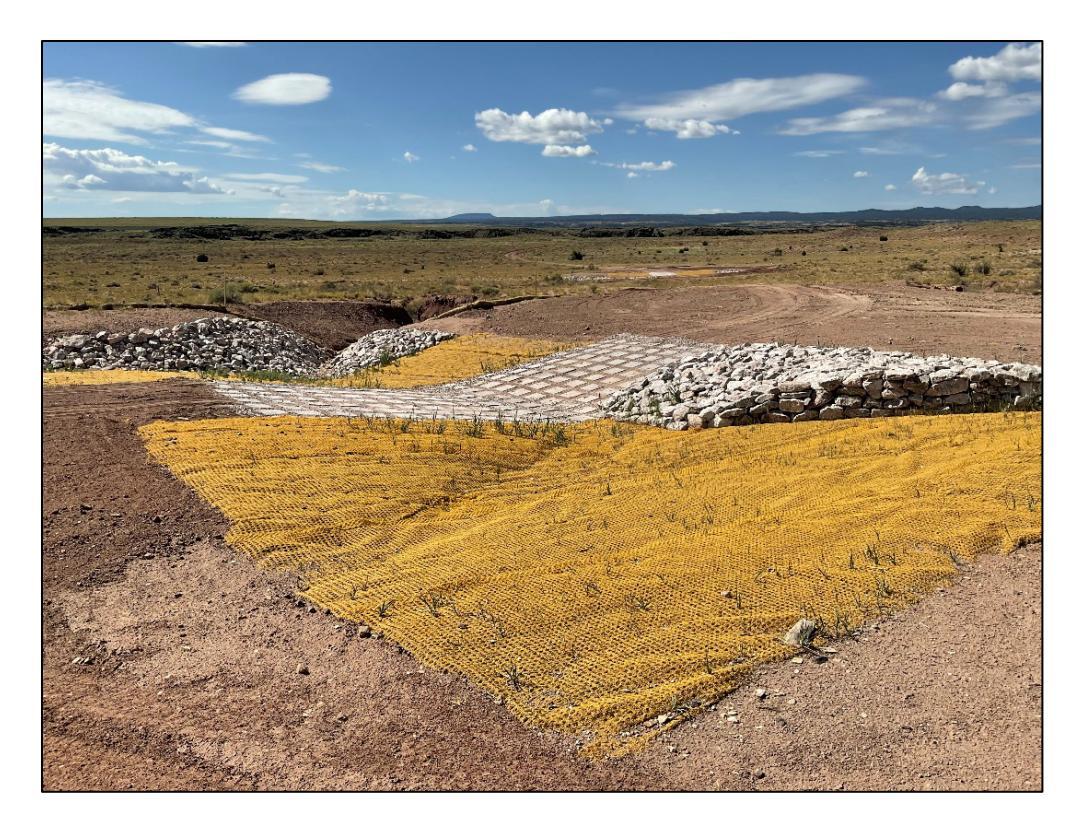
PL-2. USACE Road Repair Area: Low Water Crossing

Interior roads used to access LM assets consist of a dirt track covered at places with crushed basalt. The roads are susceptible to erosion and are repaired when they become impassable. Erosion on the road northwest of the main tailings disposal cell and along the north and eastern portions of the access road were repaired by the U.S. Army Corps of Engineers (USACE) in a road repair project between April 2024 and September 2024 (PL-2). During the August 22, 2024, road repair inspection, LM identified an old cutoff gate pole sticking up at the edge of the new road surface near boundary monument BM-16. This pole was removed in September for vehicle safety. Maintenance staff will routinely top dress areas of the access road to improve roads worn away by inclement weather and to reduce erosion. No other maintenance needs were identified.

- Treat the noxious weeds
- Continue to top dress roads to improve weather access and reduce erosion along the road to the main tailings disposal cell
- Perform minor fence repairs
- Add erosion control around the new wildlife guzzler

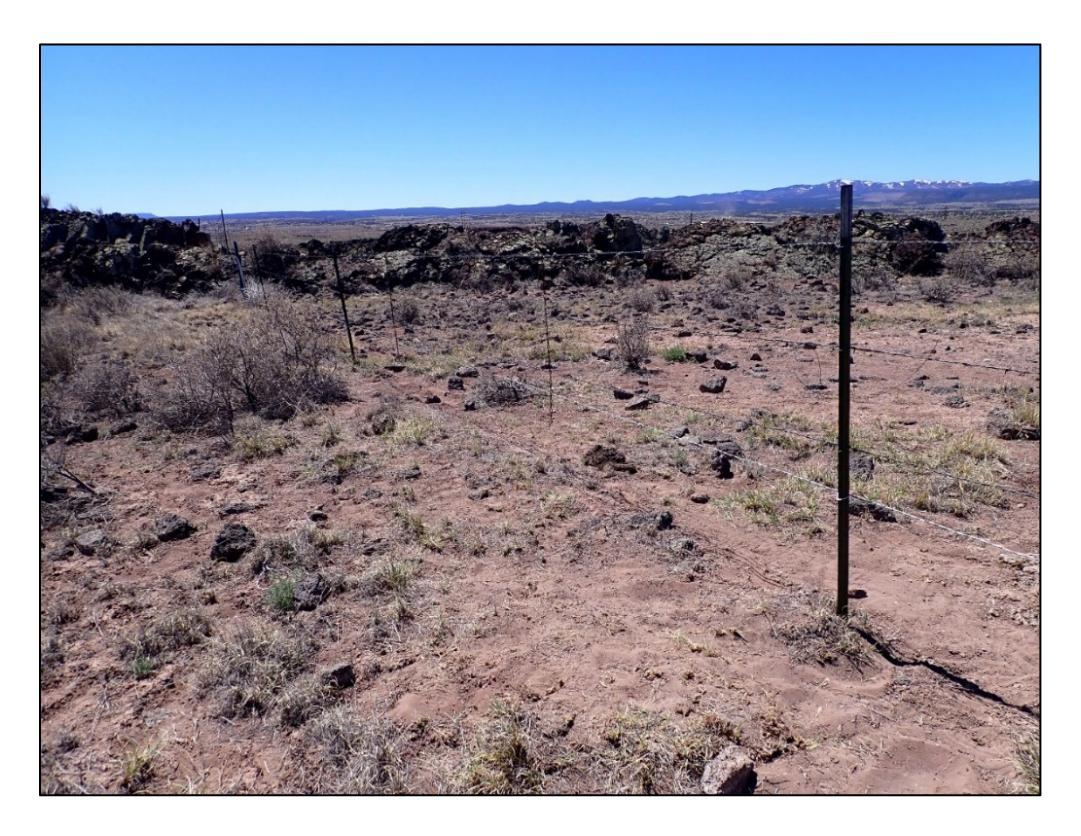
PL-3. Wildlife-Friendly Fence Modification

Wildlife-friendly fence modifications were completed on the perimeter fence on the west and south sides of the site during the weeks of April 15 and September 23, 2024. A total of 200 linear ft of fencing was modified. At these locations, the top fence strand was set at 36–38 inches, the lower strand was replaced with smooth wire and set at 14–16 inches off the ground, and the remaining strands were arranged evenly in between, approximately 6–8 inches apart. These areas were identified as wildlife crossings by subject matter experts and were installed to help reduce wildlife death and injury from fence crossings (PL-3).

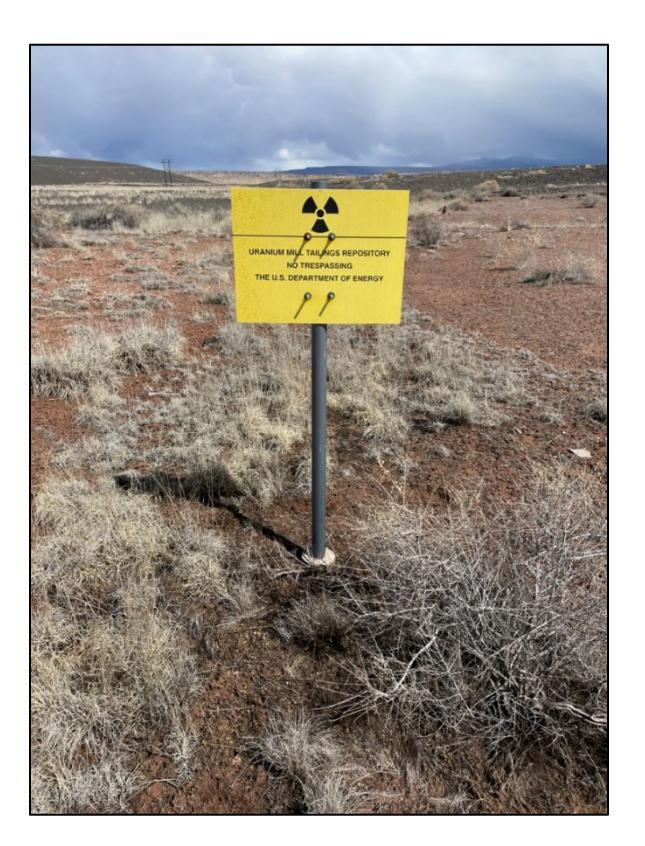
PL-4. Perimeter Sign P13

Fifty-five perimeter signs (warning and no-trespassing signs) are mounted on steel posts along the site boundary and around the main and carbonate tailings disposal cells (PL-4). Perimeter

sign P10 has bullet hole damage but is legible. Perimeter sign P16 has a loose base but remains functional. No maintenance needs were identified.

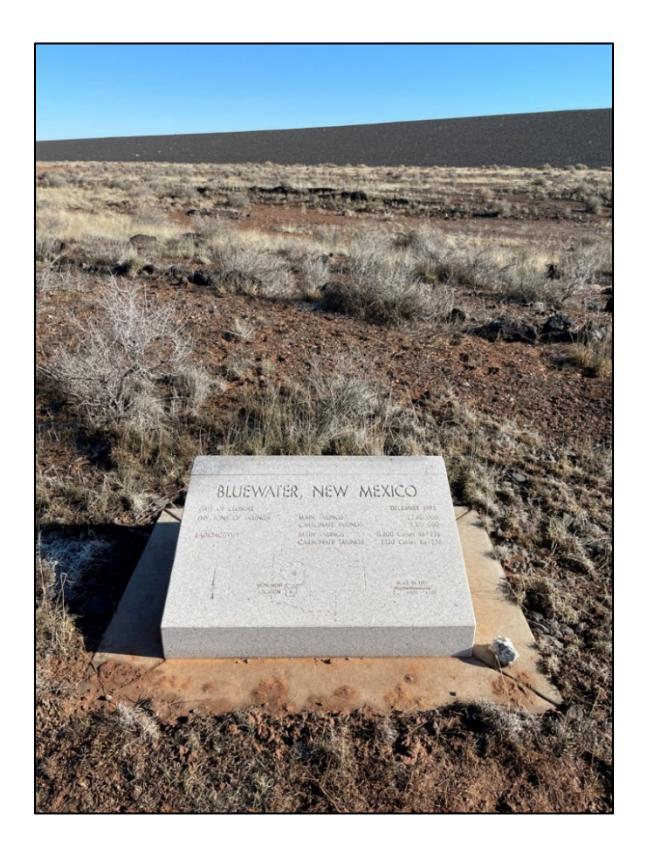
PL-5. Site Marker

The site has one granite site marker between the southwest corner of the main tailings disposal cell and the northwest corner of the carbonate tailings disposal cell (PL-5). The site marker is in good condition, and no maintenance needs were identified.

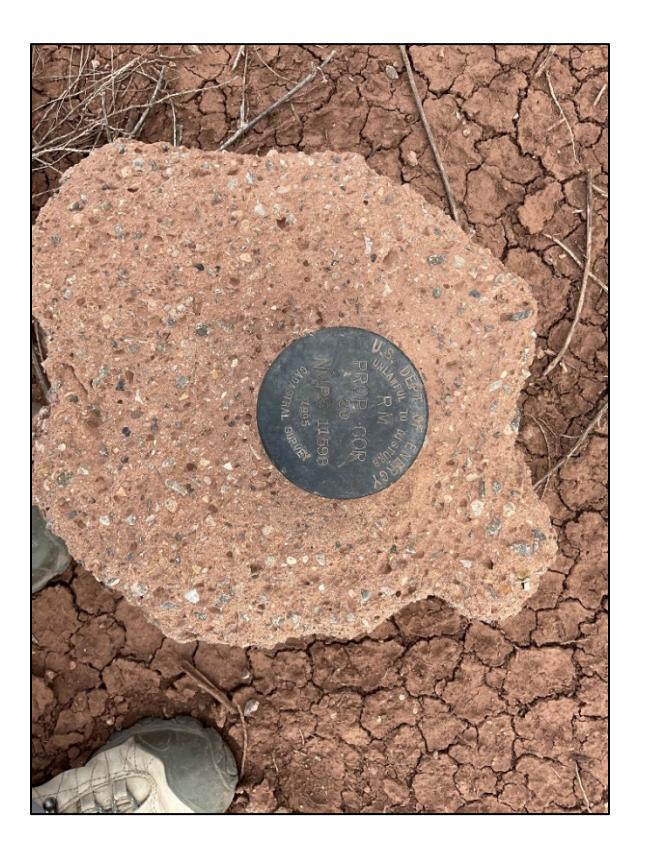
PL-6. Boundary Monument BM-20

Twenty-four boundary monuments define the site boundary (PL-6). These monuments are typically inside the perimeter fence and several feet inside the true corner or boundary line. Some monuments have become covered by drifting sand, and metal T-posts have been driven at those locations to help locate them. Other boundary monuments are in remote sections of the site and cannot be observed from site access roads. All boundary monuments were inspected during the 2024 annual inspection. Boundary monument BM-16 was buried during USACE road construction activities and was located and inspected. Some erosion was observed at the base of boundary monument BM-13, but it is stable. No maintenance needs were identified.

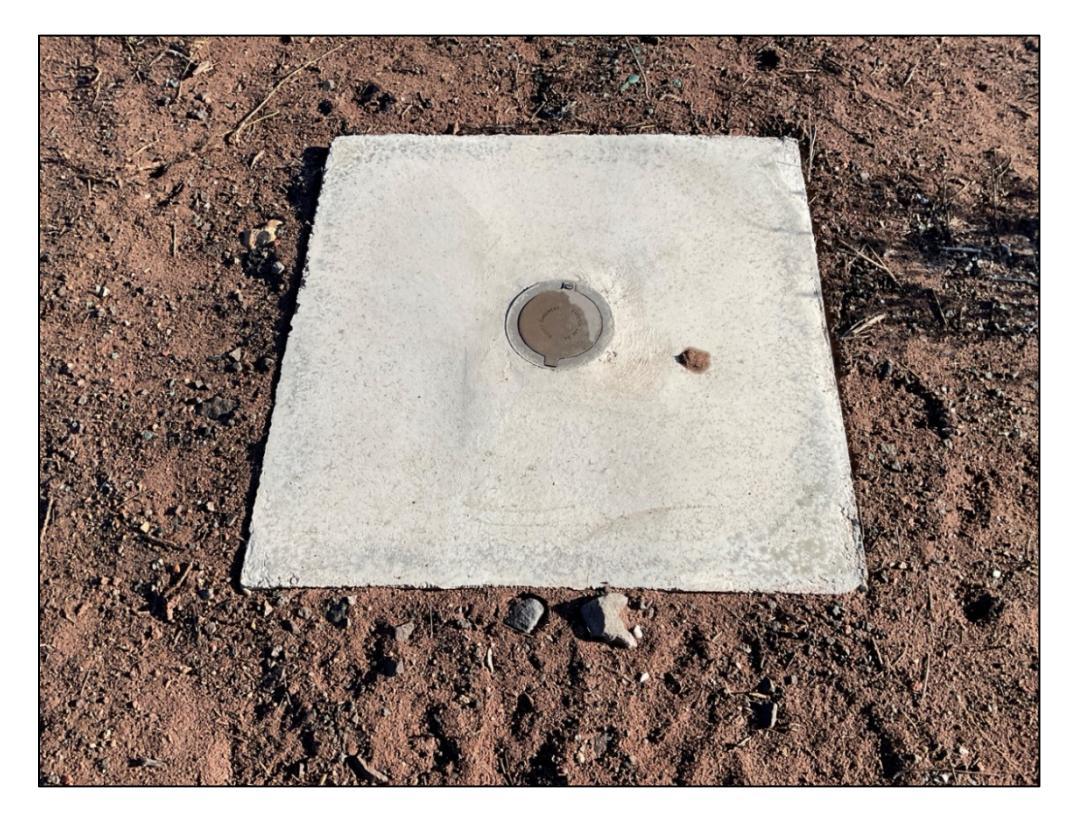
PL-7. Quality Control Monument QC-3

Thirteen aerial survey quality control monuments were installed in 2019, and an aerial survey was conducted by USACE in 2021. The aerial survey quality control monuments were inspected during the 2024 annual inspection (PL-7). No maintenance needs were identified.

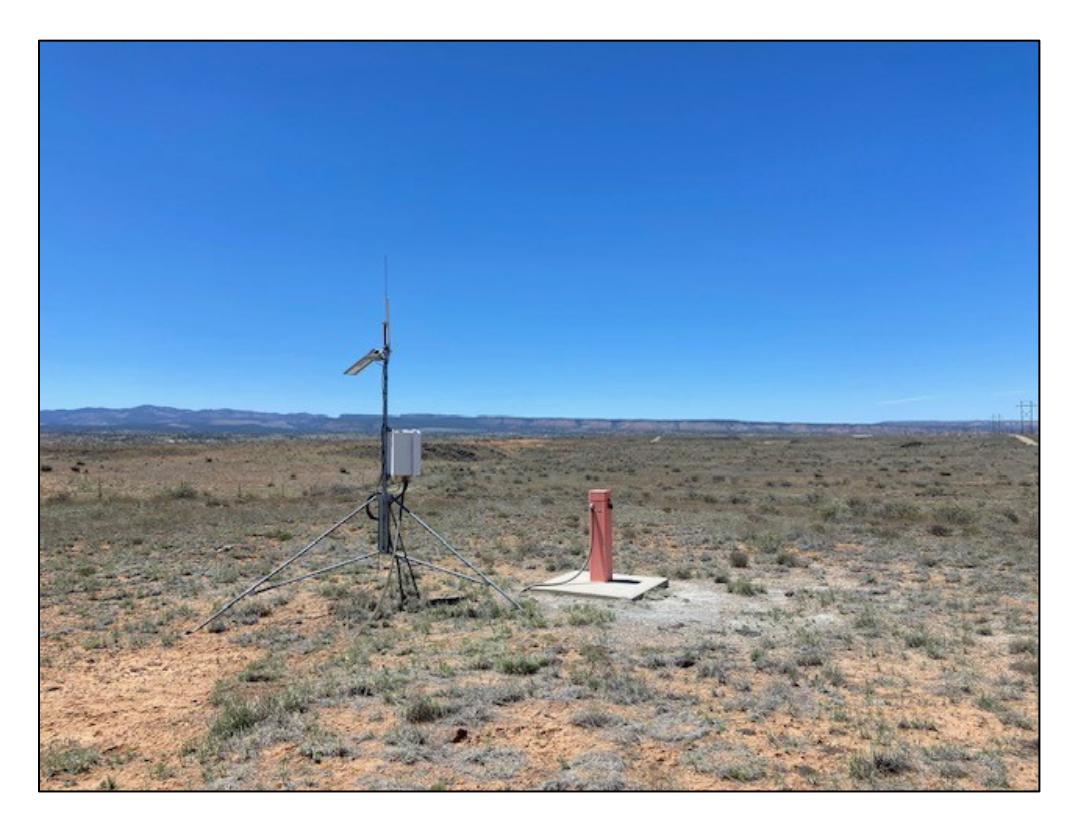
PL-8. Monitoring Well 21(M)

The site groundwater monitoring network consisted of nine monitoring wells when the site was transferred to LM in 1997. Two additional wells were installed in summer 2011, and eight more wells were installed in summer 2012 in response to elevated uranium concentrations in the two aquifers (alluvial and bedrock) at the site. The onsite groundwater monitoring network now consists of 19 monitoring wells; 10 are completed in the bedrock aquifer and 9 in the alluvial aquifer. Eleven wells (three alluvial and eight bedrock) have telemetry towers, known as System Operation and Analysis at Remote Sites (SOARS) stations to transmit groundwater level and weather data to the LM Field Support Center at Grand Junction, Colorado. The monitoring wells and SOARS stations are identified in Figure 1-2. The wellhead protectors and SOARS stations were observed to be undamaged and locked (PL-8). No maintenance needs were identified.

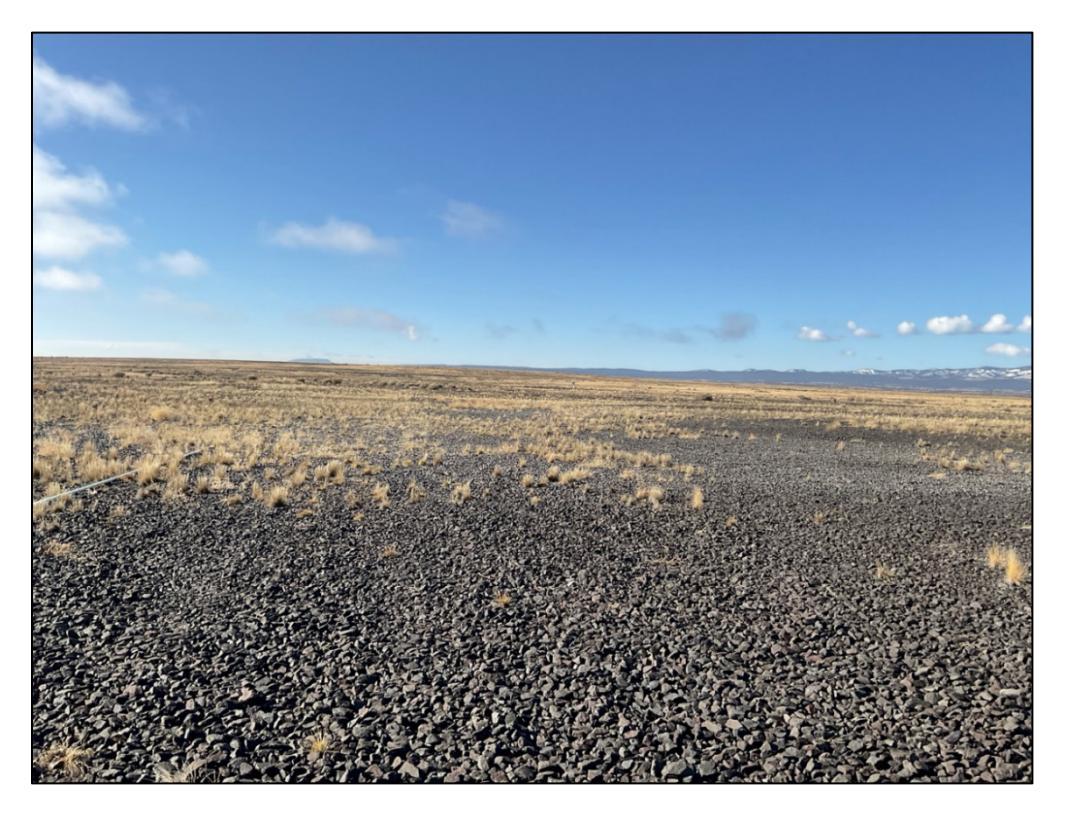
PL-9. Overview of Vegetation on Main Tailings Disposal Cell

Plant encroachment (by annual weeds, perennial grasses, forbs, and scattered perennial shrubs) continues on the main tailings disposal cell top and side slopes (PL-9). Siberian elm saplings on the top slope are periodically treated with herbicide to prevent the establishment of trees that could damage the main tailings disposal cell cover materials. No live elms were observed during the inspection.

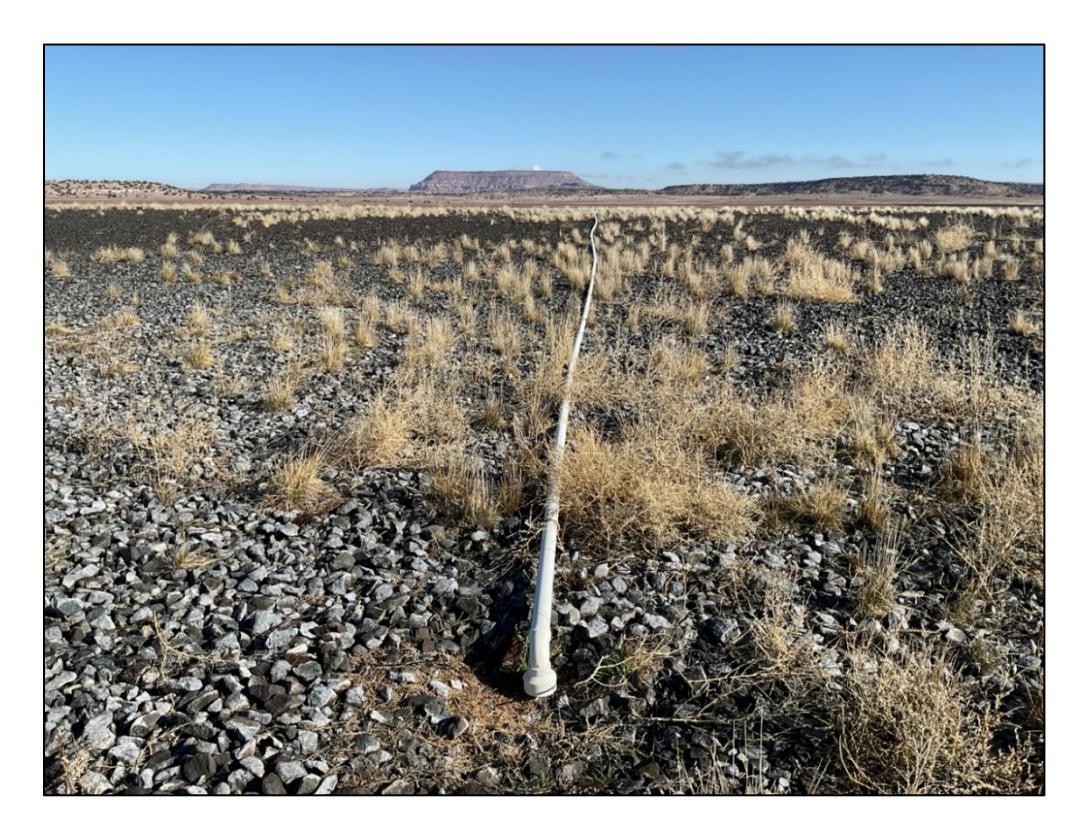
PL-10. Siphon

A 2-inch-diameter siphon was installed in fall 2015 to dewater as much of the ponded water as possible (PL-10). The siphon is manually started when the webcam indicates that a large pond has developed. The intent is to avoid potential erosion of the main tailings disposal cell cover materials if the pond surface reaches an elevation high enough to spill over the north side slope. Water would start to spill over at the lowest point along the north edge of the top slope, which could initiate erosion in that area.

The siphon is usually operated at least once a year, depending on precipitation, and it successfully removes nearly all the water; any remaining water tends to evaporate. When operated, the siphon discharges water at a rate of approximately 100 gallons per minute at the toe of the north side slope where runoff water was intended to discharge (PL-11). The discharged water ponds over a large area north of the main tailings disposal cell and eventually either evaporates or infiltrates into the soil. The discharged water does not flow off the site. Due to the lack of significant precipitation during the 2024 monsoon season (4.46 inches were measured by the onsite rain gauge), the siphon did not require operation this year. The last time the siphon was operated was in October 2022.
