# 1.0 Bluewater, New Mexico, Disposal Site

#### **1.1 Compliance Summary**

The Bluewater, New Mexico, Uranium Mill Tailings Radiation Control Act (UMTRCA) Title II Disposal Site was inspected on March 18–20, 2024. This inspection included the engineered disposal cells and the areas around the disposal cells. The monitoring well network and monitoring well access roads, perimeter road, and boundary monuments were inspected on May 7–9, August 22, and September 24, 2024, respectively. Minor settlements on the side slopes of the main tailings disposal cell, as well as settlements on the north portion of the top slope continue to be observed. No new areas of concern were identified during the inspection, and previously observed features of concern had no significant changes. Inspectors found no cause for a follow-up or contingency inspection.

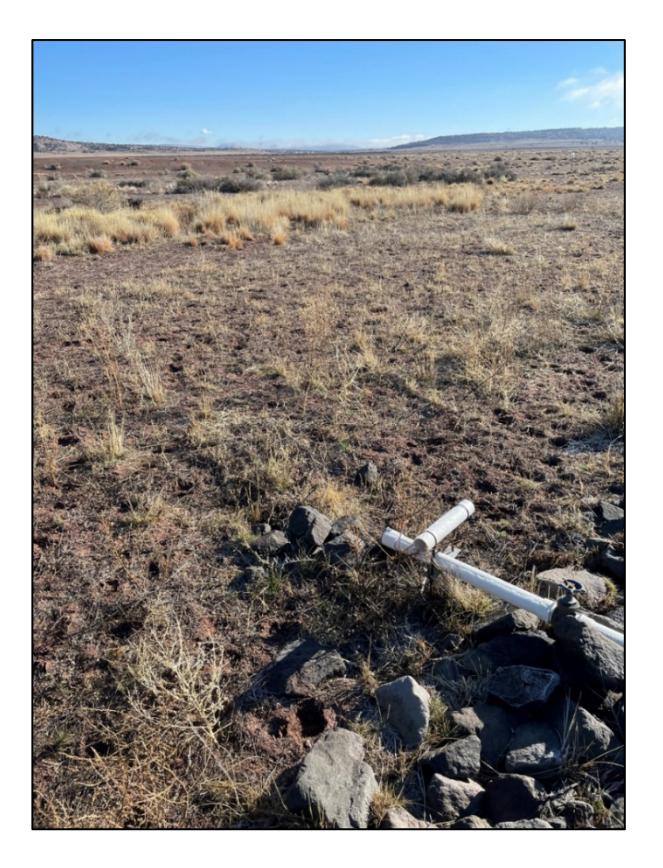
PL-11. Siphon Outflow

The siphon is usually operated at least once a year, depending on precipitation, and it successfully removes nearly all the water; any remaining water tends to evaporate. When operated, the siphon discharges water at a rate of approximately 100 gallons per minute at the toe of the north side slope where runoff water was intended to discharge (PL-11). The discharged water ponds over a large area north of the main tailings disposal cell and eventually either evaporates or infiltrates into the soil. The discharged water does not flow off the site. Due to the lack of significant precipitation during the 2024 monsoon season (4.46 inches were measured by the onsite rain gauge), the siphon did not require operation this year. The last time the siphon was operated was in October 2022.

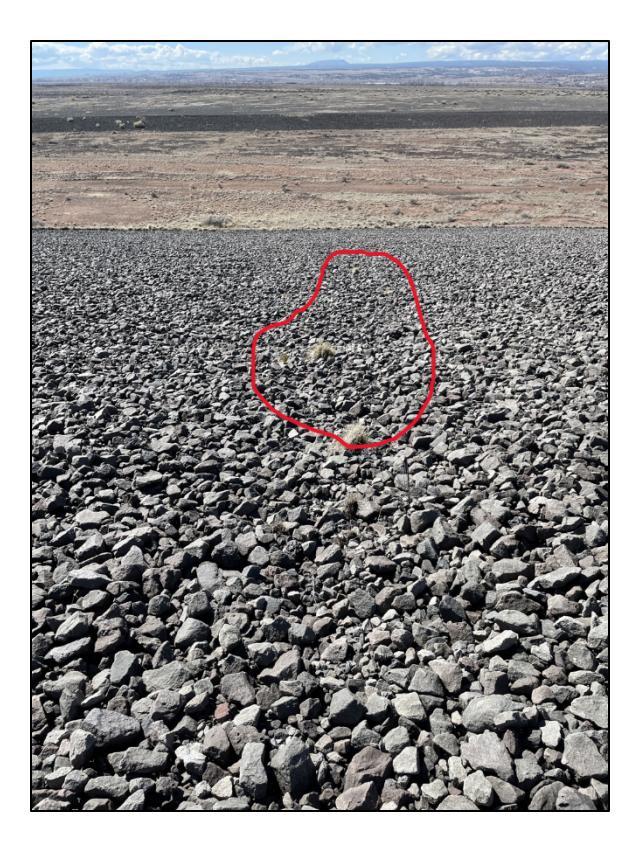
PL-14. Minor Settlement MT-06

MT-06	Potential settlement feature on the western side of the south side slope	2022	Y	Photograph PL-14.	15 ft long × 30 ft wide

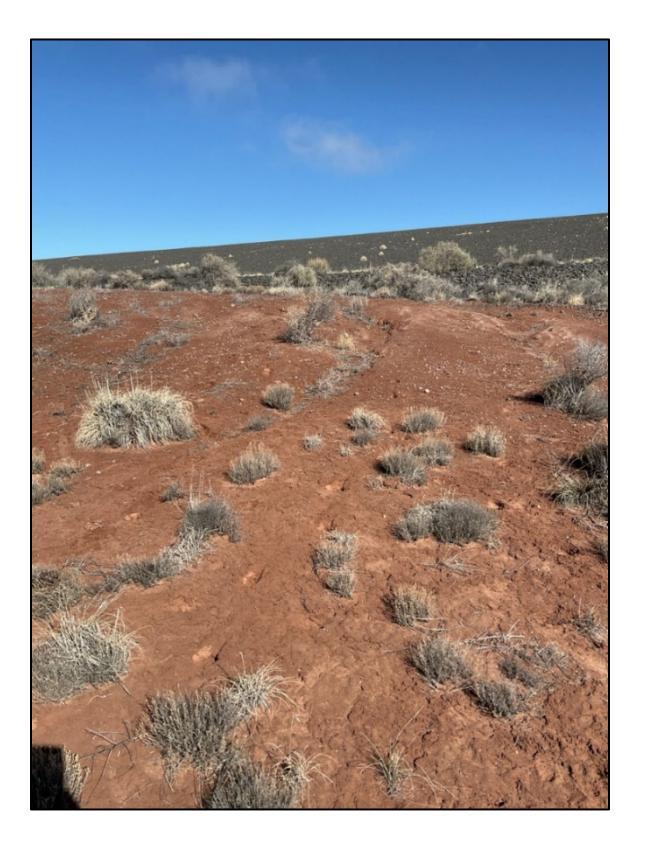
PL-15. Rilling near the South Bench

During the 2019 annual inspection, minor rills with a maximum depth of 6 inches were observed at the base of the east side slope and minor rills with a maximum depth of 8 inches were observed at the base of the south bench of the main tailings disposal cell. The rills to the east of the disposal cell showed no significant change. The rilling at the south bench appeared to be less severe than when observed in 2023 (PL-15). LM will continue to monitor the rills for potential impact to the main tailings disposal cell and south bench area. A potential animal burrow or root trace was observed in 2024 on the top slope of the main tailings pile (PL-16). Animal burrows observed on the top slope of the acid tailings disposal area in 2023 were not present during the 2024 inspection and will not be tracked in 2025. No sediment deposits were present along the toe. No maintenance needs for the side slopes, acid tailings, or south bench disposal areas were identified.

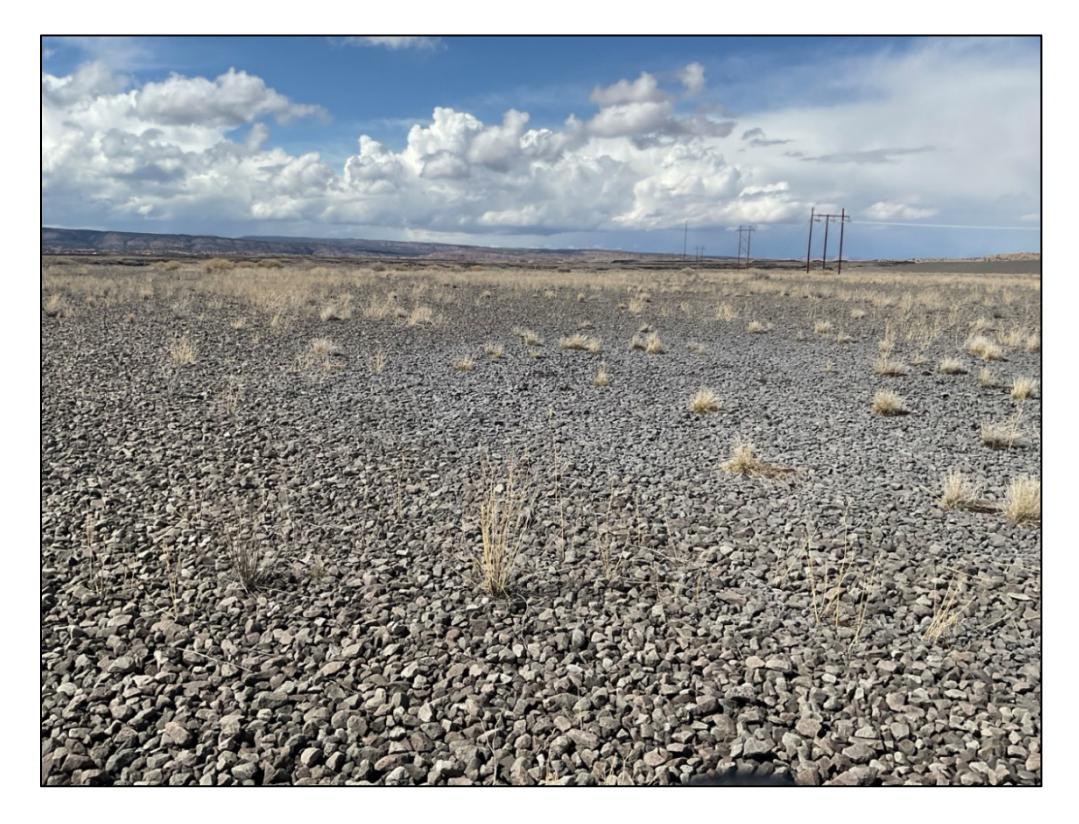
PL-17. Shallow Settlement CT-01

Settlement No.	General Description	Initial Observation	Monitoring Status (Y/N)	Notes	Approximate Dimensions
CT-01	A shallow settlement on the northwest extension	2012	Y	Photographs PL-17 and PL-18. Stormwater runoff occasionally ponds at this location. Settlement was observed to have standing water below the riprap surface during the 2024 inspection.	73 ft long × 63 ft wide
CT-02	A settlement on the north side slope	2019	Y	None.	9.5 ft long × 1.5 ft wide
CT-03	Minor settlement observed on the south-central top slope of the carbonate cell	2023	Y	Photograph PL-19.	8 ft long × 3 ft wide × 0.3 ft deep

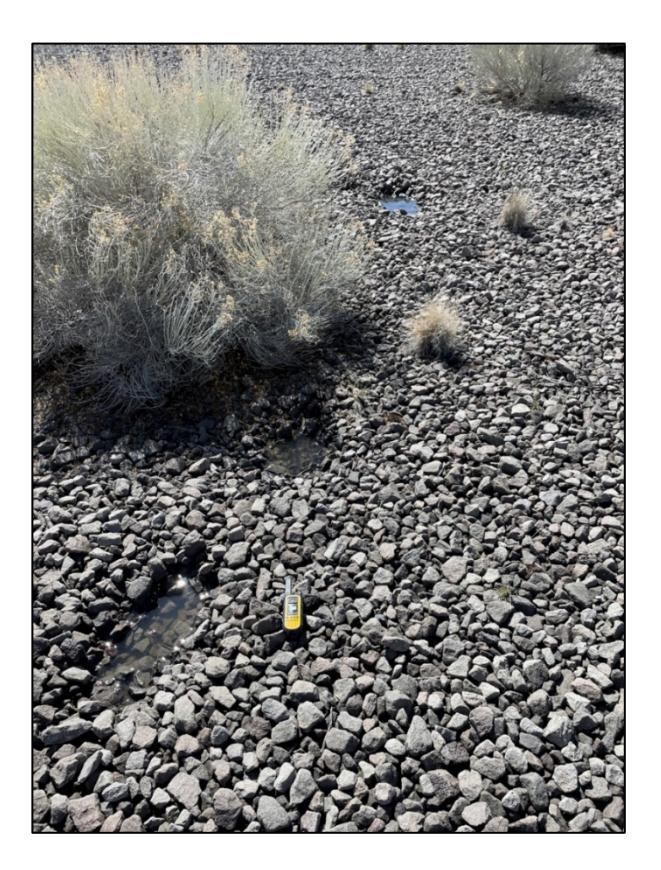
PL-20. Biointrusion Area

A biointrusion area was identified west of minor settlement CT-03 (PL-20) that appears to be caused by animals digging small potholes into the top slope riprap layer. Due to recent rains at the site, two areas of concentrated water drainage or ponding were identified on the southern and northern portions of the carbonate cell. These areas will be monitored for future rills or ponding issues (PL-21, PL-22). Annual weeds, perennial grasses, and scattered woody shrubs were on the carbonate tailings disposal cell and its extensions. Siberian elm saplings are periodically treated with herbicide. No saplings were observed during the inspection. No additional maintenance needs were identified.

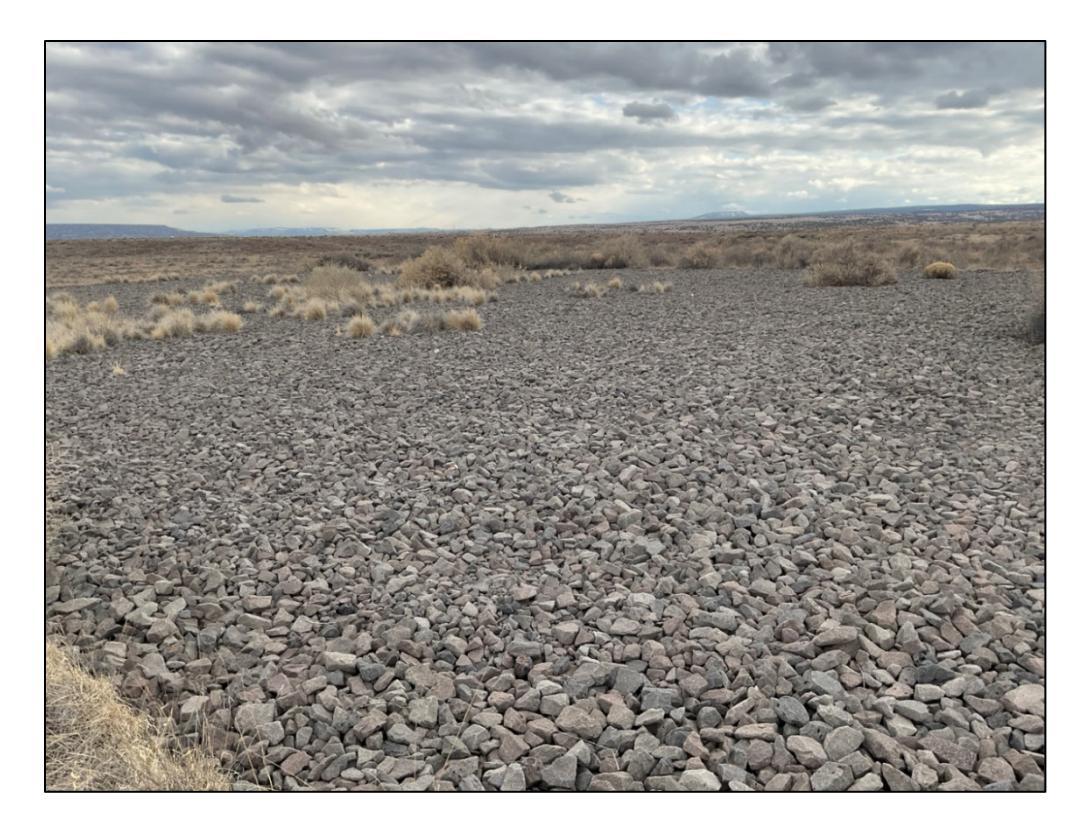
PL-24. Overview of PCB Cell

An 11-acre grass-covered disposal area is south of the asbestos disposal area. A small riprap-covered PCB cell is within the disposal area (PL-24). Two grass-covered dumps, totaling approximately 2 acres, are east of the carbonate tailings disposal cell. Inspectors observed a minor erosional area along the basalt flow at the southern interface of the east dump that was first identified in 2019 (PL-25, PL-26). The erosional area was measured in 2022 at approximately 11.3 ft long  $\times$  5.1 ft wide  $\times$  4 ft deep. Wooden stakes were placed at the edges of the feature to monitor future growth. Radon gas concentration and radiation dose rate surveys were completed near the erosional area by an LMS radiological control technician in 2023. The measurements were consistent with background levels. This area is showing evidence that riprap continues to slump into the settlement, but the area affected area has not grown in size. The erosional area will continue to be monitored. No immediate maintenance needs were identified.

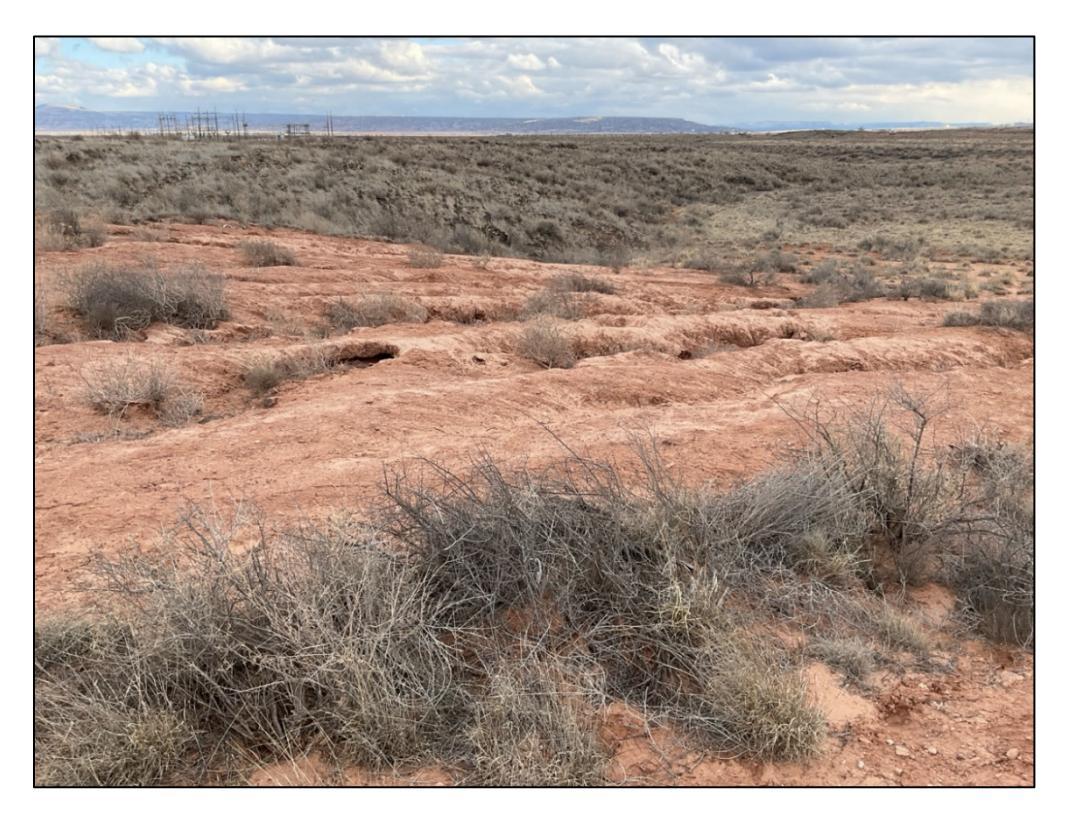
PL-27. Rilling Between the Carbonate Cell and West Dumps

A small ephemeral pond area was observed near the southwest side slope of the main tailings disposal cell near perimeter sign P50 in 2023. This pond was not present during this inspection and will be removed from tracking. Scattered tamarisk shrubs and other plants listed as noxious weeds by the State of New Mexico are onsite. Noxious weeds were treated with herbicide following the inspection. Additional rilling and animal burrows are present in the area between the disposal cell and site perimeter but do not threaten any site features (PL-27).
