1.0 Site Overview and Inspection Summary

The Burris Park, California, Site (formerly the Burris Park Field Station), is in the central part of a 57-acre park owned and maintained by Kings County Parks and Grounds Department. The site consists of a 50×50 -foot (ft) fenced area surrounding the 42×42 ft decommissioned test pad, which is reinforced by concrete protective cover. This area once consisted of 6×6 ft soil-filled concrete plots used to test the effectiveness of removing strontium-90 (90 Sr) from the soil. University of California—Berkeley (UC Berkeley) scientists applied 72 millicuries (mCi) of 90 Sr evenly to the soil in the late 1950s to conduct these tests under a contract with the U.S. Atomic Energy Commission. The site was decommissioned by filling and capping the plots with metal-mesh reinforced concrete in 1963. Although no further remediation is required, the U.S. Department of Energy (DOE) Office of Legacy Management (LM) in November 2014 accepted maintenance-only responsibility for the site and its remaining radioactive contents.

The February 2019 inspection found the site in good condition with no follow-up action required. Refer to Section 3.0 for the further i

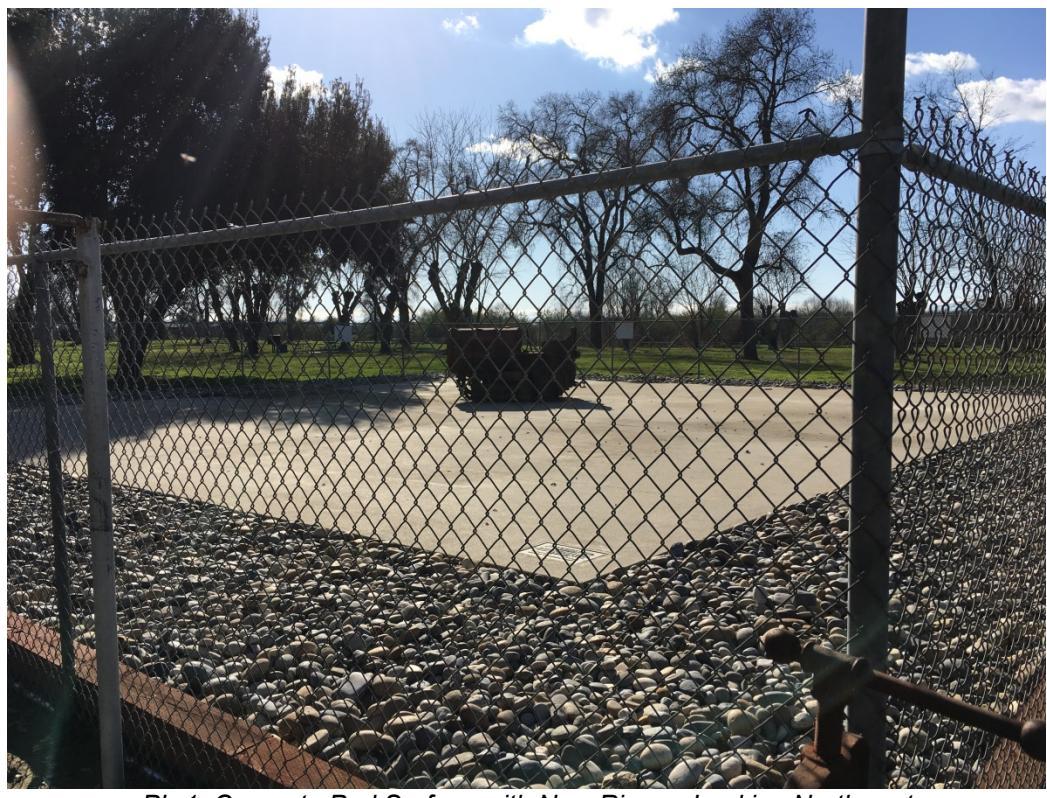
Photograph locations (PL)-1 through PL-3 represent the current condition of the IC.

PL-1. Concrete Pad Surface with New Riprap, Looking Northwest

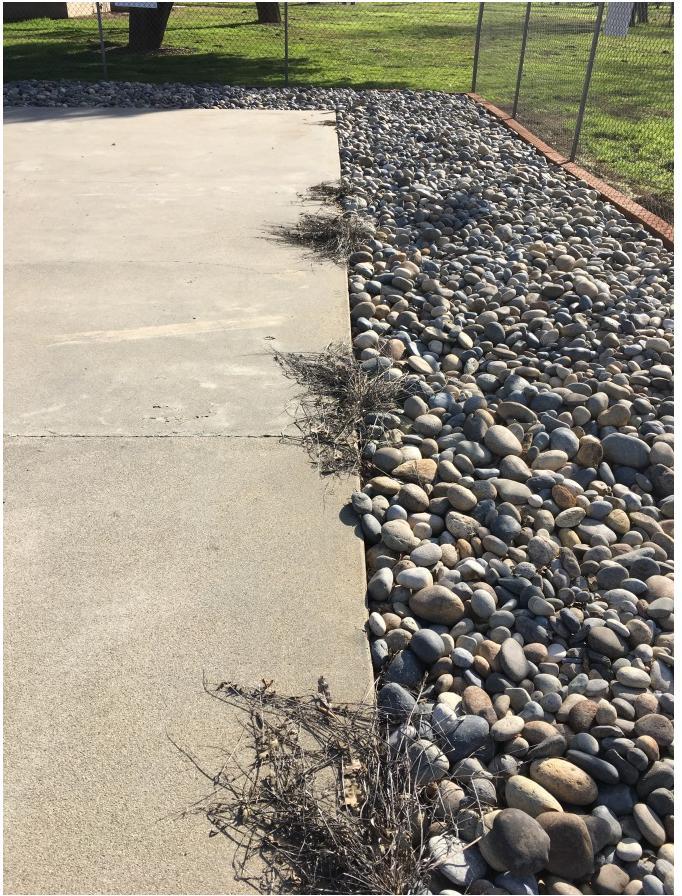
Overall, the site was found to be in good condition. Park maintenance employees have deterred vegetation growth by applying herbicide as needed around the pad year-round. While animal burrowing was noted near the site, no burrow holes were noted within the fenced area (PL-8). In addition, no soil erosion or subsidence was noted. No new surface cracks or gouges in the concrete pad were found.

PL-2. Dead Vegetation Along North Side of Pad

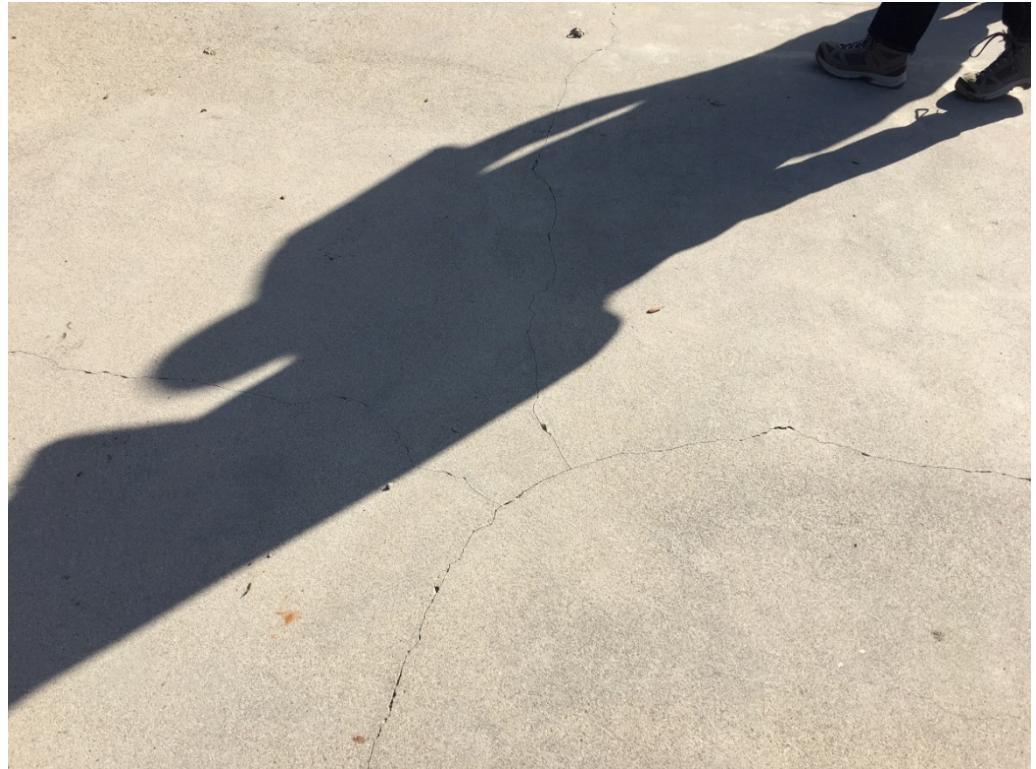
The concrete pad has minor surface cracks that do not pose a health risk. In 2014 these same cracks were scanned by a radiological control technician, and no results were above background. During 2018 maintenance activities, a surface gouge was noted in the concrete pad about 10 ft from the northwest corner of the pad. The pad was gouged before the 2018 maintenance activity and was filled with sand by the Parks and Grounds Department. A trowel and cement repair kit were used to repair the gouge during the March 2018 maintenance.

PL-3. Cracks in Concrete Pad Surface

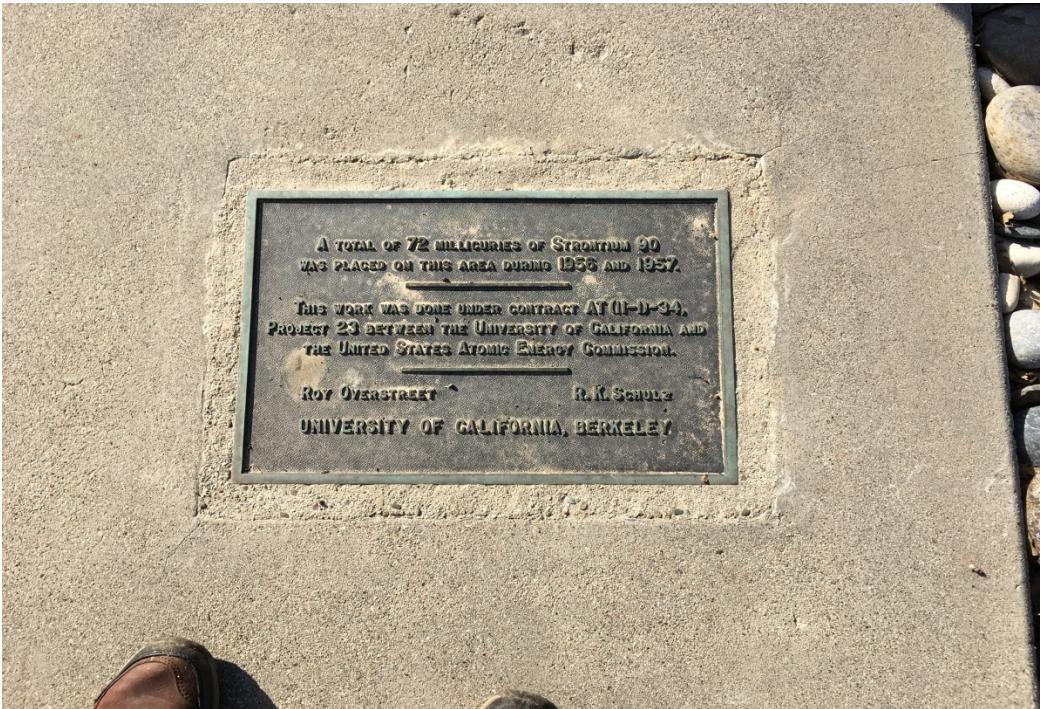
The historical bronze plaque on the southeast corner of the pad is legible and free of debris and remains in good condition. No maintenance or deferred maintenance needs for this IC were identified. Photograph PL-4 shows the current condition of the plaque.

PL-4. Historical Bronze Plaque

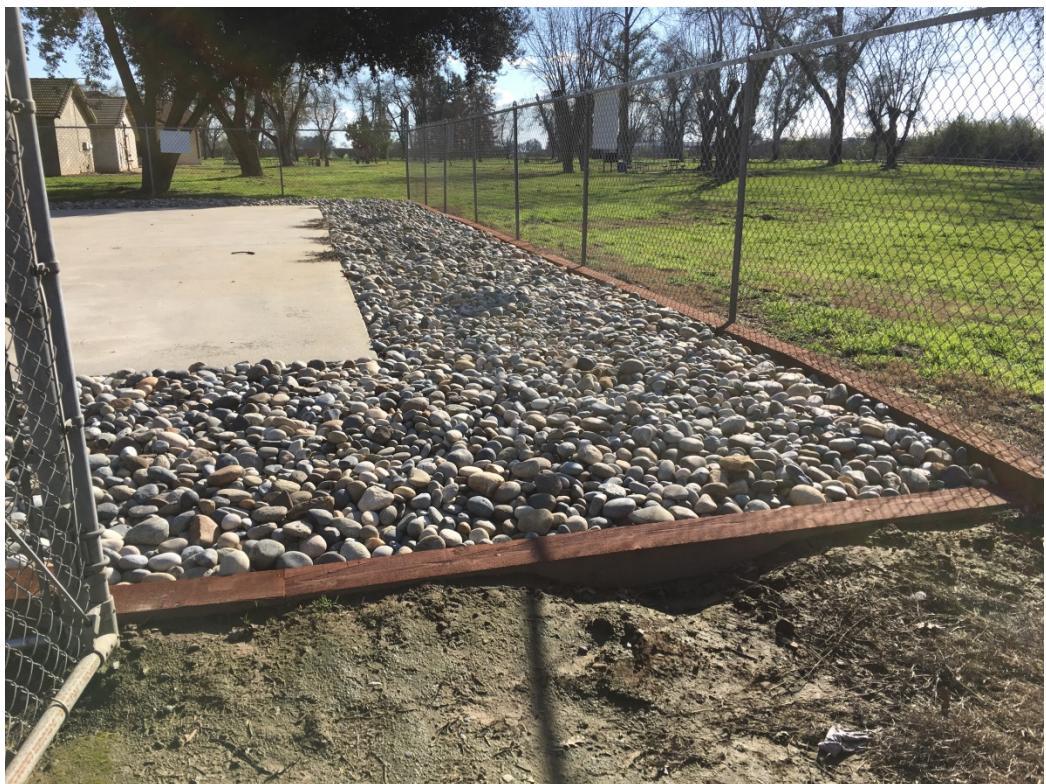
As reported in the 2016 inspection, fence maintenance restored this asset to a protective condition. The expected longevity of the fence is about 25 years. During the 2017 inspection, a closer look at the age of the fence revealed a replacement is necessary within the next 10 years. As such, LM will plan to replace the entire fence and gate in 2025. To address erosion and animal burrowing concerns at the site, LM installed a bottom fence rail around the entire fence perimeter, except the gate, and secured the fence bottom to the rails during the March 2018 maintenance activities. To further strengthen the life of the fence to prevent the riprap from pushing on the fence bottom, 4×4 timbers were placed inside the fence line. These timbers will be replaced on the same schedule as the fence replacement. Photographs PL-5 and PL-6 show the current condition of this IC.

PL-5. Interior View of Fence with New Bottom Rails and Riprap, Looking West

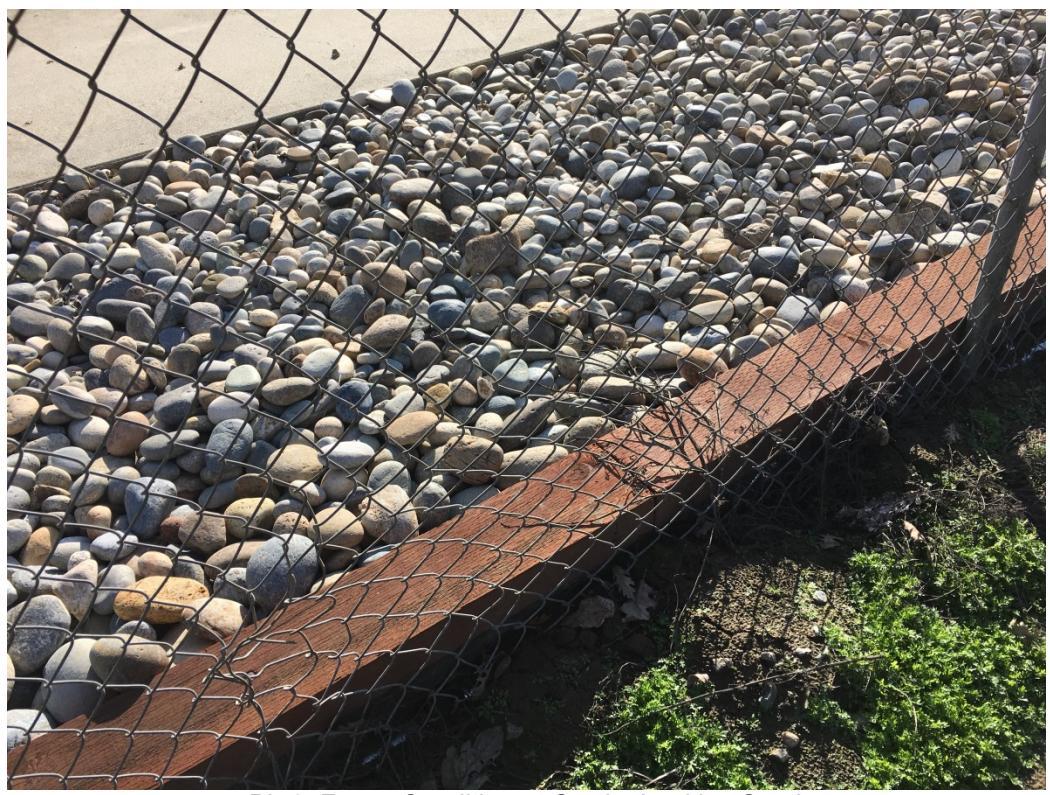
PL-6. Fence Condition at Grade, Looking South

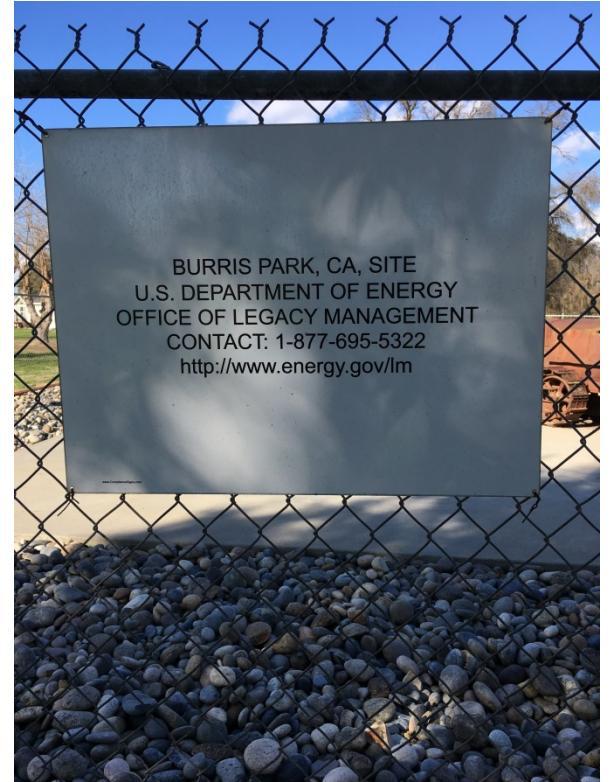
Signs on each side of the fenced area were present and found to be in good condition with no maintenance needs or cause for a follow-up inspection identified. It is recommended the rusty metal hangers for the signs be replaced with plastic/zip ties in the future. Refer to photograph PL-7.

PL-7. Verified Signage Posted on All Sides of Fencing

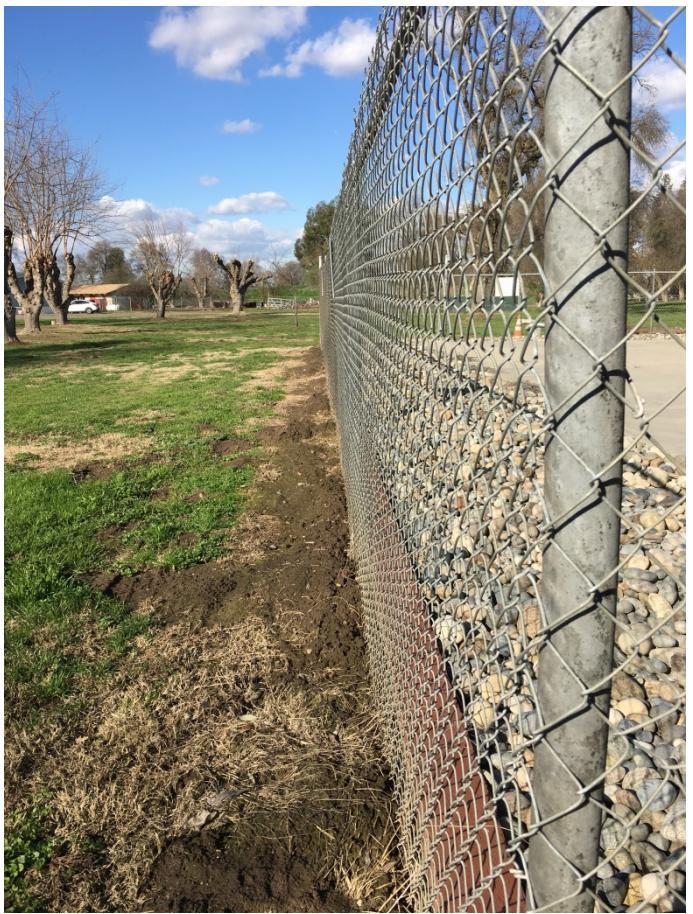
PL-8. Fencing and Animal Burrowing, Looking North

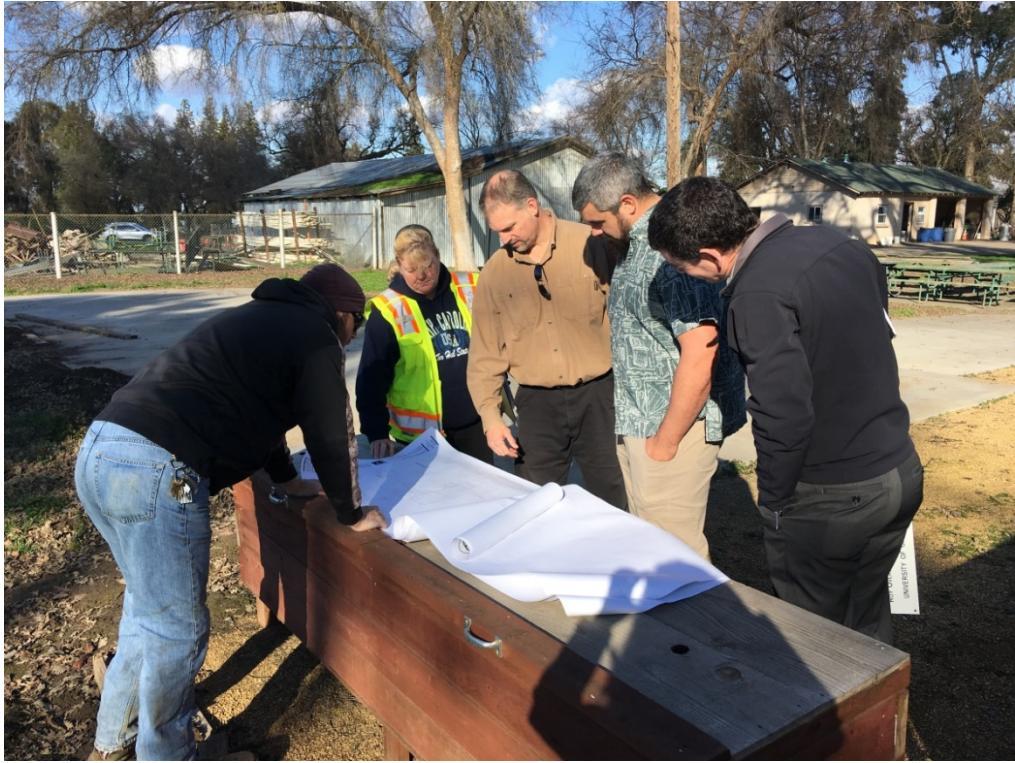
While there are no zoning changes planned for the area adjacent to the site, Kings County has expanded use of the park for an outdoor education program for students; the Parks and Grounds Department estimates that 2000 students are expected yearly. In addition, the County plans to build a greenhouse in 2019 adjacent to the eastern portion of the site, with an 8 ft buffer zone from the fence line. Parks and Grounds officials provided a copy of the greenhouse plans for review (PL-9). The County also plans to build an amphitheater within the next 3 years on the other side of the museum (south of the site). LM requested a copy of the design plans as well as a copy of the park's master plan document. Parks and Grounds officials indicated they would compile and send electronic files to LM.

PL-9. Reviewing Proposed Greenhouse Construction Drawings
