Surveillance of Site A and Plot M

Report for 2021

Surveillance of Site A and Plot M Report for 2021

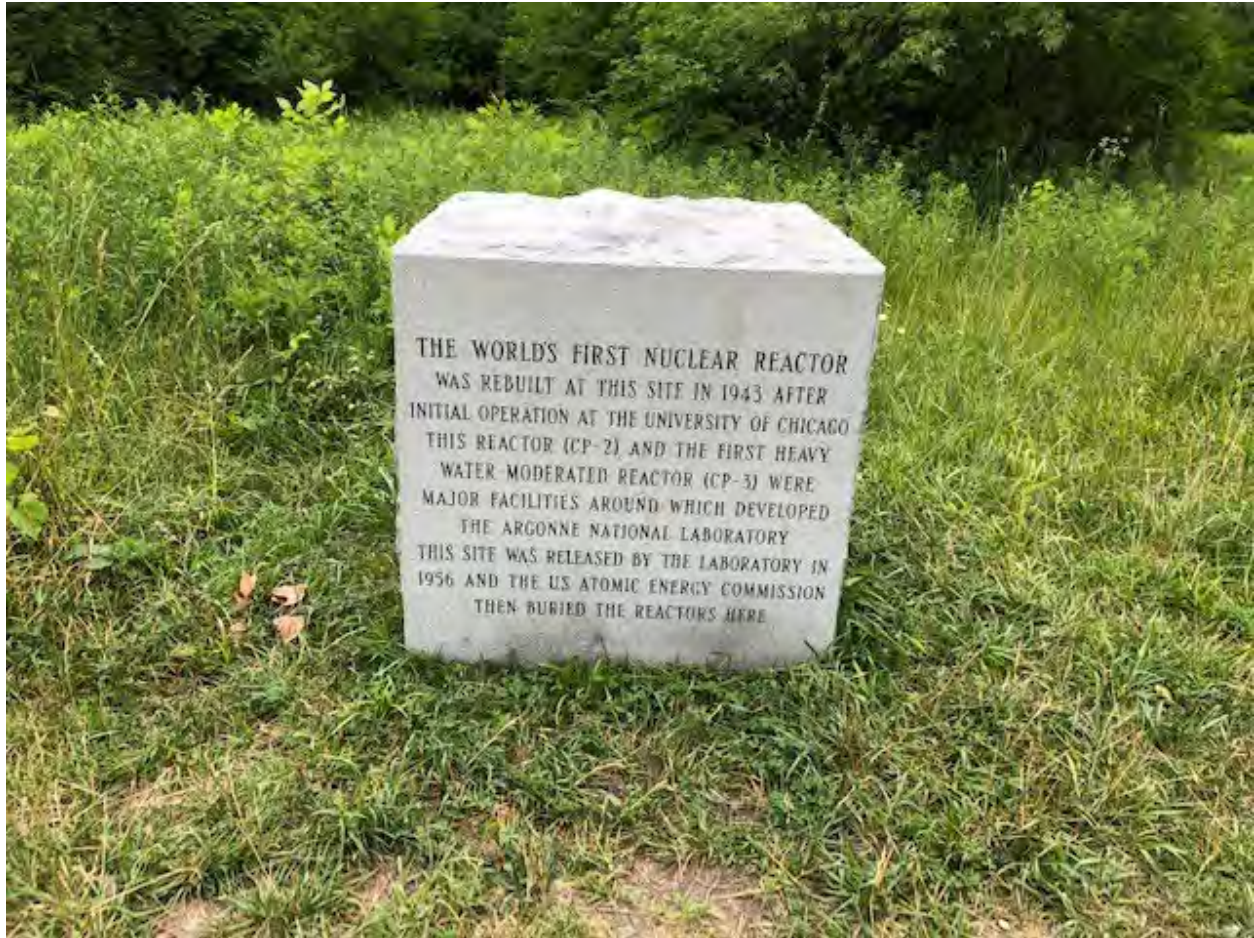
Figure 1-1 View of Site A Monument

At the request of DOE-LM during a previous annual inspection, the Site A and Plot M monuments were replaced in May of 2021. Figures 1.1 and 1.2 show views of the new monuments.
