# Data Validation Package

**October 2010**  
**Groundwater and Surface Water**  
**Sampling at the Canonsburg,**  
**Pennsylvania, Disposal Site**

**January 2011**

Legacy  
Management

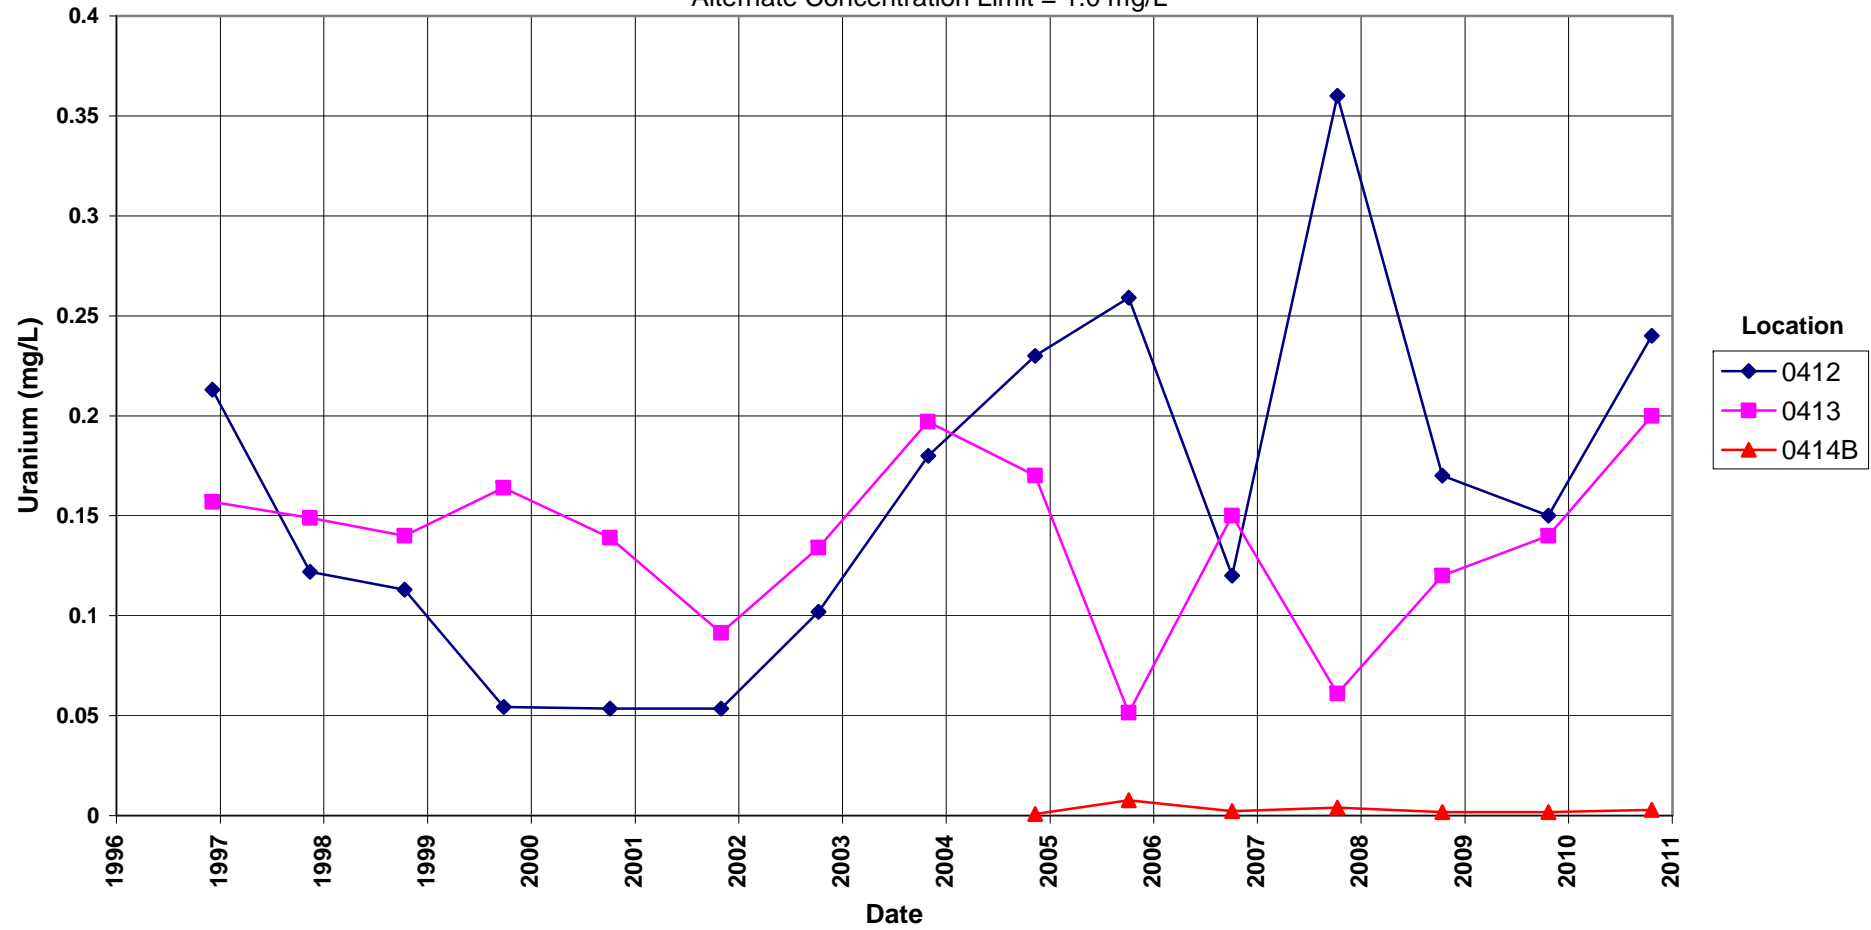
**Canonsburg Disposal Site  
Point of Compliance Wells  
Uranium Concentration**

Alternate Concentration Limit = 1.0 mg/L

The ACL for uranium was not exceeded in the point-of-compliance wells 0412, 0413, and 0414B, nor was the ACL exceeded at surface location 0602.

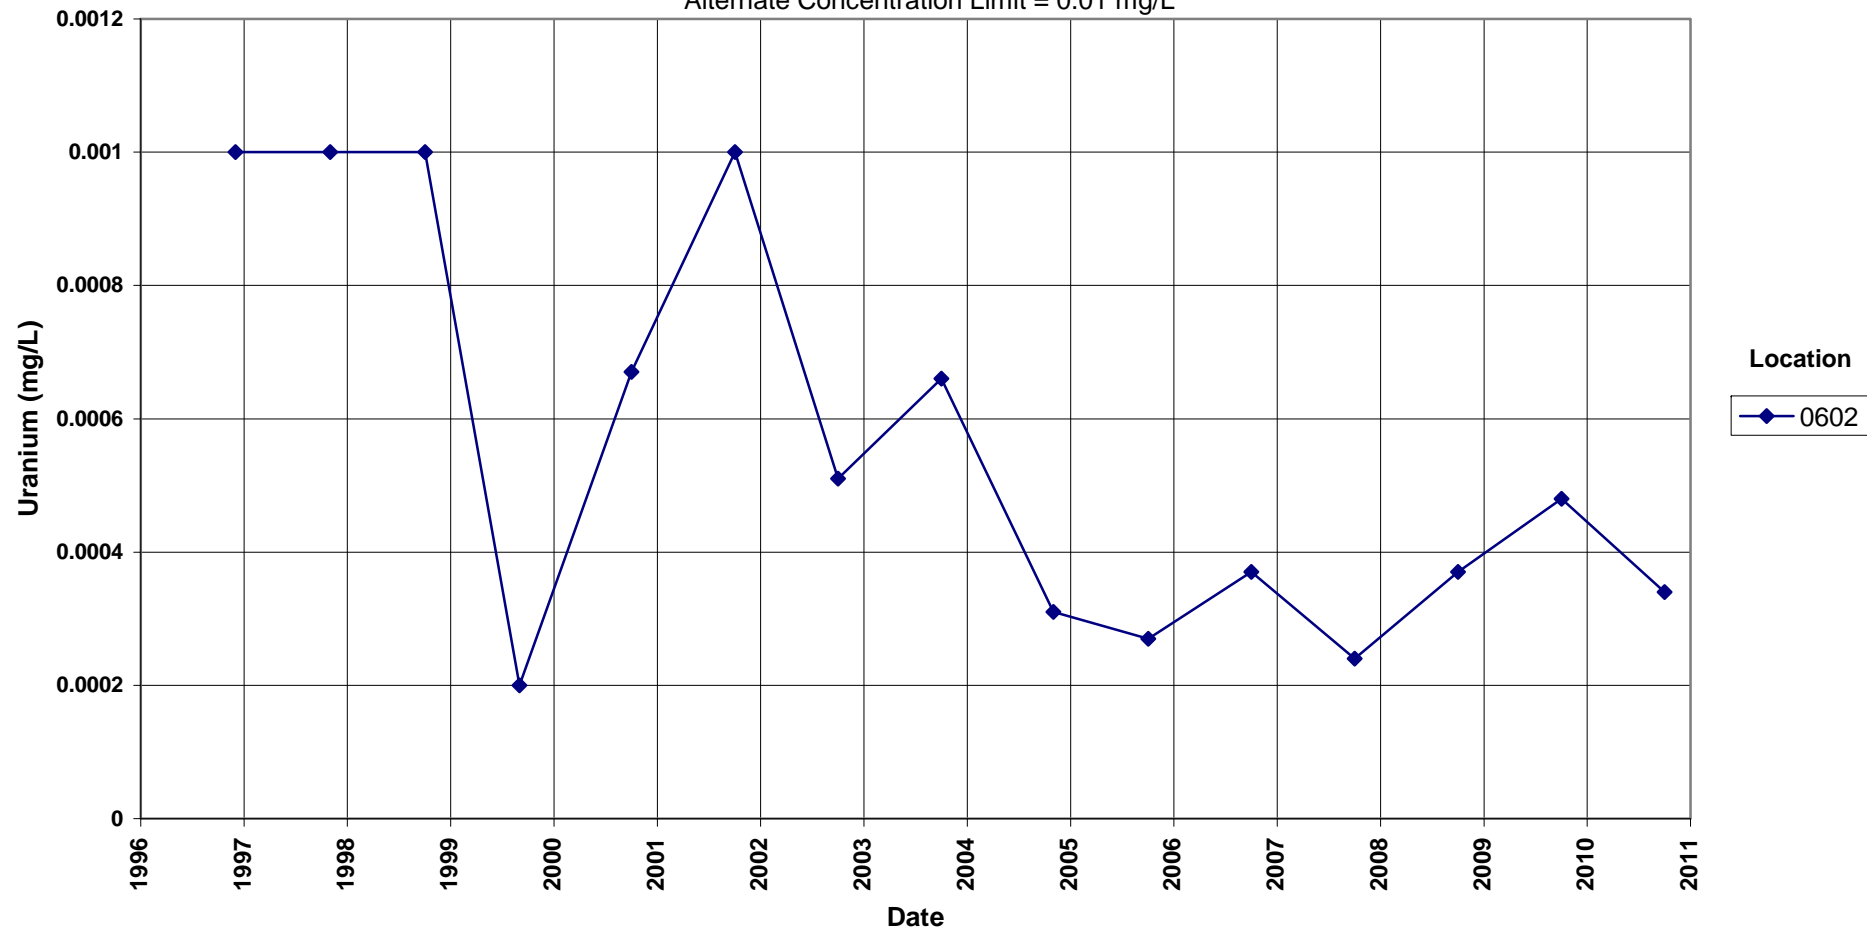
**Canonsburg Disposal Site**  
**Surface Location**  
**Uranium Concentration**

Alternate Concentration Limit = 0.01 mg/L
