**Annual Performance Report  
April 2012 Through March 2013  
for the  
Shiprock, New Mexico, Site**

**November 2013**

**U.S. DEPARTMENT OF  
ENERGY**

Legacy  
Management

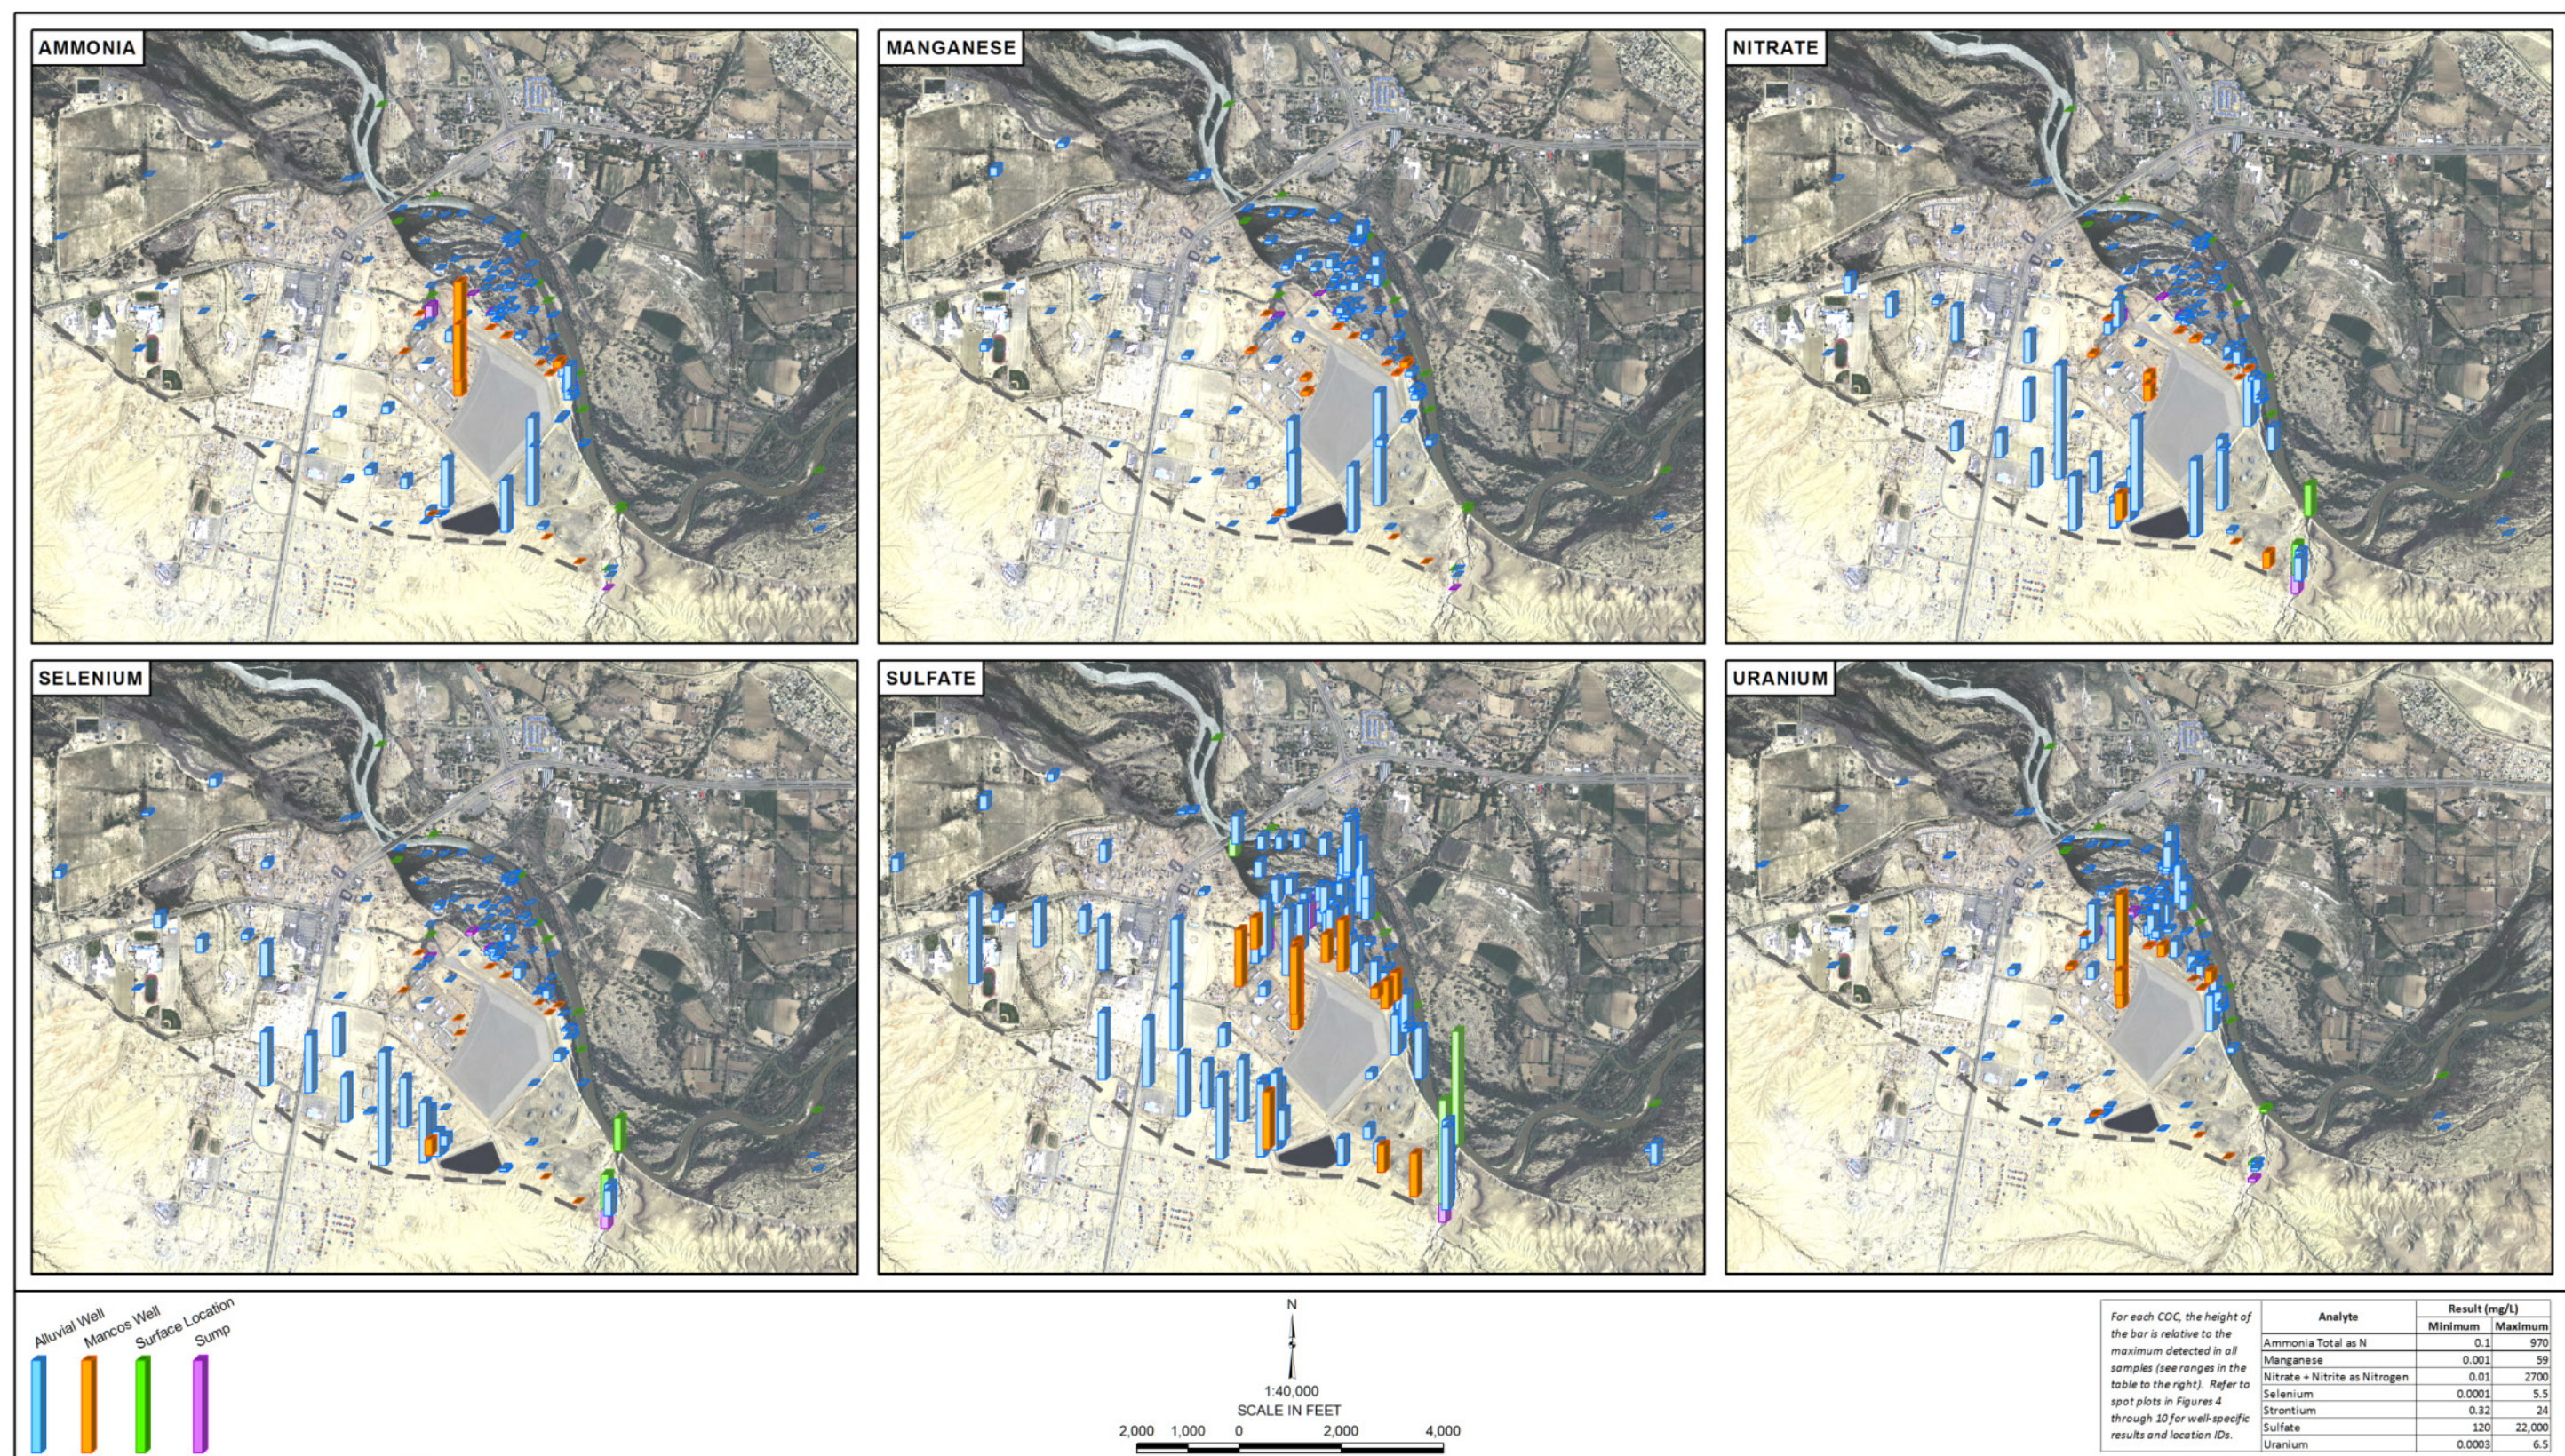
Figure 11. Comparison of Relative Contaminant Distributions for the Primary COCs, August 2012–March 2013

Selenium's spatial distribution is similar to that observed for nitrate in that concentrations are most elevated along the terrace buried escarpment and in Many Devils Wash (Figure 7 and Figure 11). The plume maps in Figure 18 indicate some reductions in selenium concentrations in the central portion of the floodplain. Selenium concentrations on the floodplain are most elevated in the Trench 1 area and, southeast of Trench 1, in wells located at the base of the escarpment (Figure 19). With few exceptions (e.g., well 0779), selenium concentrations in wells near the river are below the 0.05 mg/L GCAP compliance standard (or cleanup goal for the floodplain), and a number of results are below detection limits.

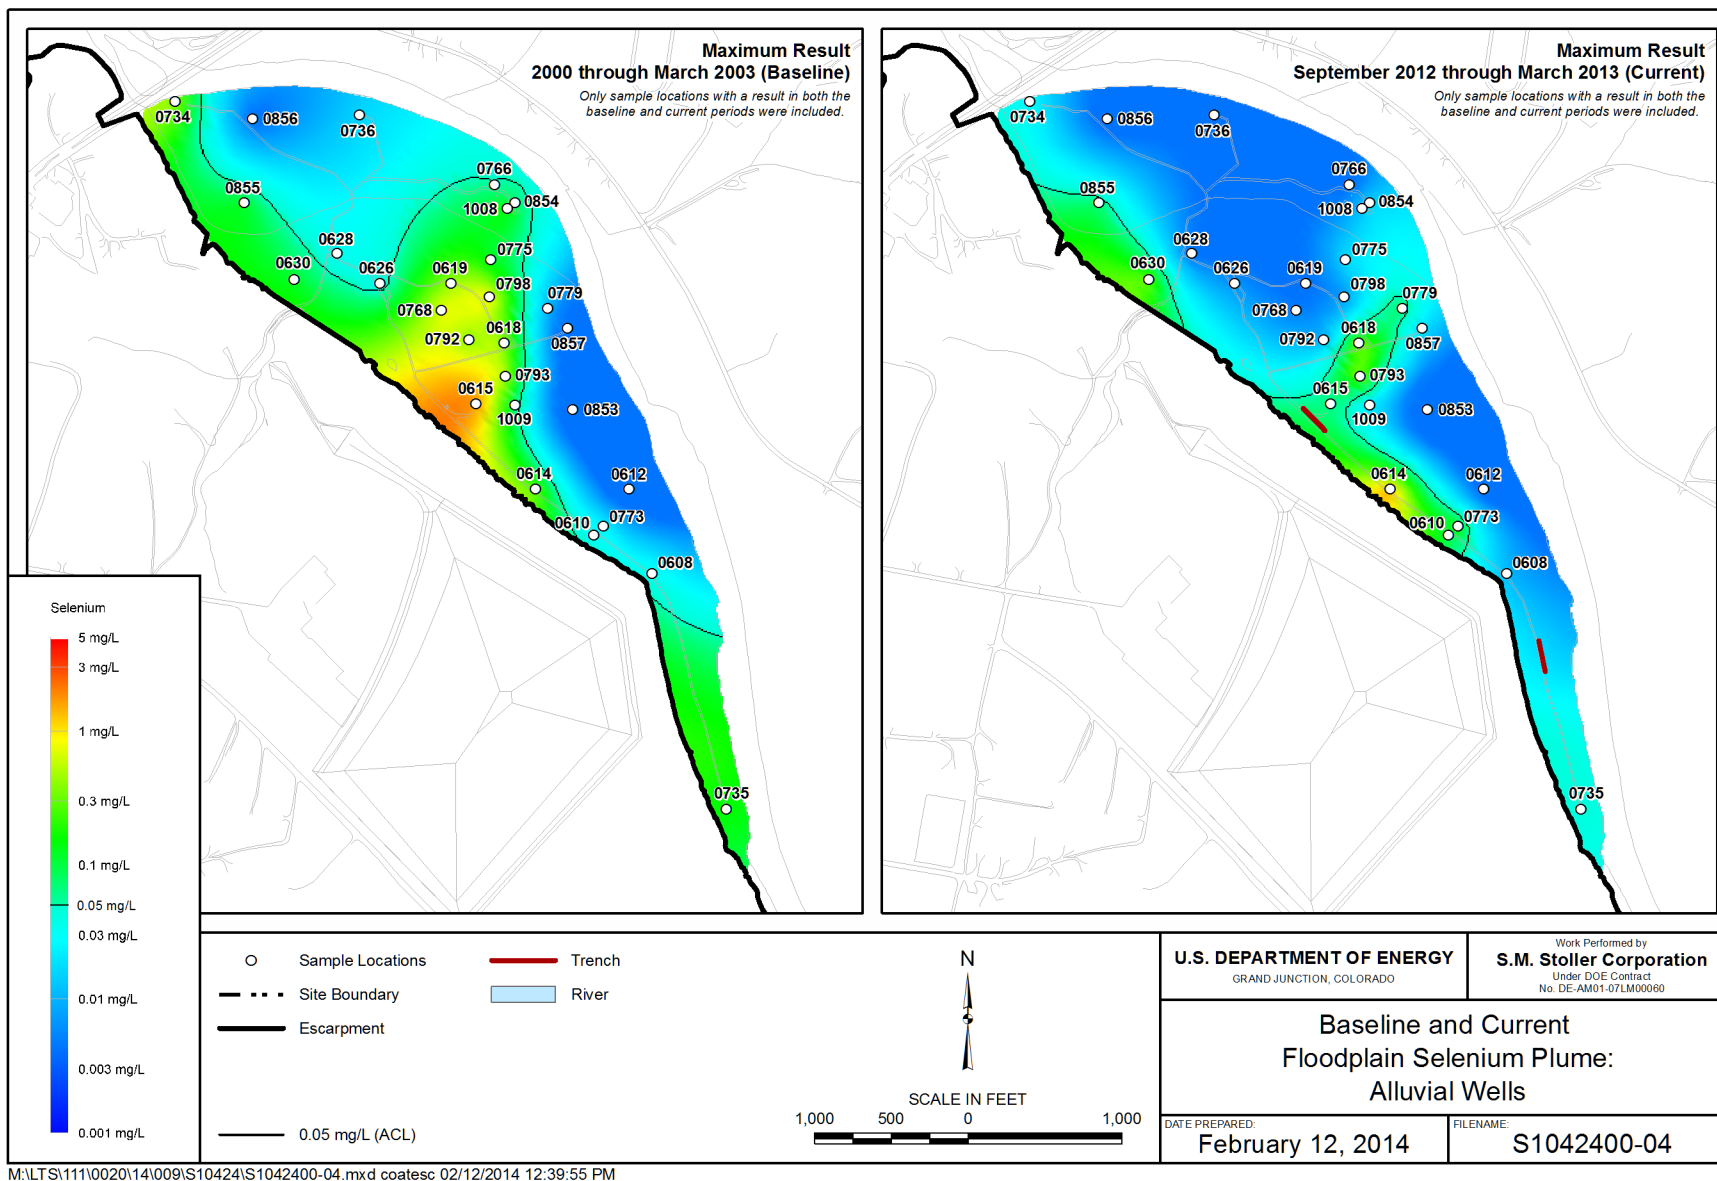
Figure 18. Baseline (2000–2003) and August 2012 through March 2013 Floodplain Selenium Plumes

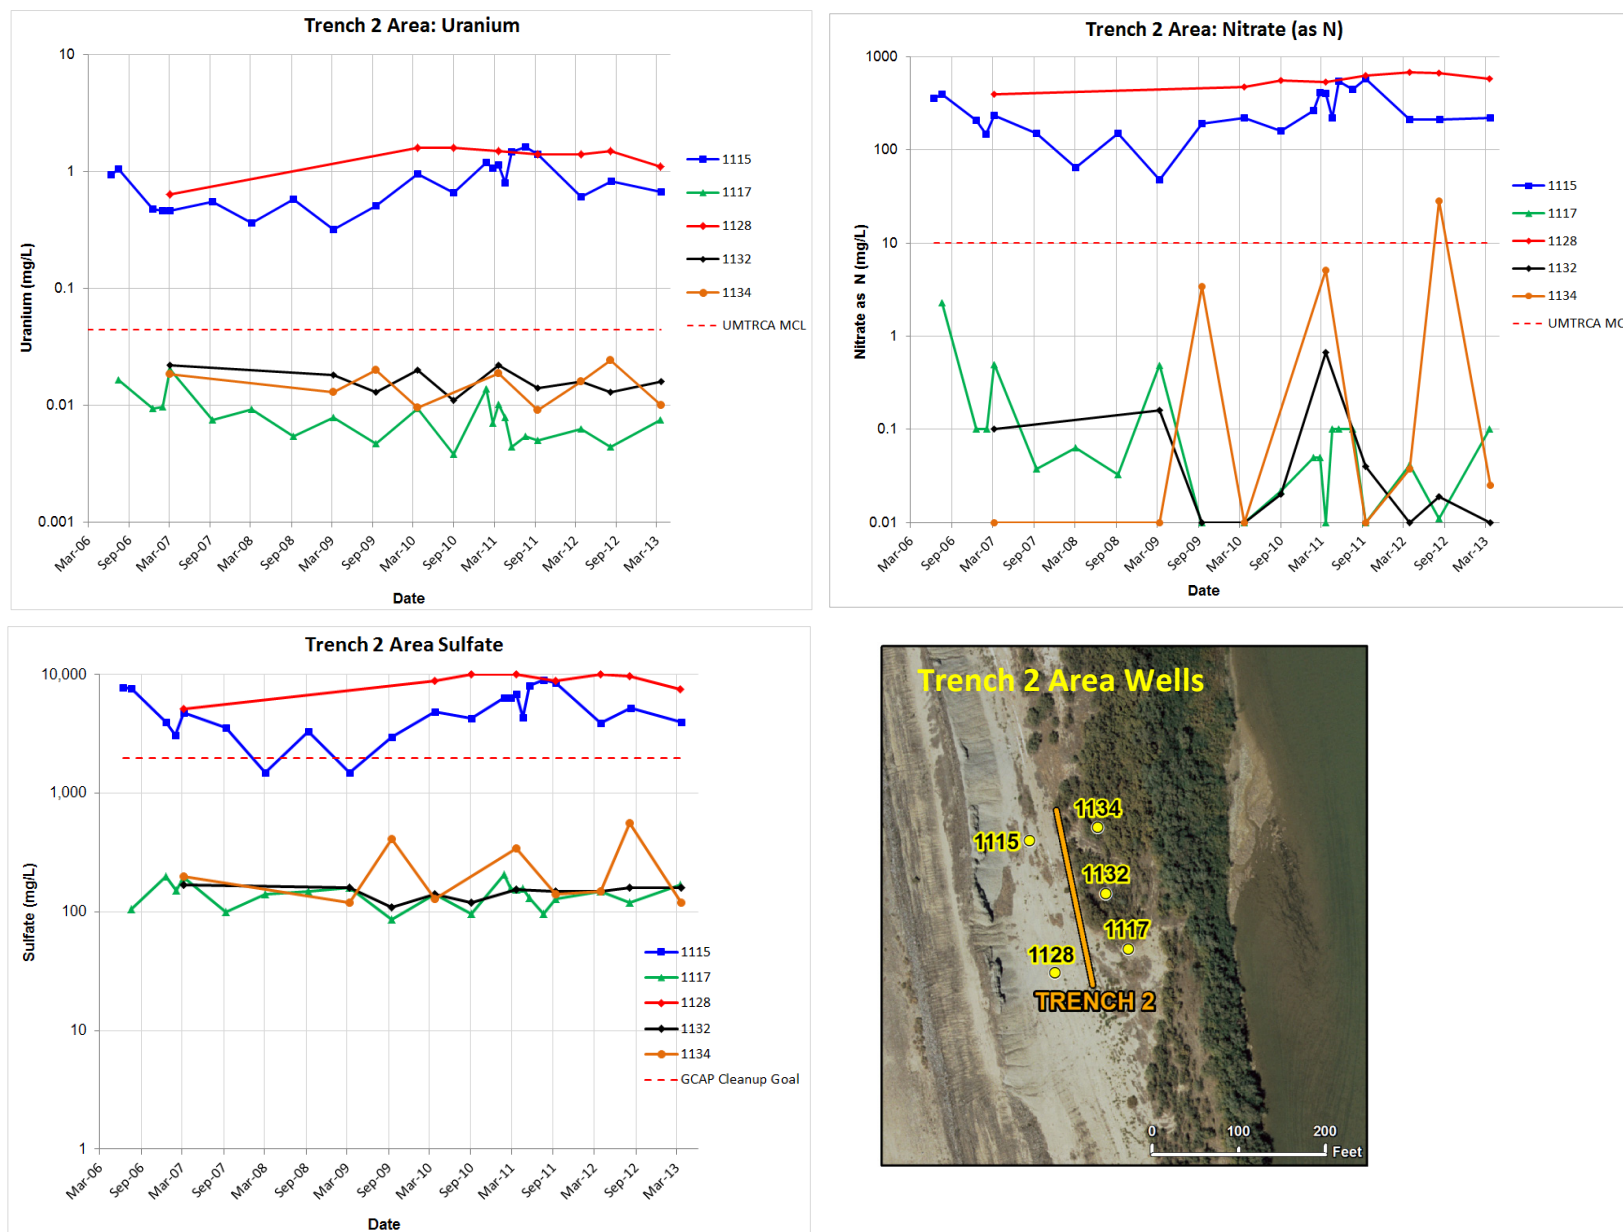
Figure 31. Uranium, Nitrate, and Sulfate Trends in Trench 2 Area Wells

Figure 31 plots uranium, nitrate, and sulfate concentrations in the wells surrounding Trench 2. In this set of plots, all data are plotted in logarithmic scale because of the marked differences in contaminant magnitude between wells on the escarpment side of the trench and wells on the river side of the trench. While uranium concentrations in wells 1115 and 1128 have generally ranged from 0.5 to 1 mg/L, levels in wells located on the river side of the trench have remained stable at about 0.01–0.02 mg/L, below the 0.044 mg/L UMTRCA MCL.

As observed for uranium, sulfate and nitrate concentrations in wells between Trench 2 and the escarpment are several orders of magnitude higher than levels measured in wells located on the river side of the trench. For example, sulfate concentrations in wells between the trench and the escarpment generally range from 3,000 to 10,000 mg/L. In contrast, levels in wells on the river side of the trench have been at or below 560 mg/L, well below the 2,000 mg/L floodplain cleanup goal. The 10 mg/L nitrate (as N) UMTRCA MCL was exceeded in well 1134 in August 2012 (28 mg/L). However, the most recent result (0.025 mg/L), is well below the cleanup goal.

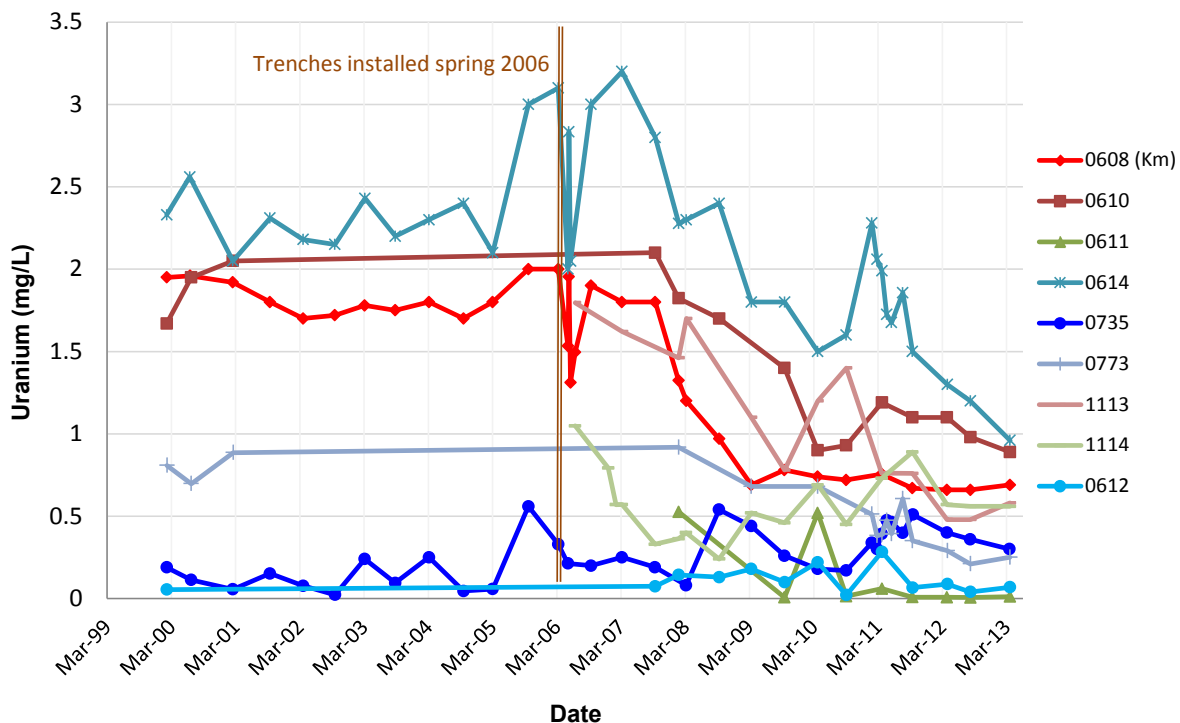
Figure 32. Uranium Trends in Southeastern Floodplain Wells

Figure 32 plots uranium concentrations in the southeast well subset shown in Figure 27. Temporal trends in concentrations in this set of wells, particularly at the base of the escarpment, are important because they may indicate decreases, if any, of contaminant discharge from the terrace to the floodplain via fractures in the Mancos Shale. In Figure 32, declines are evident for well 0608 (screened in shallow Mancos Shale) and alluvial wells 0610, 0614, 0773, and 1113, all located at the base of the escarpment. Trending is not apparent for the remaining wells in this subset.
