2014 Verification Monitoring Report, Riverton, Wyoming, Processing Site

March 2015

**U.S. DEPARTMENT OF
ENERGY**

Legacy
Management

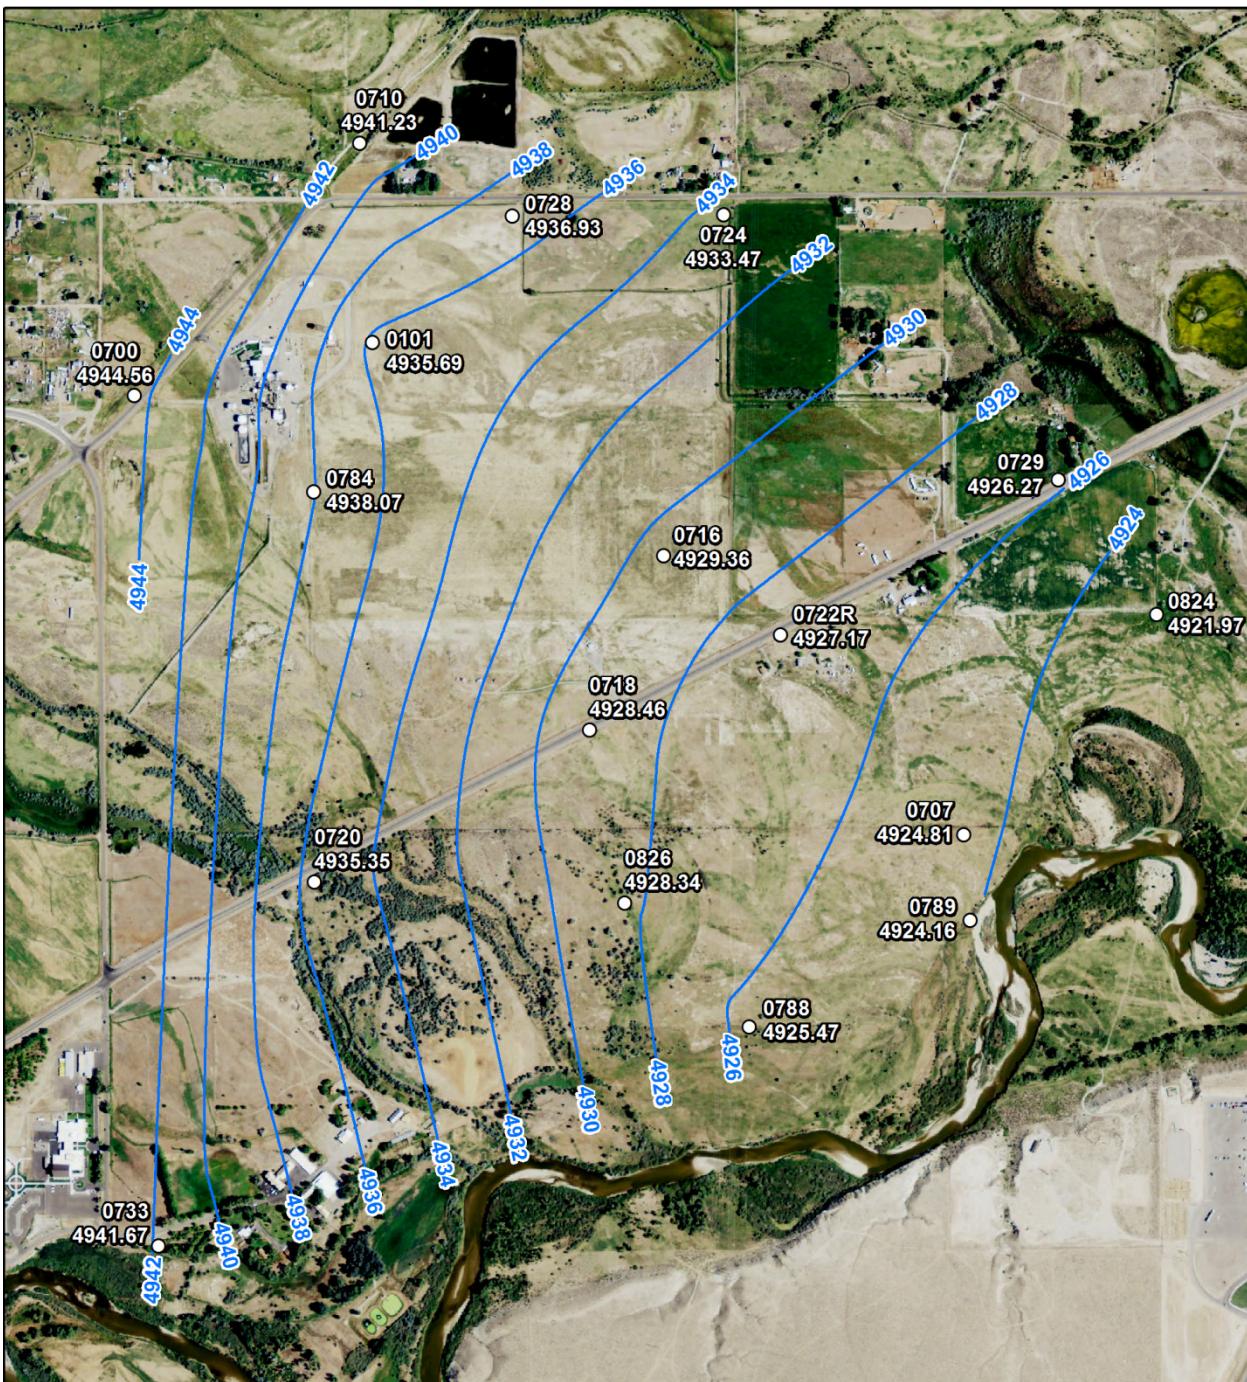
Figure 4. September 2014 Groundwater Elevations in the Surficial Aquifer at the Riverton Site

**September 2014 Groundwater Elevations
in the Surficial Aquifer
Riverton, WY, Processing Site**

Water levels were measured at all wells (except domestic wells) in the monitoring network (Figure 2) in September to verify groundwater flow direction and to assess vertical gradients throughout the IC area. Water level data are included in Appendix A.

Assessment of horizontal groundwater flow direction in the surficial aquifer is required to ensure that the monitoring network is adequate for assessing contaminant plume movement and to ensure that the IC boundary provides a sufficient buffer to prevent access to contaminated groundwater. As shown in Figure 4, groundwater elevation contours for the surficial aquifer indicated a general flow direction to the southeast in September. In addition to water levels measured in September, continuous water-level measurements recorded by pressure transducers installed in wells along the groundwater flow path demonstrate that, based on groundwater elevations, the groundwater flow does not reverse direction throughout the year (Figure 5).

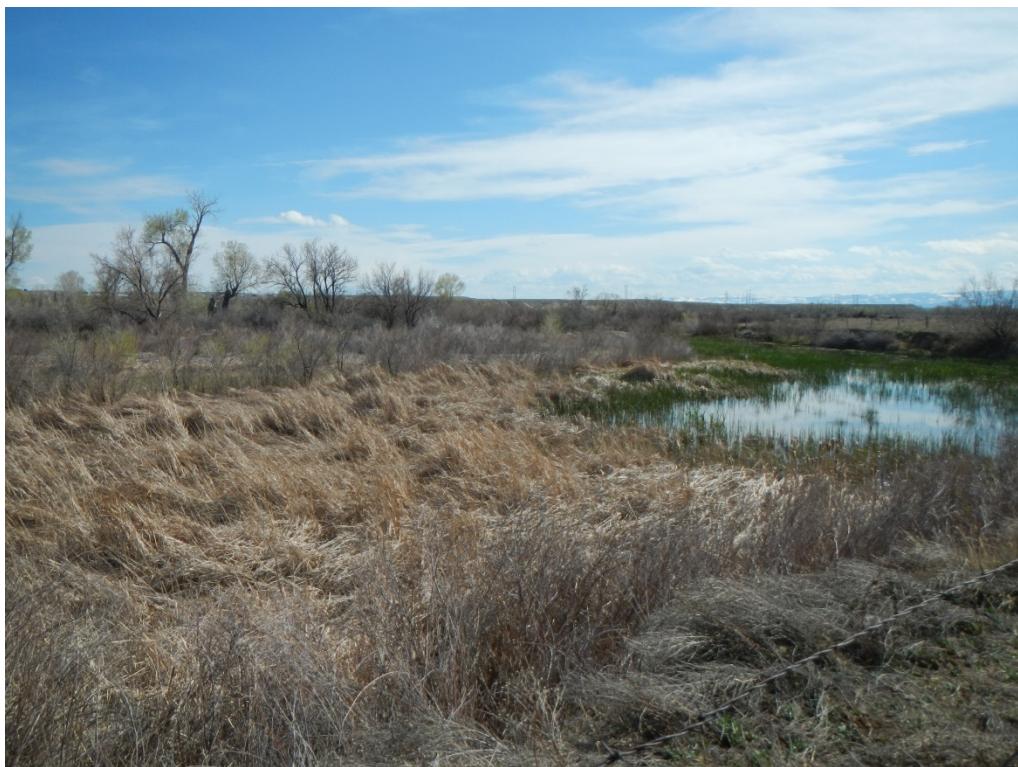
Figure 21. Oxbow Lake in May 2014

Field observations since 2002 indicate the oxbow lake is gradually filling with sediment and vegetation over time, as expected. Evidence of numerous abandoned meanders (oxbows) of the Wind and Little Wind Rivers are evident from aerial photographs. Eventually, the oxbow lake will fill in like the other abandoned channels and not be an expression of surface water at the Riverton site. Figure 21 shows a photo of the oxbow lake in May of 2014, which illustrates the progress of the vegetation and sedimentation filling in the ponded water.
