2025 Groundwater Monitoring and Inspection Report Gnome-Coach, New Mexico, Site

April 2026

Legacy
Management

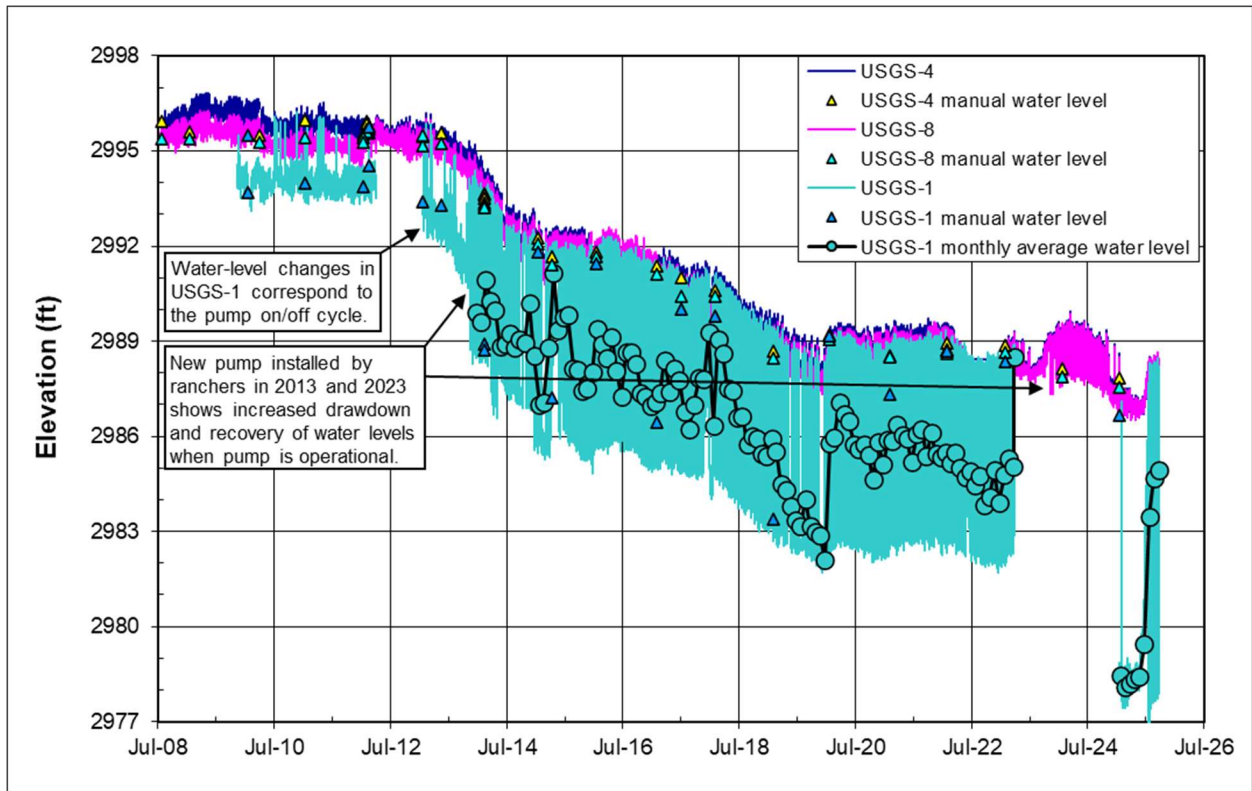
Figure 6. Groundwater Elevations in Culebra Wells, 2008 Through September 2025

Groundwater elevation data were evaluated with the historical data to assess changes in the groundwater flow system. The hydrographs for wells USGS-1, USGS-4, and USGS-8 (completed in the Culebra Dolomite) are shown in Figure 6. Groundwater elevation data from the Culebra wells continue to support a regional groundwater flow direction that is generally toward the south but is locally influenced by pumping from well USGS-1. These data also continue to show that pumping from well USGS-1 produces an almost immediate water-level drawdown response in wells USGS-4 and USGS-8, which are approximately 2350 ft northwest of well USGS-1 (Figure 6). Groundwater elevations have generally been decreasing in the Culebra wells since monitoring began in 2008 (Figure 6) but stabilized in 2020 and have generally remained stable through 2024. The exception is a brief decline between 2022 and 2023. A review of the data collected during this reporting period shows that groundwater elevations are decreasing again and that these decreases continued through this reporting period that ended in October 2025. These recent and past declines may be attributed to an increase in oil and gas activity and pumping of water from the Culebra Dolomite to support the increased drilling. The Culebra Dolomite is a highly fractured and transmissive unit, and a slight increase or decrease in groundwater elevation could be attributed to changes in pumping demands on this water bearing zone. Figure 7 is the hydrograph showing groundwater elevations for the Culebra wells during this reporting period.

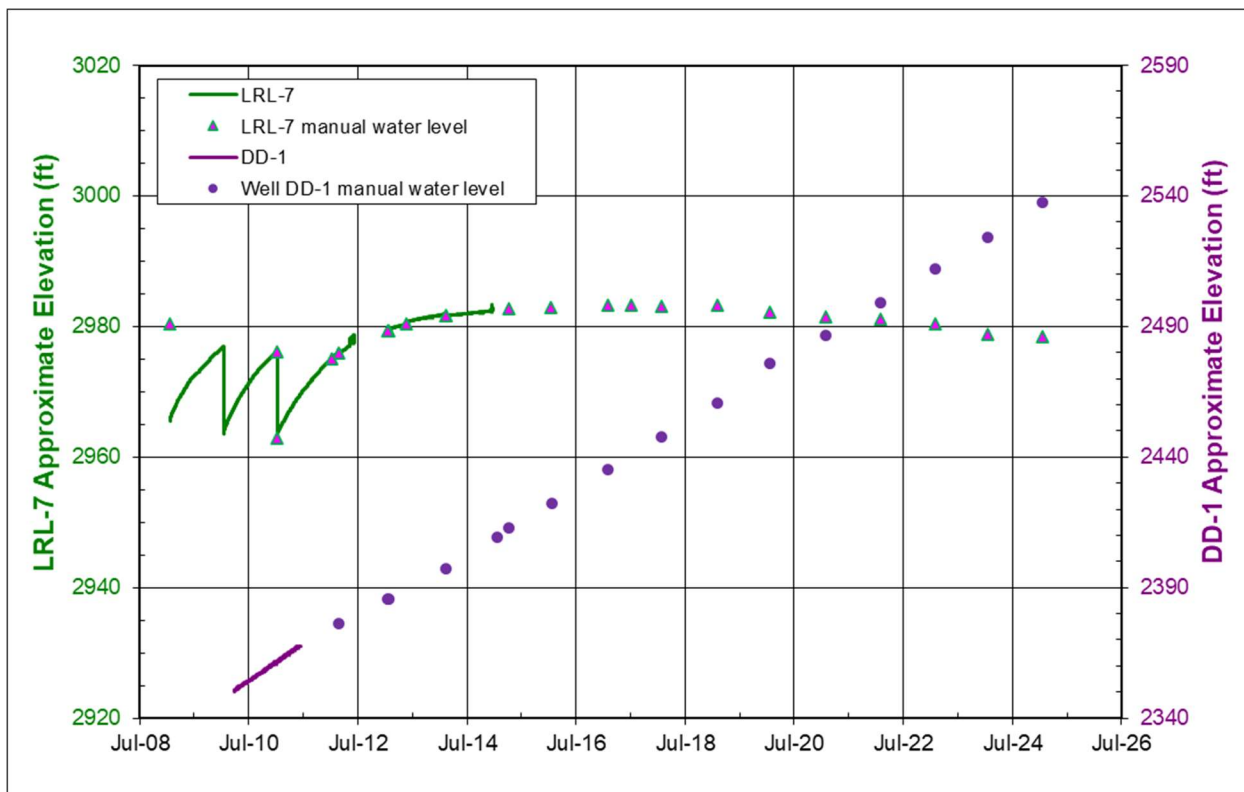
Figure 8. Groundwater Elevations in Salado Wells, 2008 Through September 2025

Manual water levels measured in January 2025 (Table 2) were used along with the top-of-casing elevations to convert the transducer data to groundwater elevations; these are presented as hydrographs to show data from the time monitoring began in 2008. The hydrographs are grouped according to each well's open interval and formation monitored (Figure 6, Figure 7, and Figure 8). A shorter time interval (2025 reporting period) of the Culebra well hydrographs are shown to highlight specific groundwater responses in Figure 7. Groundwater elevations from manual water-level measurements are shown as individual data point symbols, and transducer data appear as lines. These data were corrected for the specific gravity of water for each screened unit. The specific gravity of water from Culebra-screened wells is approximately 1.0035, and the specific gravity of water from Salado-screened wells is approximately 1.15. Borehole deviation data are available for wells USGS-1, USGS-4, and USGS-8, so groundwater elevation data from these wells include a correction for true vertical depth (Figure 6 and Figure 7). Borehole deviation data are not available for wells DD-1 and LRL-7, so groundwater elevations from these wells are approximate (Figure 8).

Fluid levels in the detonation cavity are monitored by well DD-1 and in the Coach drift by well LRL-7; both wells are in the Salado Formation. The hydrograph for wells DD-1 and LRL-7 is shown in Figure 8. The water elevations in these wells are likely not indicative of the Salado Formation because of their connection to the large unnatural openings and their use for disposal of liquid waste during site cleanup activities in the late 1960s and 1970s. Water elevations in well LRL-7 (primary vertical axis) have stabilized, are no longer rising, and have recovered from the last sampling event in January 2011. Water elevations in well DD-1 (secondary vertical axis) continue to rise at a rate of approximately 11 ft per year. Factors that influence water levels in wells LRL-7 and DD-1 include the slow refilling of the detonation cavity by the limited groundwater flow within the Salado Formation, remnant pressure effects associated with the detonation, the plastic nature of the Salado Formation, and injections of liquefied waste material associated with past disposal activities. Water elevations from wells DD-1 and LRL-7 are approximate because borehole deviation data are not available for these wells (Figure 8).

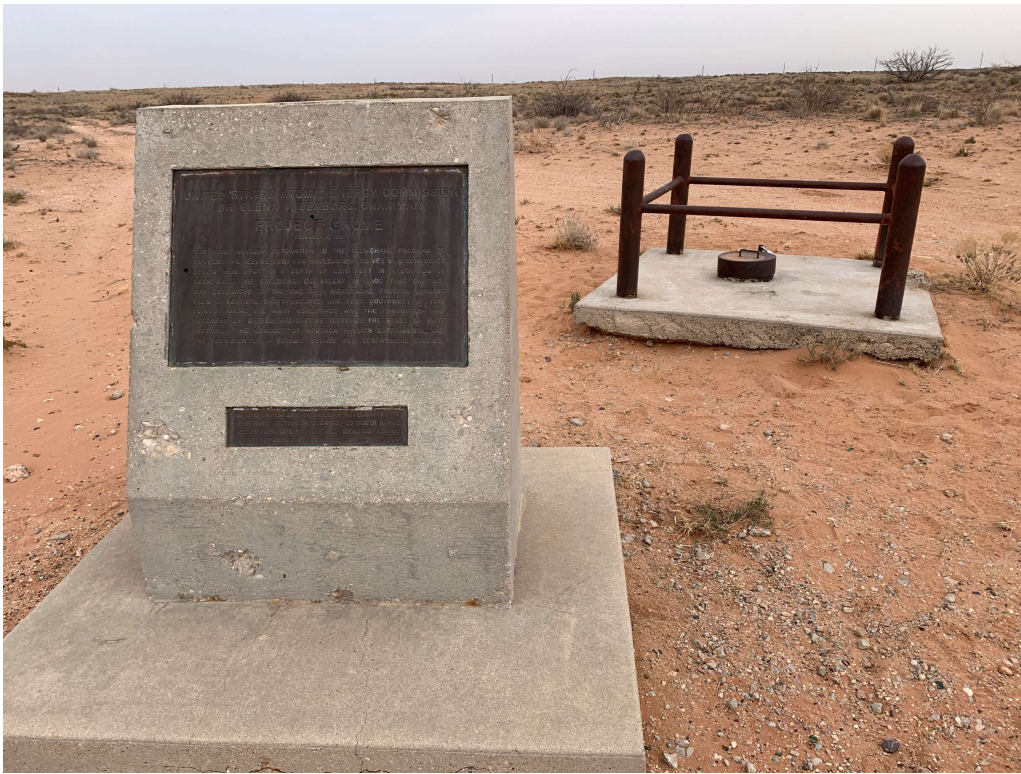
Photograph A-1. View Looking East at the Monument and Well DD-1 at the Gnome-Coach, New Mexico, Site

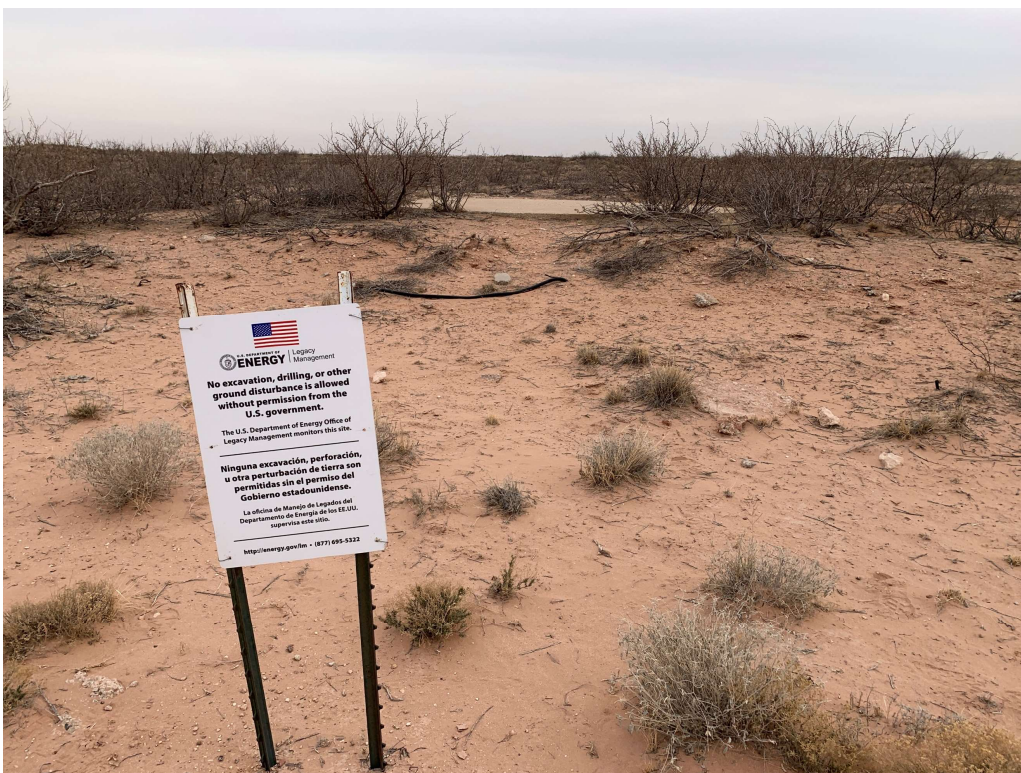
The site inspection and annual sampling were conducted on January 28, 2025. At the time of the inspection, a sign was replaced near the emplacement shaft, but the remaining signs onsite and around the site perimeter were observed to be in good condition, as were the roads, wellheads, concrete cap, and Project Gnome monument. No land use changes or significant land disturbances were observed during the inspection, and public websites were reviewed to verify that no activities were conducted or planned during the reporting period. No new applications were approved to drill a water extraction well onsite or in the sections that surround the site. Five new oil and gas well applications were approved to drill in the sections that surround the site, but no permits were approved to drill onsite. Based on these reviews and the inspection results, the ICs continue to be protective of the site. A search of seismic events indicated that 23 events having magnitudes between 2.0 and 2.93 occurred within 25 miles of the site. The frequency of these events has increased in Southeast New Mexico and West Texas since 2019. This increase has been attributed to increased oil and gas drilling and disposal of wastewater through deep injection wells within the Delaware Basin.

Photograph A-2. View Looking East at the Concrete Cap that Covers the Project Gnome Emplacement Shaft and the Sign that Notifies the Public of No Excavating or Digging Without Permission

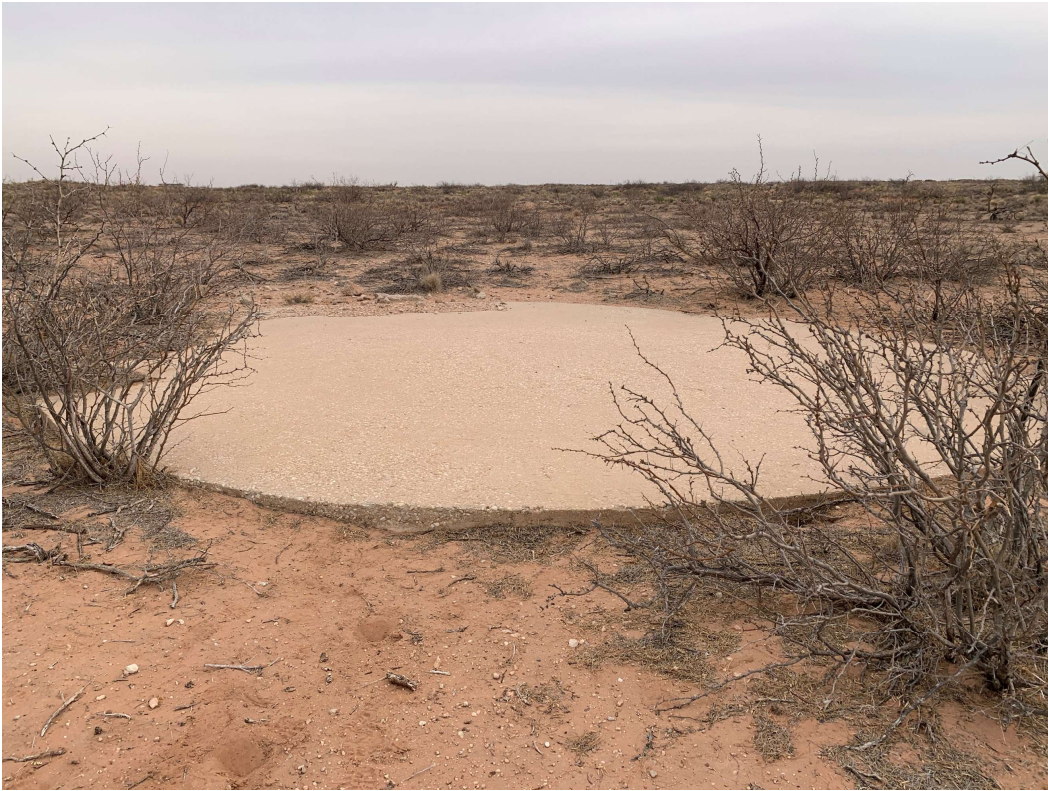
Photograph A-3. View Looking South at the Concrete Cap that Covers the Project Gnome Emplacement Shaft

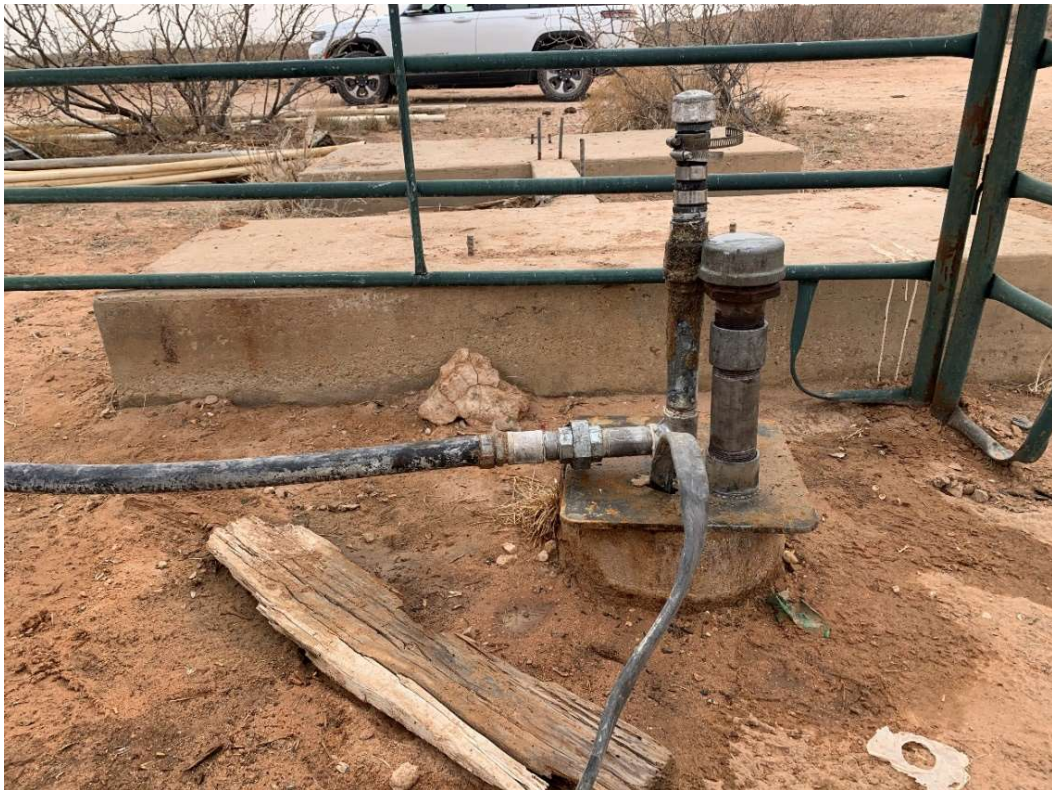
The site inspection for this reporting period was performed on January 28, 2025. The rancher installed a new water access pipe at well USGS-1 in January 2025, before the inspection on January 28. The new water access pipe changed the well top-of-casing elevation, so the onsite wells were resurveyed by the Legacy Management Support contractor in June 2025. The site wells, roads, concrete cap, and monument at surface ground zero were in good condition, and no land use changes or significant land disturbances were observed during the January 2025 inspection. One sign was replaced at the west end of the emplacement shaft, and the remaining signs onsite and around the perimeter of the site were in good condition. Appendix A provides photographs of some of the surface features at the site.

Photograph A-4. Well USGS-1 After Sampling on January 28, 2025

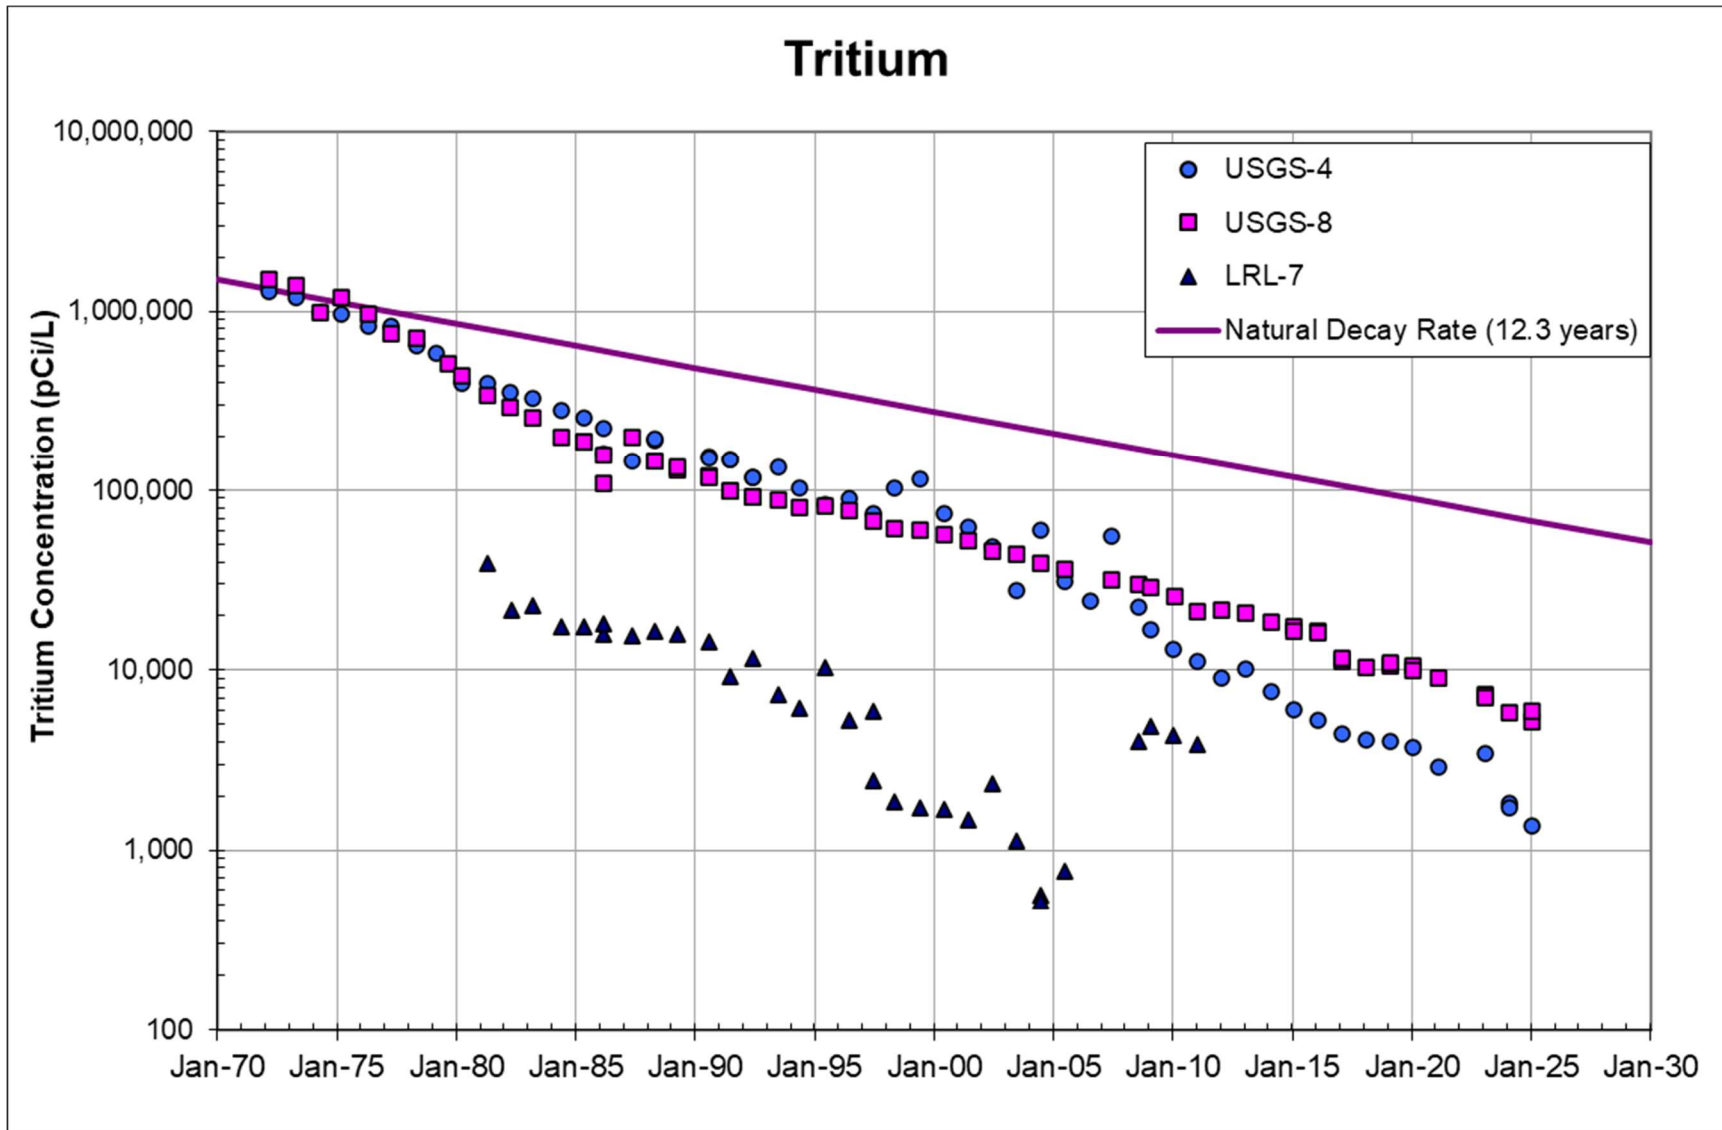
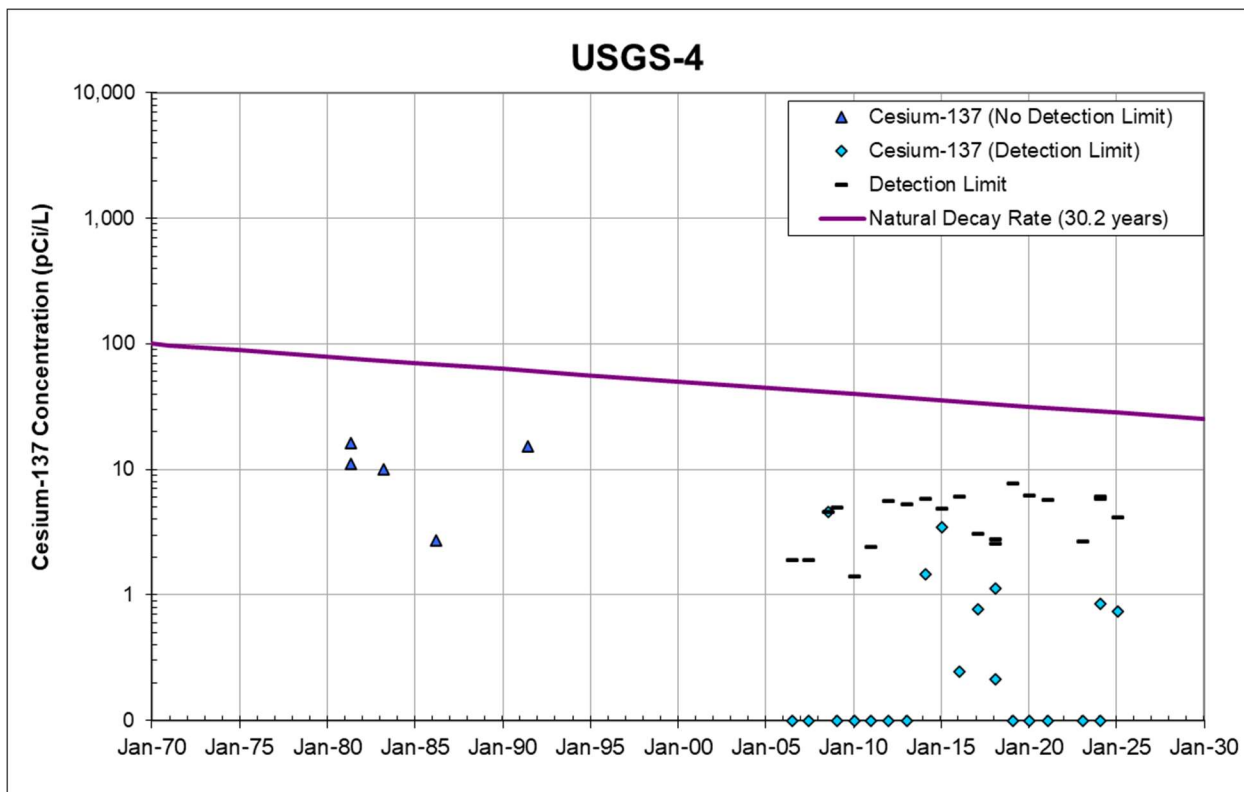
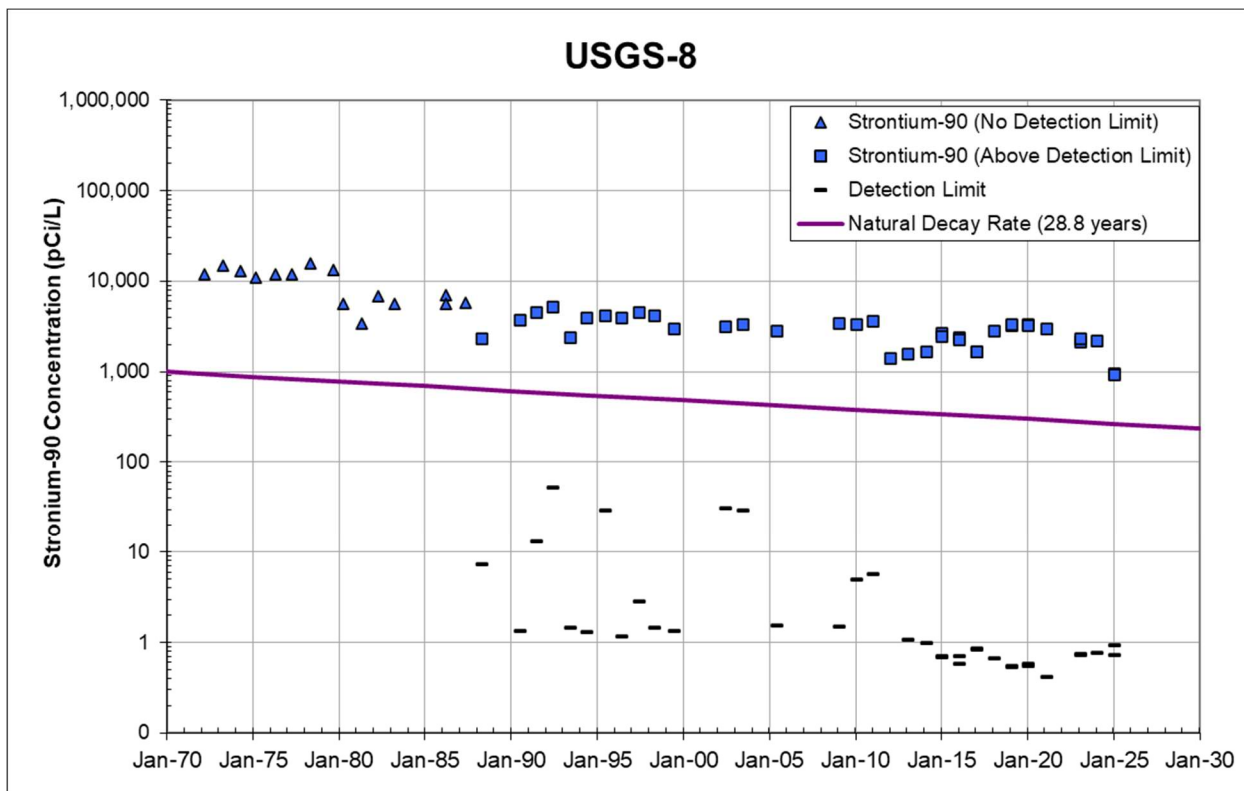
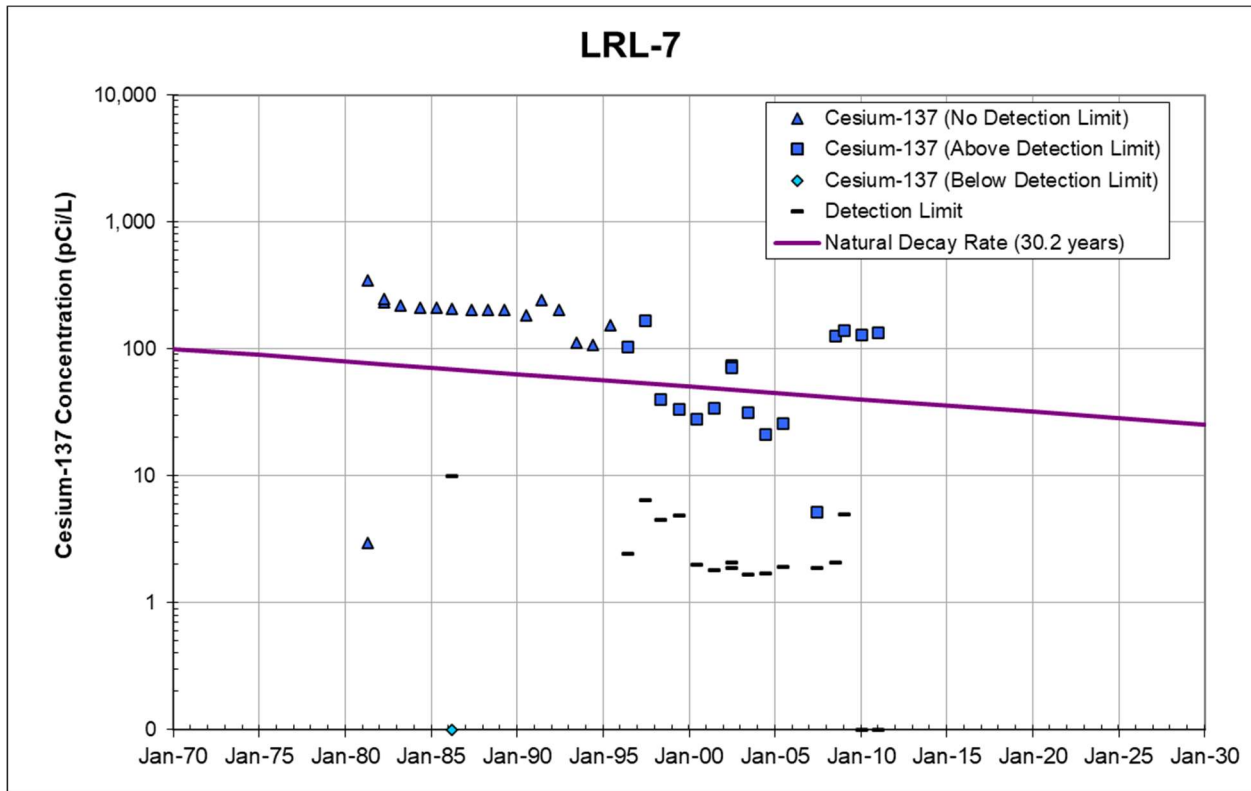
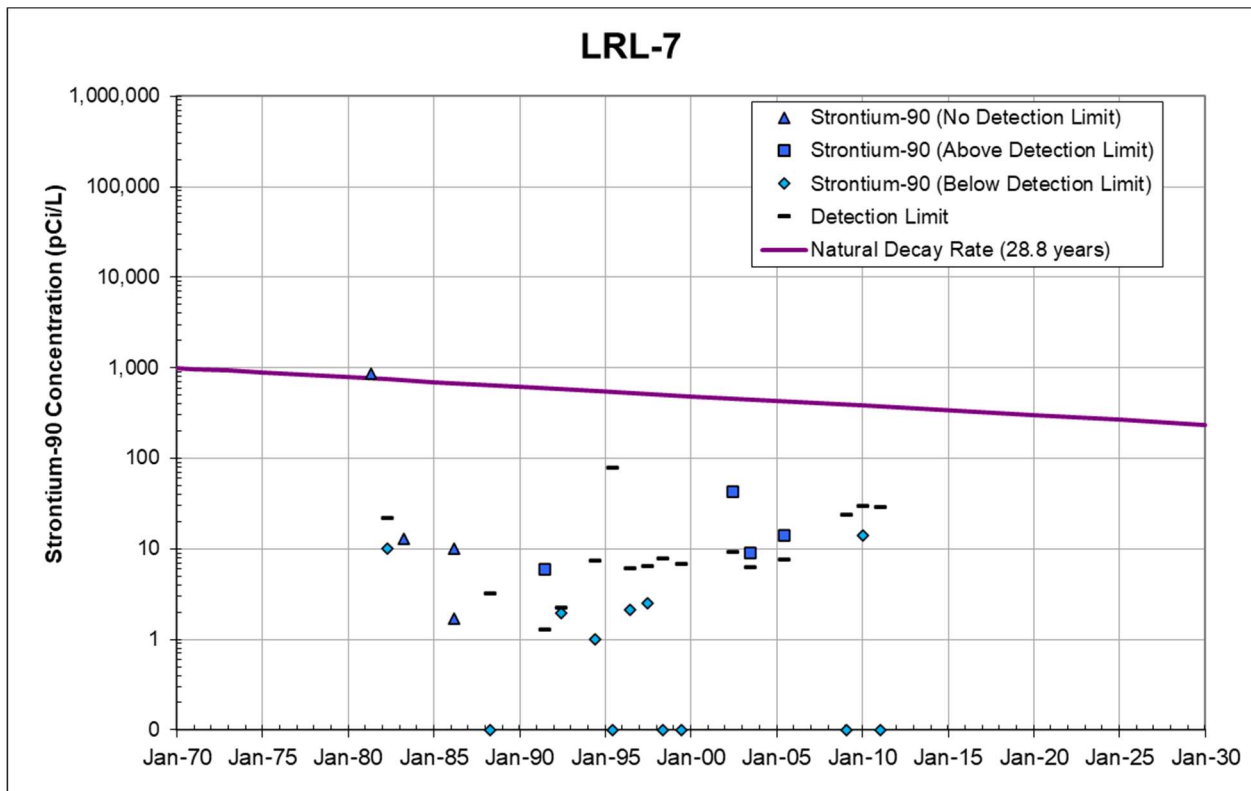
Figures B-1 through B-7 in Appendix B show temporal plots of radionuclide concentrations (1972–2025) in samples collected from wells LRL-7, USGS-4, and USGS-8 to support trend analysis. Sample results from well USGS-1 are not included because concentrations of tritium (using conventional methods), ^{90}Sr , and ^{137}Cs have not been detected above the laboratory minimum detectable concentration in this well since monitoring began in 1972. The detection of ^{90}Sr in the February 2017 (1.78 picocuries per liter [pCi/L]) and February 2023 (1.35 pCi/L) samples collected from well USGS-1 are attributed to laboratory error (DOE 2018) and results that are biased high or estimated by the laboratory (DOE 2024a), respectively. Concentrations are plotted on a semilogarithmic scale, and all sample results are plotted, including results below the laboratory minimum detectable concentration. Several results from sampling events before the late 1980s had no reported detection limit, as shown in the charts. For interpretation purposes, relatively high concentrations (i.e., concentrations significantly higher than detection limits associated with subsequent sampling) should be considered detections. The natural decay rates for tritium (12.3-year half-life), ^{90}Sr (28.8-year half-life), and ^{137}Cs (30.2-year half-life) have been included on the charts for reference. The increases in tritium concentrations in samples collected from well LRL-7 (Figure B-1) and ^{137}Cs concentrations in samples collected from wells USGS-8 and LRL-7 (Figure B-4 and Figure B-6) after the 2007 sampling event are attributed to changes in the sampling method. Before 2008, EPA collected samples using a depth-specific bailer. Starting in 2008, LM collected samples from dedicated bladder pumps using the low-flow sampling method. Tritium concentrations in samples collected from well USGS-4 (Figure B-1) continue to decrease at a rate that is greater than the natural decay rate for tritium.
