**Environmental
Restoration
Program**

**Potential Release Site Package
PRS # 320/321/322/323/324/325**

MOUND PLANT POTENTIAL RELEASE SITE PACKAGE

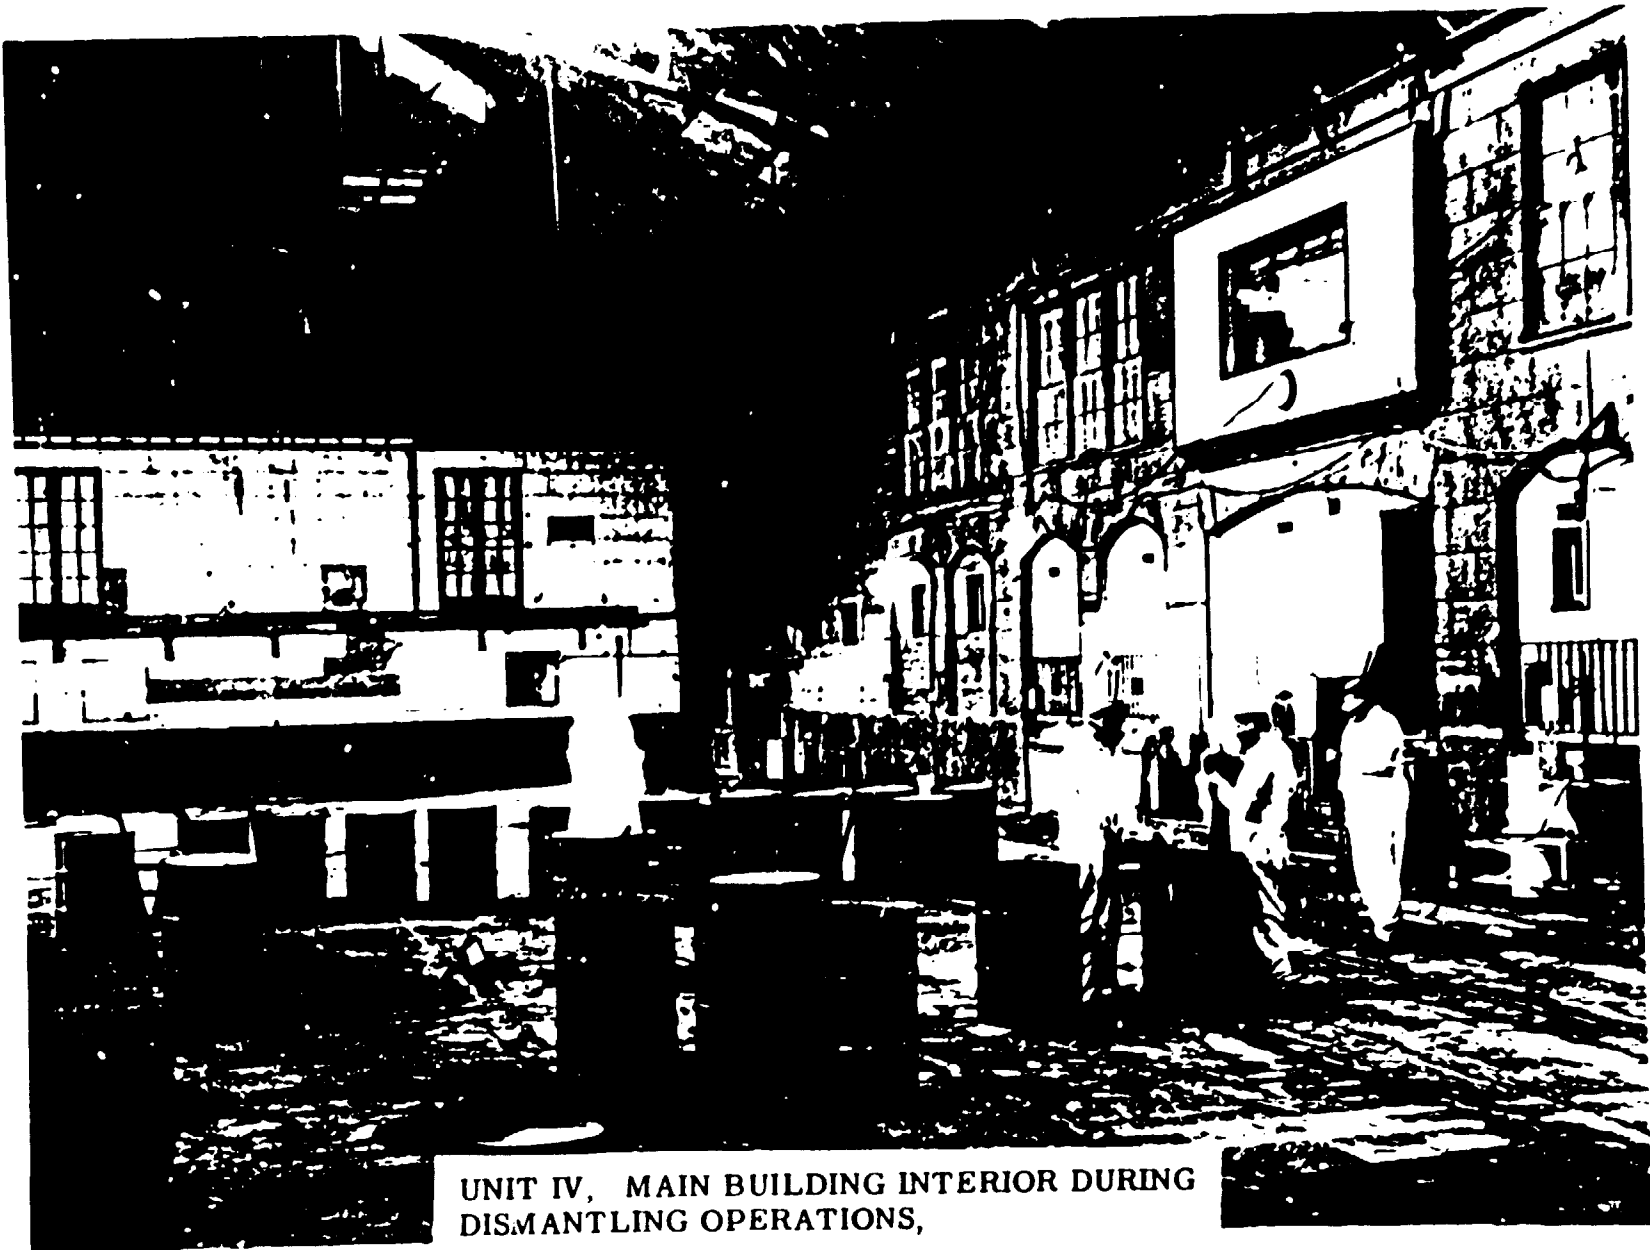
FIGURE 1

UNIT IV, MAIN BUILDING INTERIOR DURING
DISMANTLING OPERATIONS,

It was decided that it would be both less expensive and safer to dismantle the Unit IV location than to restore it to its original condition. Surveys made after the transfer of operations to Mound Laboratory showed that the interior of the playhouse was highly contaminated. Demolition was started in February 1950 and completed later the same year. The remains were moved to Mound Laboratory by truck and stored. The excavation was filled with dirt, covered with sod, and returned to the original owners.

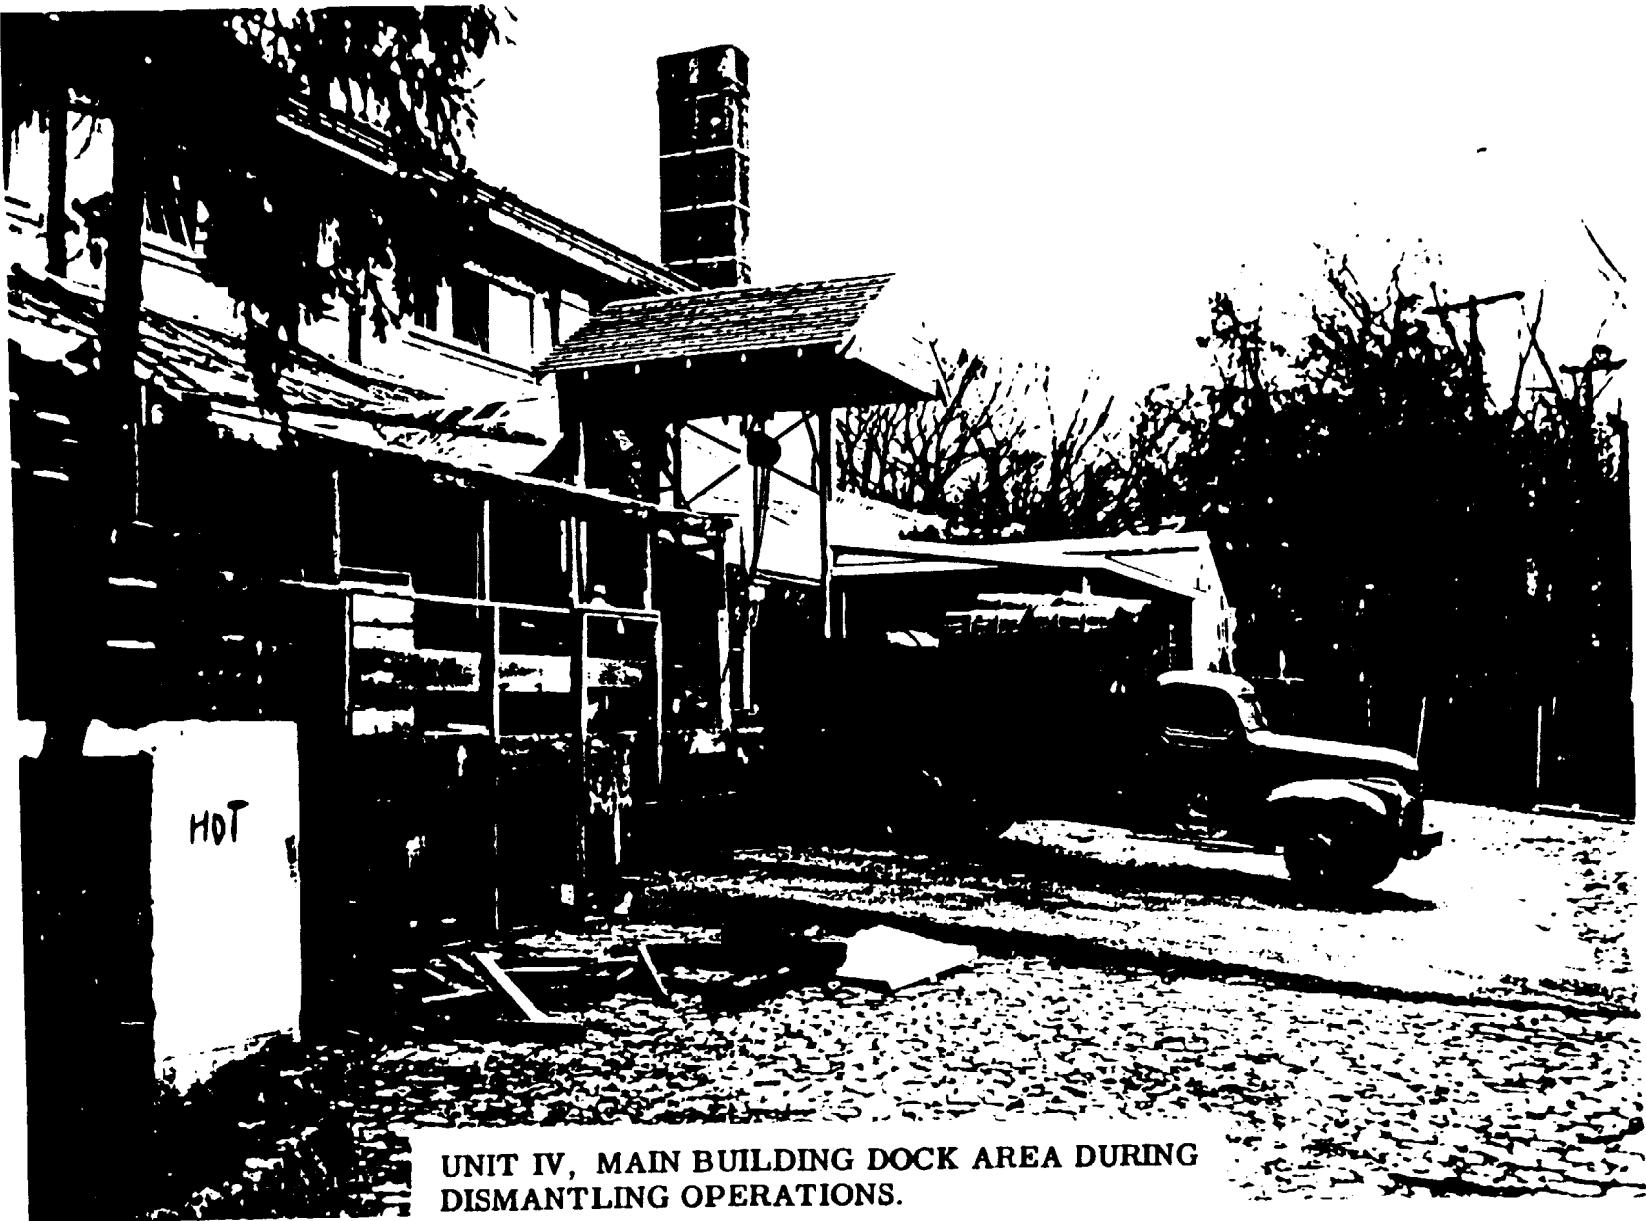
FIGURE 3

UNIT IV, MAIN BUILDING DOCK AREA DURING
DISMANTLING OPERATIONS.

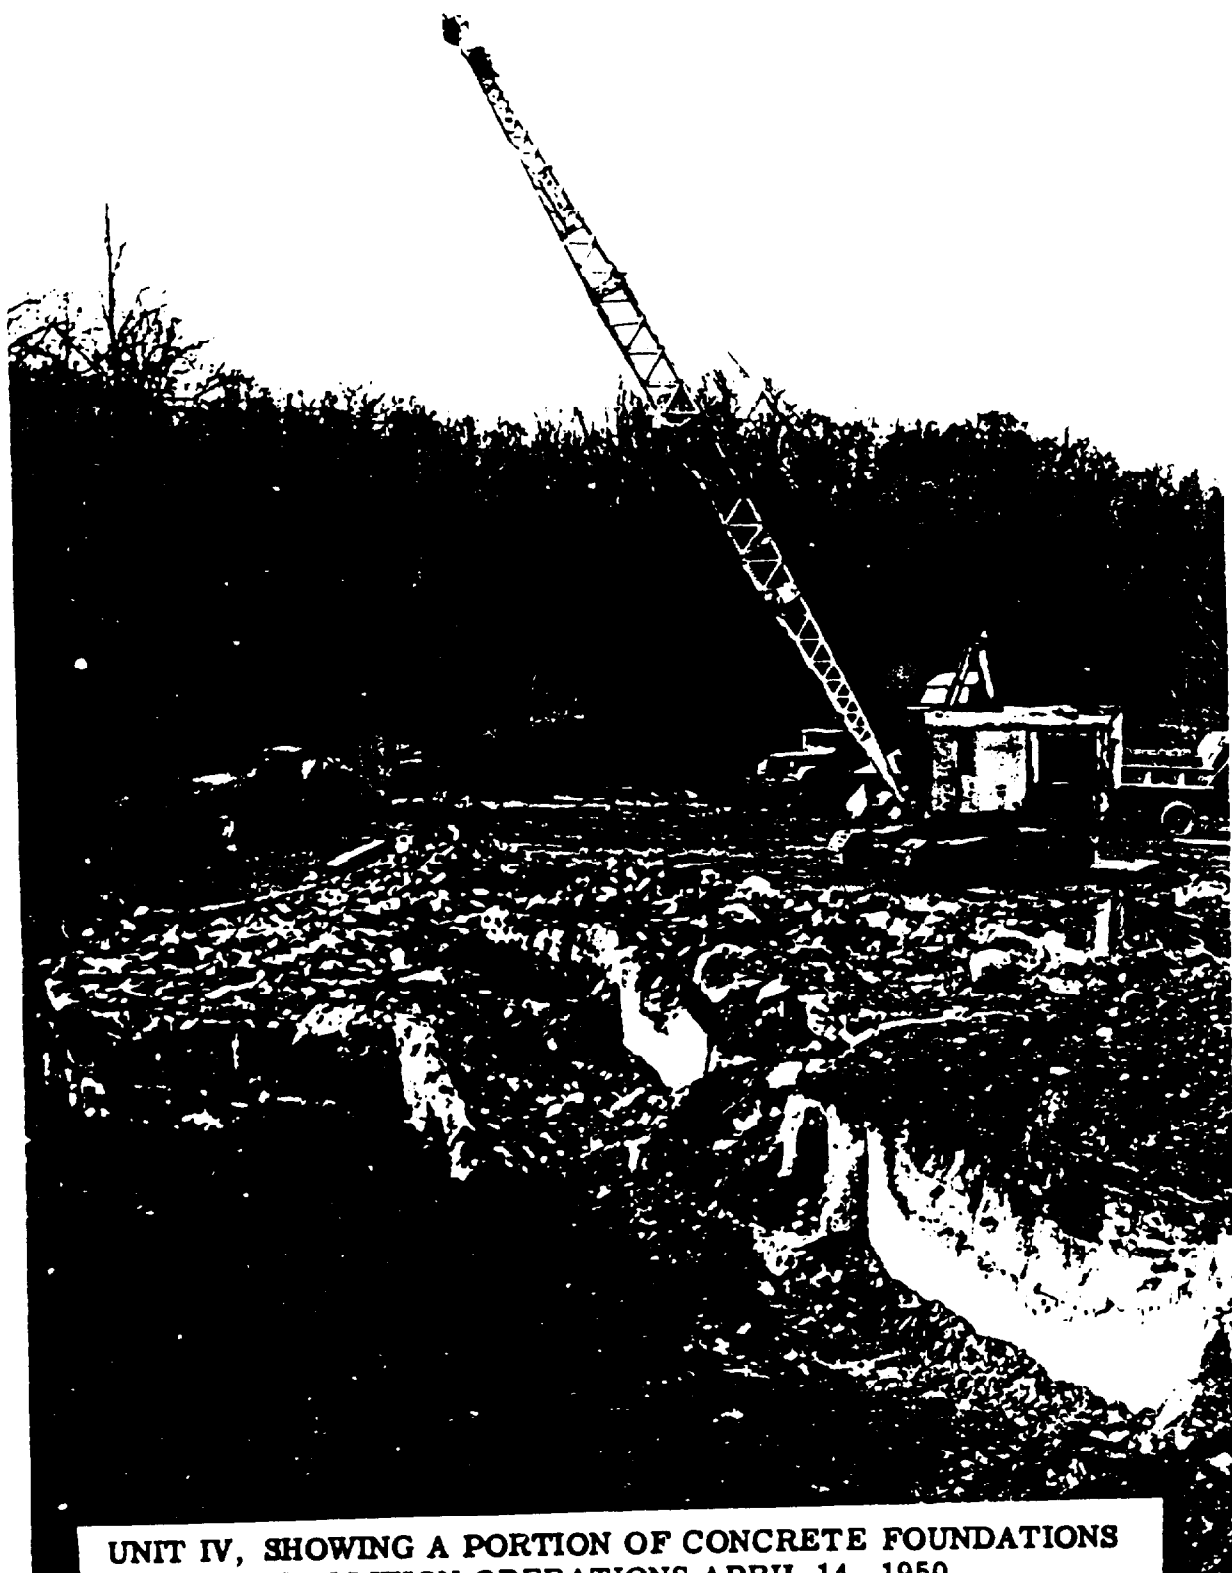
FIGURE 15

UNIT IV, SHOWING A PORTION OF CONCRETE FOUNDATIONS
DURING DEMOLITION OPERATIONS APRIL 14, 1950.
