ORNL/RASA-89/1

Results of the  
Preliminary Radiological  
Survey at B&T Metals,  
425 West Town Street,  
Columbus, Ohio (CO001)

**RESULTS OF THE PRELIMINARY RADIOLOGICAL  
SURVEY AT B&T METALS,  
425 WEST TOWN STREET,  
COLUMBUS, OHIO (CO001)**

Date Published — October 1990

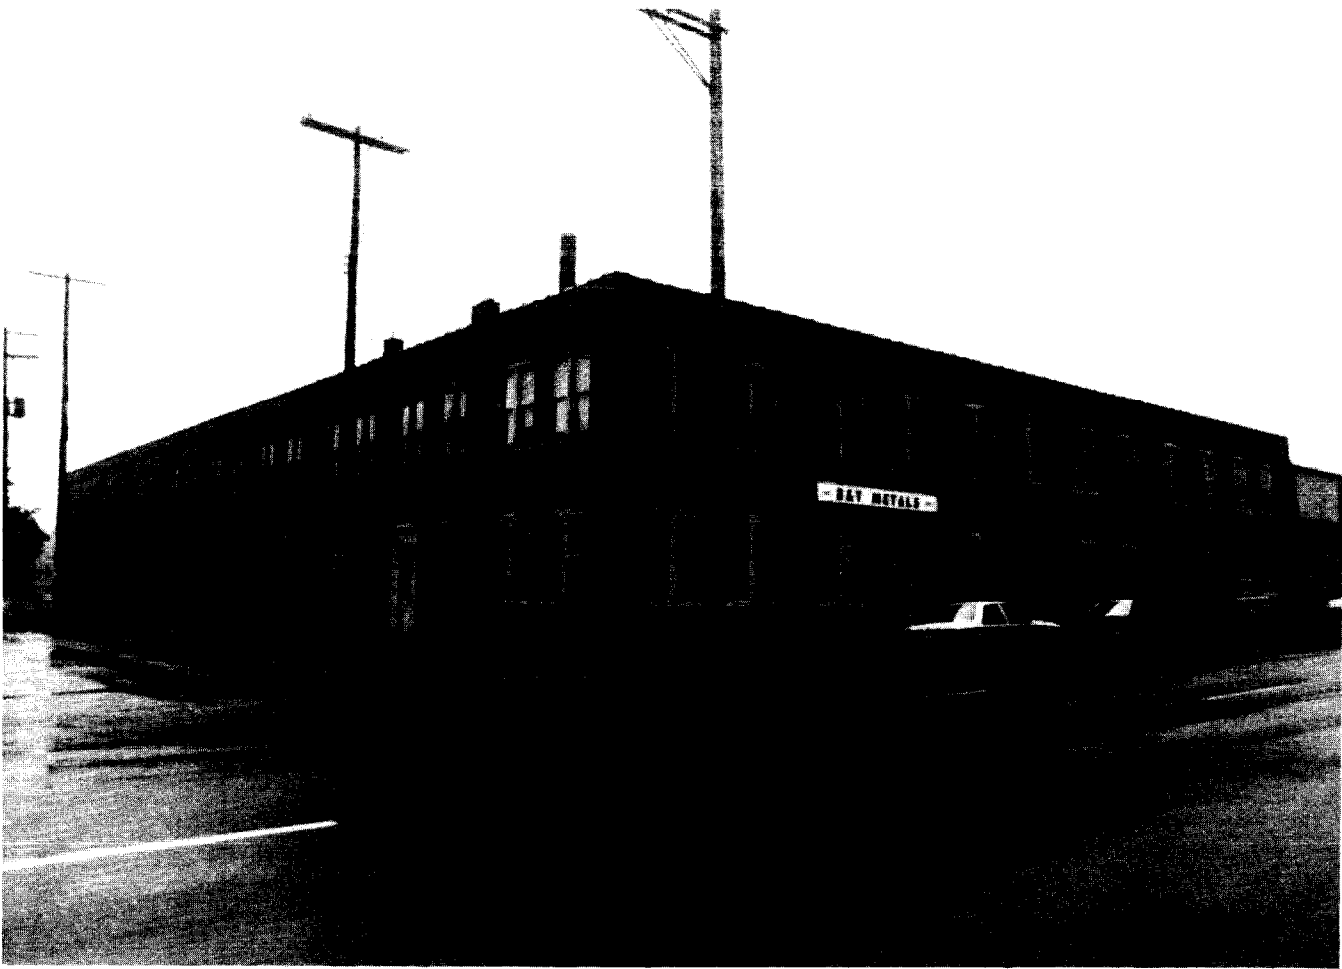
Fig. 1. B&T Metals, 425 West Town Street, Columbus, Ohio (CO001).

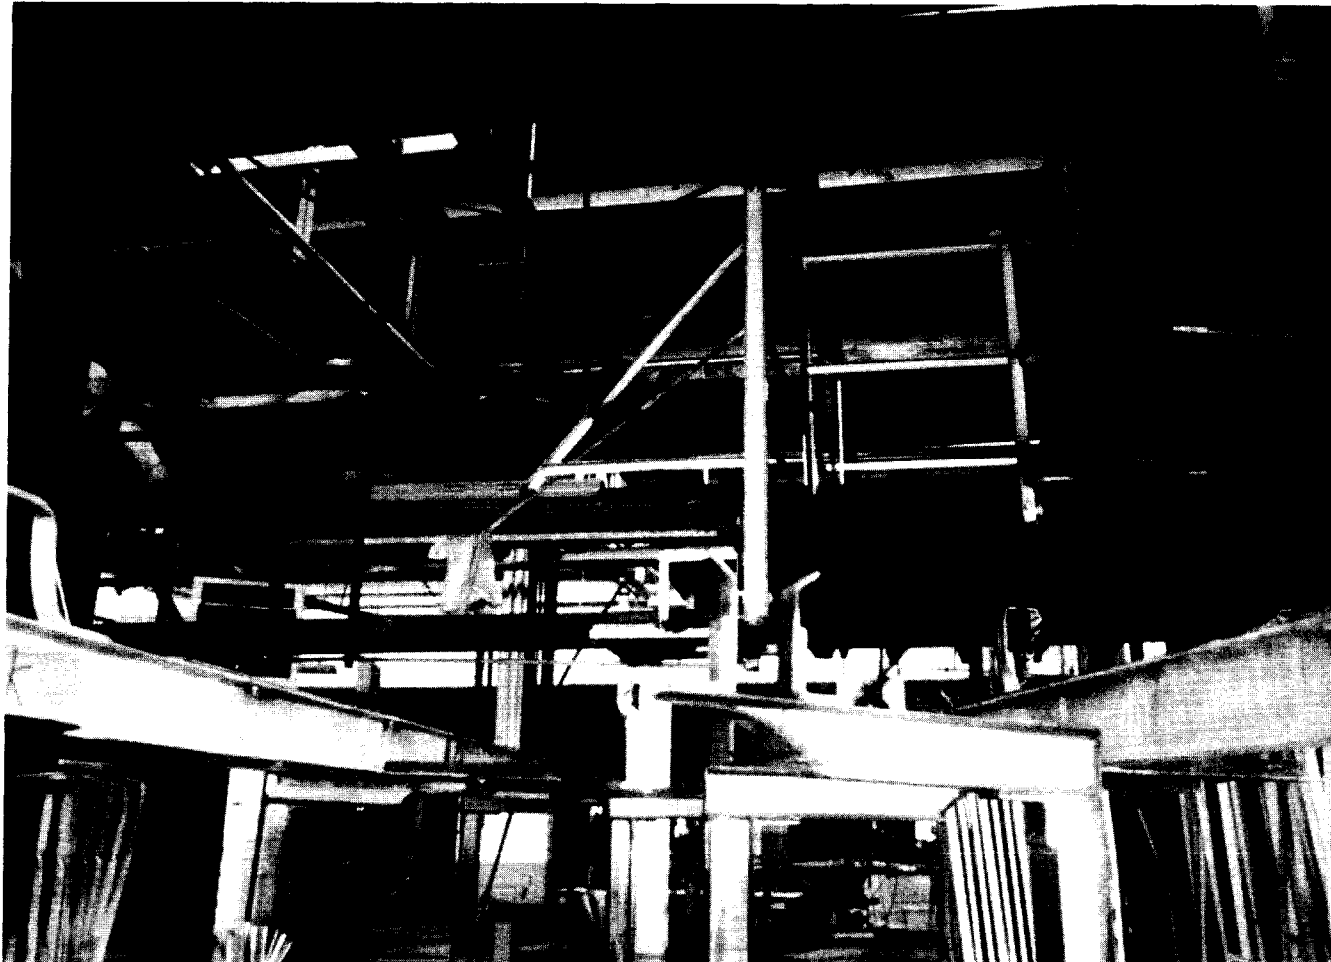
ORNL-PHOTO 3216-89

Direct alpha and beta-gamma measurements were taken at 10 locations inside the main office building (three on the floor and seven on overhead beams). These measurements and the locations are given in Table 4. Direct alpha measurements were below DOE guidelines. Direct beta-gamma measurements at the three floor locations were 0.66 mrad/h for the crack, 0.81 mrad/h for the depression, and 3.9 mrad/h for the sump (Fig. 4). These values exceed the surface dose rate guideline of 0.2 mrad/h averaged over not more than 1  $\text{m}^2$  (Table 1). Three of the seven overhead beam locations (Figs. 4 and 5) exceeded the 1.0 mrad/h maximum dose rate for a 100- $\text{cm}^2$  area. Values and locations (Fig. 4) are 1.1 mrad/h (10S, 10E), 1.5 mrad/h (20S, 10E), and 2.5 mrad/h (22S, 40E). At location 50S, 40E a measurement was taken over the dust layer on the support beam; then the dust layer was removed and another measurement was taken. With the dust intact, the measurements were 530 dpm alpha and 0.61 mrad/h beta-gamma. Following removal of the dust, the measurements dropped to 470 dpm alpha and 0.069 mrad/h beta-gamma, indicating residual radioactivity in the dust. Samples of this dust were collected for radionuclide analyses.

Fig. 5. Support beams inside the main office building, B&T Metals, Columbus, Ohio (CO001).

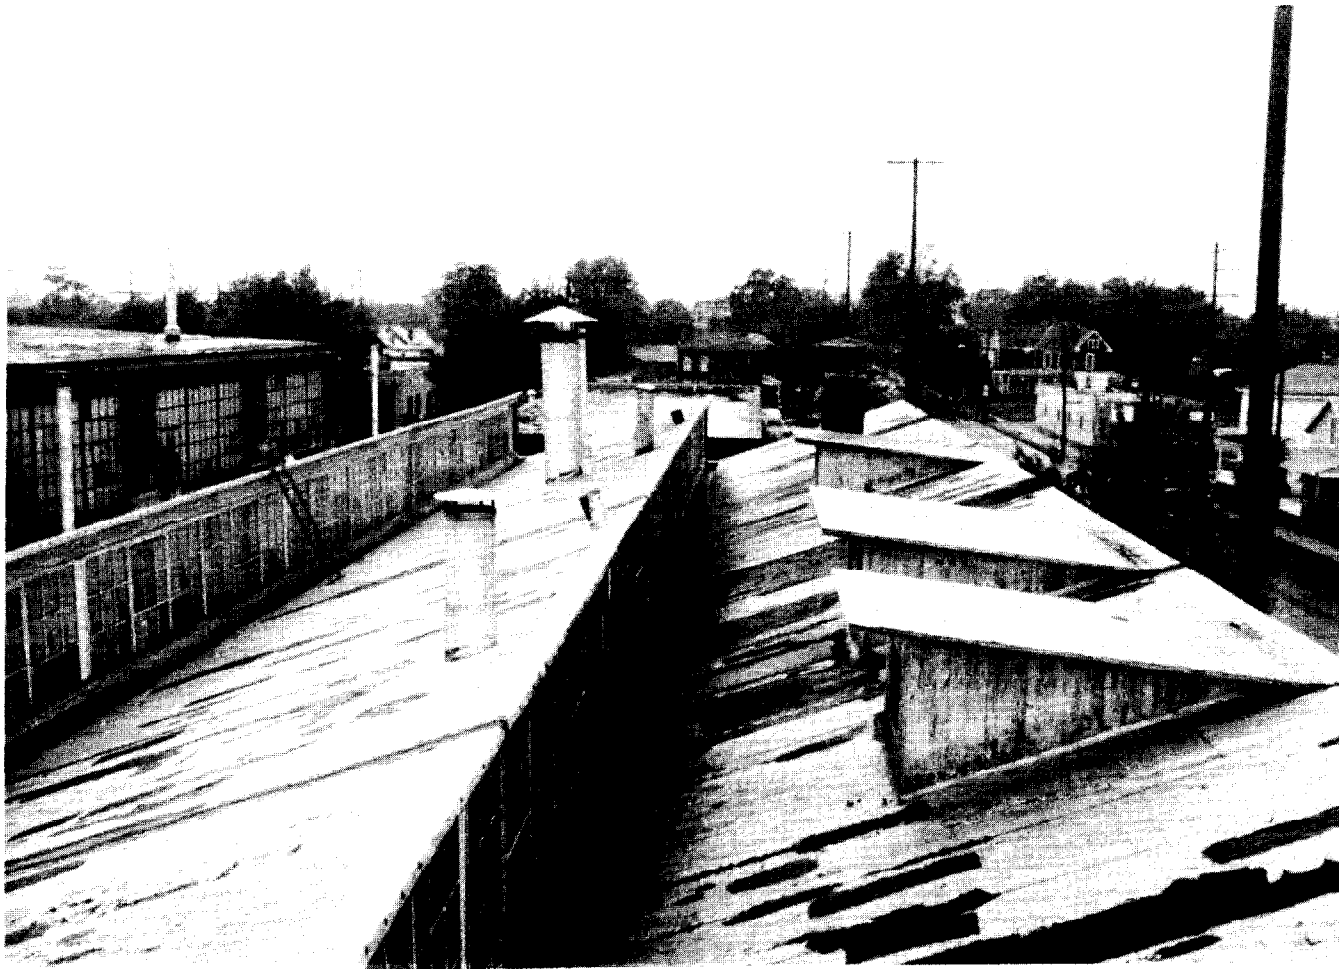
Thirty-three measurements of direct and transferable radioactivity levels were taken on the roof of the main office building. On the inclined portion of the sawtooth roof (Fig. 6), 29 measurements were taken, and 4 measurements were taken on the level roof of the first-floor annex. Measurements are shown in Table 5. Locations are shown in Fig. 7 (referenced to Fig. 4). All direct alpha measurements are well below DOE guidelines for fixed uranium concentration (Table 1). One direct beta-gamma measurement (location 20S, 2E) was 0.20 mrad/h. Other direct beta-gamma measurements were well below the guideline for surface dose rate averaged over an area  $\leq 1 \text{ m}^2$ .

Fig. 6. Sawtooth roof over the area where the MED processing took place, looking west, B&T Metals, Columbus Ohio (CO001).
