**Annual Performance Report
April 2019 Through March 2020
for the Shiprock, New Mexico,
Disposal Site**

August 2021

U.S. DEPARTMENT OF
ENERGY

Legacy
Management

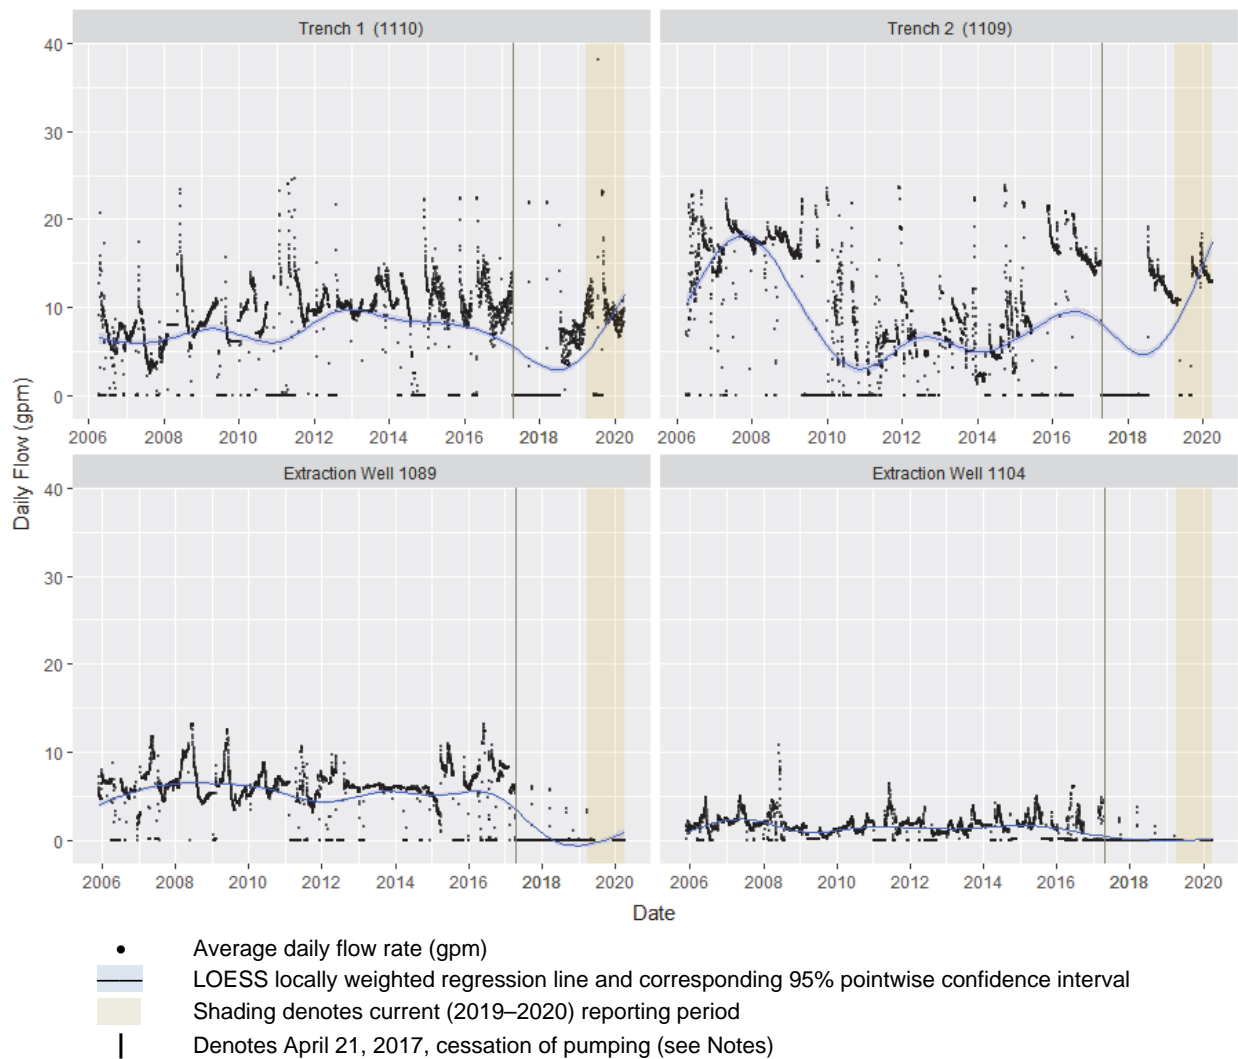
Figure 3. Historical Pumping Rates in Floodplain Trenches and Extraction Wells: 2005–2020

Notes: Data plotted are since the inception of the System Operation and Analysis at Remote Sites (SOARS) system in late 2005. For the trenches, the nonpumping period extended from April 21, 2017, until July 19, 2018, after which pumping resumed to maintain a minimum water level in the evaporation pond. Except for brief intermittent periods, pumping was not resumed at the two extraction wells.

The floodplain extraction well system consists of wells 1089 and 1104 (Figure 1), installed in late June 2003 using slotted culverts placed in trenches excavated to bedrock. As indicated above and in Table 2, there is no recent performance to report for these wells because the pumping suspension that began in April 2017 continued through the current (2019–2020) period. Since the start of operations in 2003 through the end of March 2020, totals of approximately 39.6 million and 8.6 million gallons of water have been removed from wells 1089 and 1104, respectively. Figure 3 plots historical daily flows (pumping rates) for extraction wells 1089 and 1104 and the two trenches.

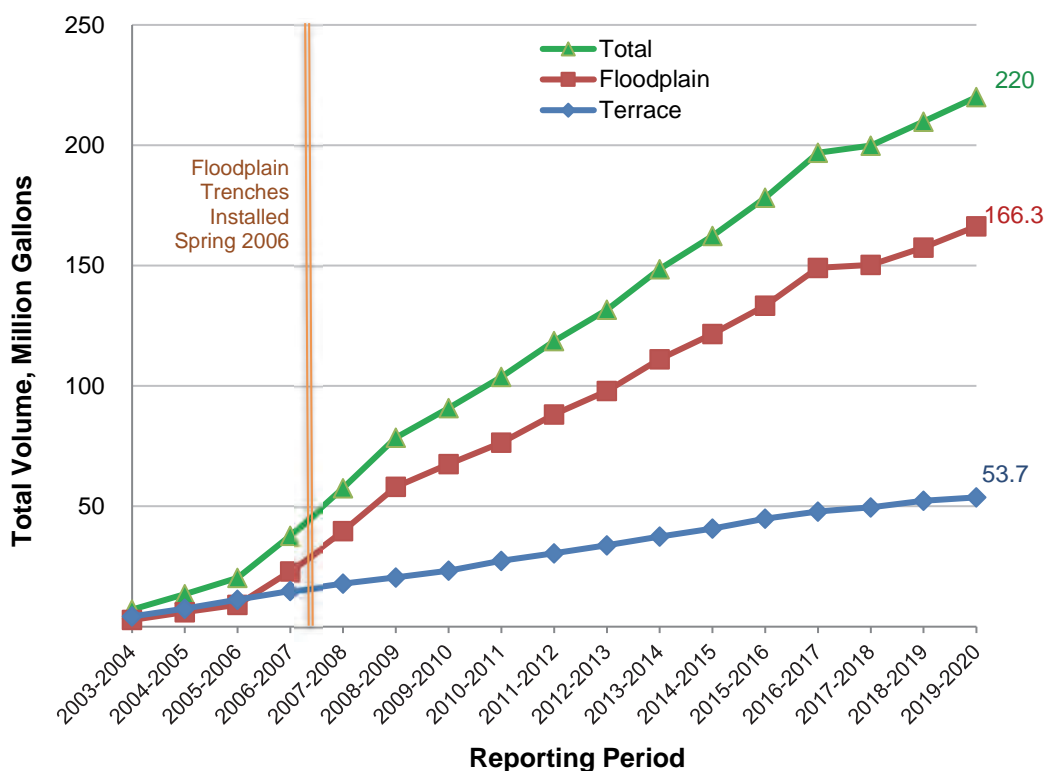
Figure 7. Total Groundwater Volume Pumped to the Evaporation Pond

From April 2019 through March 2020, about 10.2 million gallons of extracted groundwater were pumped to the evaporation pond, slightly more than the volume extracted during the previous reporting period (8.44 million gallons in 2018–2019). The bulk of this total volume (8.8 million gallons, or 86.2%) of the influent liquids entering the pond during the current reporting period was from the floodplain trenches. Pumping of Bob Lee Wash (1.2 million gallons, 11.5% of total volume) accounted for most of the remaining extraction volume.² As shown in Figure 7, at the end of the 2019–2020 reporting period, about 53.7 million gallons have been extracted from the terrace, and 166.3 million gallons have been extracted from the floodplain since DOE began active remediation in March 2003. This yields a total cumulative extracted volume of about 220 million gallons of water pumped to the evaporation pond from all sources. Total cumulative contributions are 24% from the terrace and 76% from the floodplain.

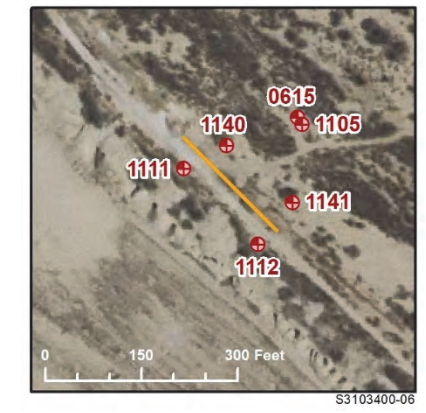
Figure A-2. Uranium, Nitrate, and Sulfate Concentration Trends in Trench 1 Area Wells: 2000–September 2019

In each plot, a nonparametric smoothing method or locally weighted regression—known as LOESS (not to be confused with the geologic term)—is used. With this approach, overall trends in the data are more apparent and not obscured by “noise.” For each constituent, wells are listed in order of increasing distance from the escarpment, shown in the inset below.

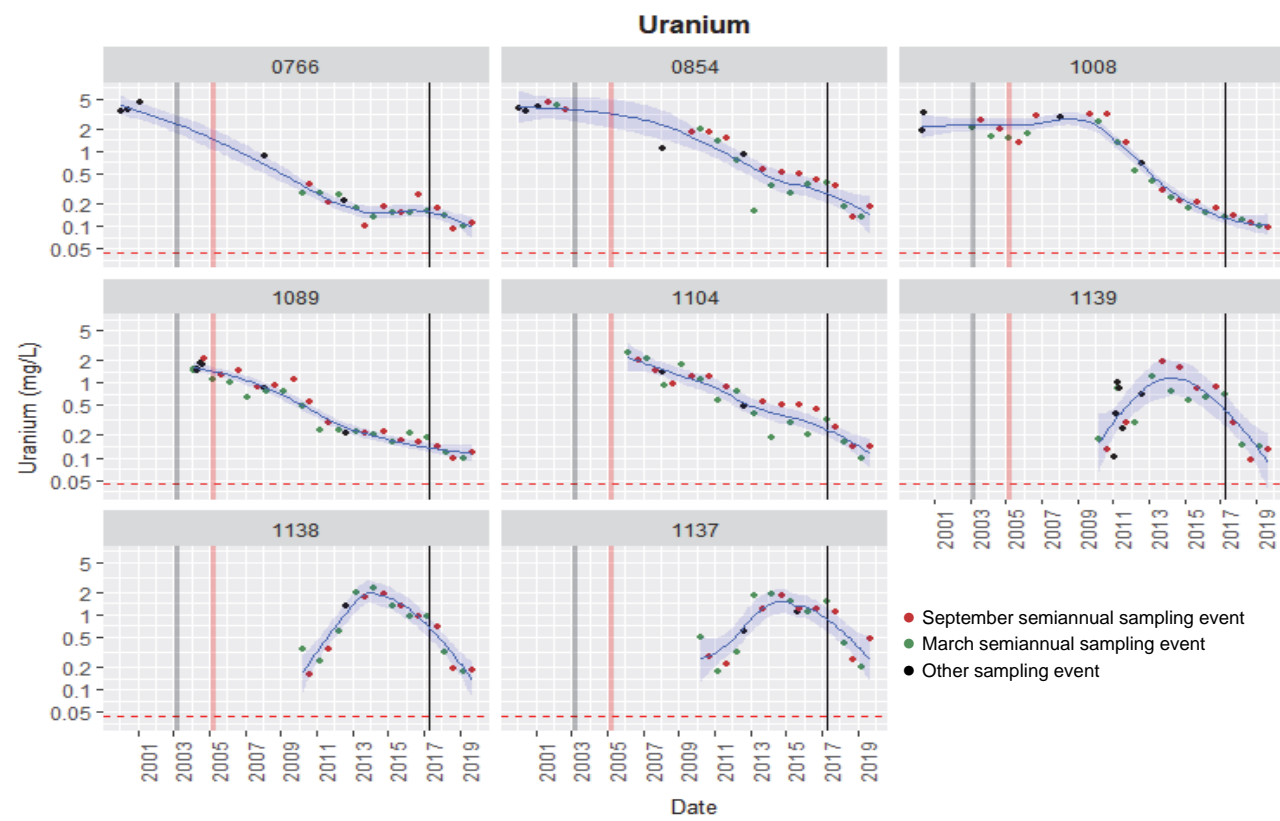
Figure A-3. Uranium, Nitrate, and Sulfate Concentration Trends in the 1089/1104 Remediation Area: 2000–September 2019

In each plot, near-river wells 1137, 1138, and 1139 are listed in order of increasing distance from the remediation area (see inset).
 — Blue line is a LOESS locally weighted regression line; shaded area is the corresponding 95% pointwise confidence interval
 - - - Denotes the 40 CFR 192 MCL or cleanup goal: 0.044 mg/L uranium, 10 mg/L nitrate as N, 2000 mg/L sulfate
 Vertical lines | | denote periods corresponding to installation of well 1089 (spring 2003) and well 1104 (spring 2005).
 Third vertical line | denotes when pumping on the floodplain was suspended, on April 21, 2017 (Figure 3).
 This suspension was sustained through the 2019–2020 reporting period at extraction wells 1089 and 1104 (Table 2).

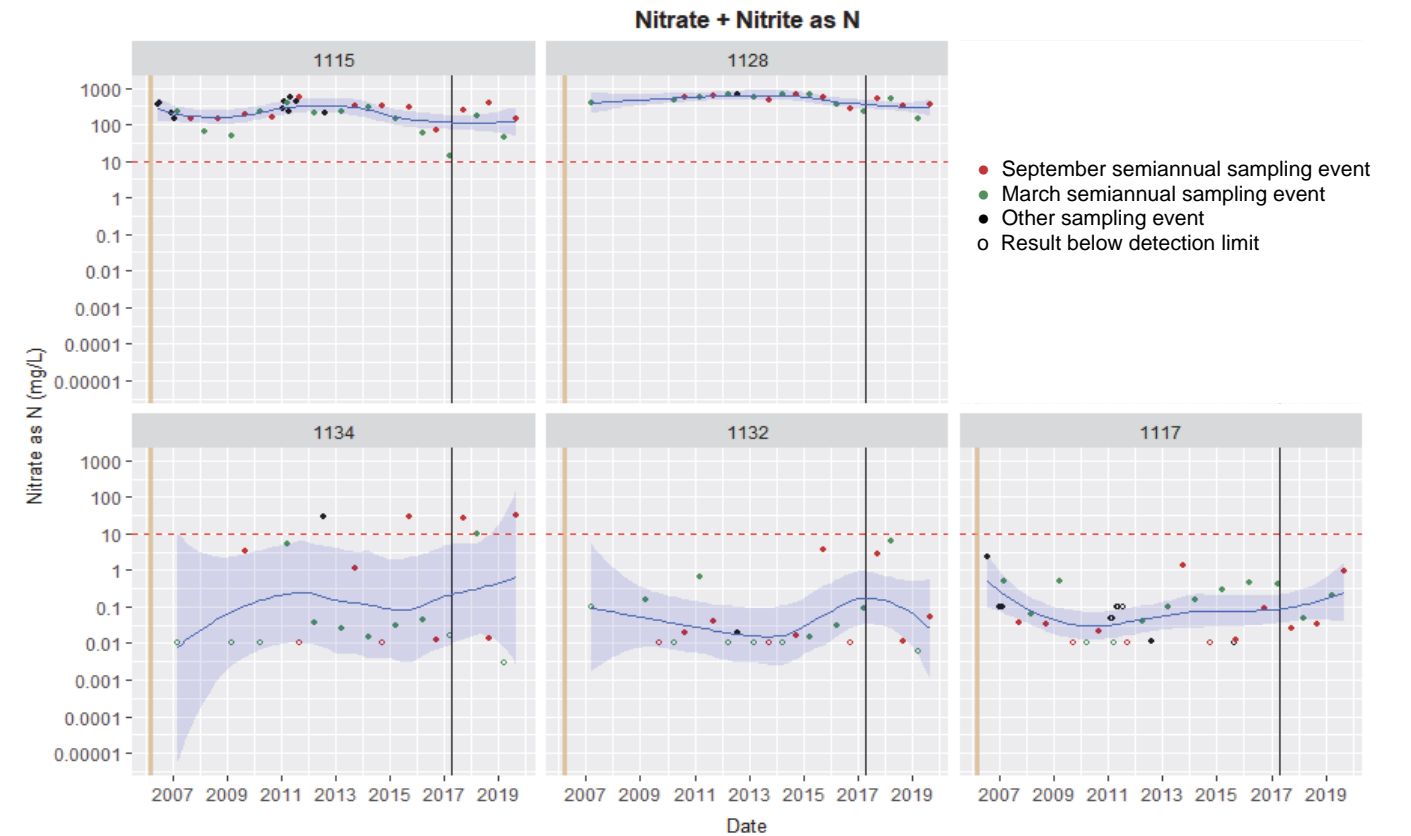
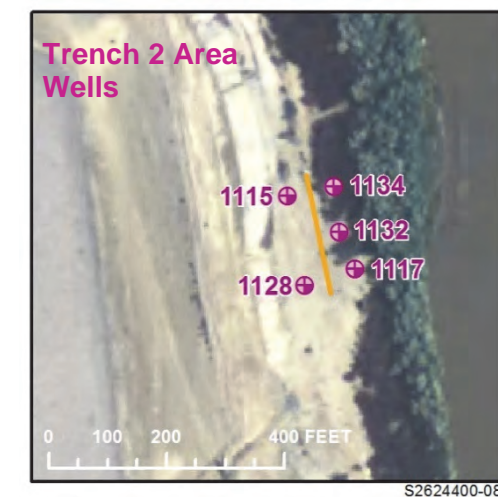
Figure A-4. Uranium, Nitrate, and Sulfate Concentration Trends in Trench 2 Area Wells: 2006–September 2019

Wells on the escarpment side of the trench, with the highest contaminant concentrations, are plotted first (in the upper portion of the figure). Wells on the river side of the trench, with markedly lower concentrations, are shown in the bottom portion of each plot (locations shown in inset below).

Vertical line | denotes time when Trench 2 was installed, in spring 2006. Trench 2 wells were installed between June 2006 and February 2007. Second vertical line | denotes when pumping on the floodplain was suspended, on April 21, 2017 (Figure 3). Pumping resumed at Trench 2 on July 19, 2018, and continued through most of the 2019–2020 reporting period.

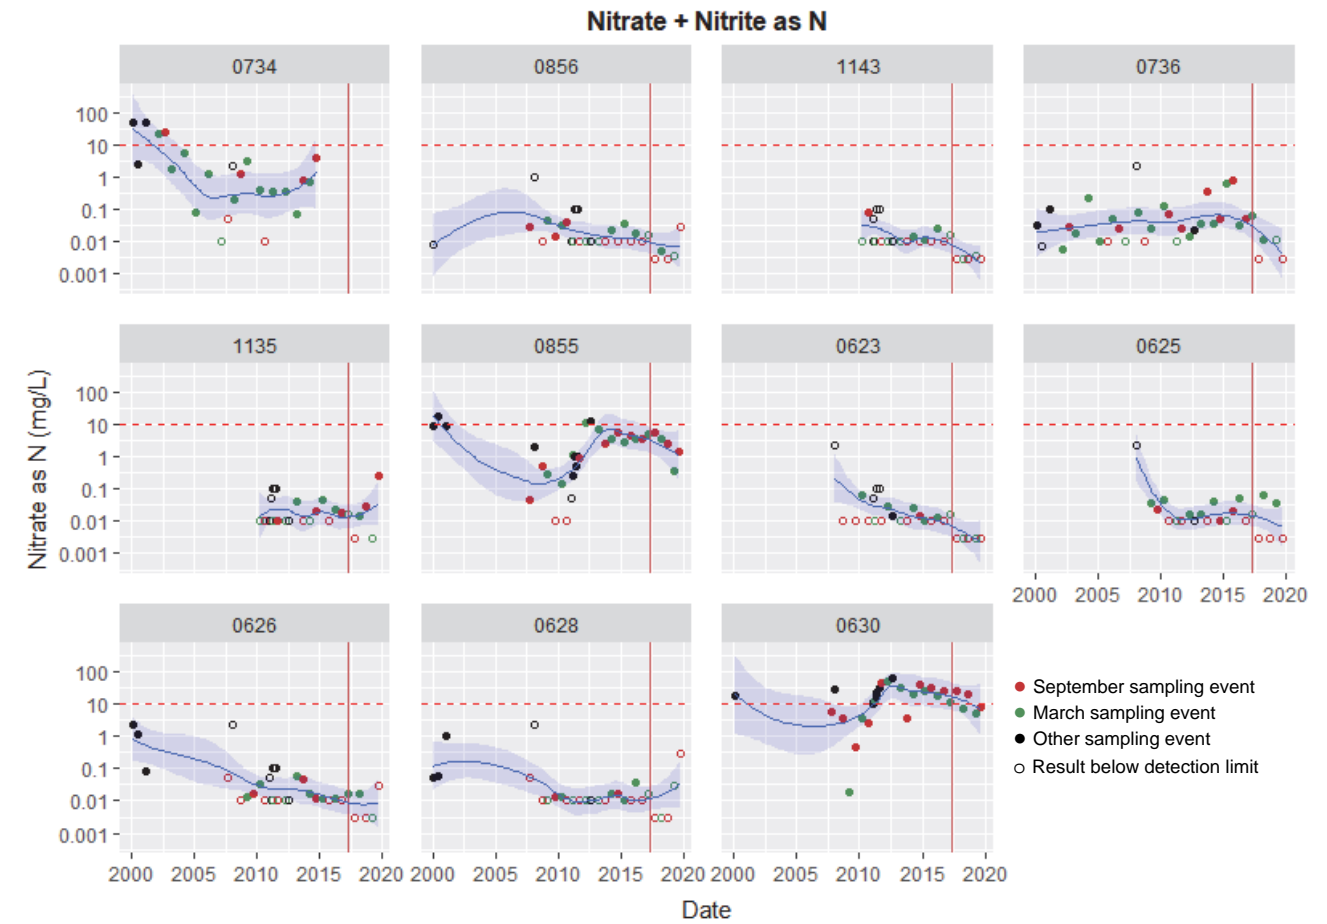
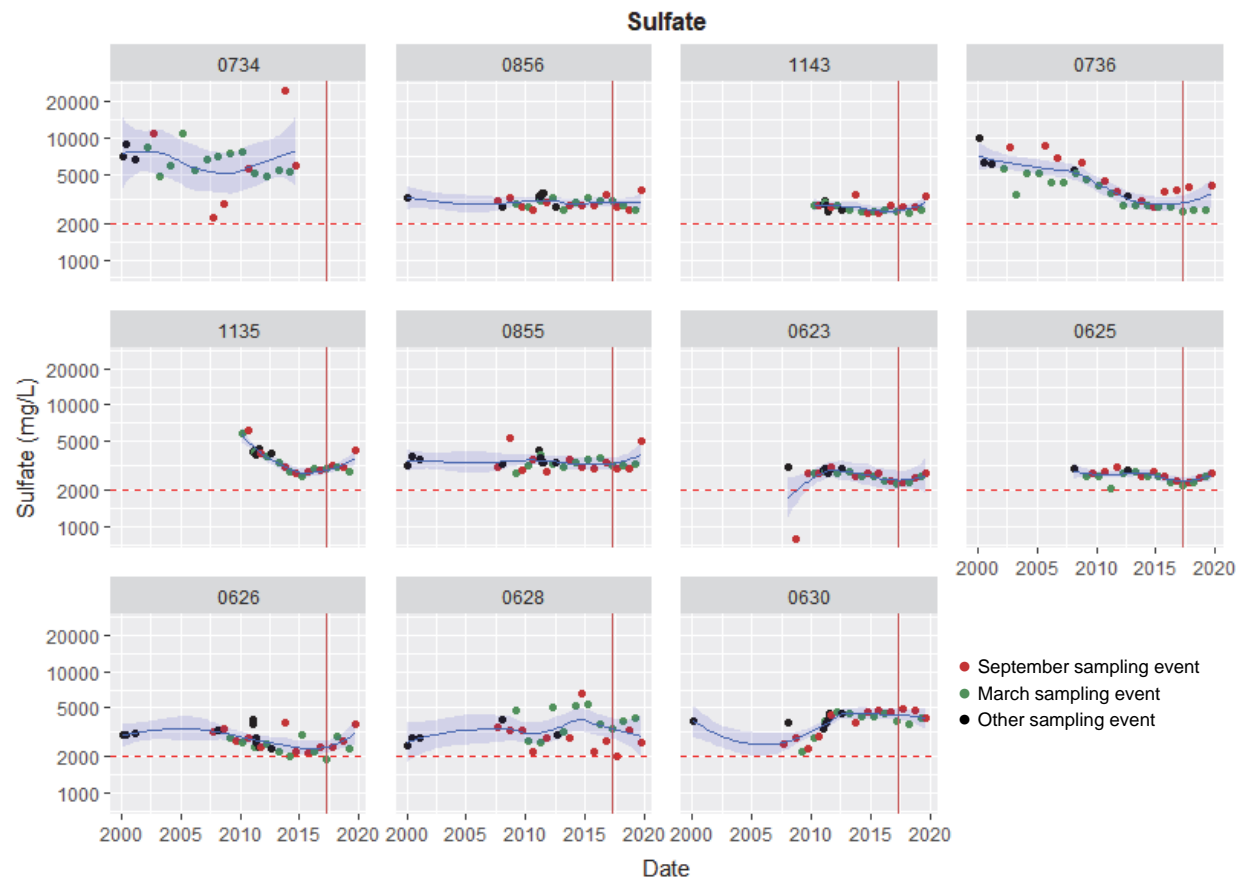
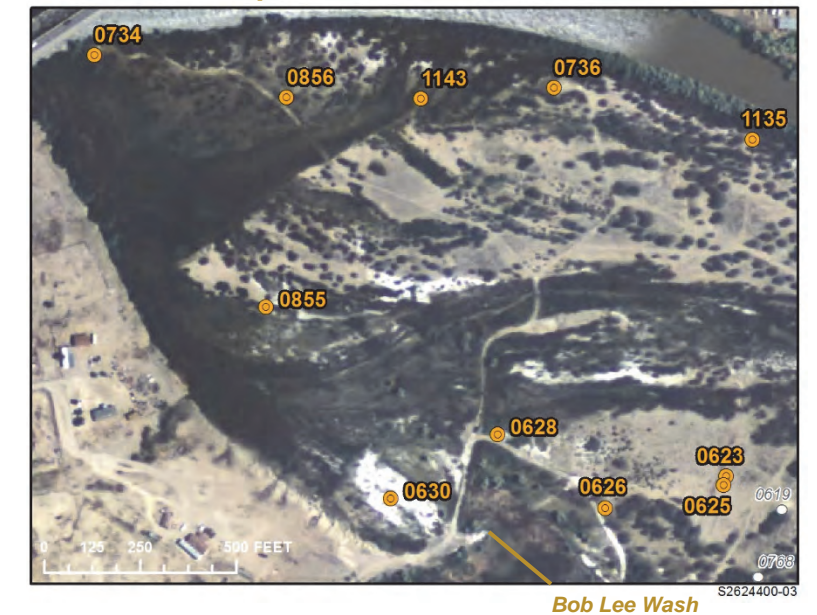
Figure A-8. Uranium, Nitrate, and Sulfate Concentration Trends in Western Floodplain Wells: 2000–September 2019

The large gap in sampling between 2000–2001 and 2007 for wells 0626, 0628, 0630, 0855, and 0856 causes a balloon-like appearance of the confidence band around the LOESS smoothing line.
