**2015 Annual Land-Use Covenant
Inspection Report
for DOE Areas at the Laboratory
for Energy-Related Health
Research/Old Campus Landfill
Superfund Site
University of California, Davis**

January 2016

U.S. DEPARTMENT OF
ENERGY

Legacy
Management

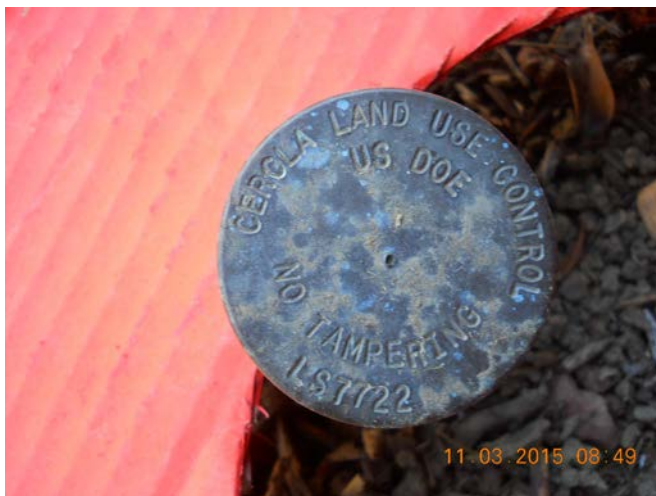
Monument 1: northwest corner of Dry Wells A-E Area (photo No. 2831).

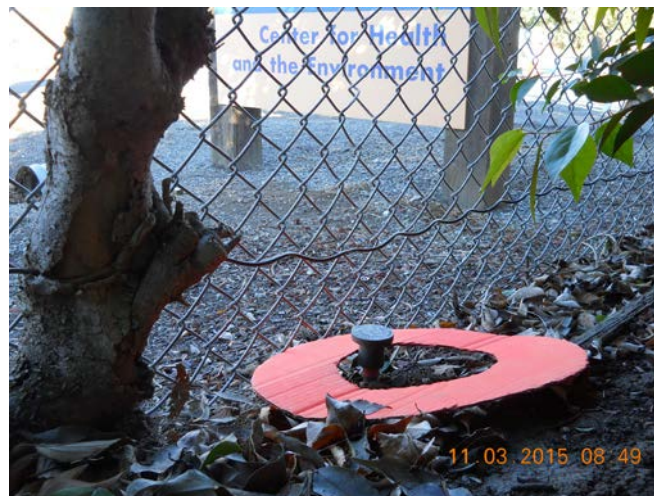
View northwest: Monument 1, within orange ring in foreground; entrance sign in background (photo No. 2830).

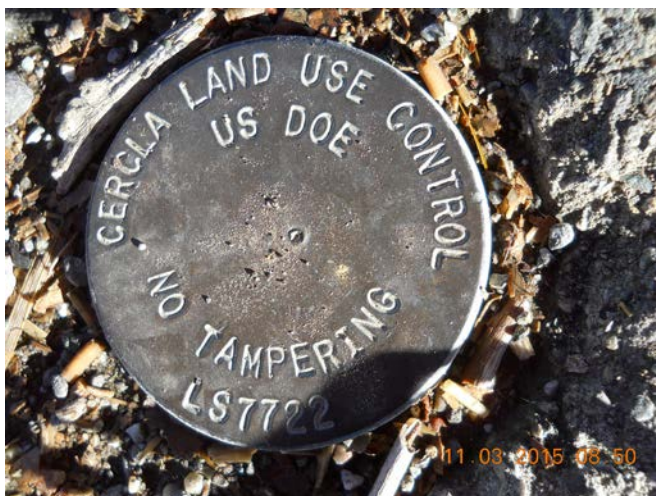
Monument 2: northeast corner of Dry Wells A-E Area (photo No. 2833).

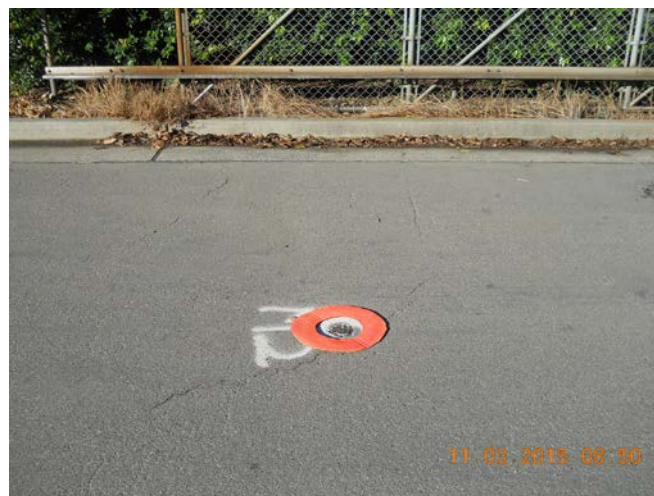
View west: Monument 2, within orange ring; bottom of retracted entrance gate in background (photo No. 2832).

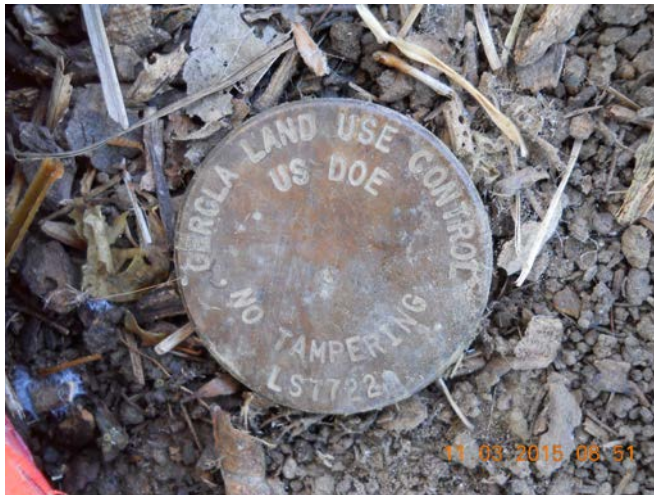
*Monument 3: southwest corner of Dry Wells A-E Area
(photo No. 2836).*

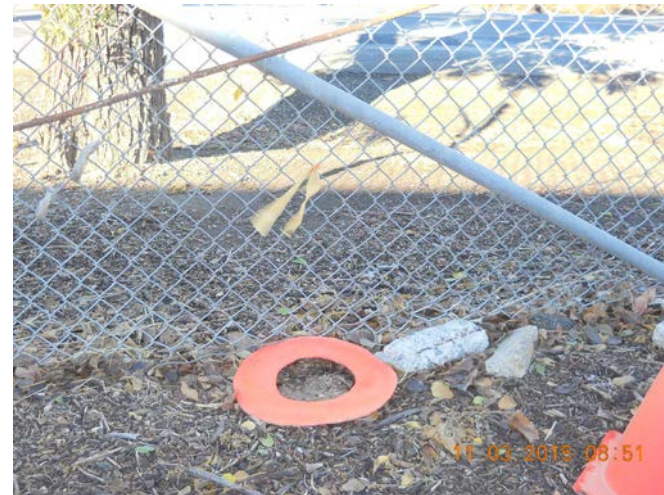
*View west: Monument 3, within orange ring;
west perimeter fence in background (photo No. 2834).*

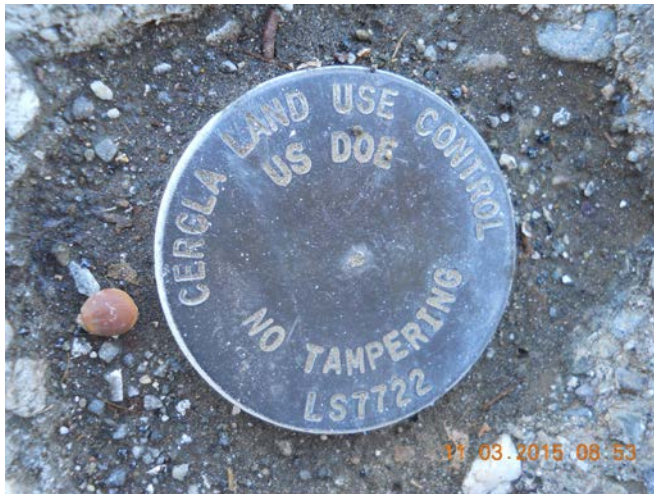
*Monument 4: southeast corner of Dry Wells A-E Area
(photo No. 2839).*

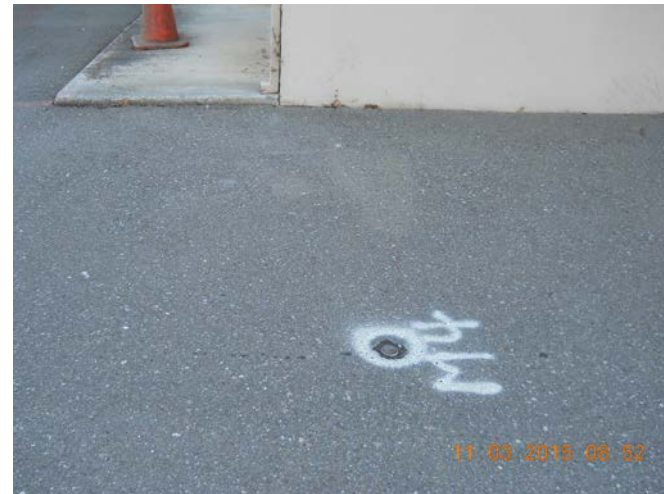
*View east: Monument 4 with Building H-219 in background
(photo No. 2837).*

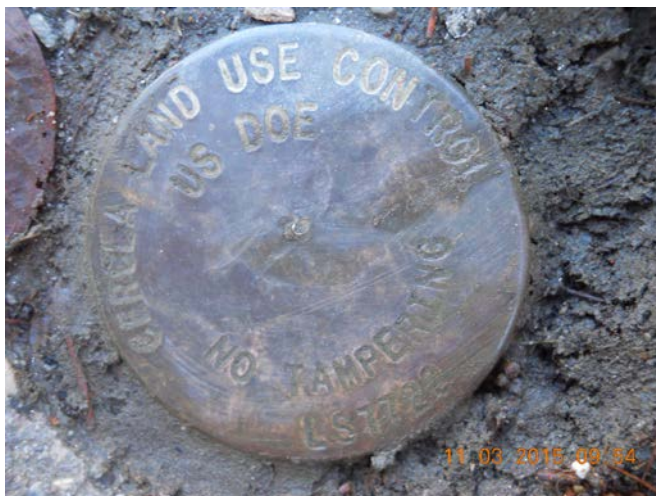
Monument 5: northwest corner of Domestic Septic System 4 (photo No. 2859).

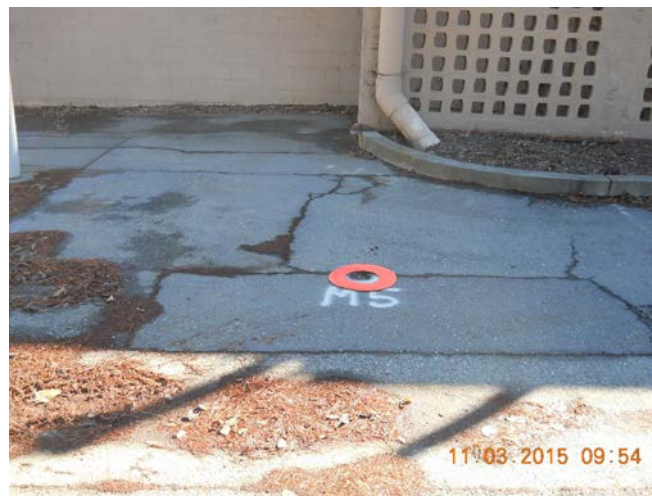
View east: Monument 5, within orange ring; Building H-215 in background (photo No. 2858).

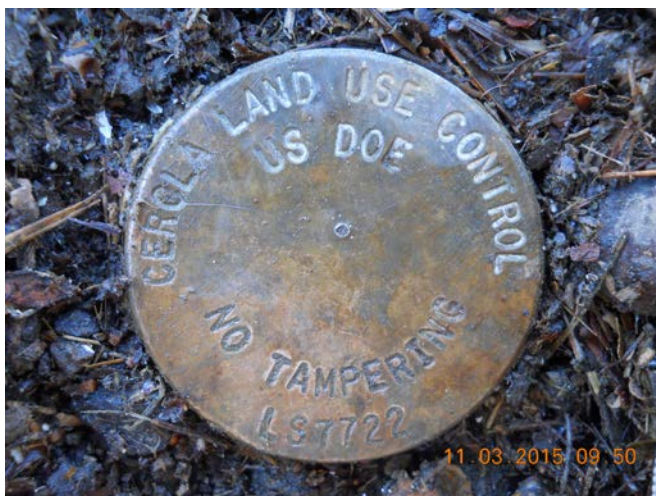
Monument 6: adjacent to northwest corner of Building H-218; Radium/Strontium Treatment Systems Area (photo No. 2857).

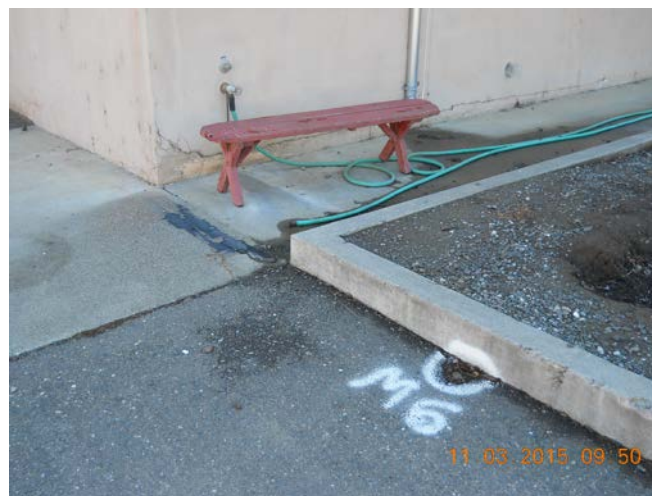
View southeast: Monument 6 with corner of Building H-218 in left of background (photo No. 2856).

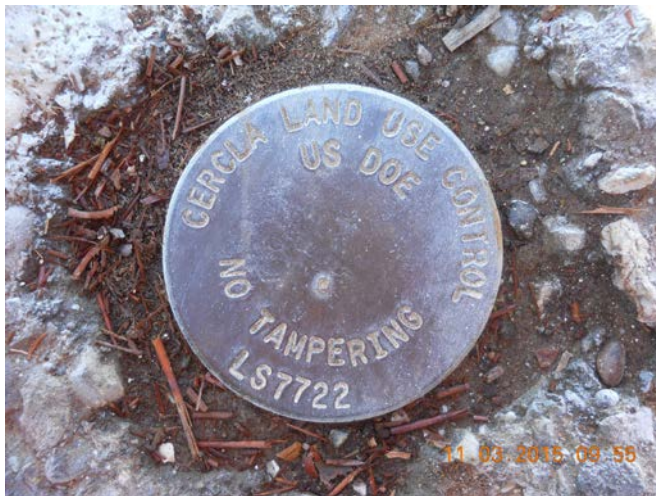
Monument 7: southwest corner of Domestic Septic System 4 (photo No. 2861).

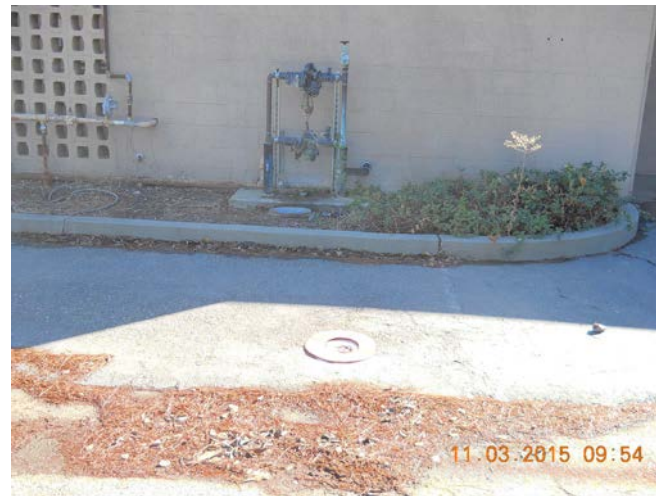
View east: Monument 7, within orange ring; Building H-215 in background (photo No. 2860).

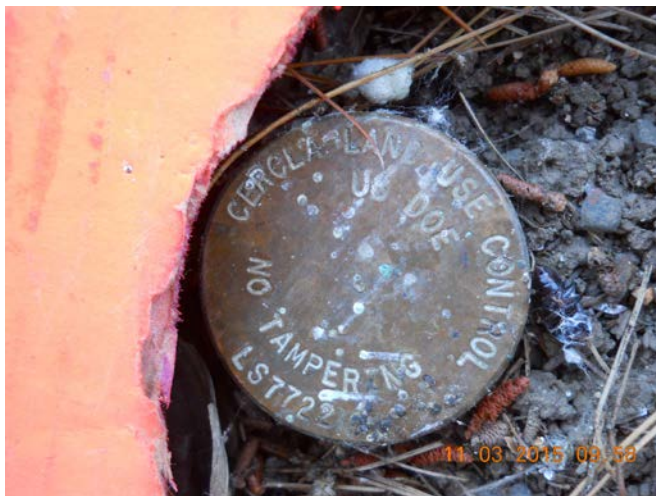
Monument 8: southwest corner of radium-226 leach trench; Radium/Strontium Treatment Systems Area (photo No. 2863).

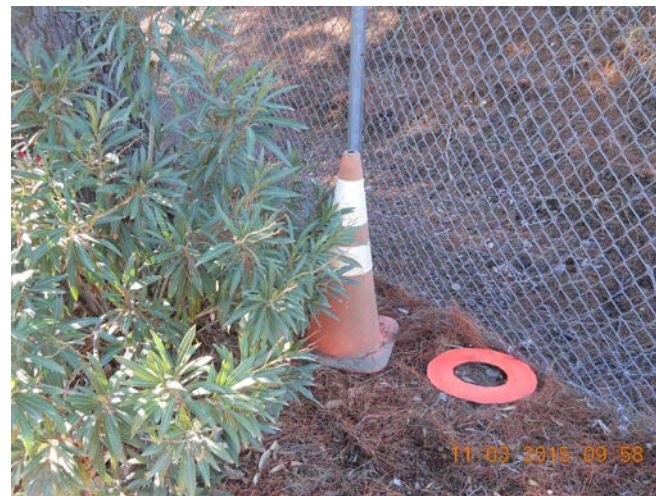
View southwest: Monument 8, within orange ring; west perimeter fence upper right (photo No. 2862).

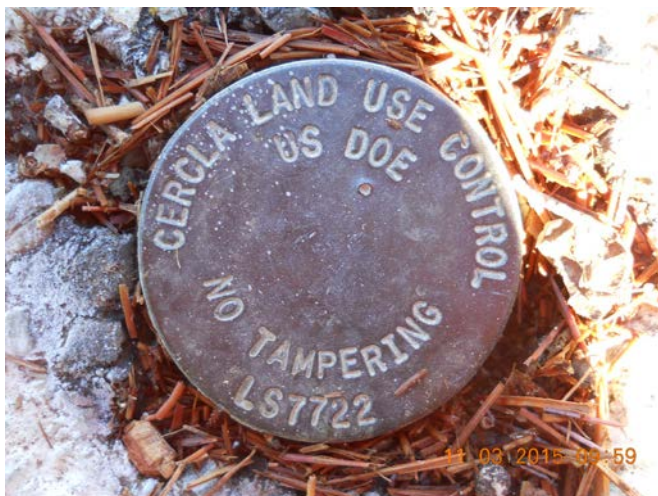
Monument 9: southeast corner of radium-226 leach trench;
Radium/Strontium Treatment Systems Area (photo No. 2865).

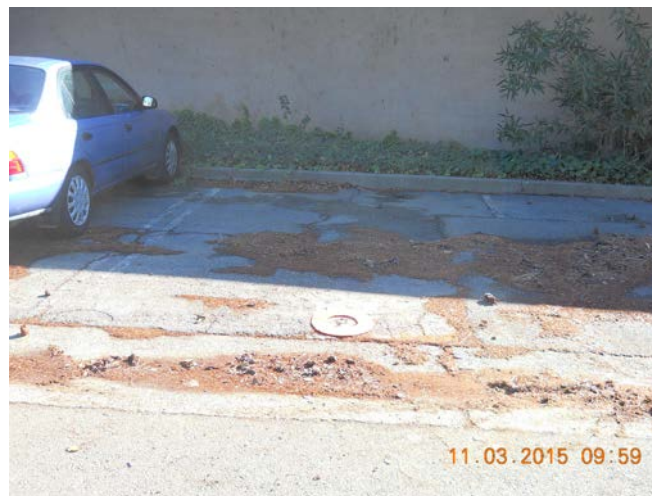
View east: Monument 9, within orange ring;
Building H-215 in background (photo No. 2864).

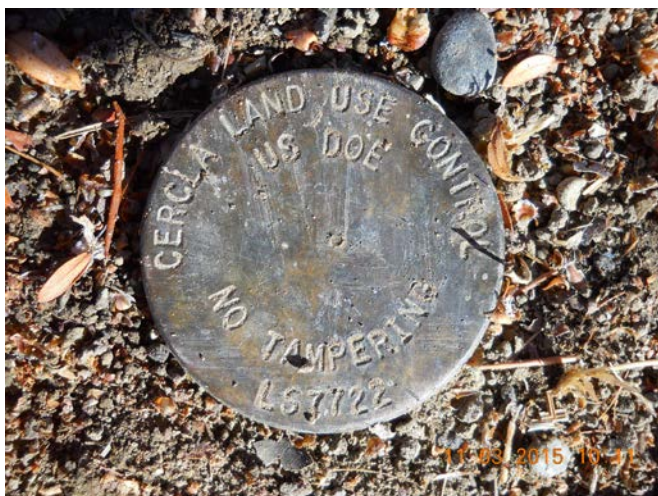
Monument 10: northeast corner of former leach field in
Domestic Septic System 3 Area (photo No. 2875).

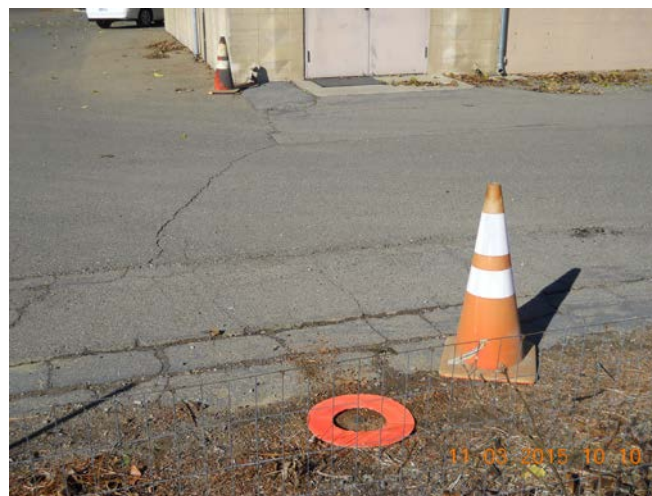
View northwest: Monument 10, within orange ring in foreground;
Building H-216 in background (photo No. 2874).

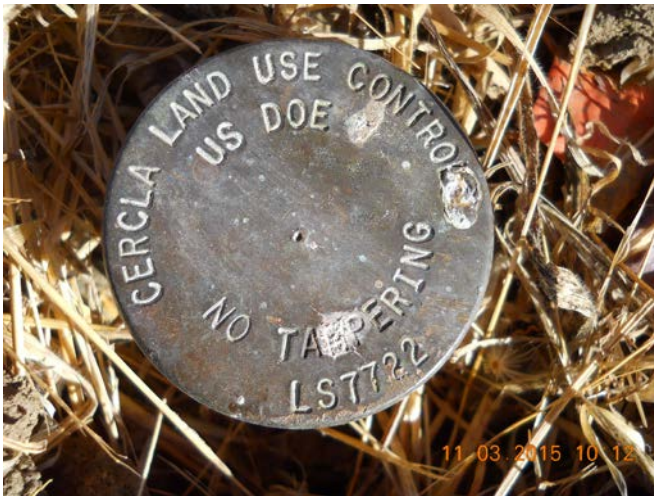
Monument 11: northeast corner of Eastern Remediation Support Area (photo No. 2877).

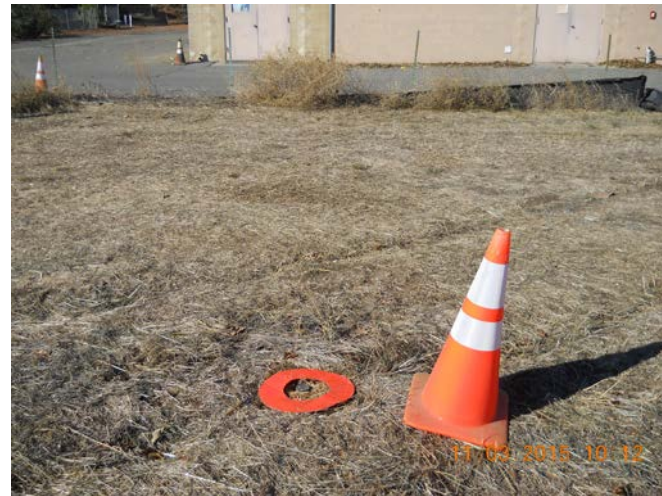
View west: Monument 11, within orange ring in foreground; Building H-216 in background (photo No. 2876).

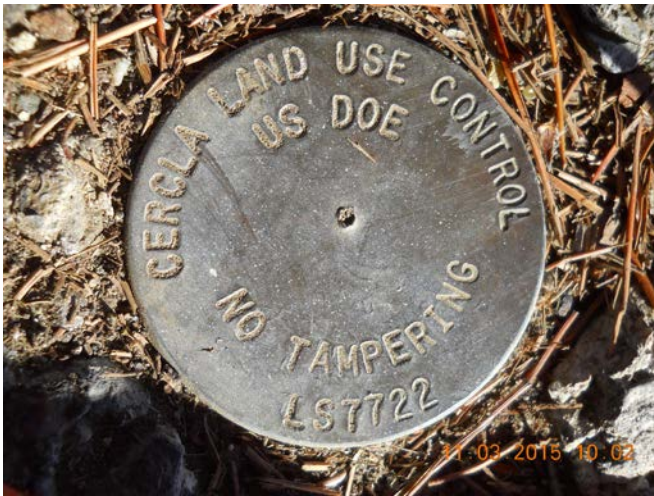
Monument 12: northwest corner of Southwest Trenches Area (photo No. 2867).

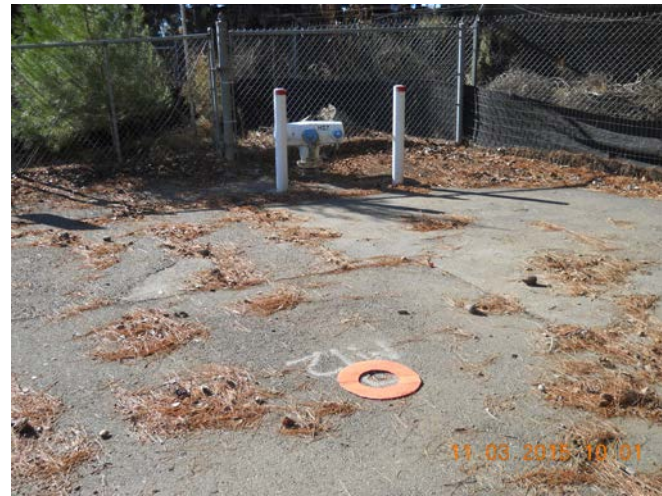
View south: Monument 12, within orange ring in foreground; water hydrant in background (photo No. 2866).

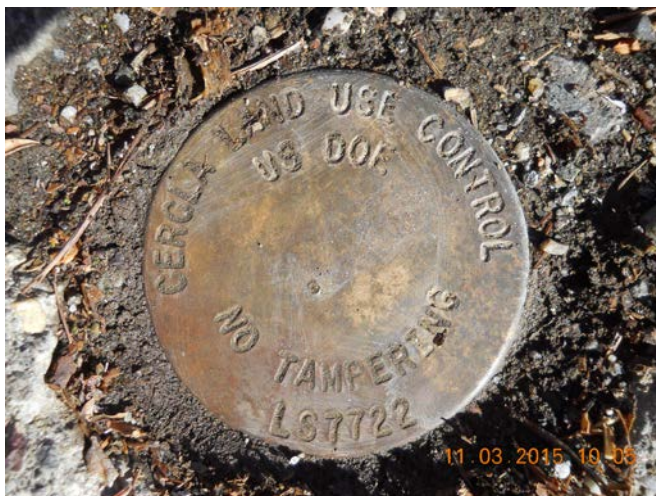
Monument 13: southwest corner of Domestic Septic System 3, at northern perimeter of Southwest Trenches Area (photo No. 2869).

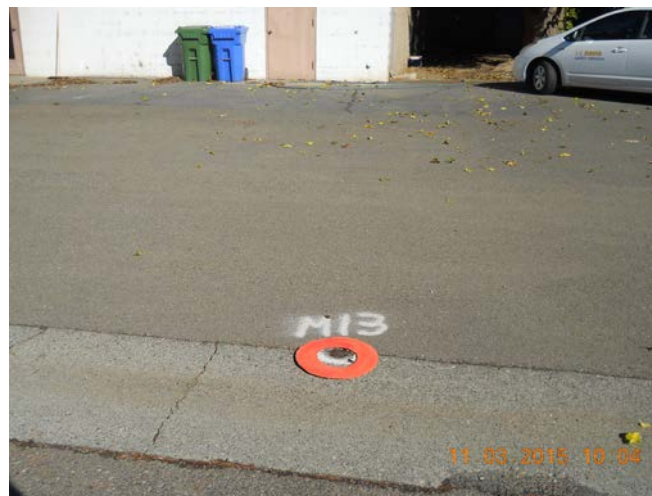
View north: Monument 13 within orange ring at edge of concrete swale; Building H-215 in background (photo No. 2868).

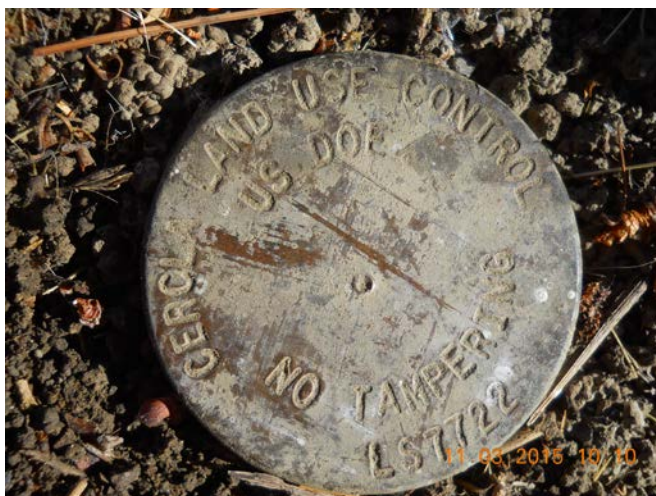
Monument 14: southeast corner of Domestic Septic System 3 (photo No. 2873).

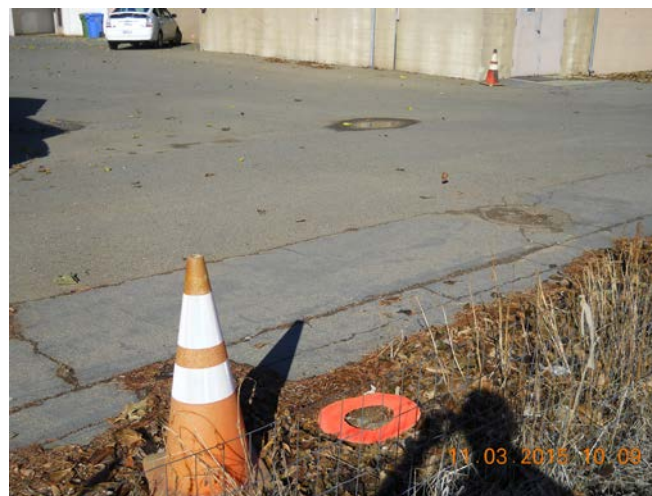
View northwest: Monument 14, within orange ring in foreground; Building H-216 in background (photo No. 2872).

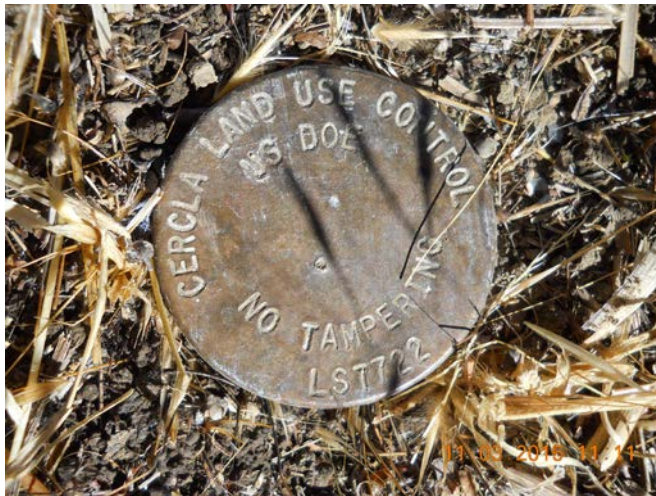
*Monument 15: eastern corner of Southwest Trenches Area
(photo No. 2901).*

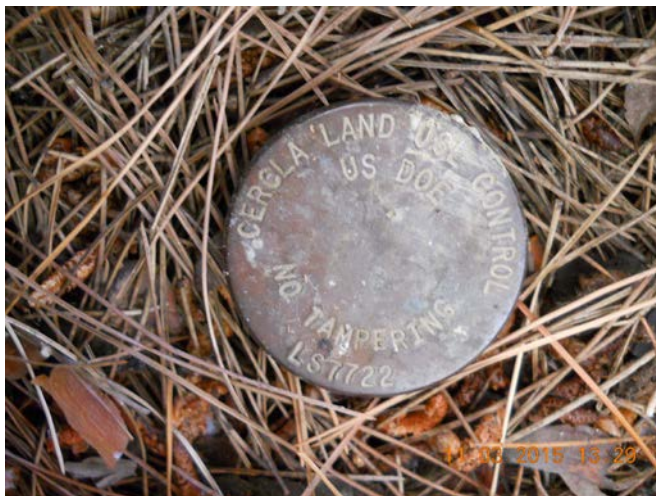
*Monument 16: southwest corner of Southwest Trenches Area
(photo No. 2943).*

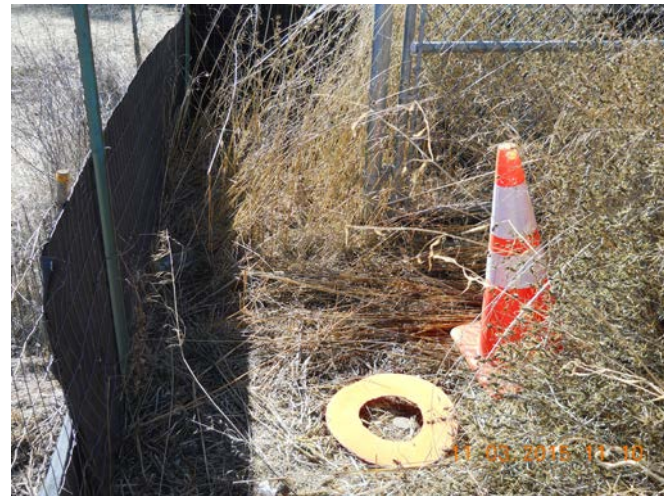
*View south: Monument 15, within orange ring in foreground;
former Western Dog Pens silt fence to left and trailer shed
fence in right of background (photo No. 2897).*

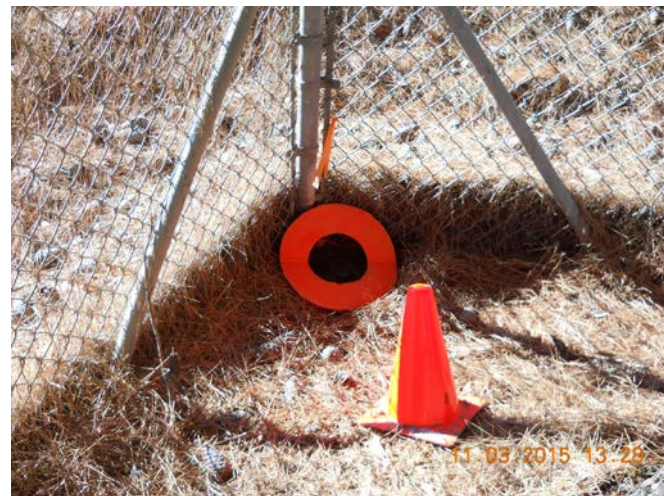
*View southwest: Monument 16, within orange ring;
southwest corner post of perimeter fence in background
(photo No. 2939).*

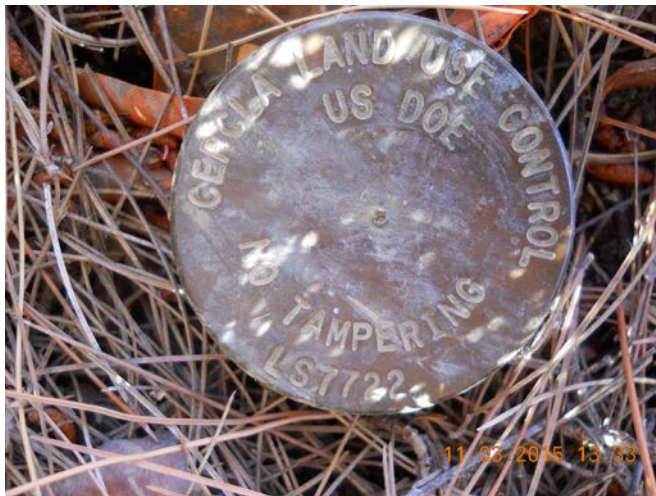
Monument 17: southeast corner of Southwest Trenches Area (photo No. 2946).

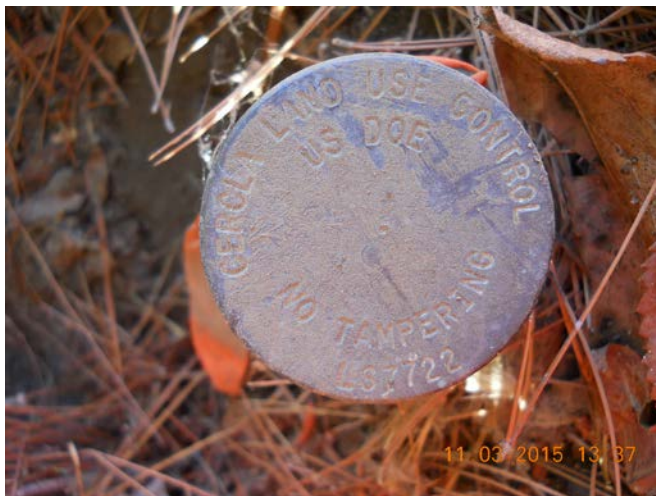
Monument 18: southeast corner of Eastern Remediation Support Area (photo No. 2951).

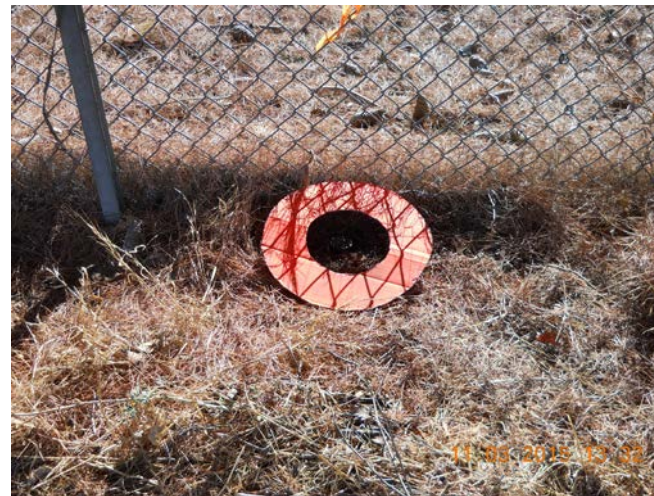
View south: Monument 17, within orange ring; south perimeter fence behind; foot of North Levee in background (photo No. 2944).

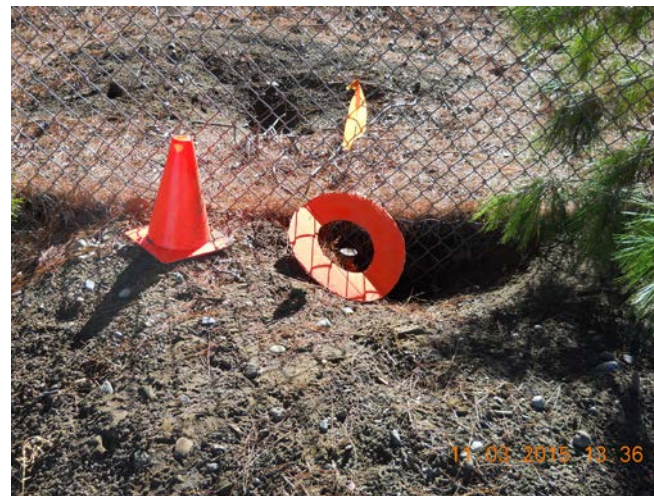
View south: Monument 18, within orange ring; foot of North Levee in background (photo No. 2948).

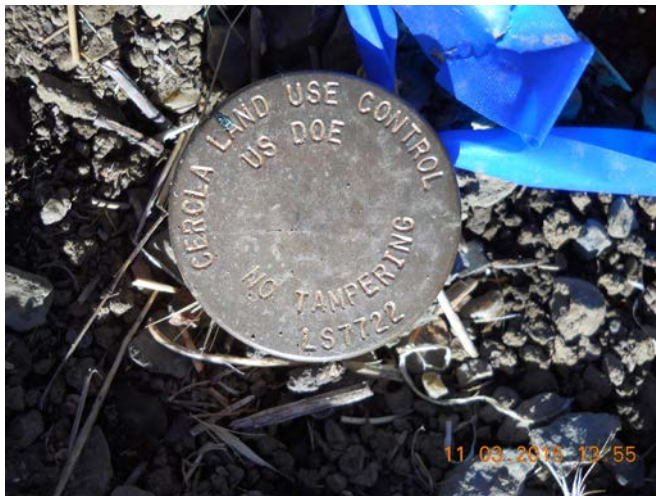
*Monument 19: northwest corner of Eastern Dog Pens Area
(photo No. 2959).*

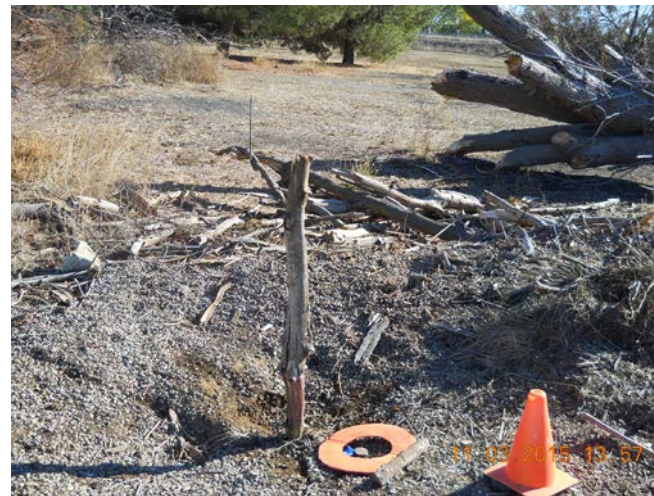
*View southeast: Monument 19, within orange ring;
Eastern Dog Pens Area in background (photo No. 2960).*

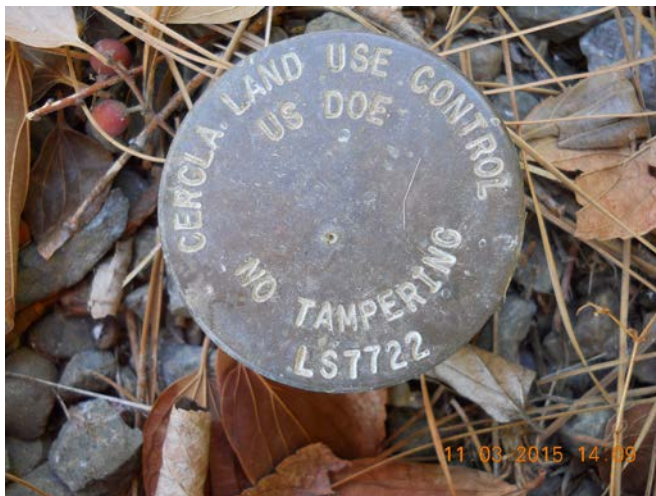
*Monument 20: northeast corner of Eastern Dog Pens Area
(photo No. 2966).*

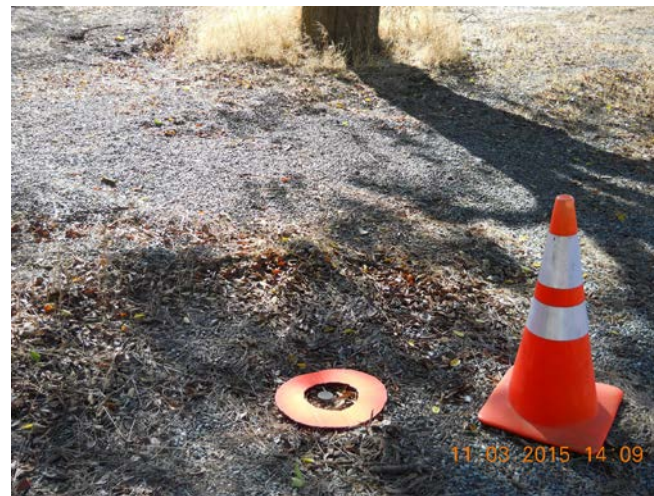
*View southwest: Monument 20, within orange ring;
Eastern Dog Pens Area in background (photo No. 2964).*

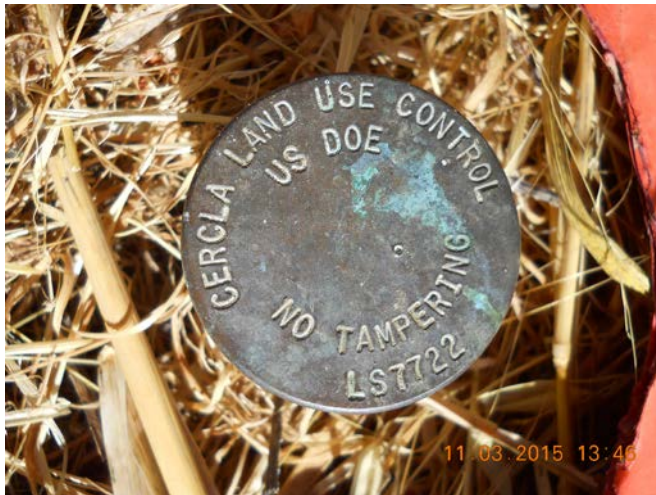
*Monument 21: southwest corner of Eastern Dog Pens Area
(photo No. 2955).*

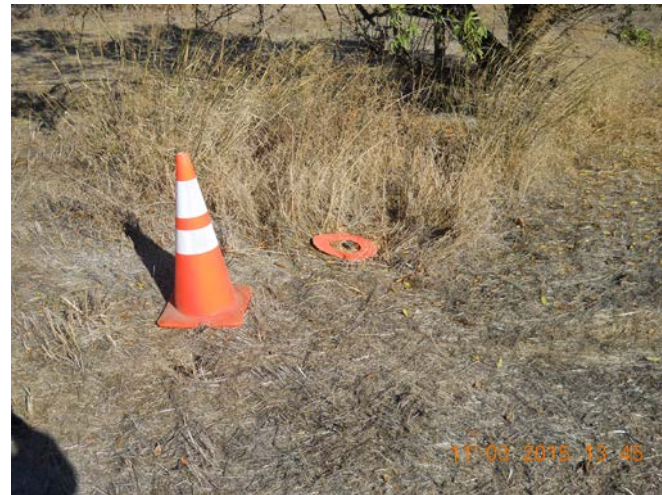
*View northeast: Monument 21, within orange ring;
Eastern Dog Pens Area in background (photo No. 2954).*

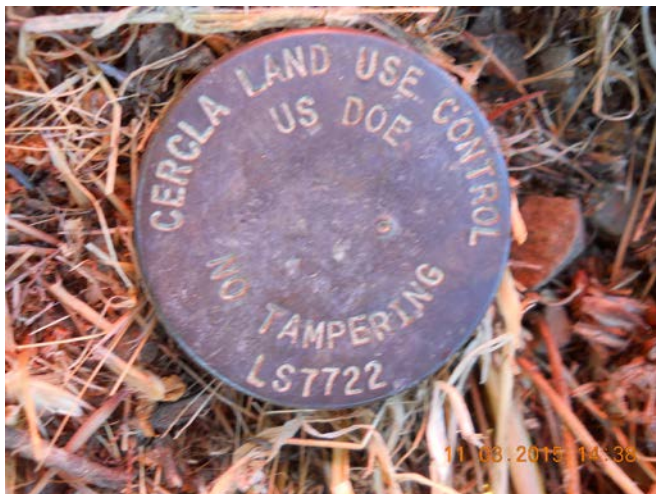
*Monument 22: southeast corner of Eastern Dog Pens Area
(photo No. 2975).*

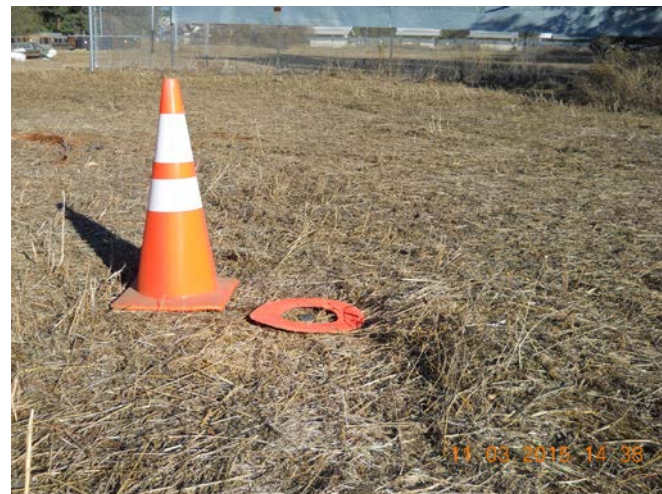
*View east: Monument 22, within orange ring;
Cobalt-60 Area fence in background (photo No. 2974).*

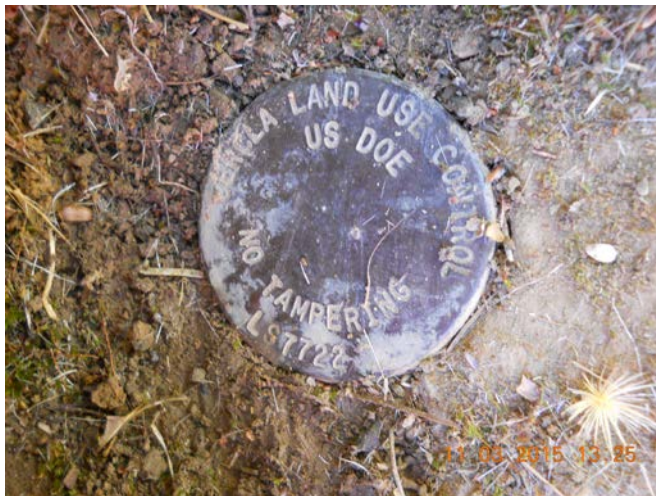
Monument 23: western perimeter point of Southwest Trenches Area (photo No. 2938).

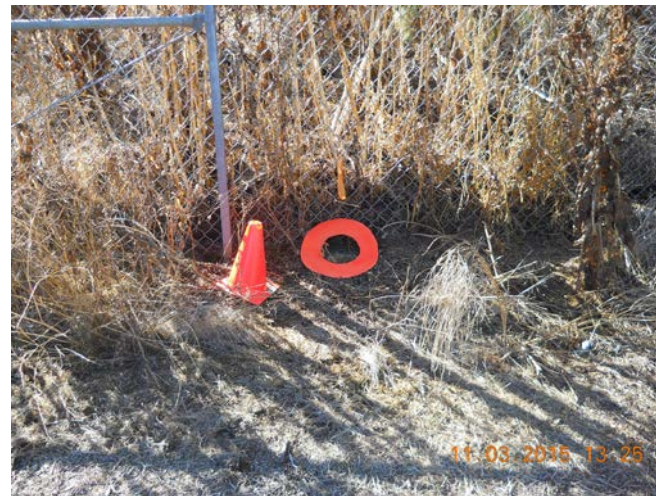
View west: Monument 23, within orange ring; west perimeter fence in background (photo No. 2936).

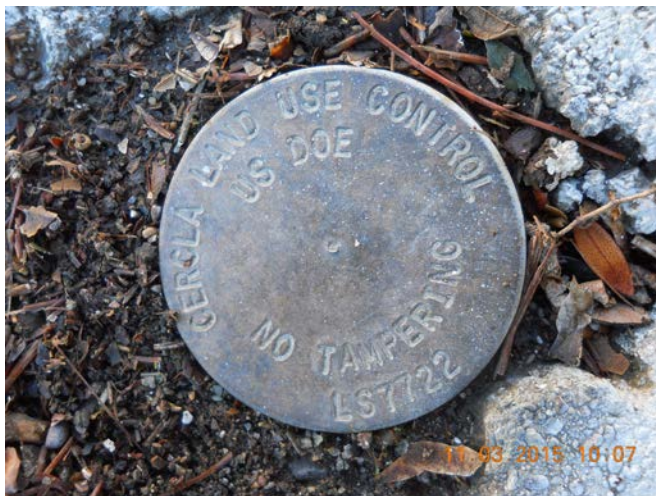
Monument 24: northeast corner of Southwest Trenches Area, at southern perimeter of Domestic Septic System 3 (photo No. 2871).

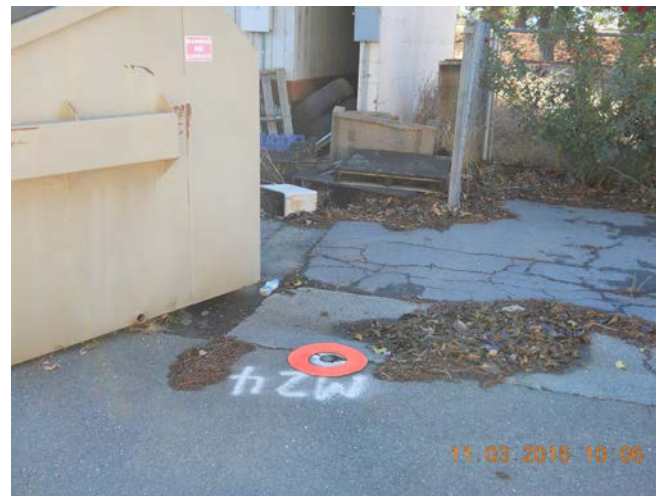
View southeast: Monument 24, within orange ring on edge of concrete swale—waste bin and trailer shed behind; rose planter in right of background (photo No. 2870).

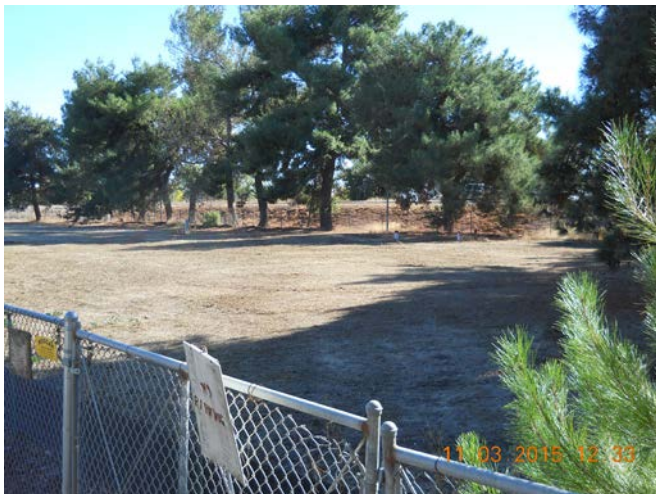
View southeast over Southwest Trenches Area: North Levee in background (photo No. 2914).

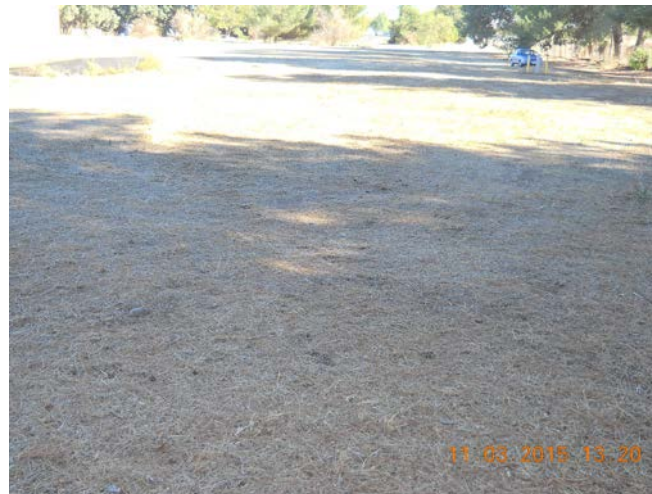
View east over Southwest Trenches Area: Western Dog Pens Area and UC Davis Southern Trenches Area in background (photo No. 2933).

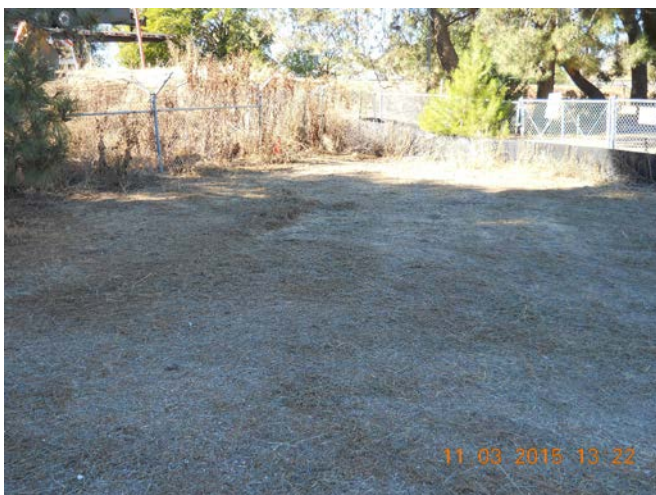
Northwest corner of Southwest Trenches Area (photo No. 2935).

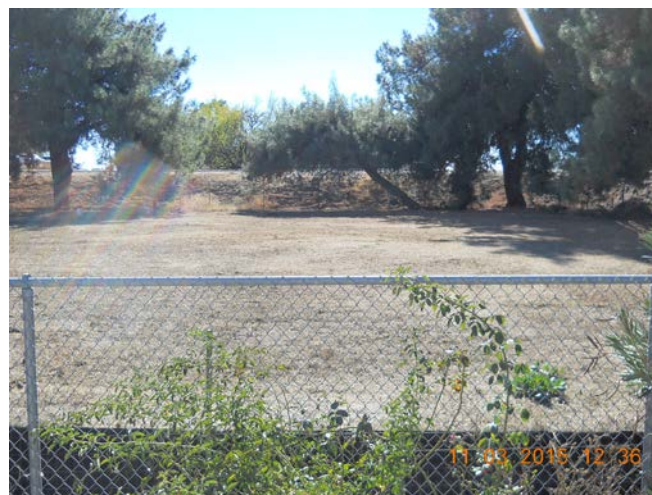
View south over Southwest Trenches Area: North Levee in background; shoulder of Old Davis Road to right (photo No. 2916).

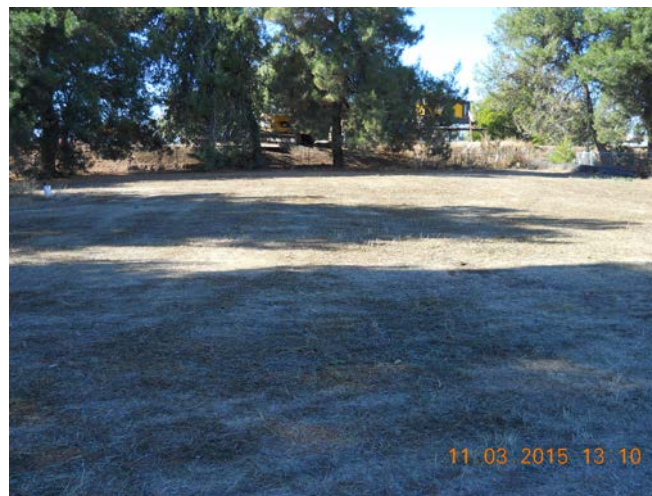
View west over Southwest Trenches Area: shoulder of Old Davis Road in background (photo No. 2926).

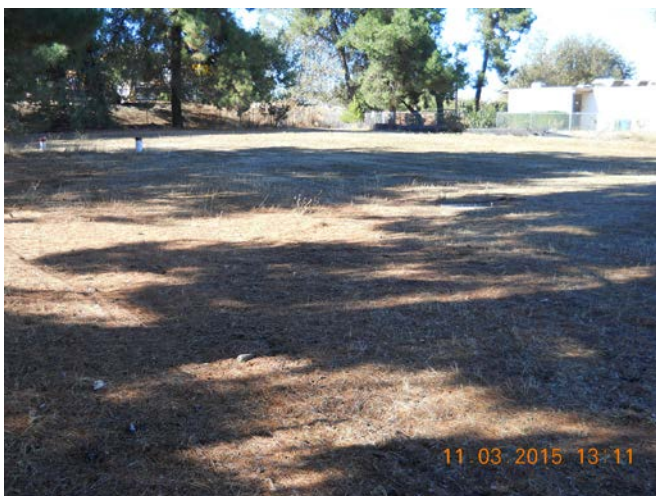
View northwest over Southwest Trenches Area (photo No. 2927).

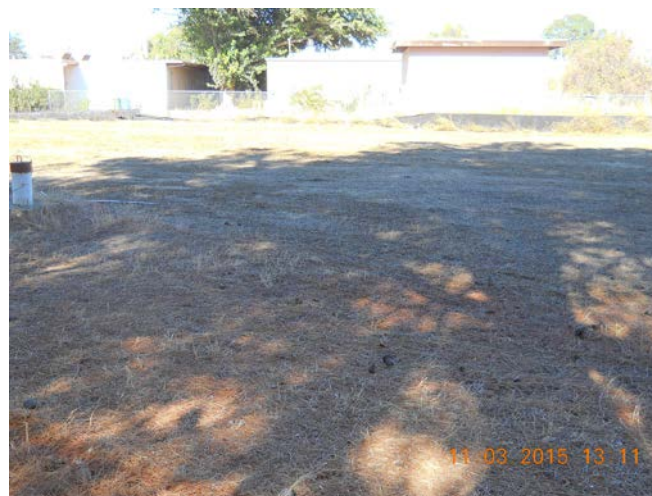
View north over Southwest Trenches Area (photo No. 2928).

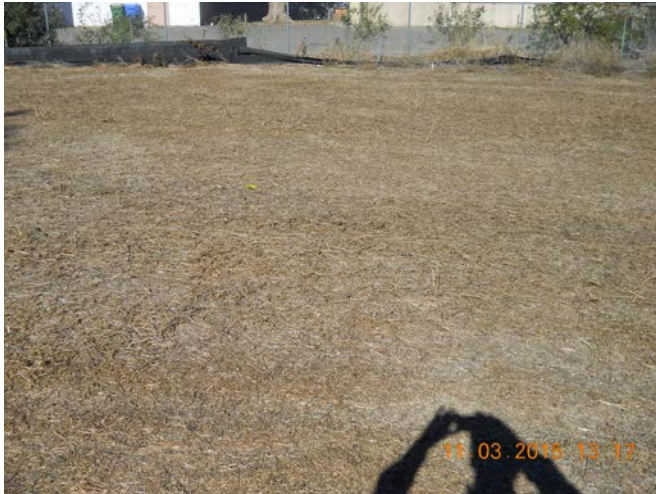
*View north from center of Southwest Trenches Area
(photo No. 2929).*

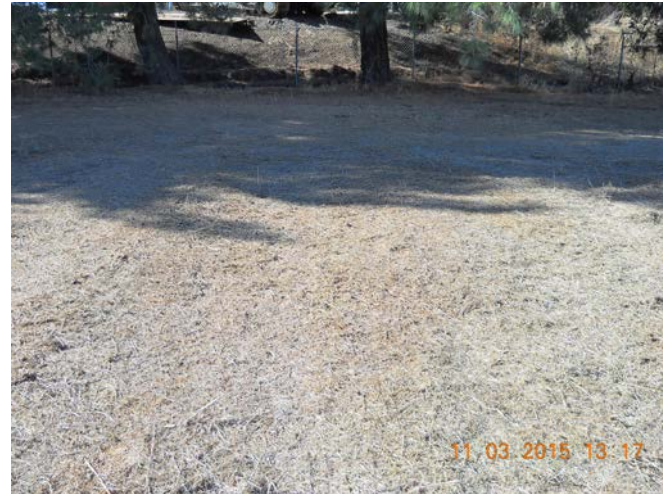
*View west from center of Southwest Trenches Area
(photo No. 2930).*

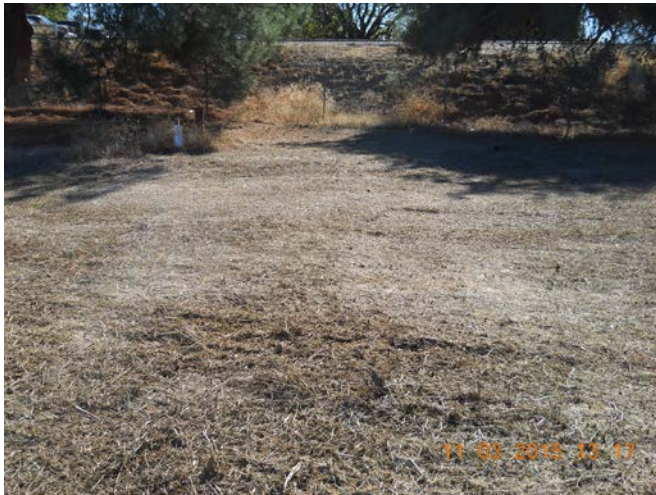
*View south from center of Southwest Trenches Area
(photo No. 2931).*

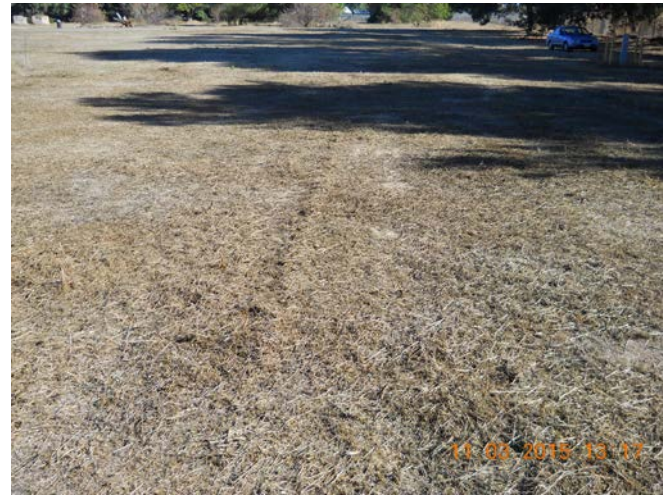
*View east from center of Southwest Trenches Area
(photo No. 2932).*

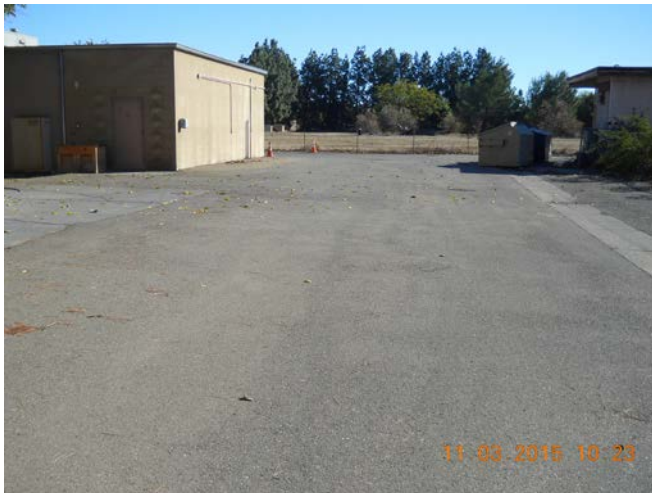
View east over former leach field part of Domestic Septic System 3 Area: Building H-216 to left; storage unit to right; Western Dog Pens Area in background (photo No. 2878).

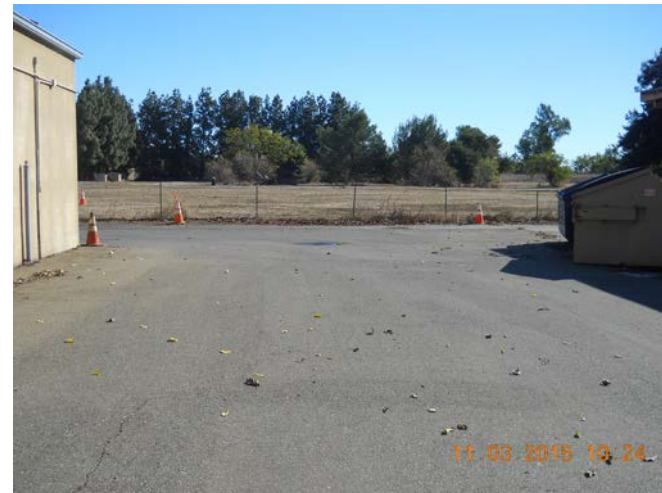
View east over eastern half of Domestic Septic System 3 Area (photo No. 2879).

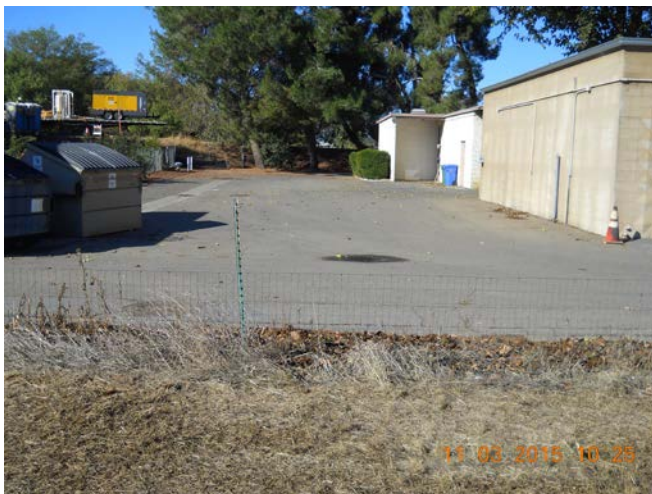
View west over former leach field part of Domestic Septic System 3 Area: Buildings H-215 and H-216 to right; shoulder of Old Davis Road in background (photo No. 2880).

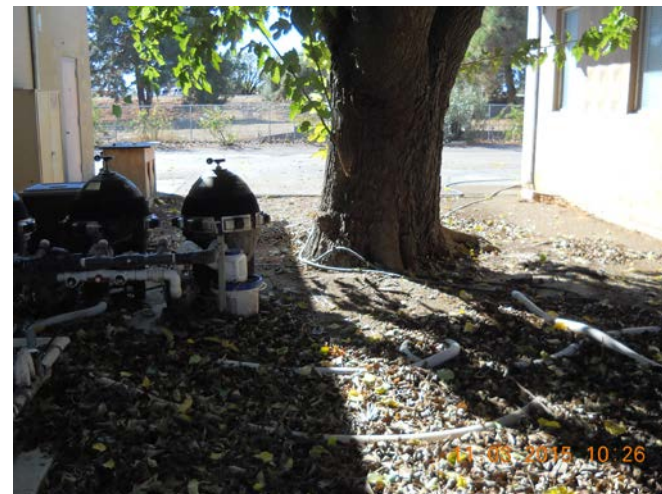
View south over septic tank part of Domestic Septic System 3 Area: Building H-216 to left; Building H-215 to right (photo No. 2881).

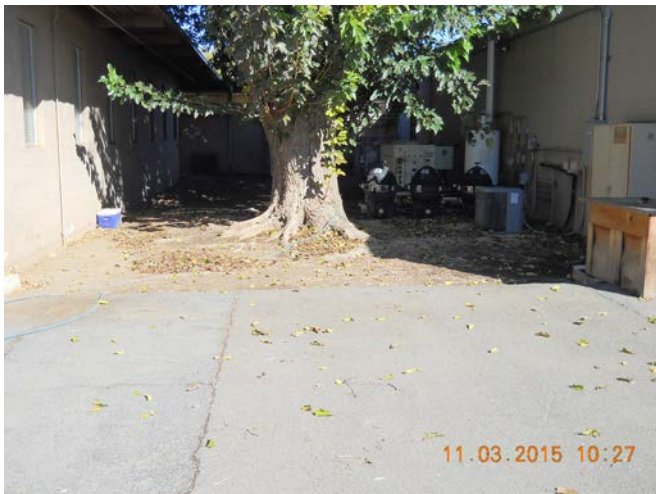
View north over septic tank part of Domestic Septic System 3 Area: Building H-215 to left, Building H-216 to right; Domestic Septic System 4 Area in background (photo No. 2882).

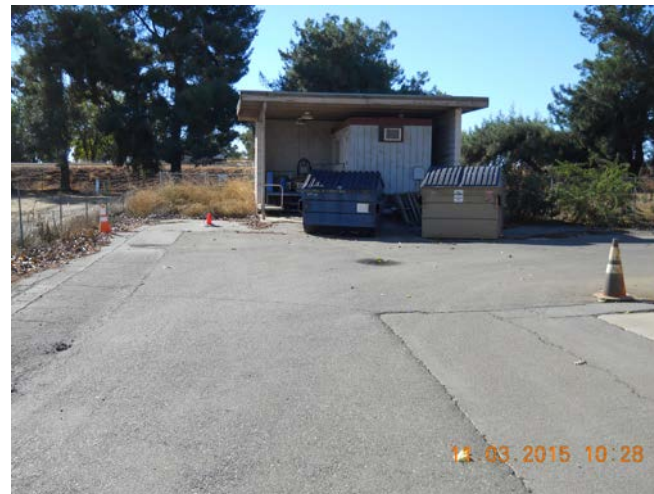
View south over east end of Domestic Septic System 3 leach field: trailer in background (photo No. 2883).
